MEMORANDUM

TO: Members of the Forest and Beach Commission

SUBJECT: Tree Removal (Private)
Block: 24 Lot: 10 & 12
E/ Santa Fe St., 4 & 5 houses north of 2nd Ave.
Applicants/Owners: Michael Kamm & San Carlos Agency / Michael Kamm and
Cliff, Debbie, Taylor, and Deborah Mar

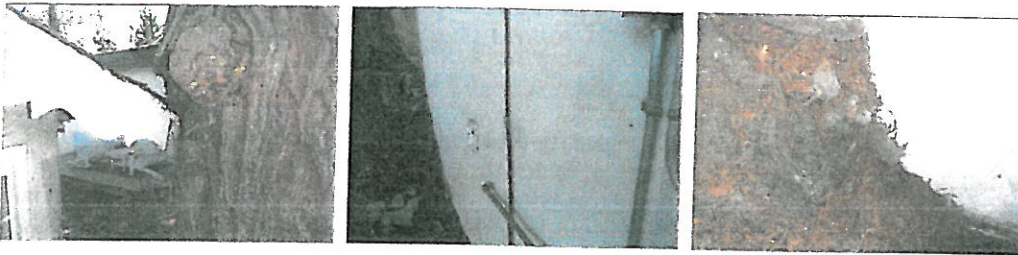
A tree adjacent to the structure has caused damage to the eaves, laundry room, and siding and is threatening the foundation. Recommending consulting an arborist who could make suggestions on trimming the tree or consulting a licensed contractor who could make suggestions on moving the laundry room.

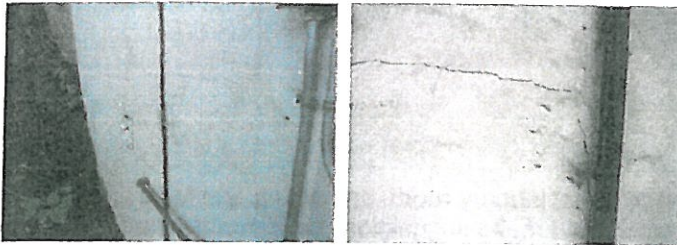
There are chips or cracks in the stucco that should be sealed to prevent moisture intrusion. Recommend further evaluation by a licensed stucco contractor or qualified installer prior to the close of escrow.

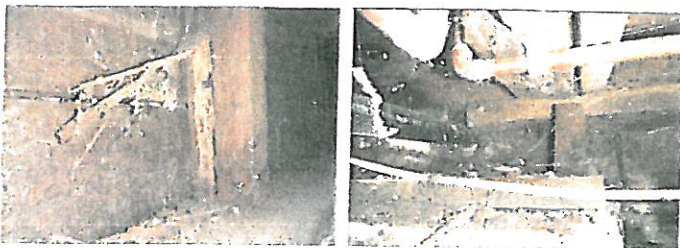
Portions of the framing are insect or moisture damaged and should be evaluated by a termite inspector or licensed contractor prior to the close of escrow.

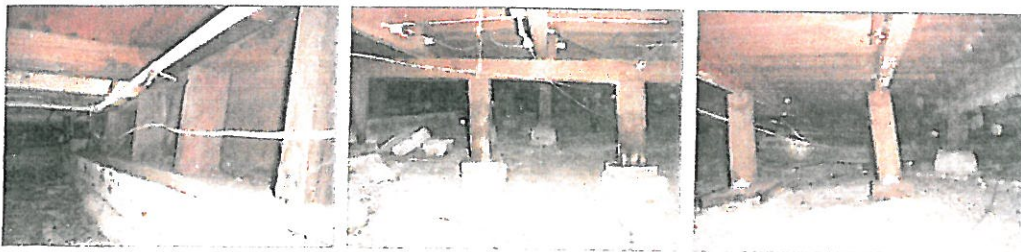
The cripple walls are leaning, several of the support posts are leaning or do not have pier blocks and are in contact with the soil. Recommend further evaluation of the entire by a structural engineer prior to the close of escrow

The floor framing should be evaluated for the reasons indicated - *Continued*

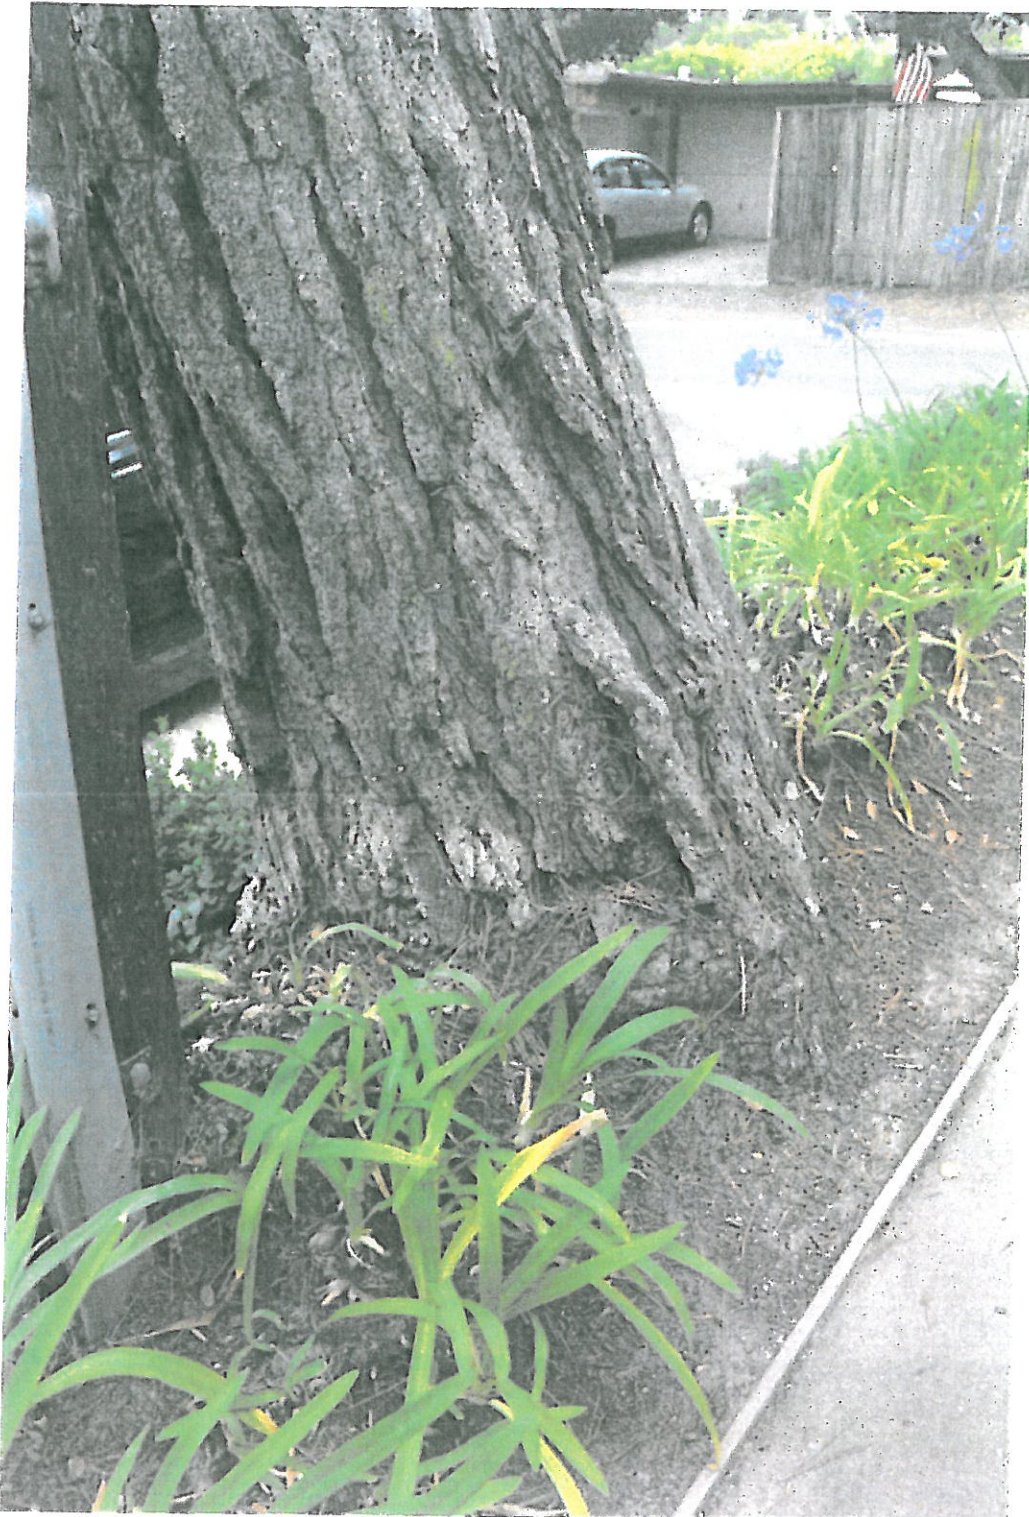
The tree has very limited soil volume that is not covered in asphalt or the residences. Small soil volume will limit the development of strong structural roots. Because there are asphalt driveways on two sides of the tree with the house and road on the other two sides there is very limited space for roots to grow and develop. Any kind of obstruction of roots or the root collar can contribute to tree failure. The California Tree Failure Report indicates that 34 percent of all recorded Monterey pine failures occurred at the roots.

Limited soil area

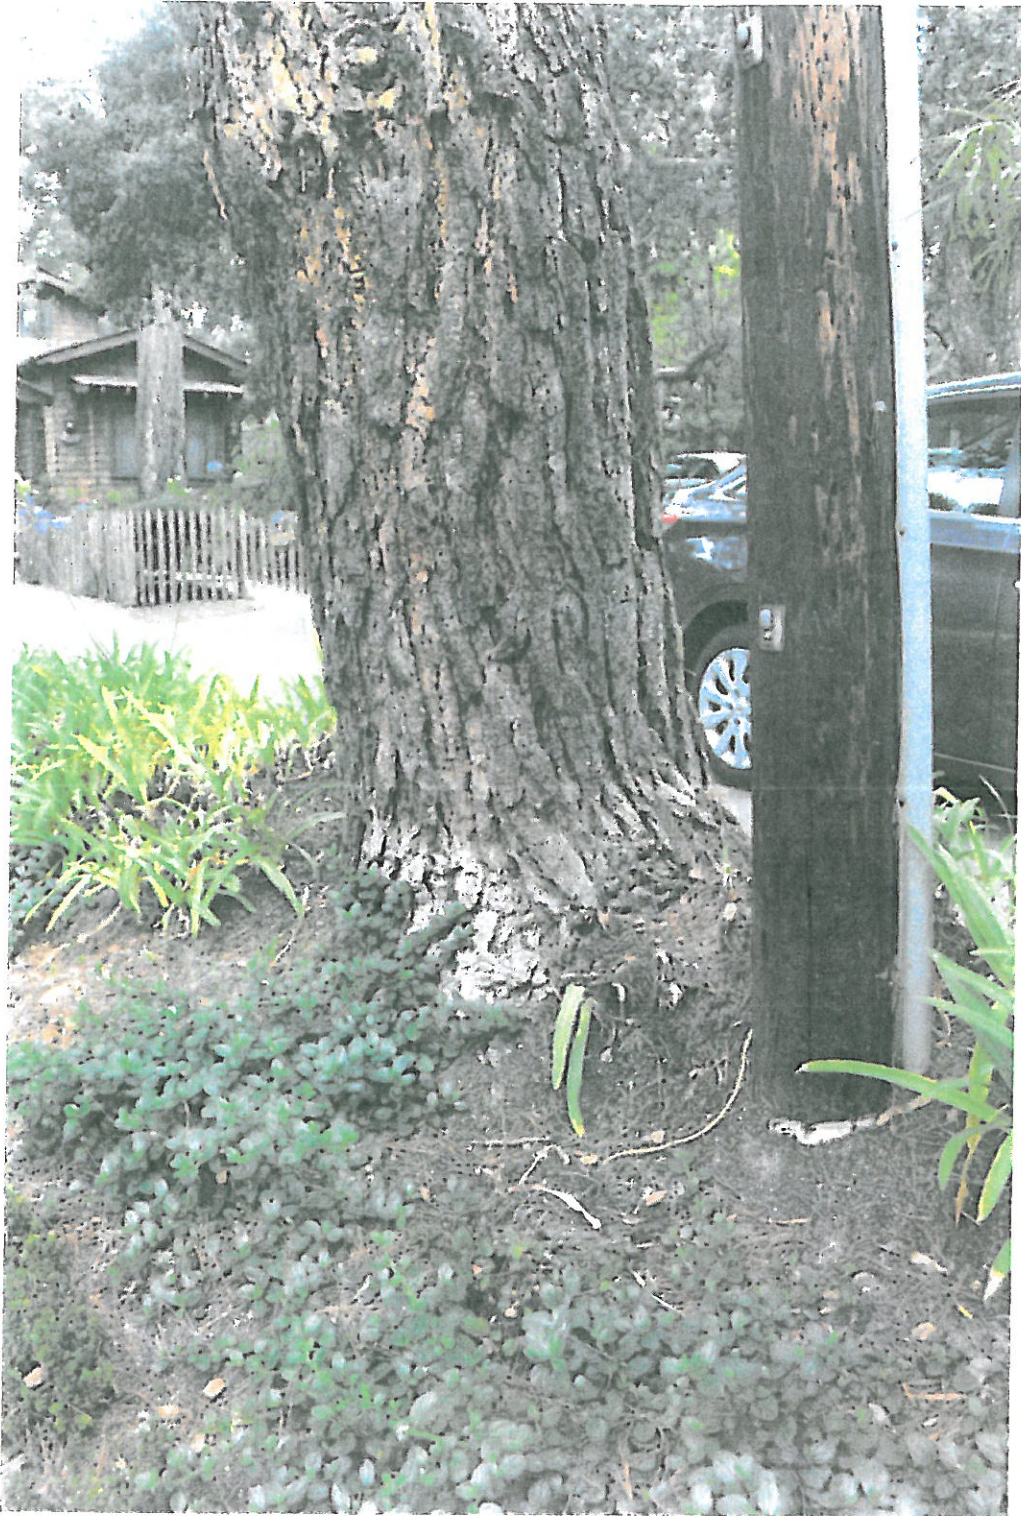
Obstruction from utility pole

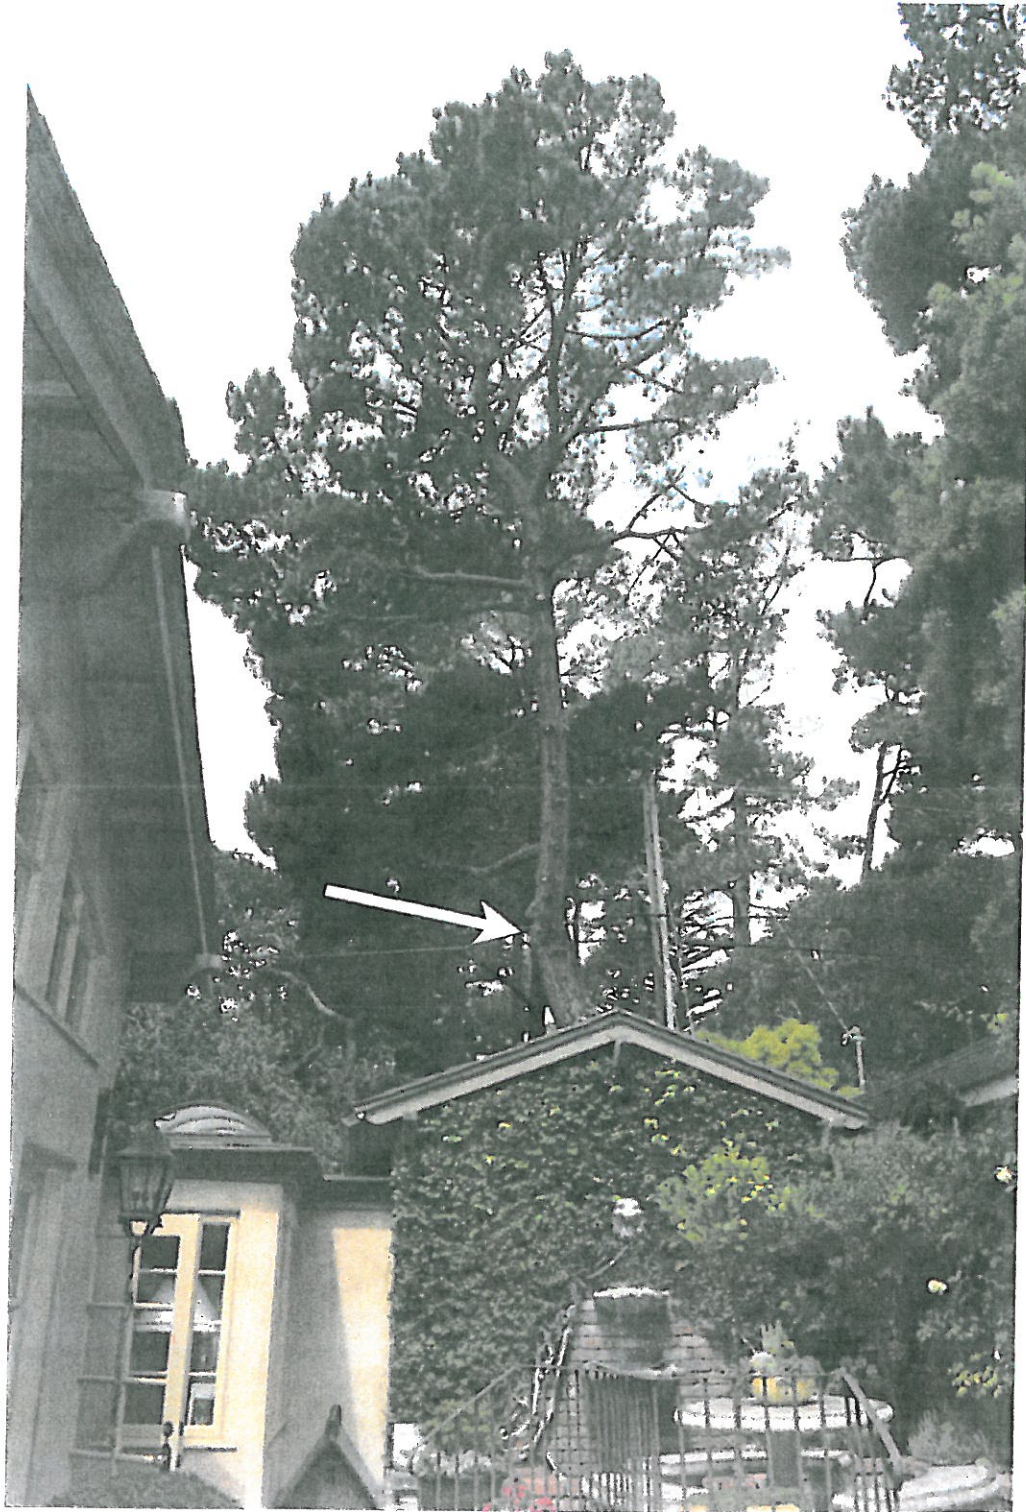
Abrupt bend in stem

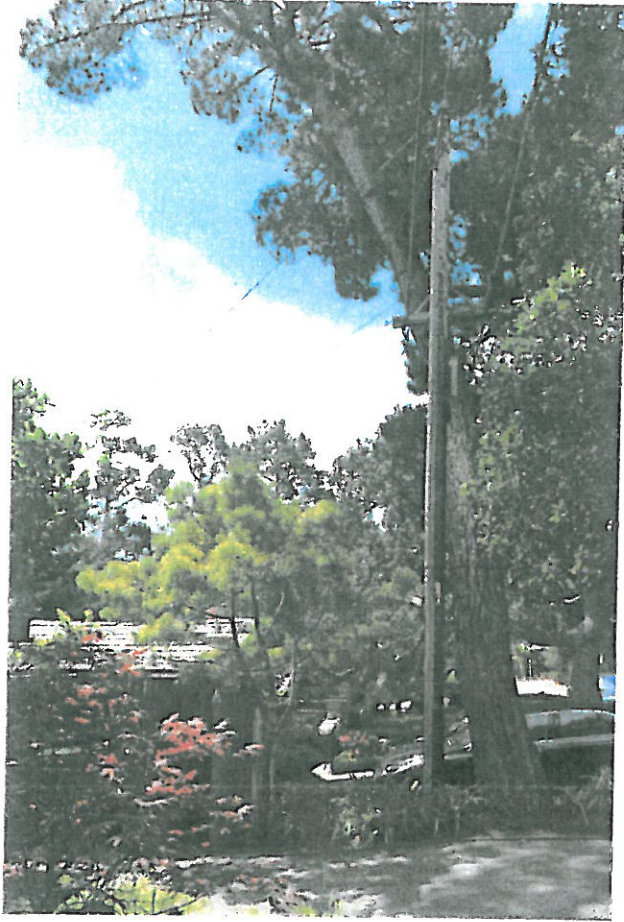
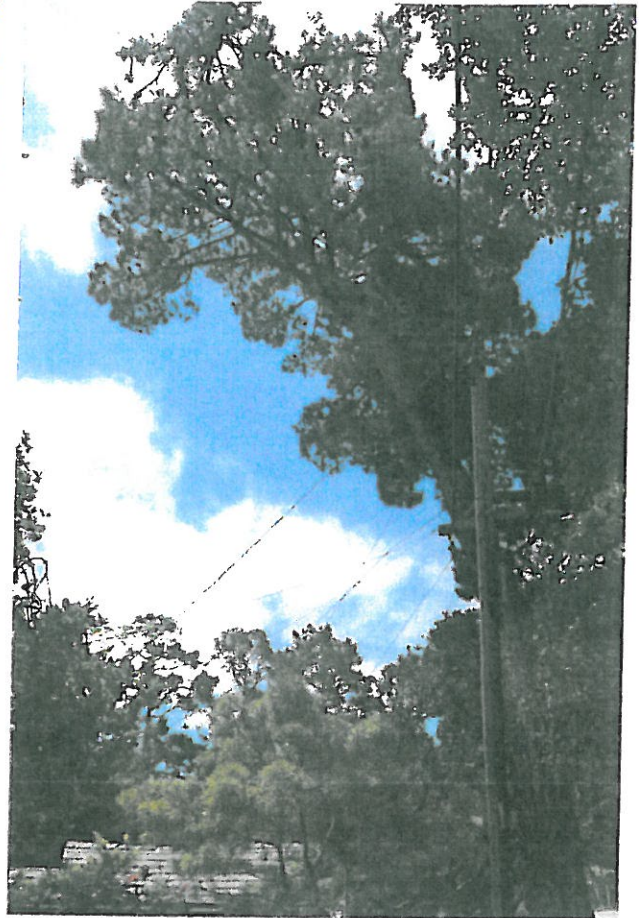
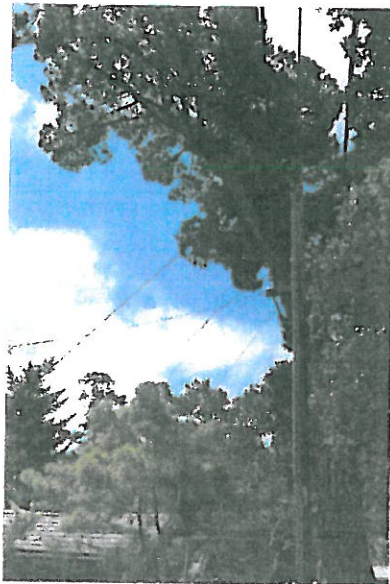
Trees with bows are characterized by the upper portion or crown of the tree bending over more than the lower stem. Typically this architecture is caused by a partial failure of wood fibers at some point in the life of the tree and was caused by either high winds or the tree being suppressed by larger trees nearby. Trees with poor trunk taper, especially conifers or **excurrent** trees like the Monterey pine, and those with low live crown ratio, will be less stable during storm events or high winds (Dunster, 2009). Trees with bowed stems and poor trunk taper have a likelihood of failure of either **possible** or **probable** (Dunster, J, Smiley, E, Matheny, N, and Lilly, S. 2013). Because of the combination of bowed stem, low live crown ratio, and poor trunk taper the likelihood of stem or tree failure is *probable*.

Bowed stem
