GEOTECHNICAL INVESTIGATION
For
Second Avenue between Lopez and North Casanova Street
Carmel-by-the Sea, California

Prepared By
HARO, KASUNICH AND ASSOCIATES, INC.
Geotechnical & Coastal Engineers
Project No. M9928
February 2010

Subject: Geotechnical Investigation Report

Reference: Roadway Distress
Second Avenue between Lopez and North Casanova Streets
Carmel-by-the-Sea, California

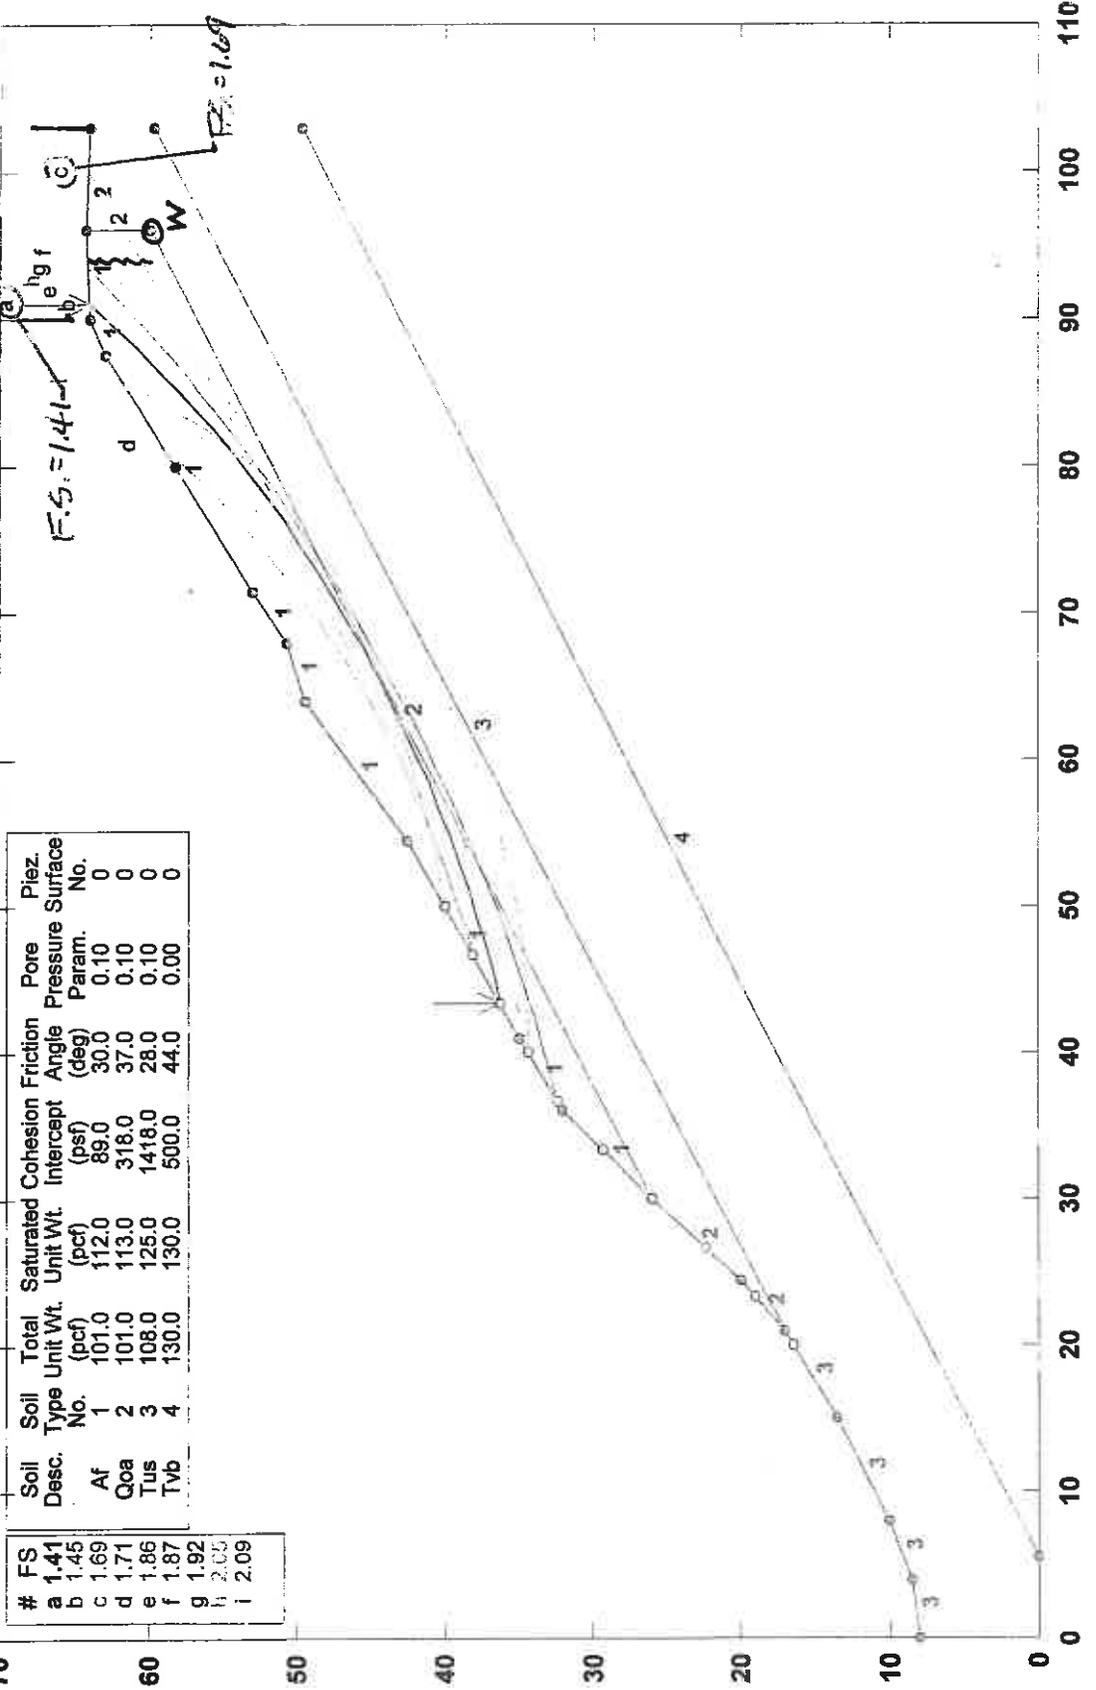
M 9928-Second Avenue, Carmel Section 2-2, STATIC

Hg. B-1	Static Condition Circular Failure Surface	
	Outboard side of road:	min. FS=1.41
	Inboard side of road:	min. FS=1.69
Hg. B-2	Seismic Condition Circular Failure Surface	
	Outboard side of road:	min. FS=0.85
	Inboard side of road:	min. FS=0.99
Hg. B-3	Seismic Condition Planar Failure Surface	min. FS=0.92

STABL6H FSmin=1.41
Safety Factors Are Calculated By The Modified Janbu Method

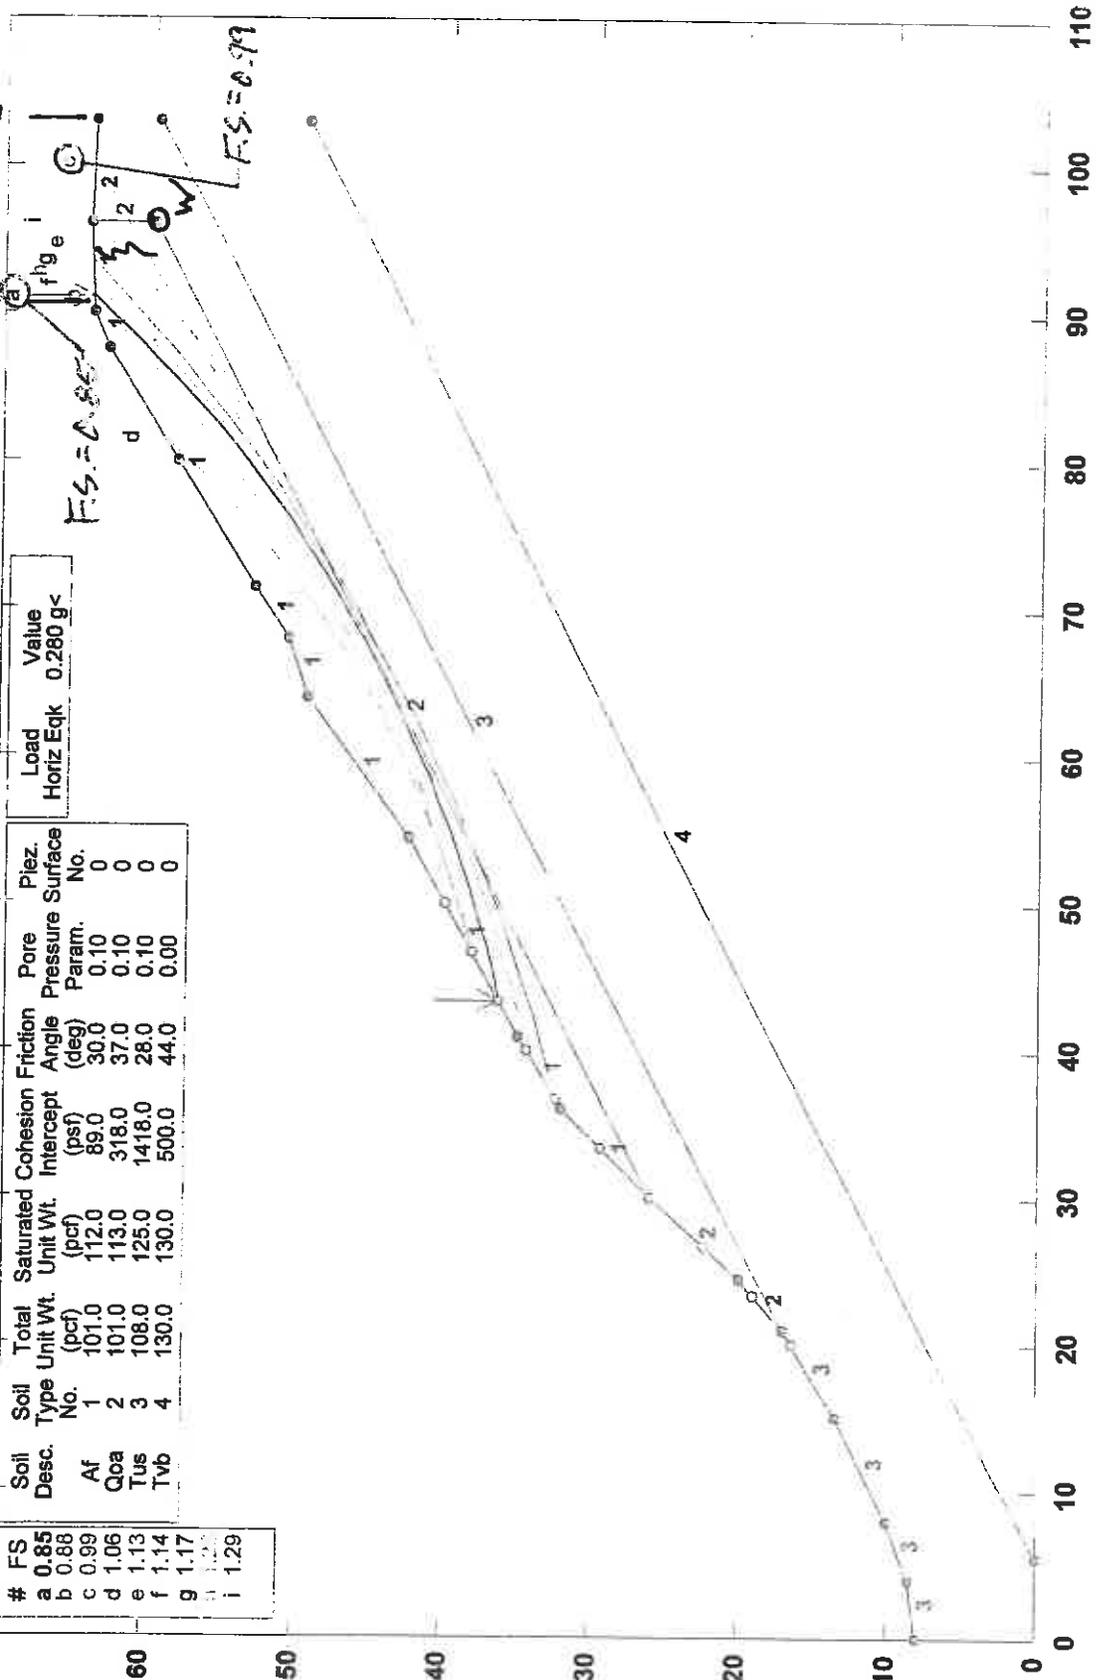
STABL6H FSmin=0.85
Safety Factors Are Calculated By The Modified Janbu Method

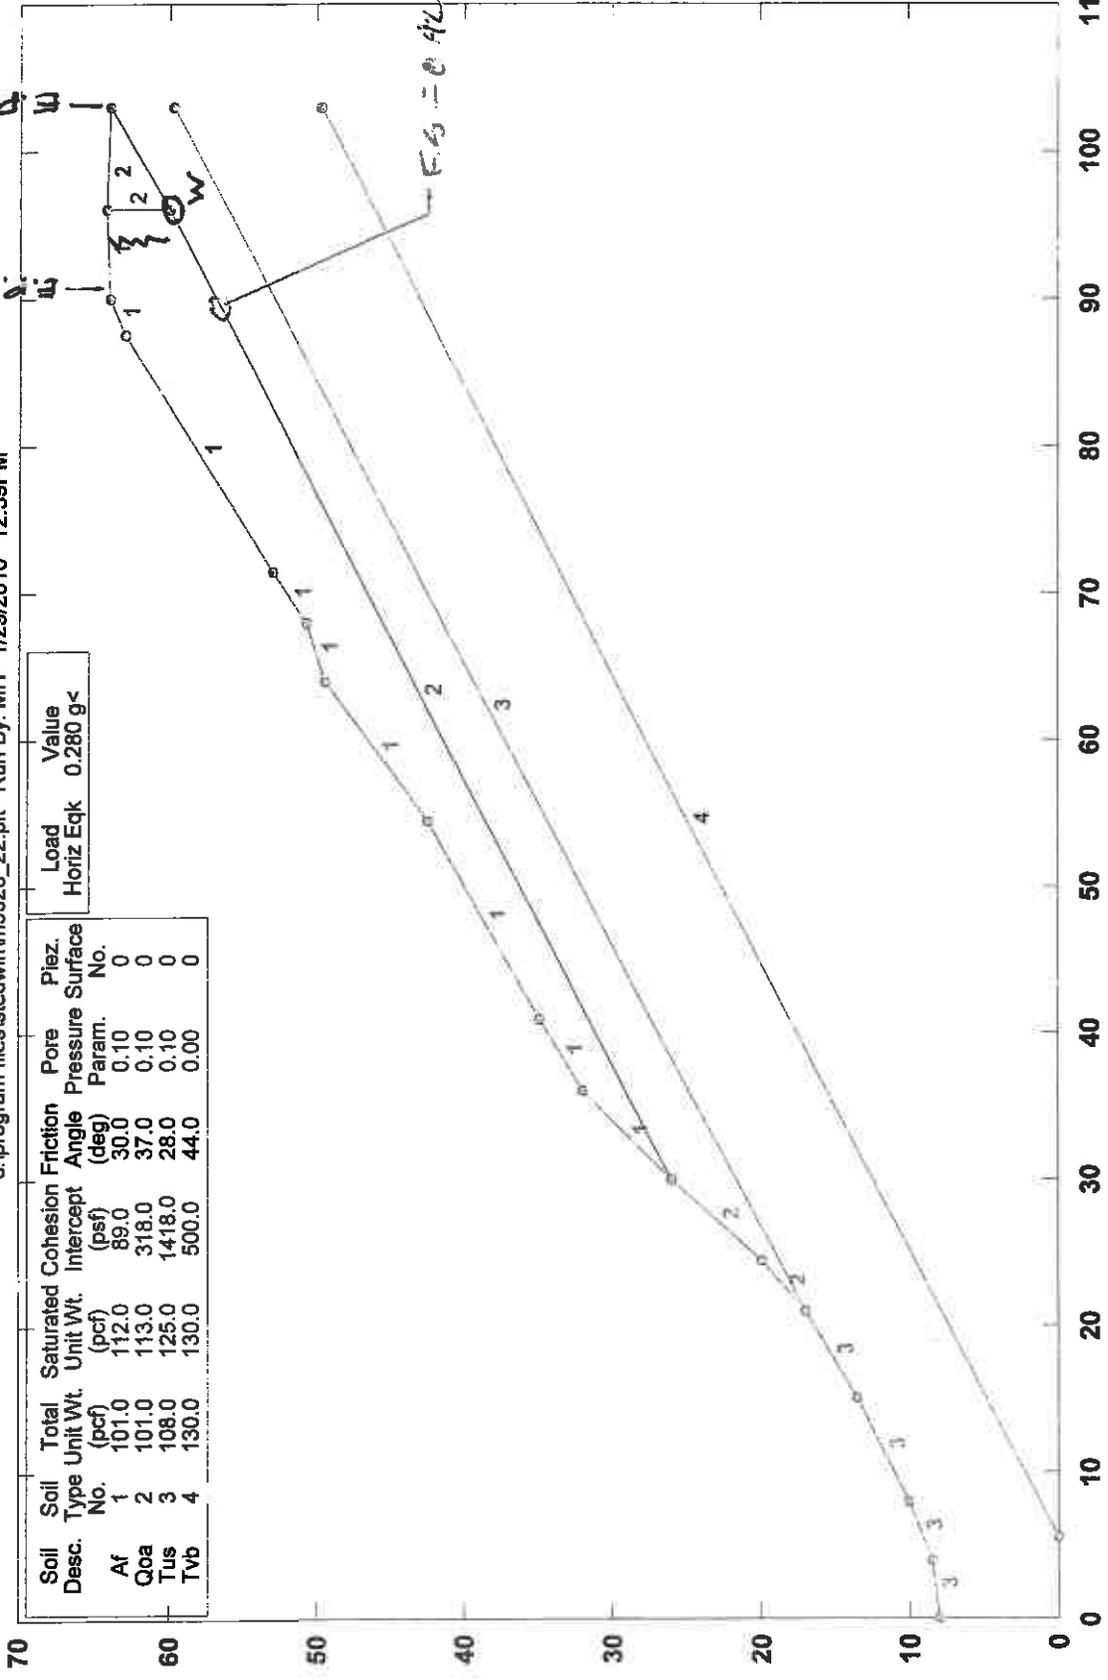
M 9928-Second Avenue, Carmel Section 2-2, SEISMIC, planar, inbd ssmh

STABL6H FSmin=0.92
Factors of Safety Calculated by Janbu Method

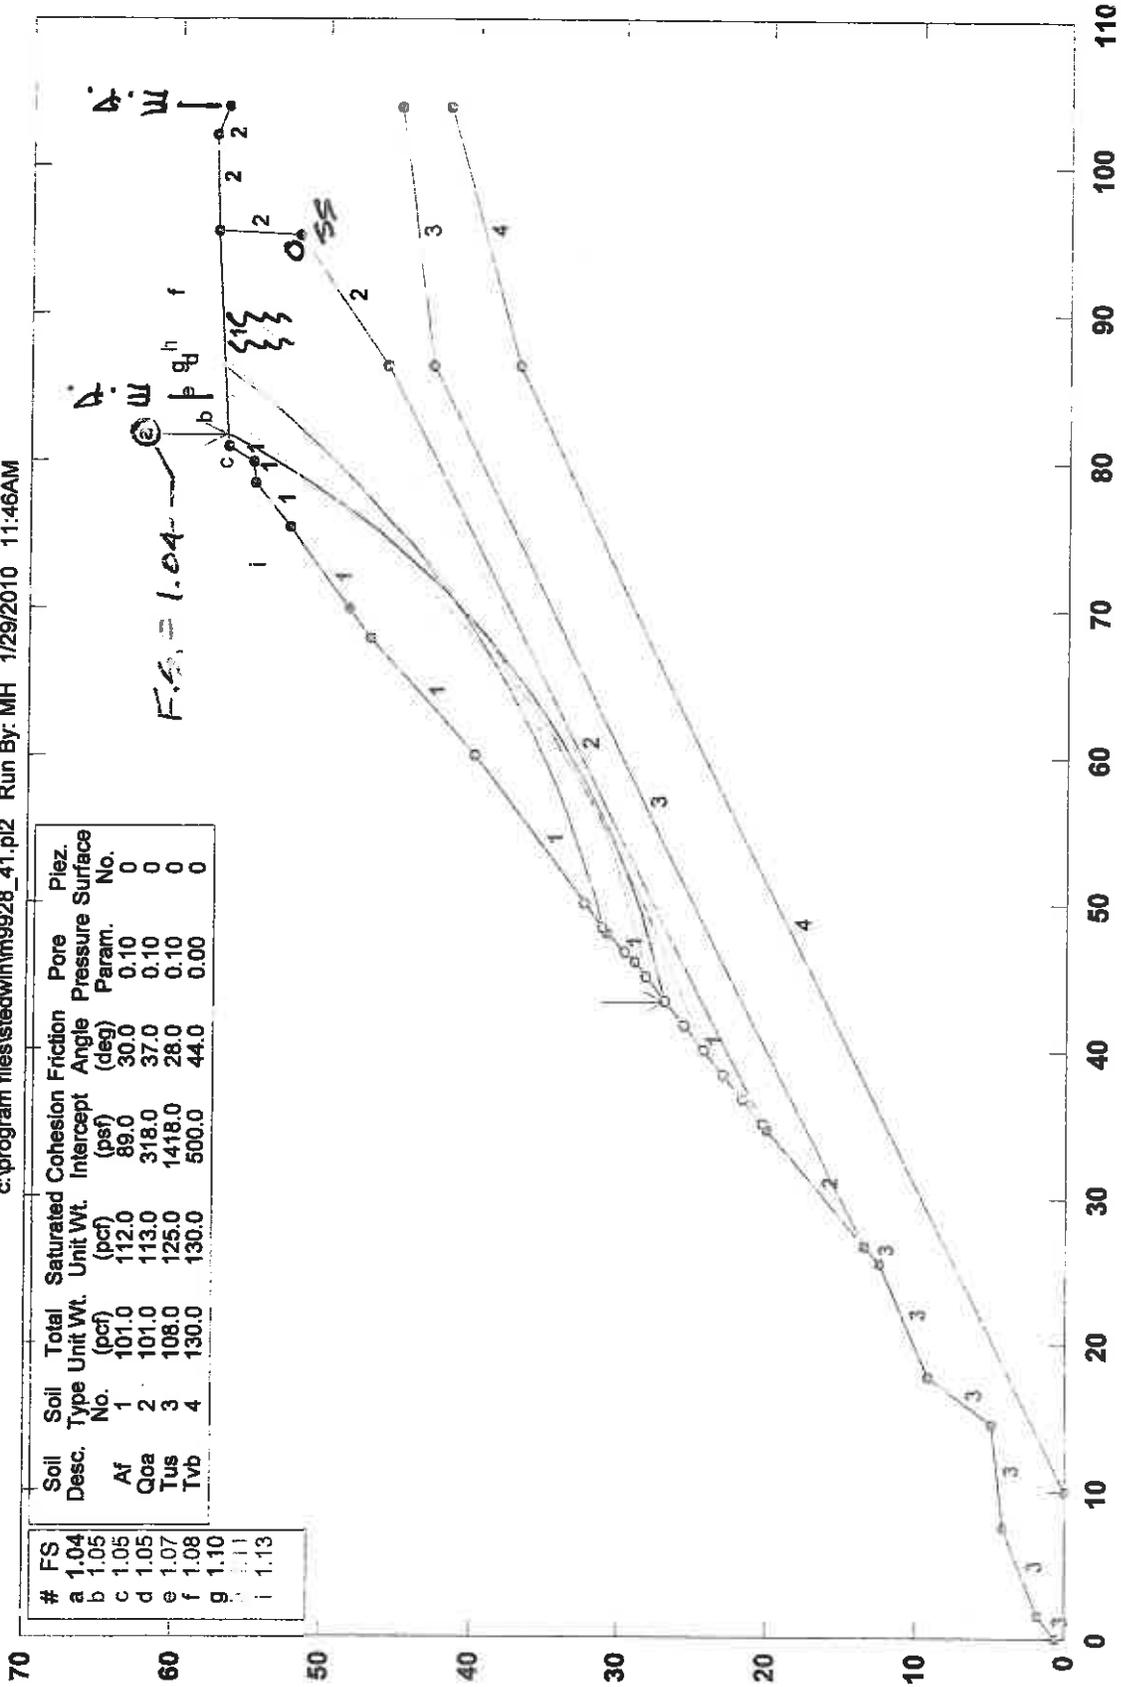
M9928-Second Avenue, Carmel Section 4-4, static, outboard

Hg. B-4	Static Condition Circular Failure Surface	
	Outboard side of road:	min. FS=1.04
Hg. B-5	Static Condition, Circular Failure Surface	
	Inboard side of road:	min. FS=1.16-1.42
Hg. B-6	Seismic Condition, Circular Failure Surface	
	Outboard side of road:	min. FS=0.70
	Inboard side of road:	min. FS=0.78
Hg. B-7	Seismic Condition, Planar Failure Surface:	min. FS=0.76

STABL6H FSmin=1.04
Safety Factors Are Calculated By The Modified Janbu Method

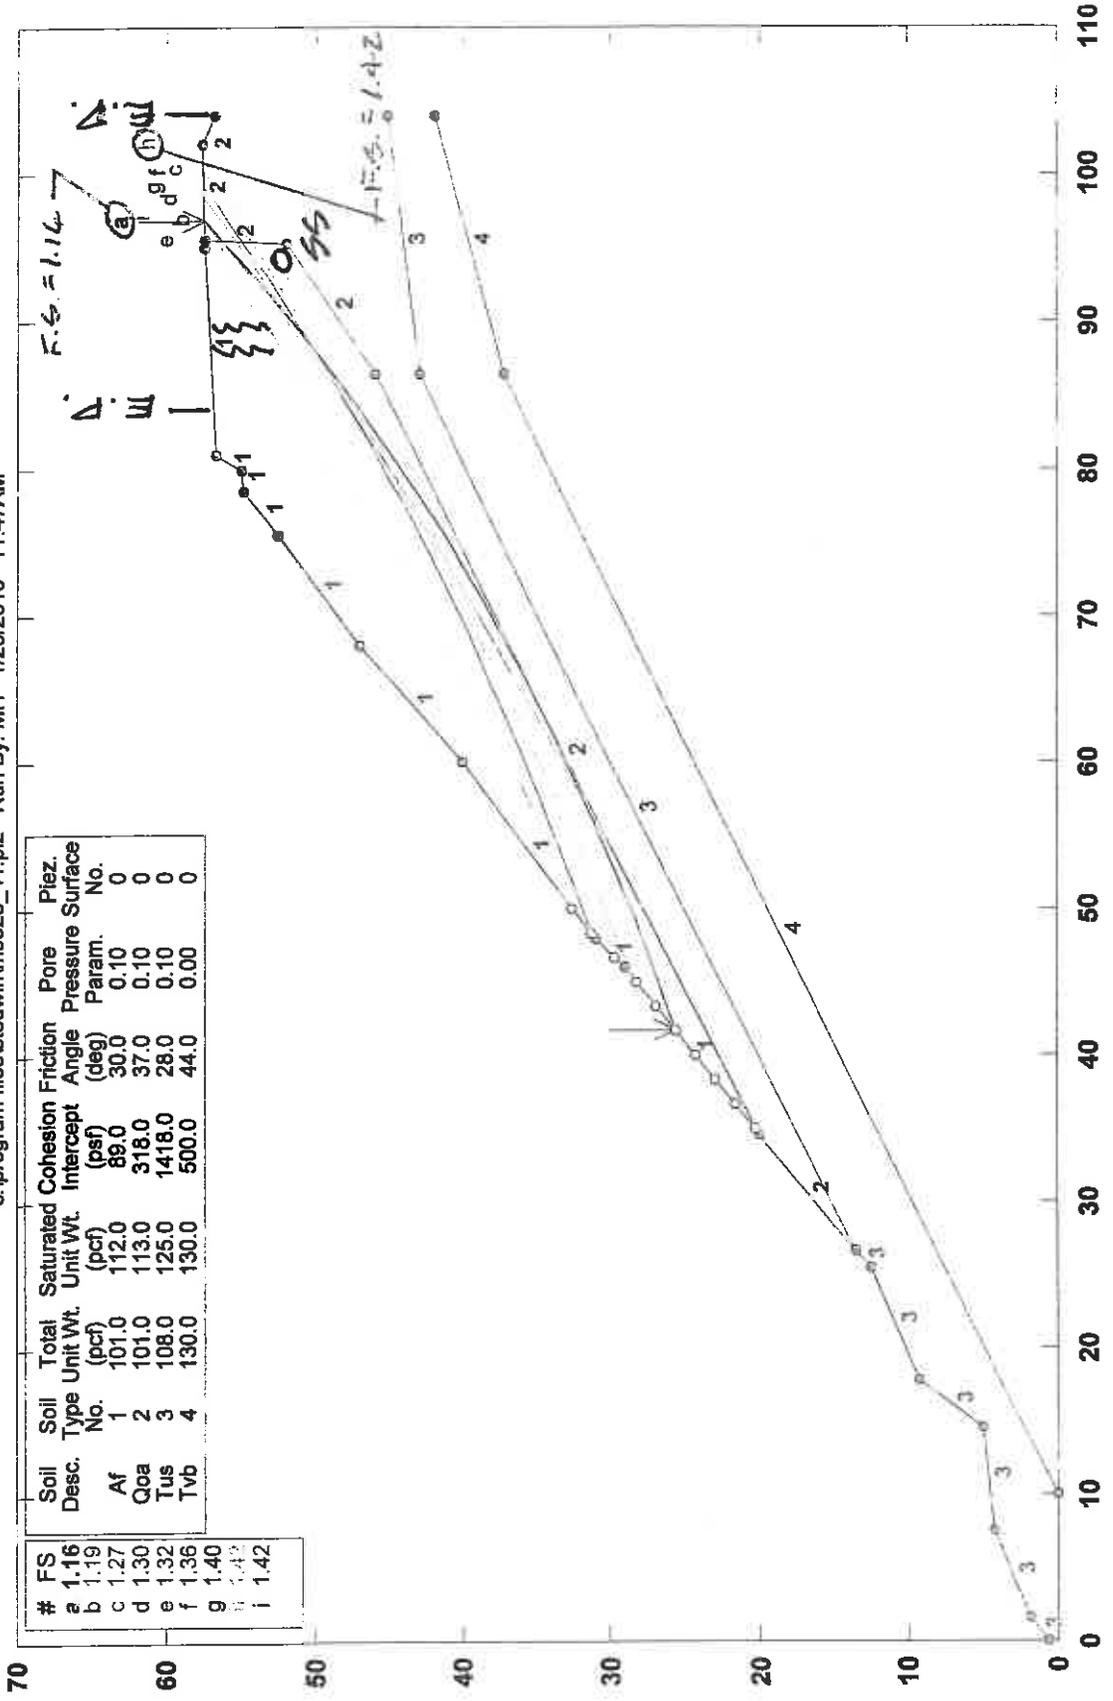
M9928-Second Avenue, Carmel Section 4-4, static, inboard

Statically, the outboard half of the road, which is coincident with the distress observed, yielded Factors of Safety ranging between failing to barely stable (FS= 0.83 to 1.41) suggesting potential instability of this section of the road. Refer to Figures B-1, B-4, B-8, and B-9. However for the inboard side of the road the static Factors of Safety ranged from barely stable to stable (FS= 1.16 to 1.69). Refer to Figures B-2, B-5 and B-11 in Appendix B.

STABL6H FSmin=1.16
Safety Factors Are Calculated By The Modified Janbu Method

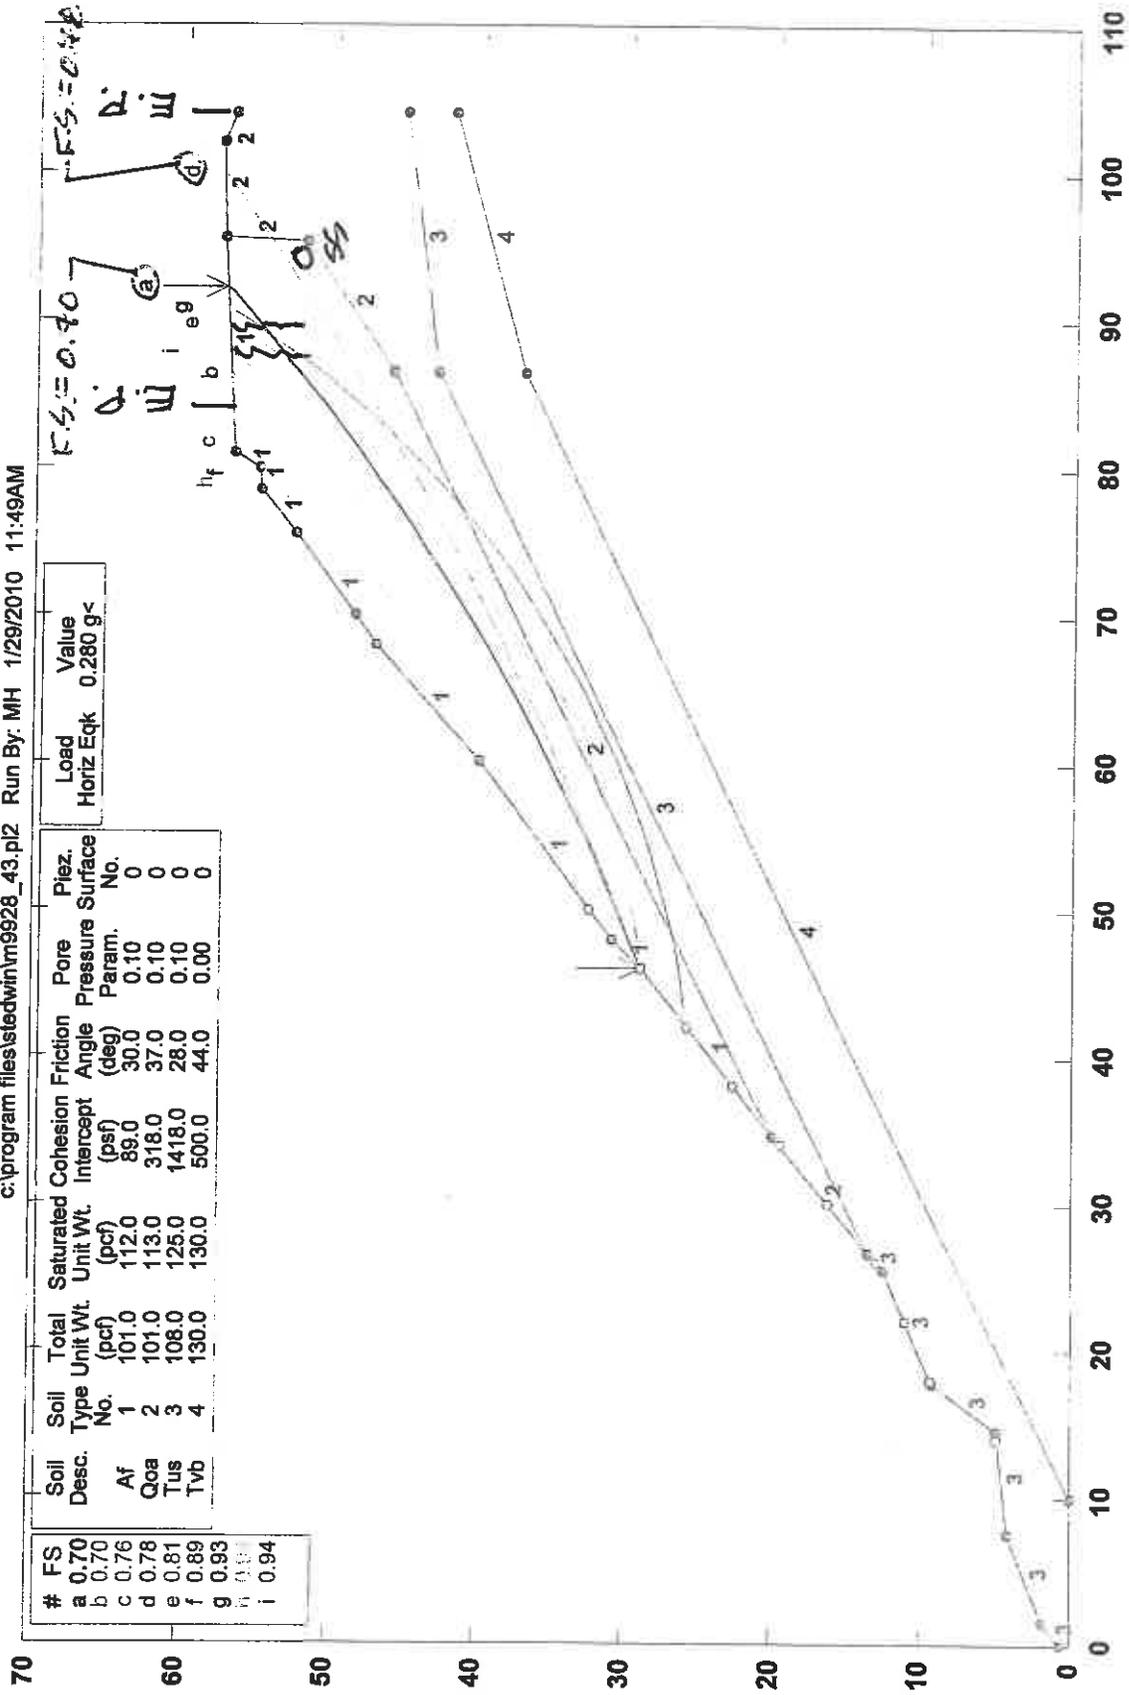
M9928-Second Avenue, Carmel Section 4-4, SEISMIC

STABL6H FSmin=0.70
Safety Factors Are Calculated By The Modified Janbu Method

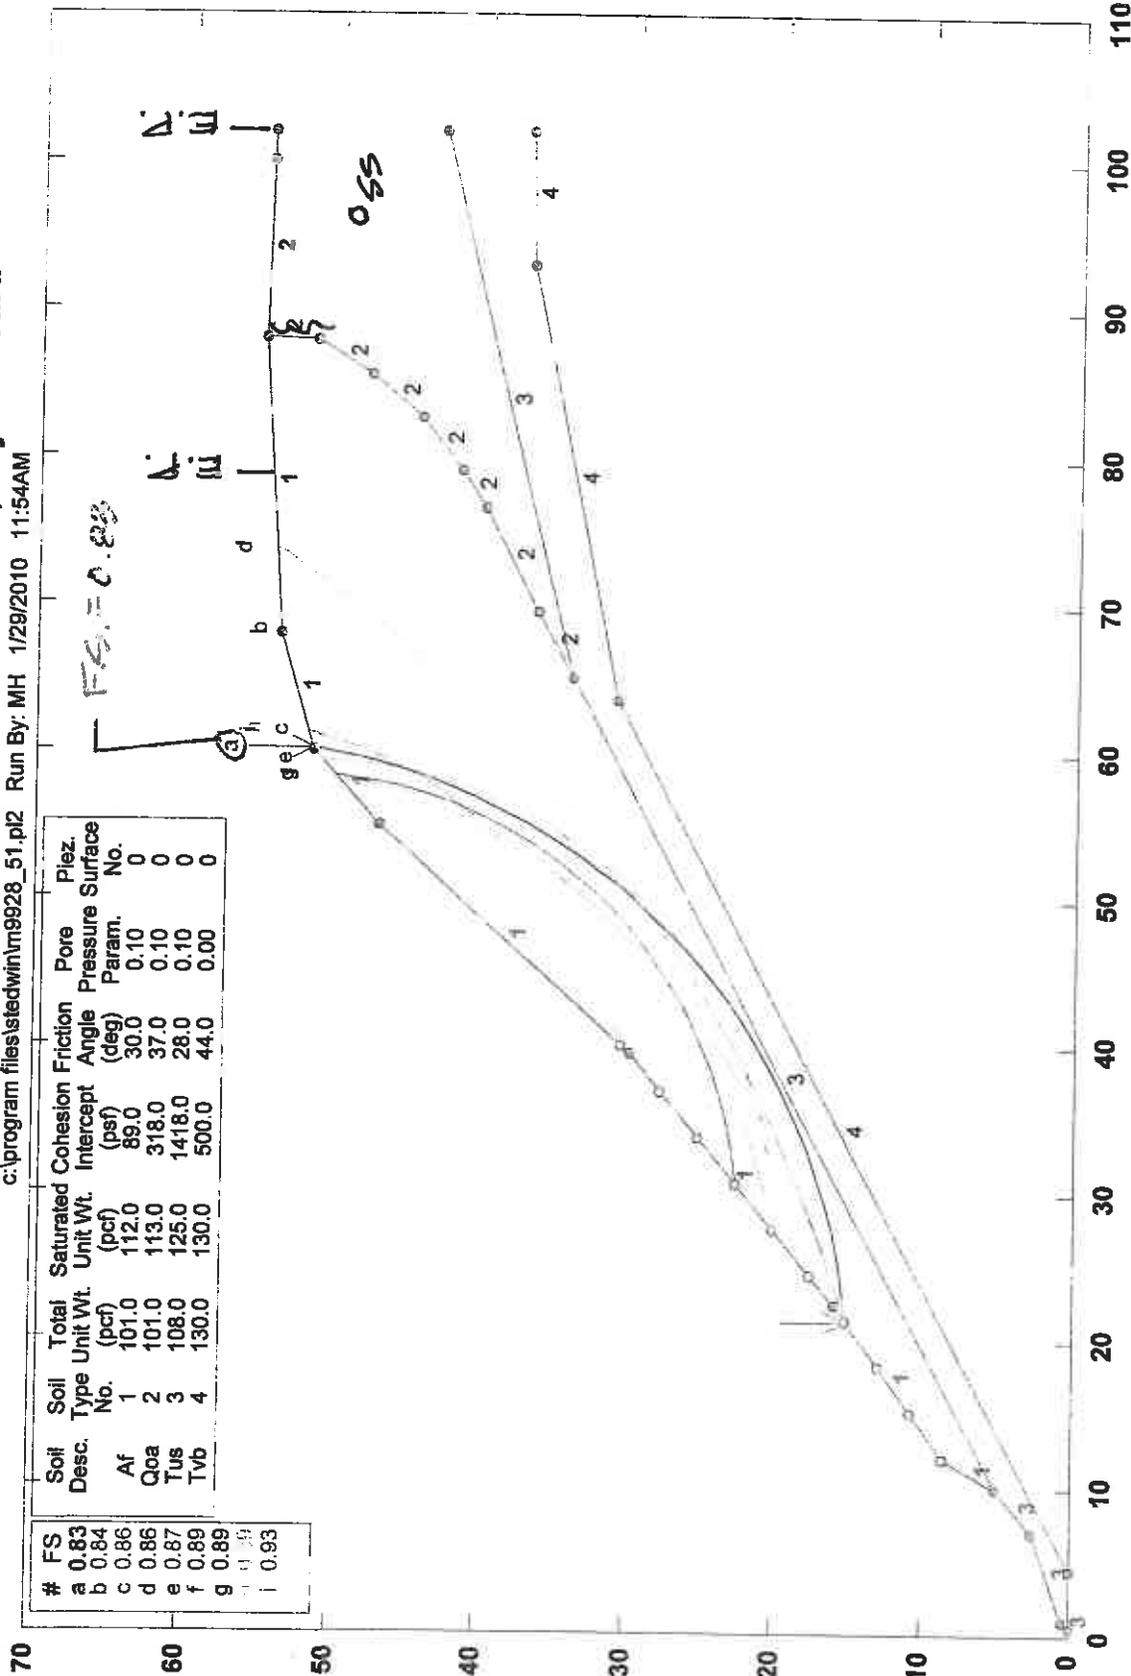
M9928-Second Avenue, Carmel Section 5-5, STATIC, very outboard

Hg. B-8	Static Condition, Circular Failure Surface	
	Outermost edge of Road:	min. FS=0.83
Hg. B-9	Static Condition, Circular Failure Surface	
	Outboard side of road:	min. FS=0.97
Hg. B-10	Seismic Condition, Circular Failure Surface	
	Outboard side of road:	min. FS=0.57
Hg. B-11	Static Condition Planar, Failure Surface	
	Inboard side of Road:	min. FS=1.30
Hg. B-12	Seismic Condition, Planar Failure Surface:	min. FS=0.74
Hg. B-13	Seismic Condition, Planar Failure Surface	
	Failure Plane through Soil Layer #3	min. FS=2.02

#	FS
a	0.83
b	0.84
c	0.86
d	0.86
e	0.87
f	0.89
g	0.89
h	0.89
i	0.93

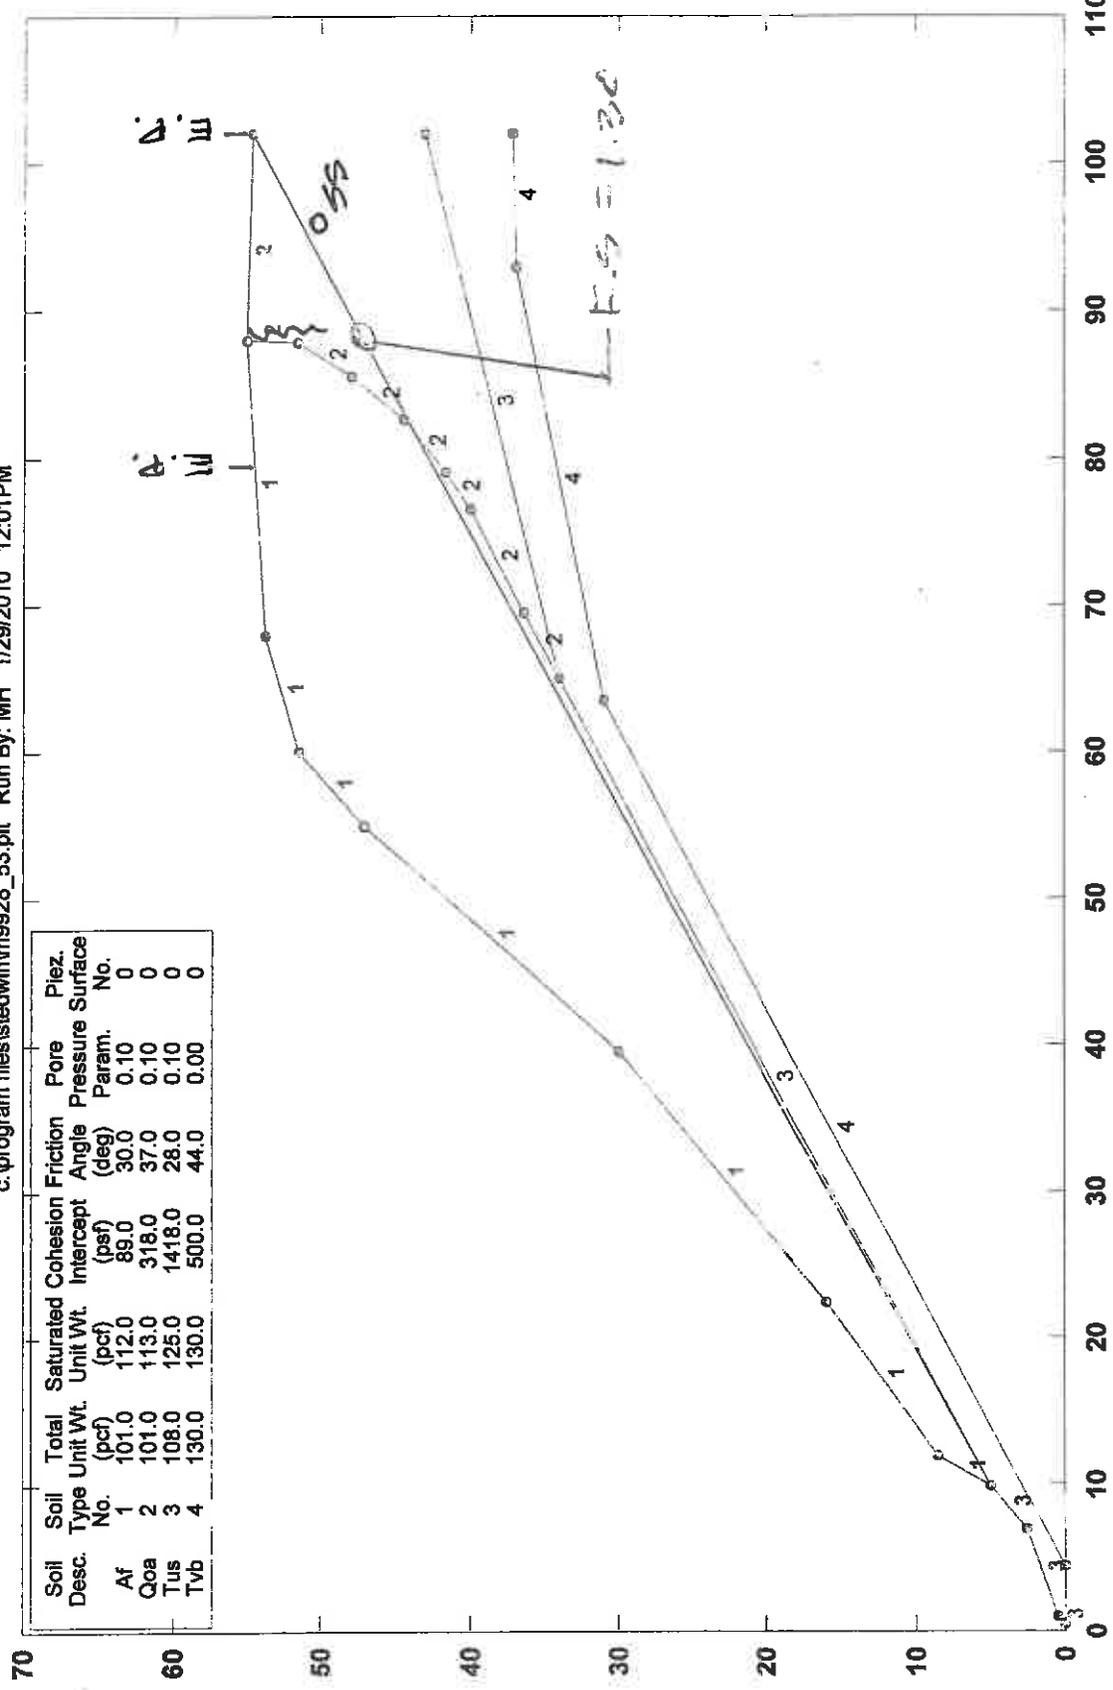
M9928-Second Avenue, Carmel Section 5-5, STATIC, planar

STABL6H FSmin=1.30
Factor Of Safety Is Calculated By The Modified Bishop Method

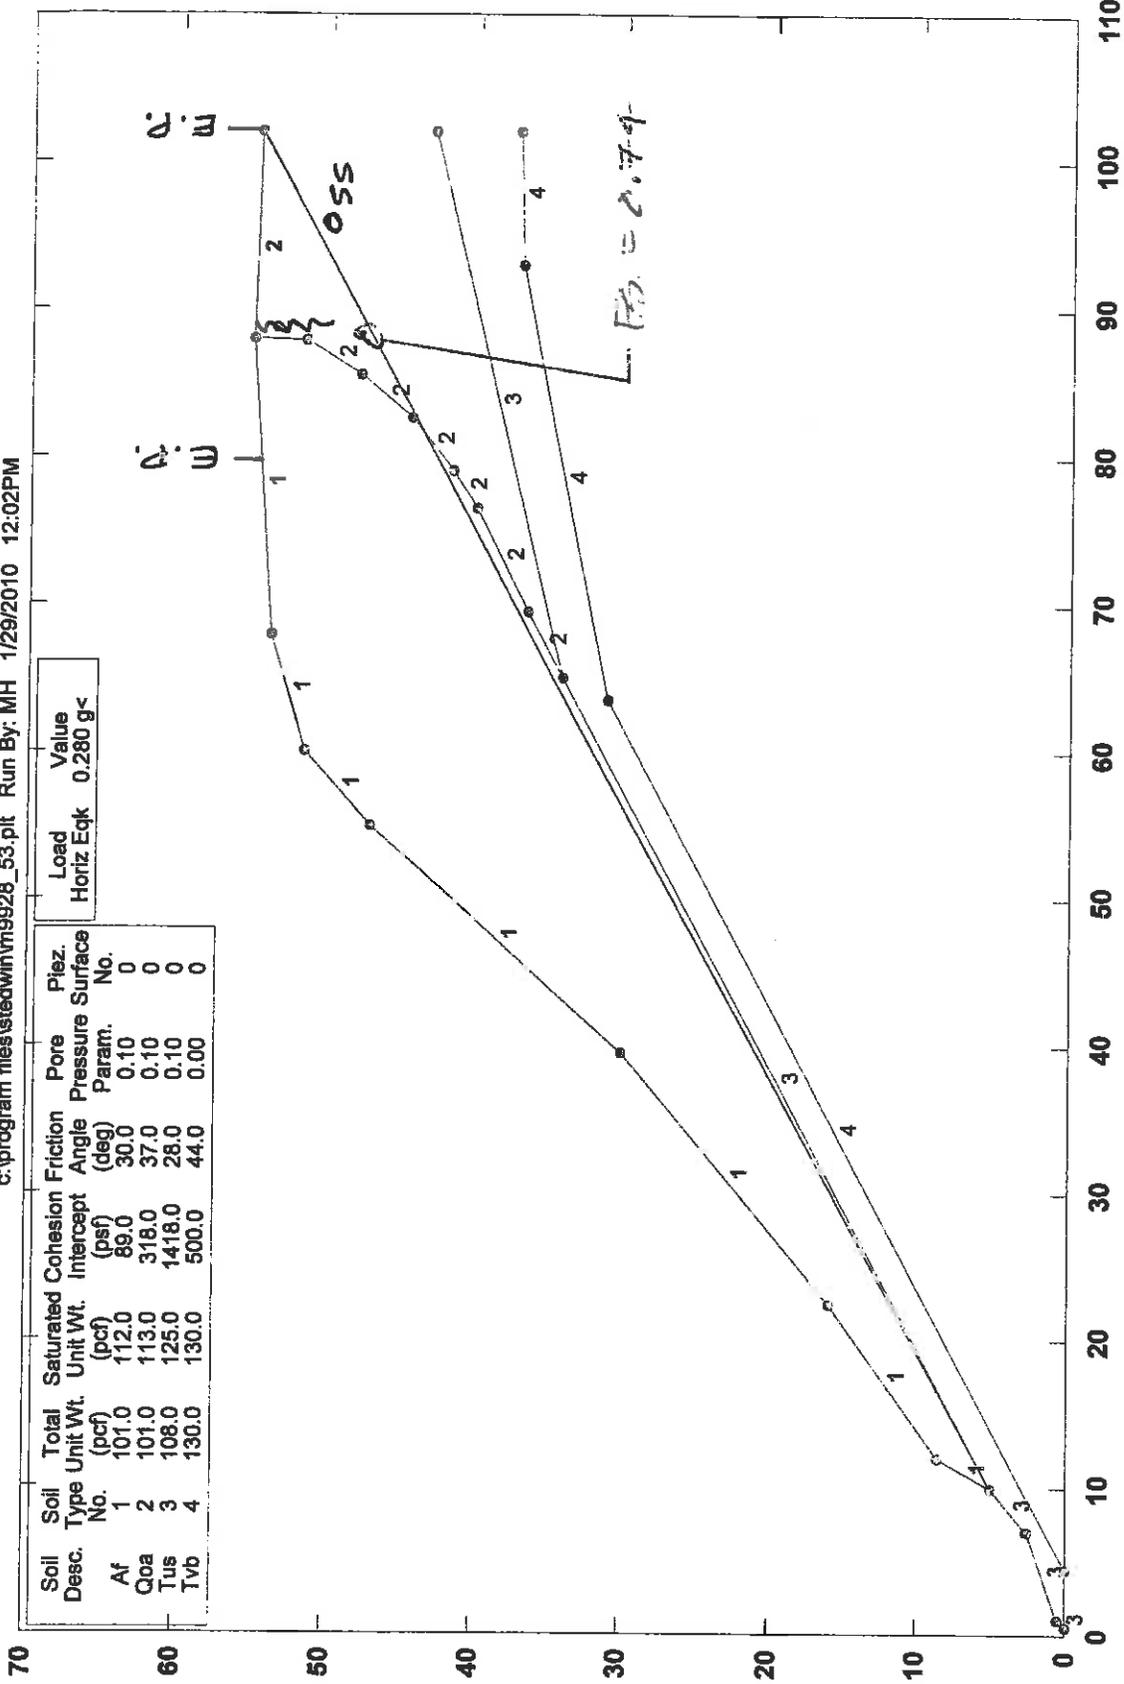
STABL6H FSmin=0.74
Factor Of Safety Is Calculated By The Modified Bishop Method

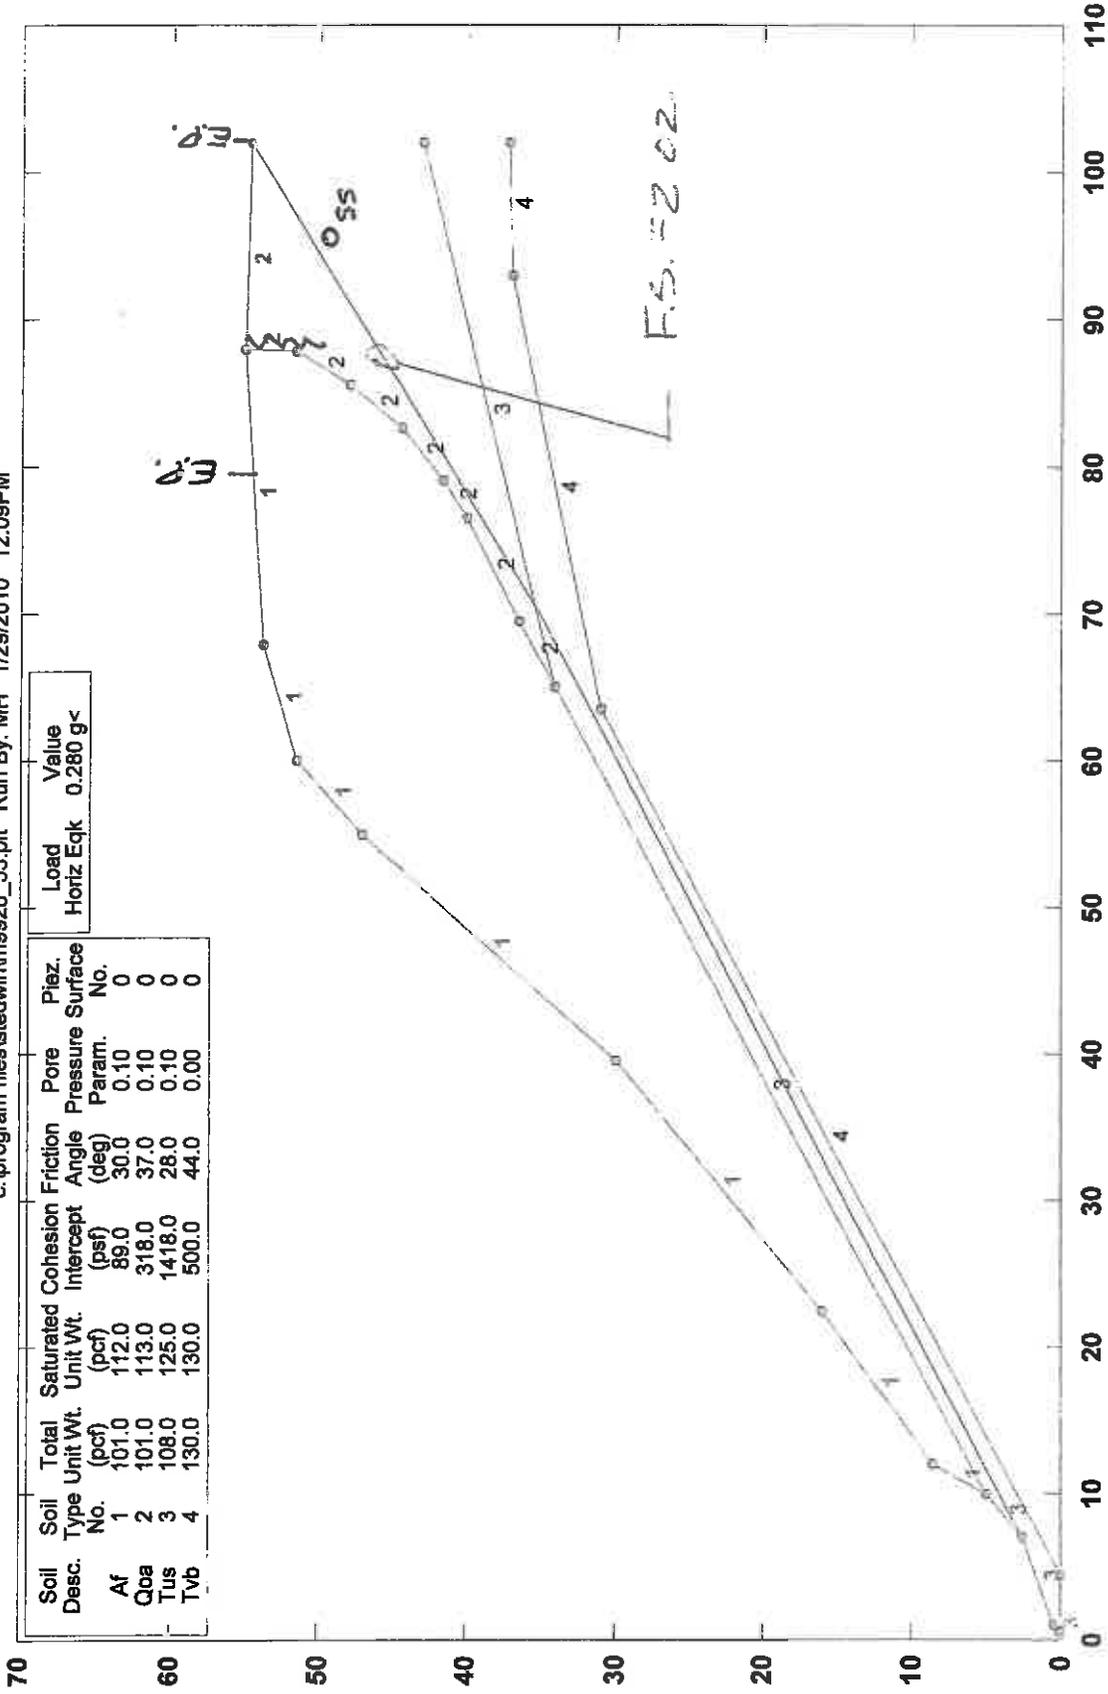
M9928-Second Avenue, Carmel Section 5-5, SEISMIC, planar, thru Soil 2

STABL6H FSmin=2.02
Factor Of Safety Is Calculated By The Modified Bishop Method
