Carmel Gas Incident

April 2014

At the request of PG&E, Exponent has conducted an investigation of the gas leak and subsequent explosion on March 3, 2014 in Carmel-by-the-Sea (Carmel), California.

Inadequate verification of system status and configuration when performing work on a live line.

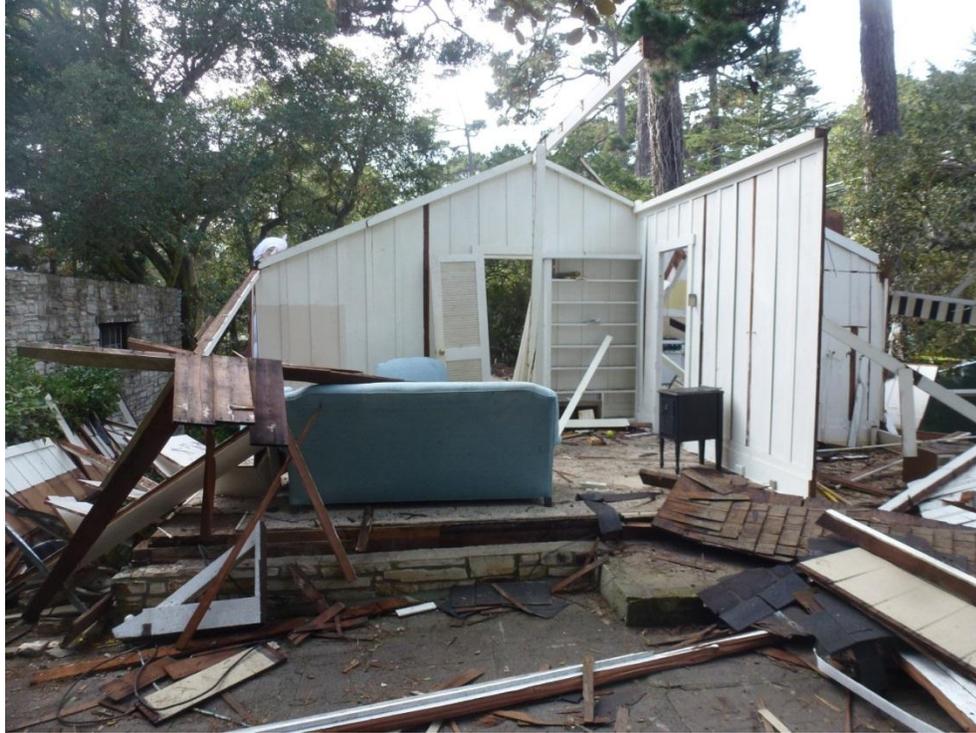
some of the interior walls remained in place (Figure 9 and Figure 10). Debris was scattered across the property and in nearby trees.

Figure 9. Incident house looking West from the entryway. Photograph by Exponent on March 4, 2014.

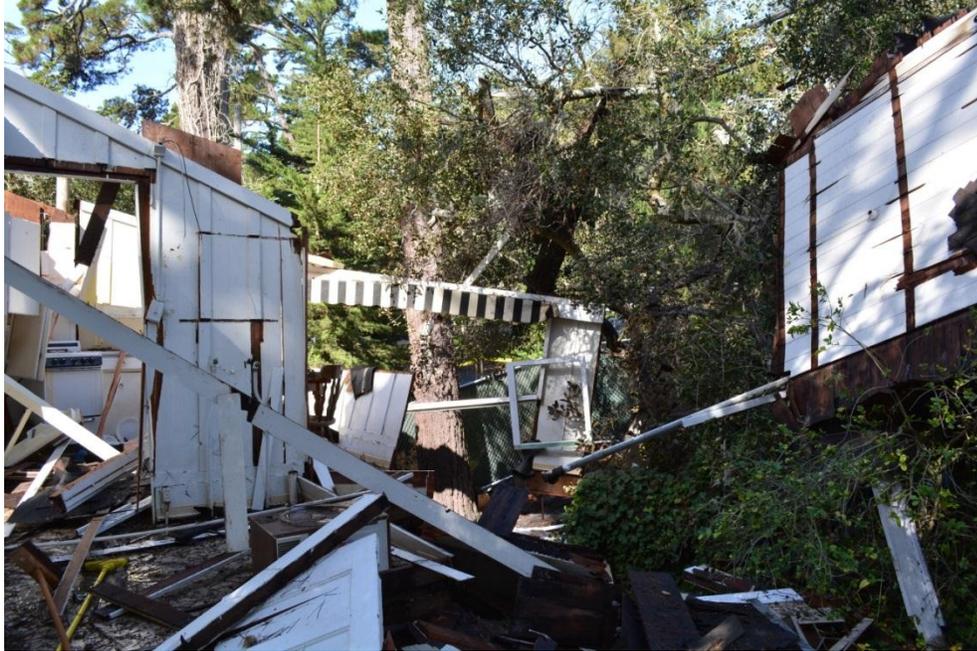
Figure 10. Incident house looking West into the laundry room. Roof section on right side of picture. Photograph by Exponent on March 4, 2014.

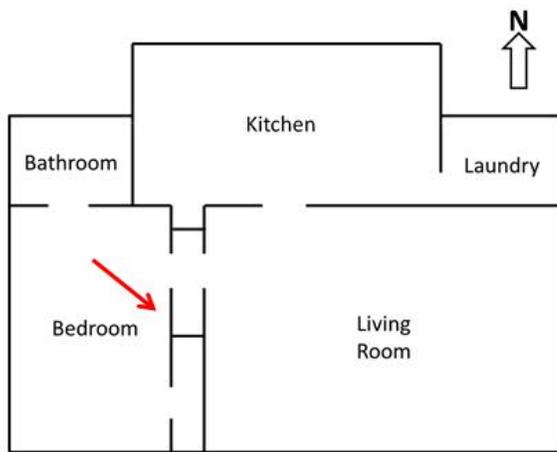
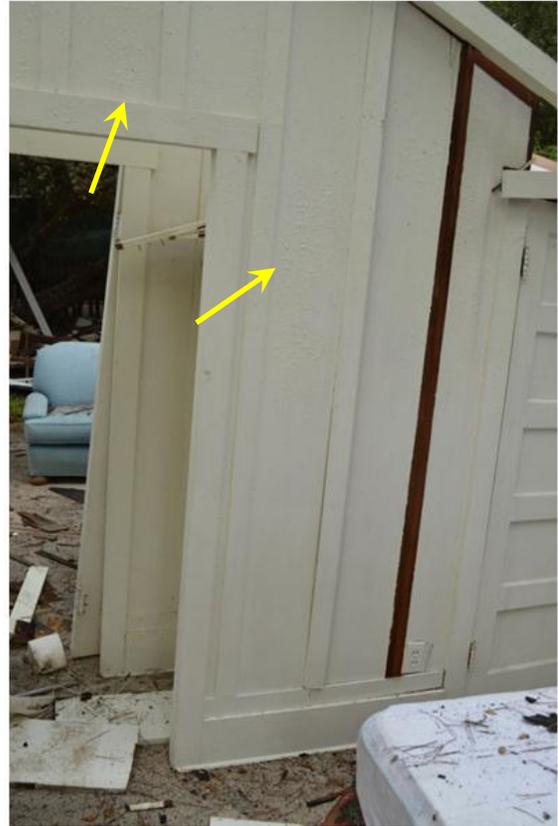
Figure 11. Interior walls and furniture. An unburned couch in the living room is visible in the background and the corner of an unburned mattress is visible in the foreground. Yellow arrows indicate some areas of wall blistering. Photograph by Exponent on March 6, 2014.

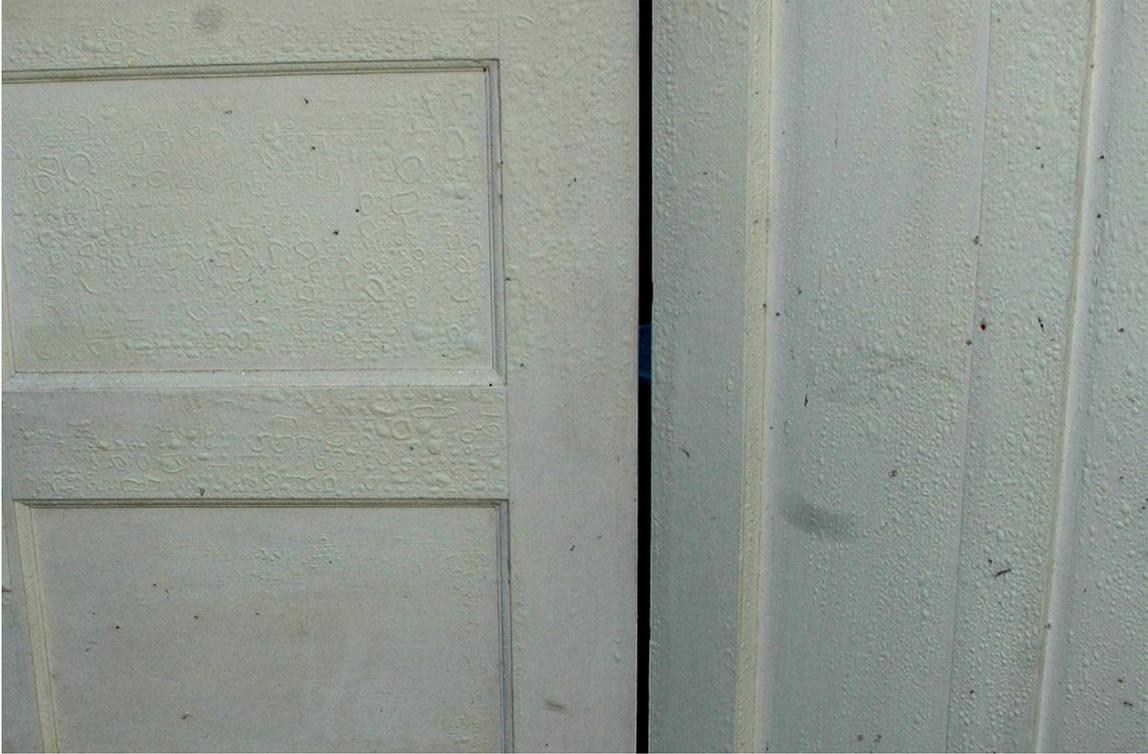
Figure 12. Close-up of the paint blistering on bedroom wall and door. Photograph by Exponent on March 7, 2014.

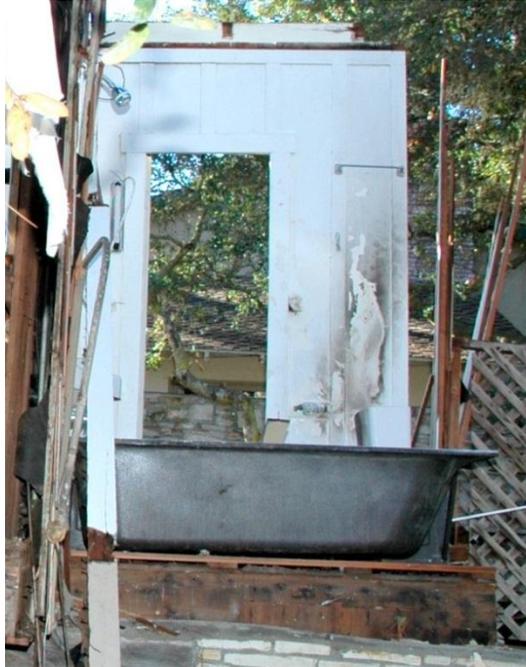
Figure 13. Fire pattern on bathroom wall, looking South from 3rd Avenue. Photograph by Exponent on March 7, 2014.

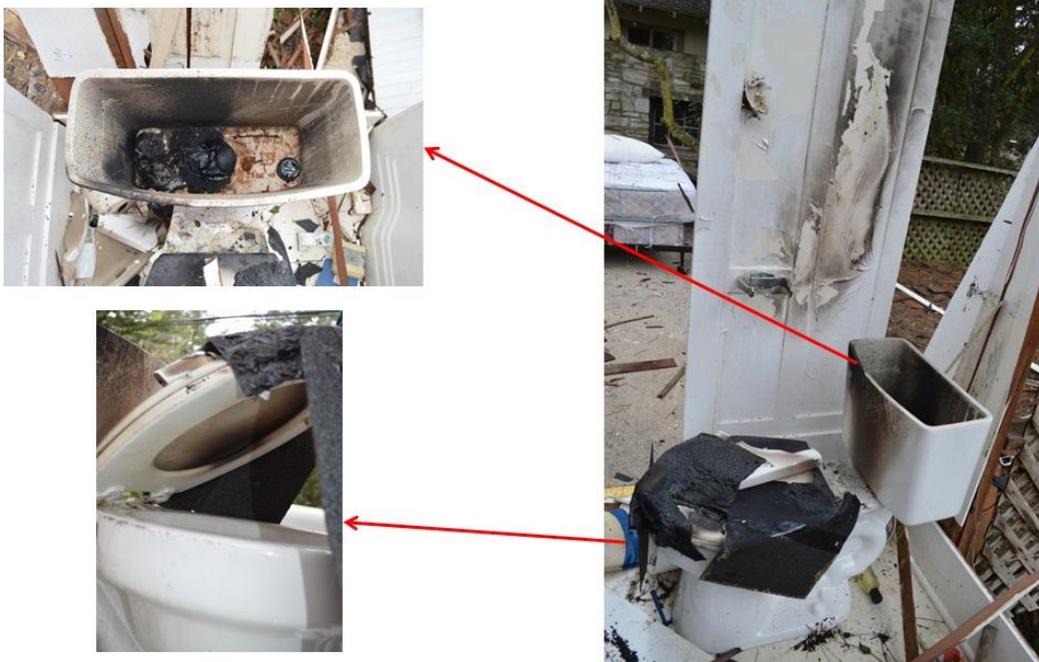
Figure 15. Damage to bathroom toilet. Burn marks below toilet seat and melted components inside toilet tank. Photographs by Exponent on March 6, 2014.

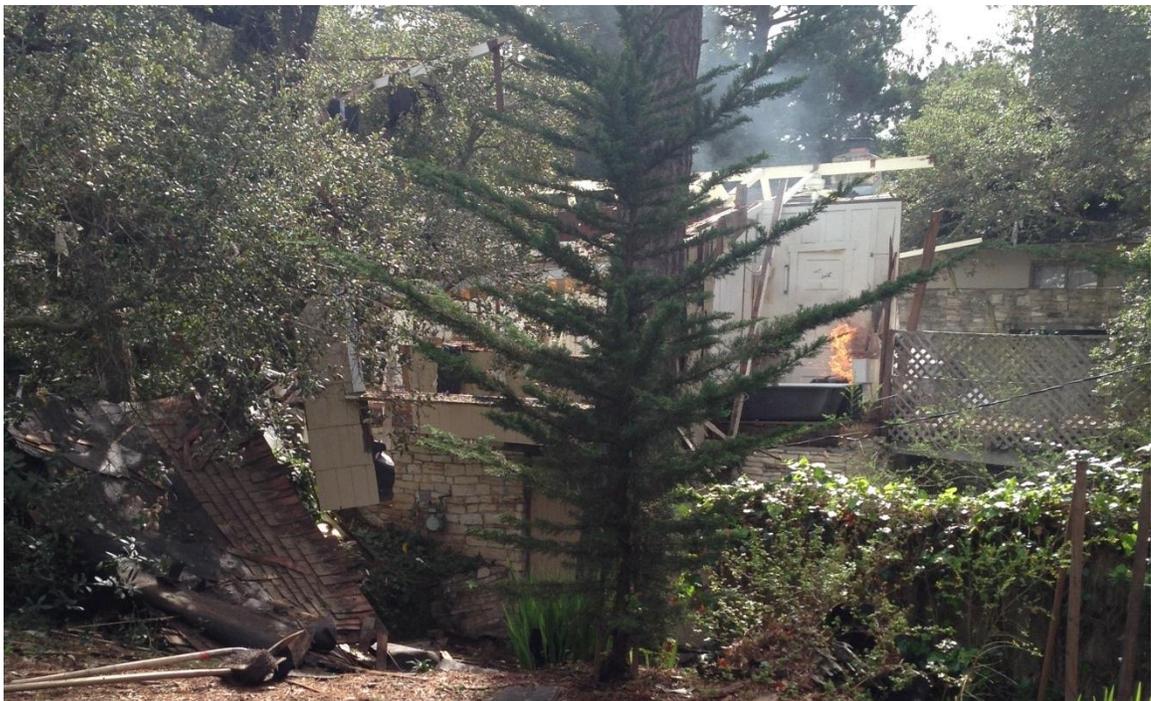
Figure 16. Photograph taken shortly after the explosion showing flames over bathroom toilet. Photograph provided to Exponent by PG&E.

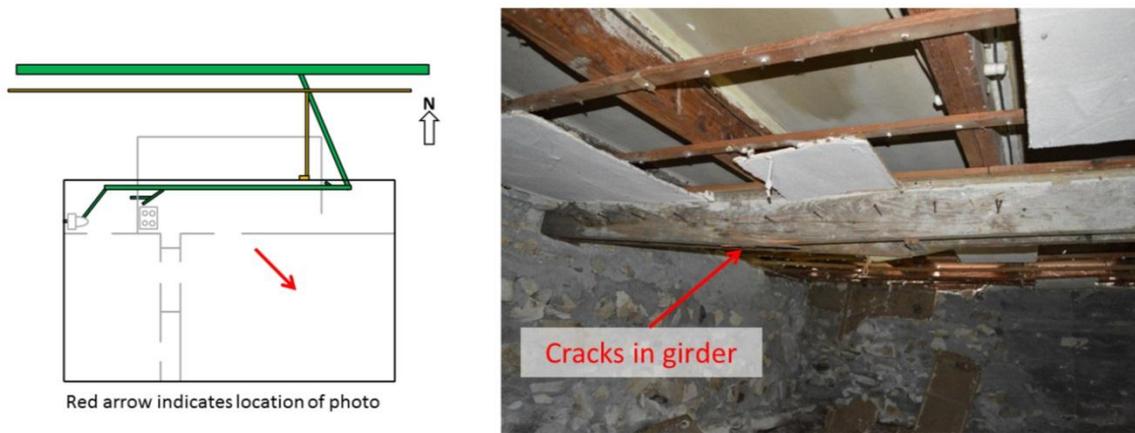
The basement area showed limited damage compared to the main floor. The perimeter walls did not show evidence of damage from the recent explosion and the windows' glasses were undamaged. The ceiling finishes had collapsed in several areas and two of the wooden beams showed longitudinal cracks (Figure 17).

An Exponent engineer deemed the first floor of the structure unsafe due to recent damage to joists and girder framing. Shoring of the first floor from the basement level was recommended in order to continue inspection on the first floor. Recommendations were also made to remove falling hazards from trees, neighboring bushes, and cantilevered portions of the structure.

Figure 17. Incident house basement. Ceiling girder with multiple longitudinal cracks. Photograph by Exponent on March 5, 2014.

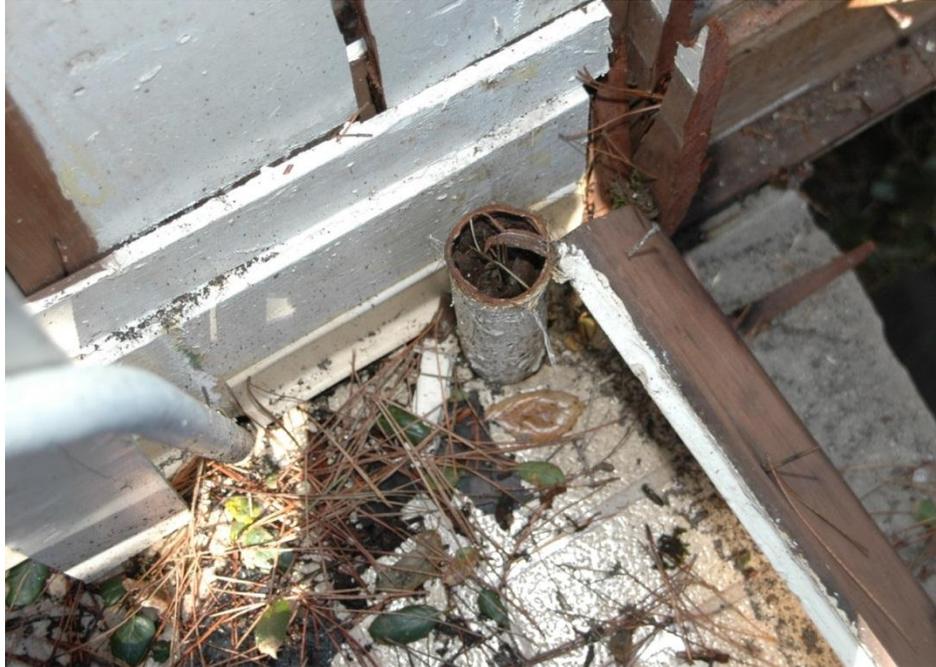
Figure 18. Sewer vent pipe (broken off) in the laundry room. Vent pipe likely broken off during the explosion. Photograph by Exponent on March 7, 2014.

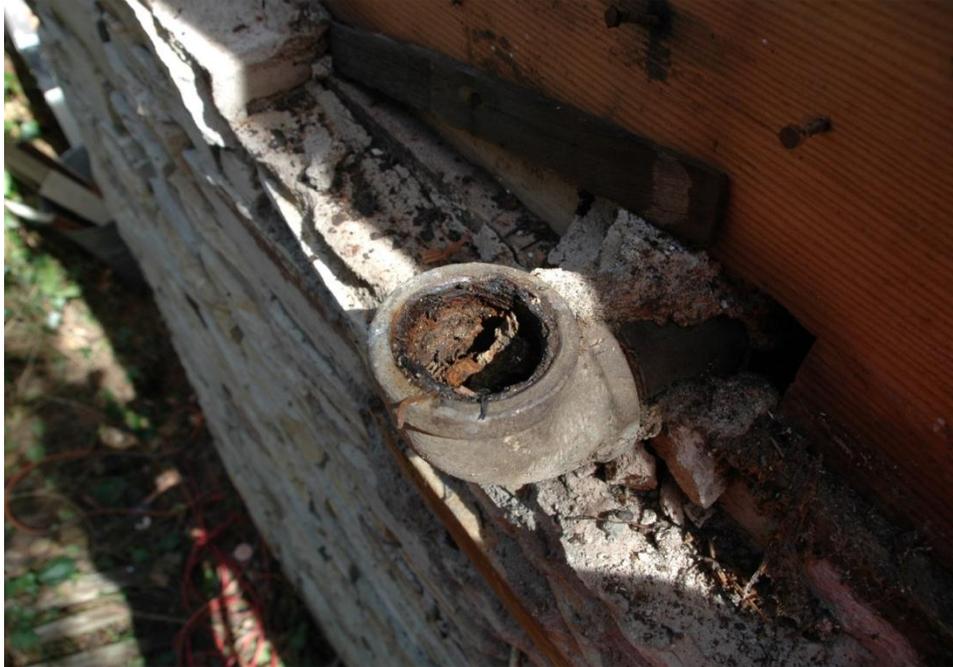
Figure 19. Vent pipe (broken off) in the bathroom. Vent pipe likely broken off during the explosion. Photograph by Exponent on March 7, 2014.

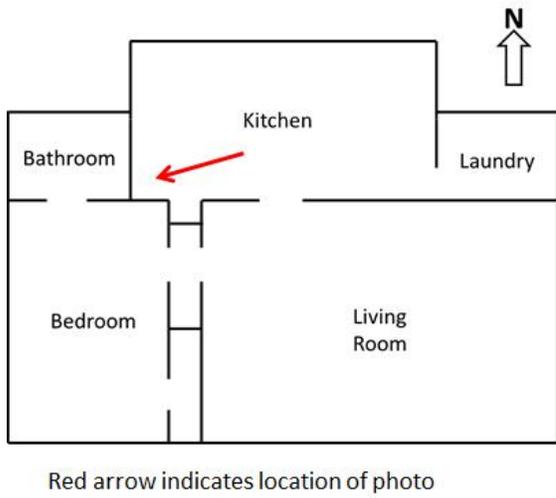
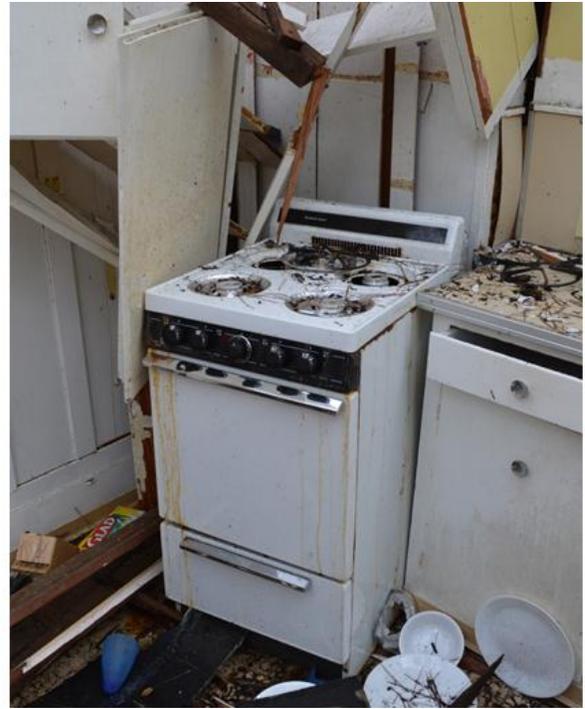
Figure 20. Location of kitchen stove. Photograph by Exponent on March 6, 2014.

Stove: A kitchen stove was present in the subject house. The location of the stove is shown in Figure 20. The appliance shut-off valve for the stove was found in the open position and the stove was equipped with a continuous pilot flame (Figure 21). Based on these facts, the stove cannot be ruled out as a likely ignition source for the incident explosion.

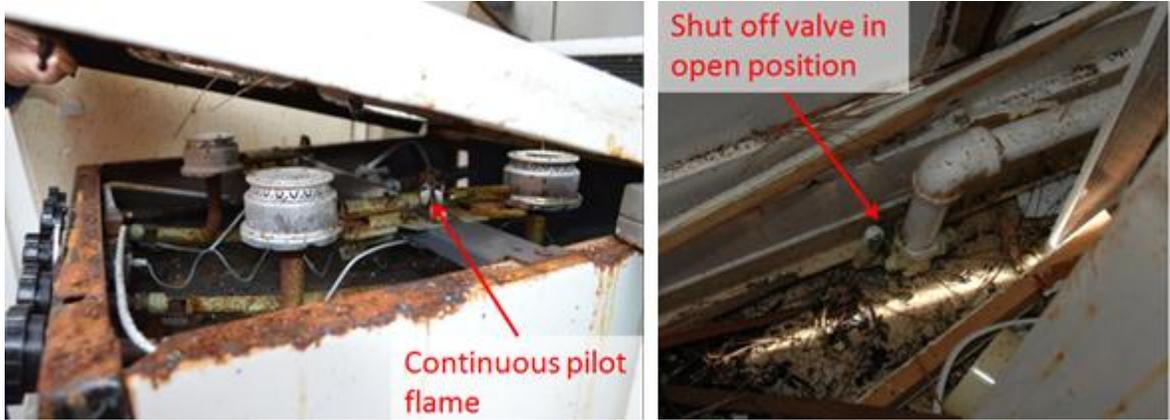
Figure 21. Kitchen stove components. Photographs by Exponent on March 6, 2014.

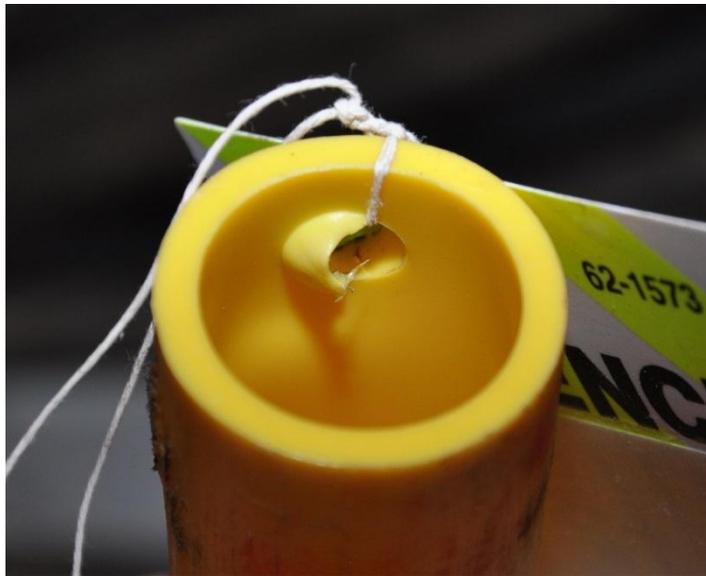
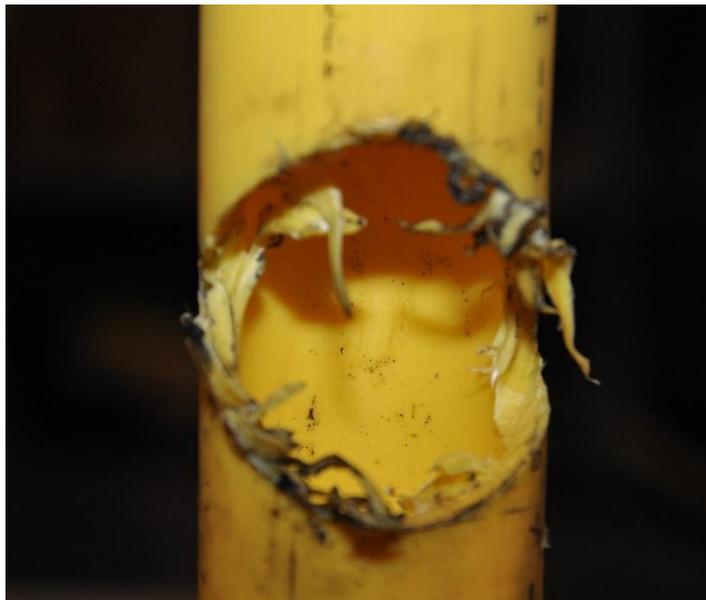
Gas leak: Inspection of the 2-inch gas main and inserted 1¼-inch plastic piping shows that there was a hole created in the plastic pipe after the Save-a-valve was tapped. This hole resulted in a pressurized natural gas release from the plastic pipe. The gas leak at this location may have started when the Save-a-valve was welded onto the steel pipe, before the Save-a-valve was tapped. A second hole was introduced into the plastic pipe when an M/2 line stopper fitting was tapped a short time after the first tapping operation. This second hole caused additional gas to leak.

Figure 29. Perforations in plastic gas line: Save-a-Valve fitting (top) and M/2 fitting (bottom). Photographs by Exponent on March 10, 2014.

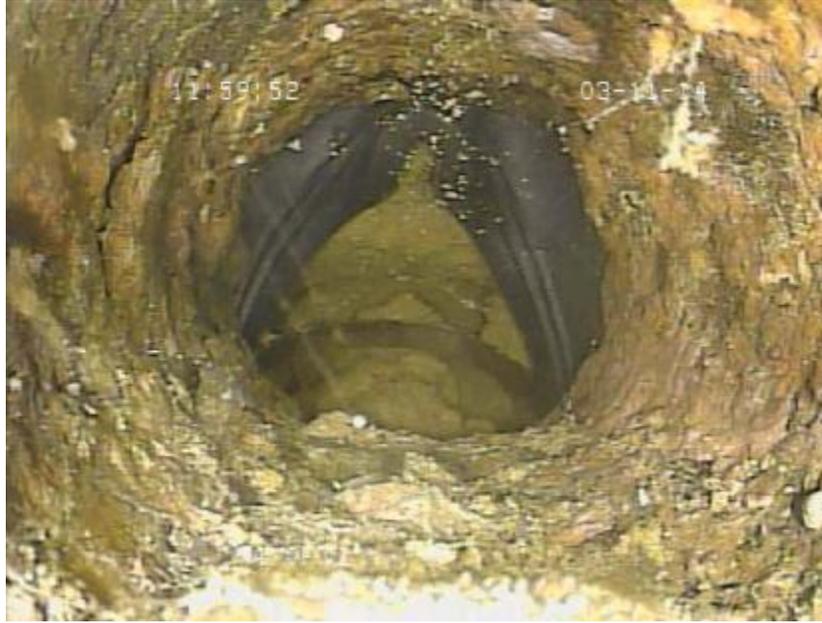
Gaps around the sewer lateral (at the break tap) and the sewer main were observed. The lateral was an approximately 4-inch cast iron pipe for the subject residence. As shown in Figure 36, the sewer lateral had debris accumulated around its interior perimeter and showed clear evidence of lack of recent use, including presence of spider webs, dryness and deterioration.

Figure 36. Sewer lateral conditions approximately 5 feet from tap with sewer main. Deterioration, spider webs and debris in cast iron pipe in area closest to camera. Separation and dislocation of lateral away from camera. Source: FES.

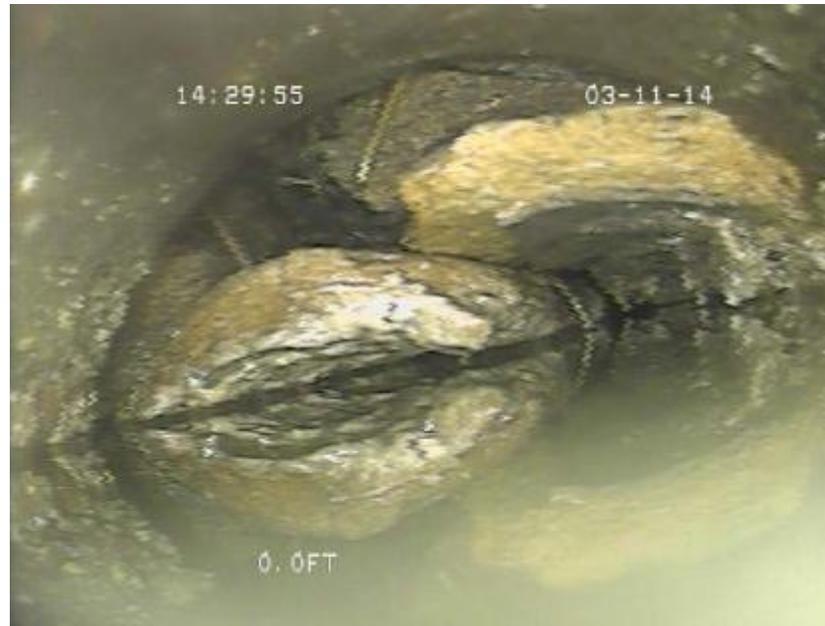
The sewer main south of the manhole along Guadalupe Street consisted of an unlined clay pipe, with an approximate diameter of 8 inches. A collapse was observed approximately 1½ to 2 feet

Figure 37. Collapse of sewer main along Guadalupe Street, south of manhole. Standing water at bottom. Source: FES.

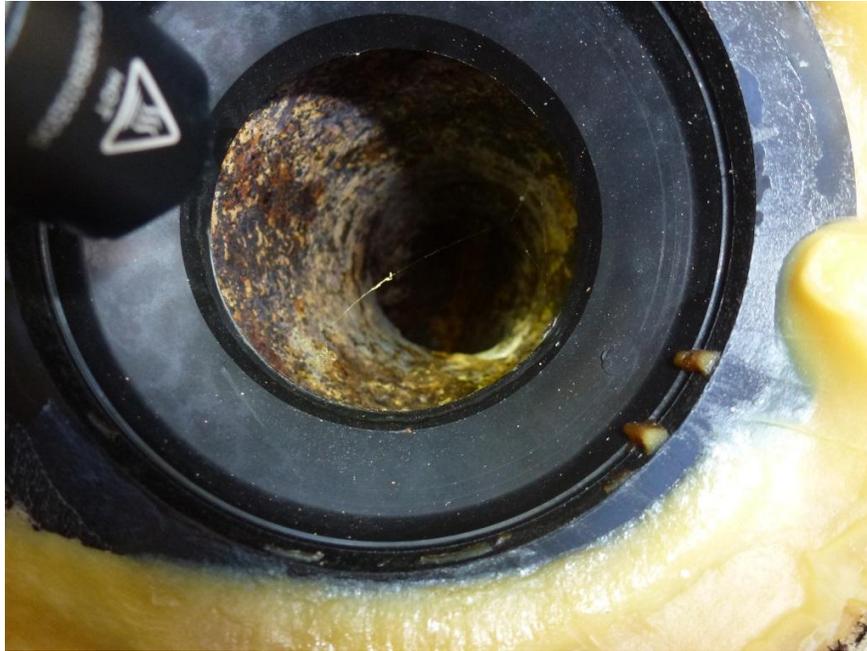
Figure 40. Sewer pipe riser below toilet. Cast iron pipe is dry, spider webs are visible. Photograph by Exponent on March 11, 2014.

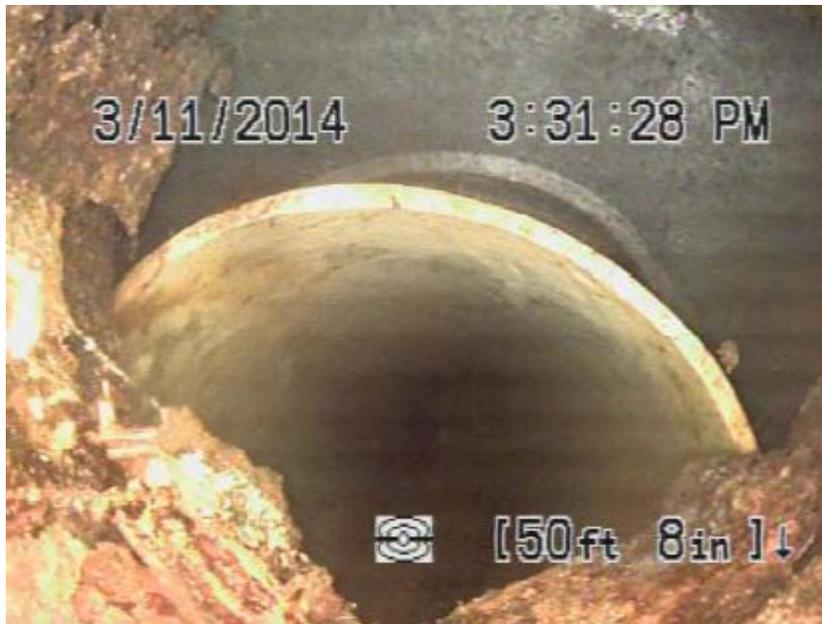
Figure 42. Dislocated joint between an apparently white plastic pipe and cast iron sewer lateral. Source: FES.

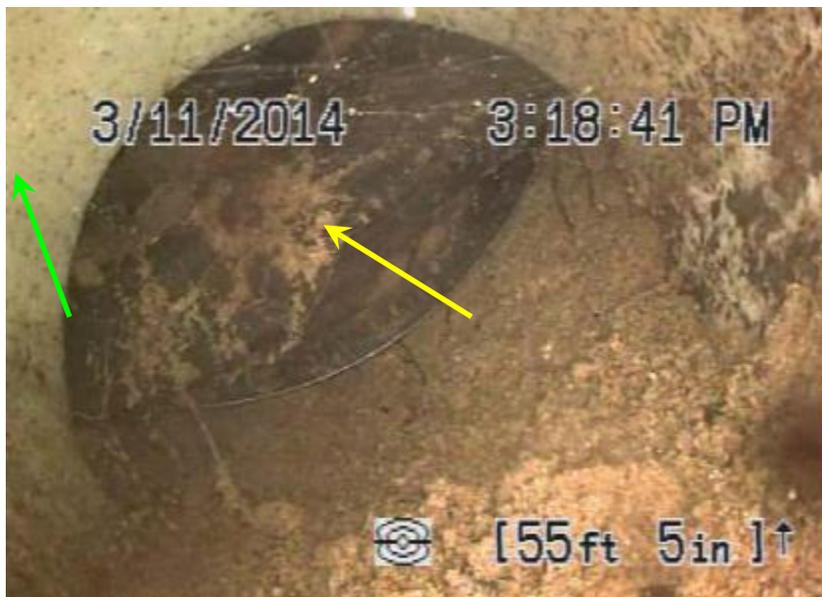
Figure 43. Sewer lateral joint offset at connection between white plastic pipe segment (green arrow) and apparent cast iron pipe (yellow arrow). Source: FES.

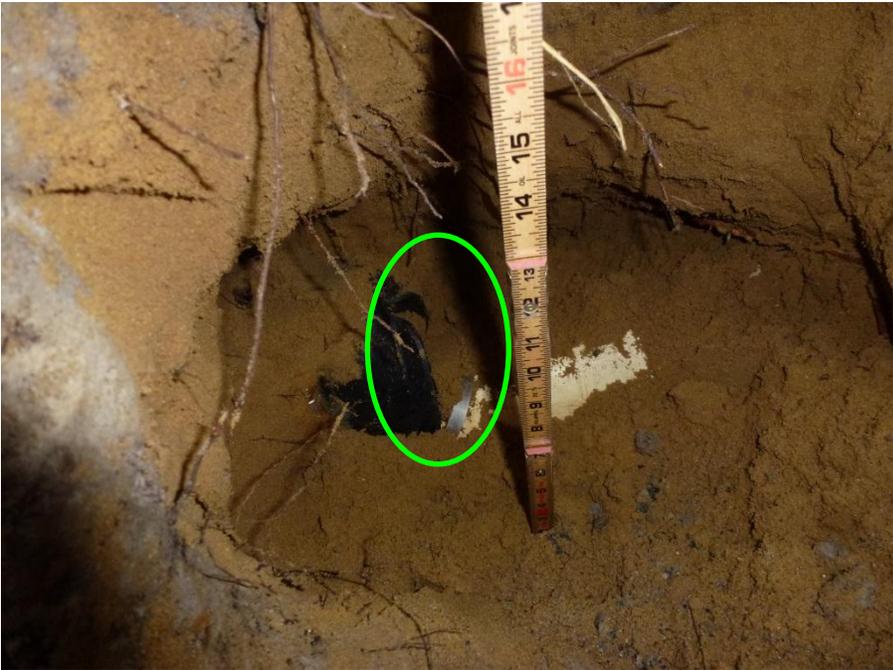
Figure 46. Sewer lateral offset joint (green oval), and white plastic segment of sewer lateral. Sand backfill surrounding sewer lateral. Photograph by Exponent on March 21, 2014.

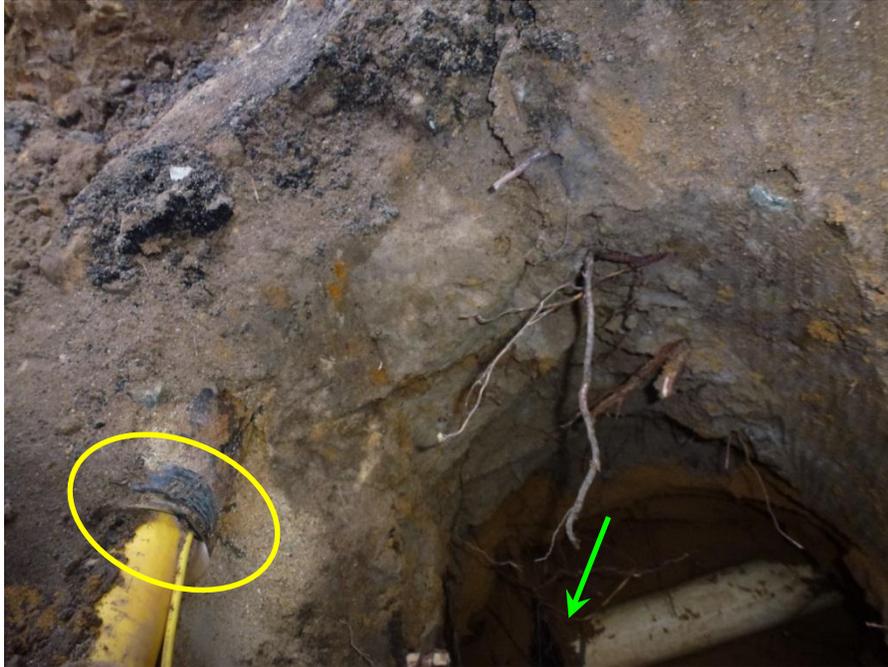
Figure 47. End of annular space in gas main along 3rd Avenue (yellow oval) in vicinity of sewer lateral offset joint (green arrow). Photograph by Exponent on March 21, 2014.

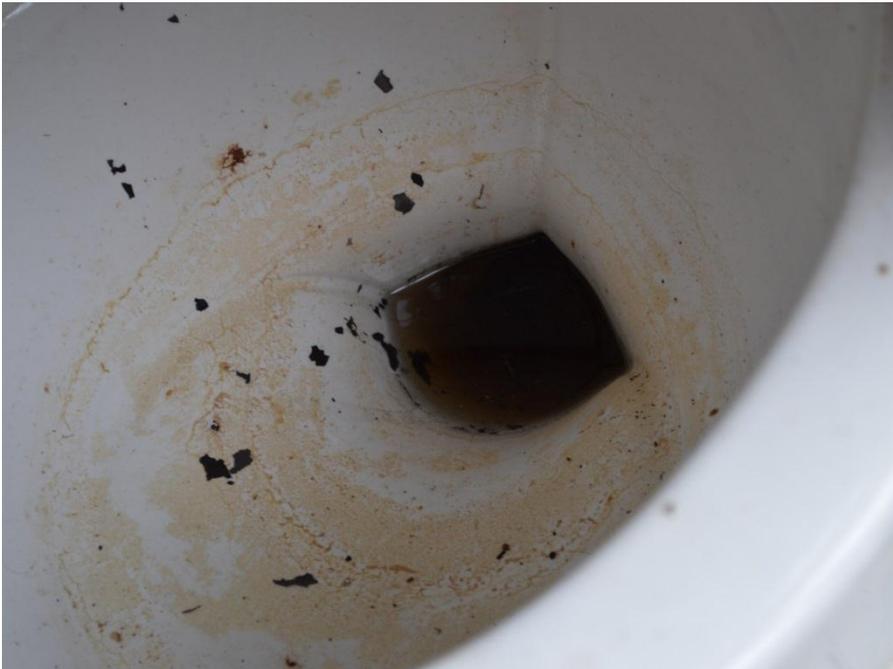
Figure 50. Low water level in the bathroom toilet bowl three days after explosion. Photograph by Exponent on March 6, 2014.
