G. A. Graebe & Associates, Inc.

Pursuant to our contract with the City of Carmel-by-the-Sea, dated November 12, 2014 which covers stairs "1" through "9", and our first amendment to the contract dated February 13, 2015, which covers beach access stair "0", we are pleased to submit the requested work for Structural Preventive Maintenance Program for the ten Carmel Beach Stairways at Carmel Beach, in Carmel, CA 93923.

1. Structural maintenance report, pictures and a sketch for Stairs "0" through "9".
2. Total Conceptual Cost.
3. Drawing: Overall Site Plan.
4. USB flash drive.

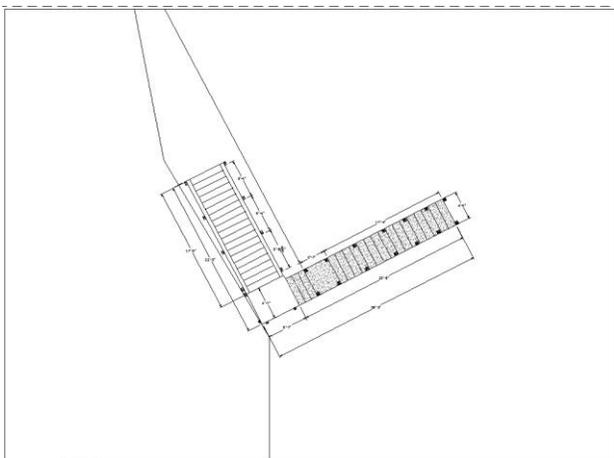
Stair 9

<u>Nb</u>	<u>Deficiency Description</u>	<u>Picture #</u>	<u>Priority Ranking</u>	<u>Conceptual Remediation</u>	<u>Cost</u>
1	The upper concrete stair flight has deteriorated / rusted steel pipe guard rails wrapped with 1x wood	see picture 054	High	All fourteen guard rail posts at the upper flight need to be removed and replaced with 1 ½-in diameter stainless steel post-installed posts conforming to current building code, see picture 054.	\$7,500
2	We noted excessive moisture in the bottom 4x6 pressure treated guard rail post and severe rust in the bolted connection of post to the stringer.	see pictures 081, 085	High	We recommend replacing the lower wood flight with concrete stairs and stone veneered retaining walls similar to lower flight of stair 4; see pictures 112 & 114 in stair 4.	\$30,000
3	Wet 6x12 pressure treated stringers at the lower wood flight	see pictures 079, 094, 095	High	We recommend replacing the lower wood flight with concrete stairs and stone veneered retaining walls similar to lower flight of stair 4; see pictures 112 & 114 in stair 4.	Cost is included in item 2

4	We noted deteriorated 2 - 6x 12 wood base at the bottom of the stair.	see pictures 087, 094	Moderate	We recommend replacing the lower wood flight with concrete stairs and stone veneered retaining walls similar to lower flight of stair 4; see pictures 112 & 114 in stair 4.	Cost is included in item 2

5	Deteriorated 4x6 pressure treated guard rail post at the bottom of the lower flight, see picture 081.	see picture 081, 094, 095	Moderate	We recommend replacing the lower wood flight with concrete stairs and stone veneered retaining walls similar to lower flight of stair 4; see pictures 112 & 114 in stair 4.	Cost is included in item 2
6	Rusted landing pre-bent steel bearing plates, steel joist angles and bolts, see picture 069. the tube steel diagonal braces have surface rust.	see picture 069, 073	Moderate	We recommend replacing the wood framed landing with concrete landing.	\$8,000
7	Rusted angle bracket between the two guard rail posts.	see picture 046	Moderate	We recommend replacing the lower wood flight with concrete stairs and stone veneered retaining walls similar to lower flight of stair 4; see pictures 112 & 114 in stair 4.	Cost is included in item 2
8	We noted rusted bearing angle connections supporting the wood steps.	see pictures 078, 079	Moderate	We recommend replacing the lower wood flight with concrete stairs and stone veneered retaining walls similar to lower flight of stair 4; see pictures 112 & 114 in stair 4.	Cost is included in item 2

9	Rusted angle bolts at guard rail posts toward the ocean side.	see pictures 046, 088, 097.	Moderate	We recommend replacing the lower wood flight with concrete stairs and stone veneered retaining walls similar to lower flight of stair 4; see pictures 112 & 114 in stair 4.	Cost is included in item 2
10	Rusted / perforated hand rail at the bottom flight.	see pictures 082, 090, 091.	Moderate	Replace rusted / perforated hand rail at the bottom flight with stainless steel one, compliant to building code requirements.	\$6,500

11	We noted green moss at the top of 2x6 rail cap.	see picture 092.	Low	We recommend replacing the lower wood flight with concrete stairs and stone veneered retaining walls similar to lower flight of stair 4; see pictures 112 & 114 in stair 4.	Cost is included in item 2
12	Spalling in concrete steps	see picture 101	Moderate	Saw cut concrete in spalled area, pour high strength non shrink concrete, drill and dowel to repair broken step.	\$1,500
13	Broken 2x6 rail cap.	see picture 057	Moderate	We recommend replacing it with naturally durable wood.	\$1,000
14	White growth appeared on guard rail posts at landing.	see picture 075	Low	We recommend replacing the lower wood flight with concrete stairs and stone veneered retaining walls similar to lower flight of stair 4; see pictures 112 & 114 in stair 4.	Cost is included in item 2
15	Crack in bottom 4x12 stair steps	see picture 096	Low	We recommend replacing the lower wood flight with concrete stairs and stone veneered retaining walls similar to lower flight of stair 4; see pictures 112 & 114 in stair 4.	Cost is included in item 2

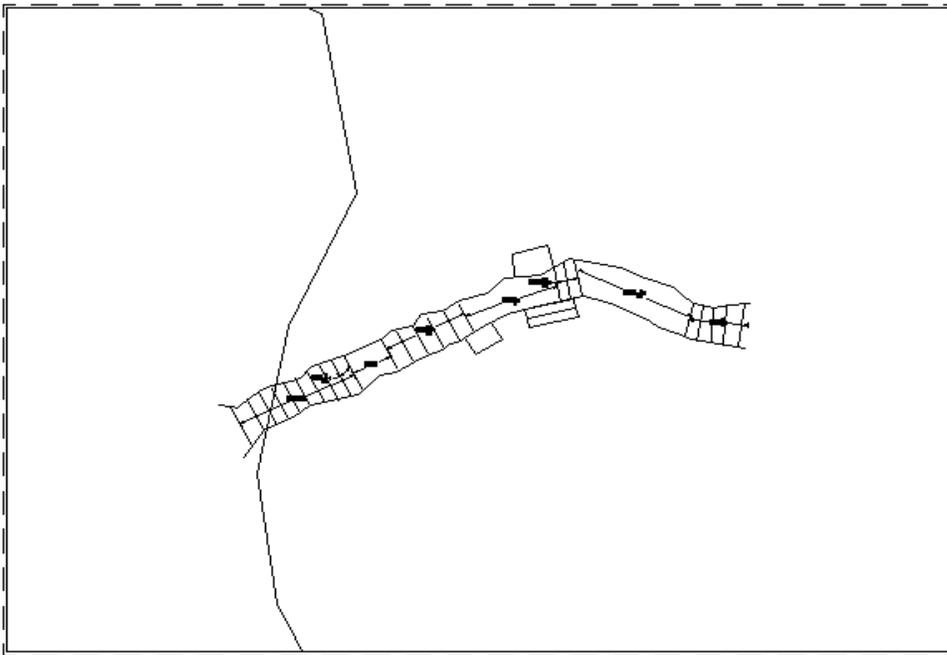
Stair 8

<u>Nb</u>	<u>Deficiency Description</u>	<u>Picture #</u>	<u>Priority Ranking</u>	<u>Conceptual Remediation</u>	<u>Cost</u>
1	We noticed moisture around the guard rail post below the wash and localized muddy conditions at the lower ten steps. Notice how the upper steps appear to be dry	see pictures 029, 031, 032, 033 & 035	High	We recommend further investigation for the cause of the water. A French drain pipe could be a possible solution to divert the water away from the steps. More specific solutions can be proposed once the source of the leak has been determined.	TBD
2	b. The upper 11'-4" landing appeared to have an excessively steep slope.	see picture 113	Moderate	We recommend reducing the slope and adding one or two steps as necessary.	\$15,000
3	The drain in the wash needs maintenance.	see picture 110	Moderate	We recommend periodically cleaning it to prevent flooding.	City of Carmel
Total					\$15,000

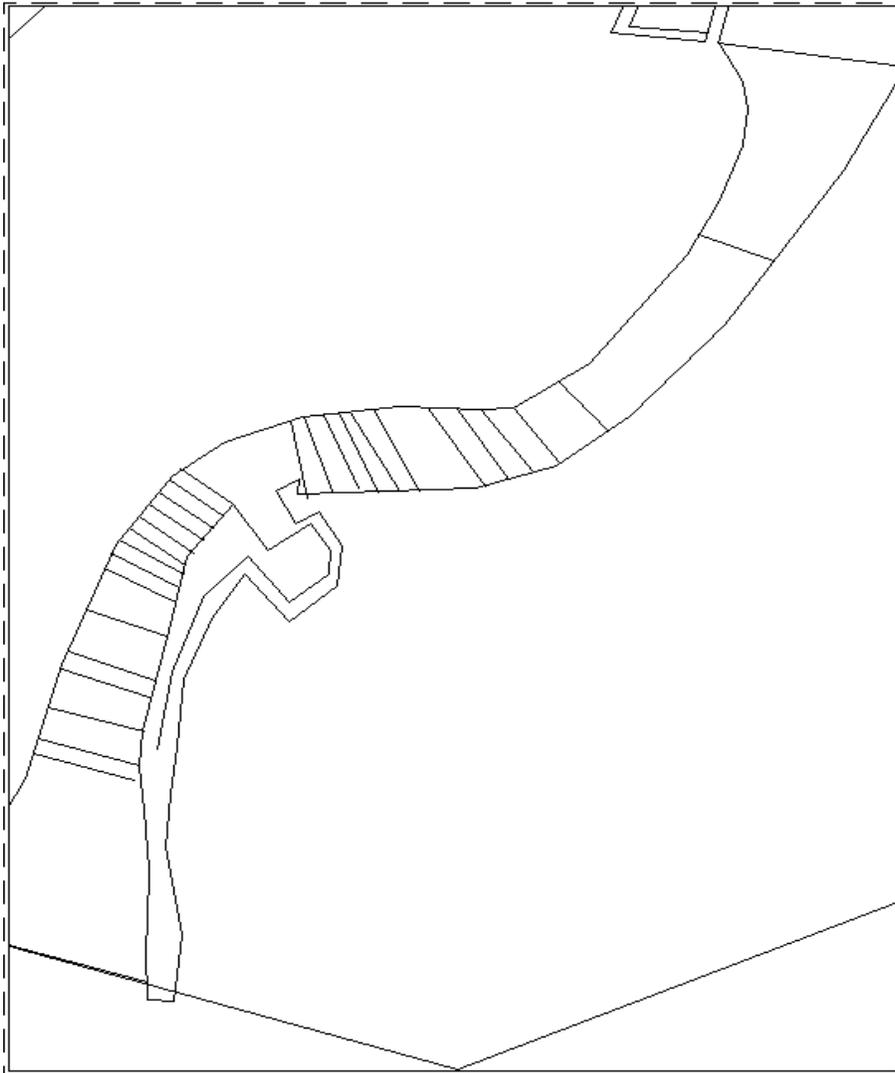
Stair 7

<u>Nb</u>	<u>Deficiency Description</u>	<u>Picture #</u>	<u>Priority Ranking</u>	<u>Conceptual Remediation</u>	<u>Cost</u>
1	Surface rust on loose guardrail	see picture 010	Moderate	We recommend replacing the guardrail with code compliant stainless steel.	\$2,500
2	The drain in the wash appeared open with some sand on the side.	see picture 14	Moderate	We recommend periodically cleaning it to prevent flooding.	City of Carmel
Total					\$2,500

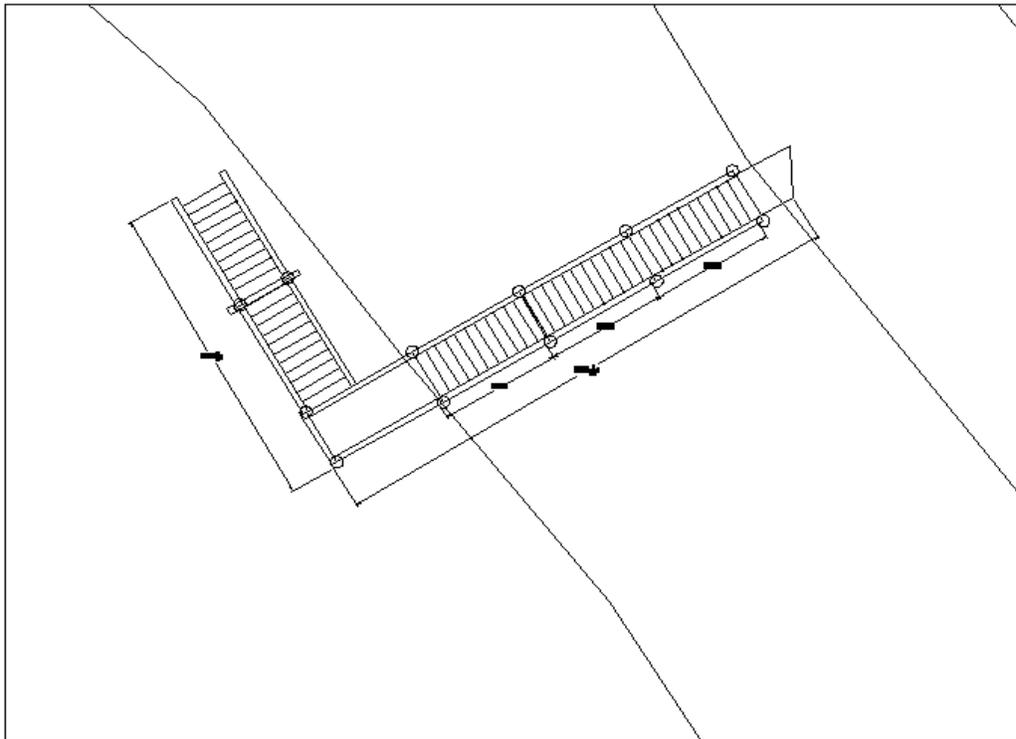
Stair 6

<u>Nb</u>	<u>Deficiency Description</u>	<u>Picture #</u>	<u>Priority Ranking</u>	<u>Conceptual Remediation</u>	<u>Cost</u>
1	Green moss coated the bottom of the steps, the 6x12 stringers, and 6x12 landing beams.	see pictures 062, 070, 083, 087	Low	We recommend scrubbing off all moss and treating the wood with approved protection material to prevent further deterioration of those members.	\$1,500
2	We noted Splitting in the upper flight posts and the landing guardrail posts, and heavy rust in bolted post connections;	see pictures 056, 057, 058	Moderate	We recommend replacing the guardrail posts as well as the 2x6 intermediate boards and using stainless steel bolted connections. Avoid splicing the 2x6 intermediate boards at the bolted connection. Note that the lower flight guard rail posts and their connections are in satisfactory condition see picture 076.	\$3,500
3	We noted rusted bearing angles between the step and the stringers;	see pictures 064, 065, 066, 069 & 070.	Moderate	We recommend replacing the angle and the screws with stainless steel material w/ same dimensions.	\$2,500

4	We noted rusted bolted connections in the timber poles;	see pictures 056, 058.	Moderate	We recommend replacing all rusted bolts with same size stainless steel.	\$2,500
5	We noted a 3/8-in wide vertical splitting in the 12-in timber pole supporting the lower flight and the landing	see picture 076 A	Moderate	We recommend running two 5/8-in stainless steel machine bolts at the top and bottom of the pole to support the split pieces together.	\$500
6	We noted a 1/4-in wide splitting in the 12-in timber pole supporting the lower flight;	see picture 055	Moderate	We recommend running a 5/8-in stainless steel machine bolt at the top of the pole to support the split pieces together.	\$500

7	We noted splitting in the 12-in timber pole supporting the upper flight	see picture 089	Low	We recommend monitoring this pole.	\$0
8	We noted deteriorated 2x6 guardrail top boards	see picture 085	Moderate	We recommend changing these boards with pressure treated same size boards.	\$1,200
9	The bottom flight terminates in sand for an approximate distance of 9-ft	see pictures 075 & 082	Moderate	We could not verify the framing condition under the sand since it was not accessible. We recommend exposing those buried members and replacing them with pressure treated lumber in case they turn out to be deteriorated.	\$2,500
Total					\$14,700

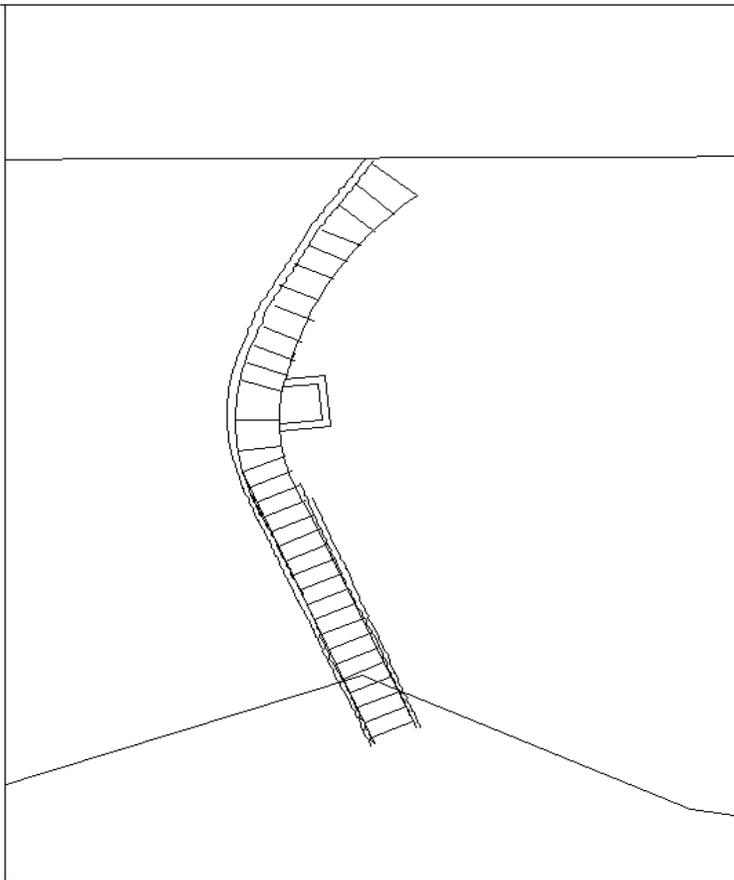
Stair 5

<u>Nb</u>	<u>Deficiency Description</u>	<u>See Picture #</u>	<u>Priority Ranking</u>	<u>Conceptual Remediation</u>	<u>Cost</u>
1	Horizontal cracks run left to right on the vertical face of the steps	034, 036	Moderate	We recommend demolishing the existing stairs & rebuilding it similar to the first couple of steps, see picture 050. The existing retaining wall appears to be in satisfactory condition and can stay unless it shows signs of structural defects during demolishing of the existing stairs.	\$15,000
2	Spalling concrete / mortar over what appeared to be natural stone steps	040, 046, 047	Moderate	This item is included in item 1.	Cost is included in item 1.
Total					\$15,000

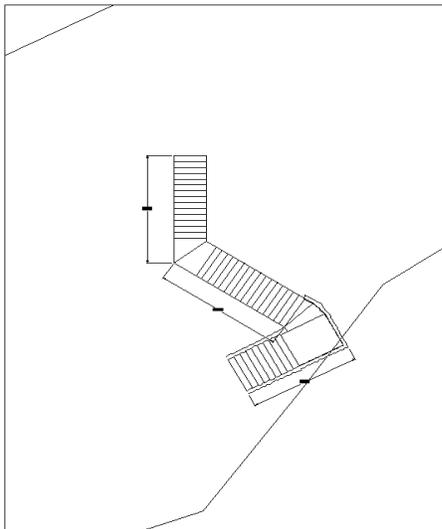
Stair 4

<u>Nb</u>	<u>Deficiency Description</u>	<u>See Picture #</u>	<u>Priority Ranking</u>	<u>Conceptual Remediation</u>	<u>Cost</u>
1	In both wood flights, the 4x12 steps, 6x12 stringers and 6x12 landing beams appeared to be in unsatisfactory structural condition due to structural foundation failure. The steps are sloping in the longitudinal direction while the right hand (coming down) guard rail is leaning to the right.	100, 101, 123 at upper flight & 105, 115 at intermediate flight	High	We recommend demolishing the existing wood stair portion and rebuilding it.	\$27,500
2	1 1/2-in settlement at the end of some steps	015, 016	High	This item is included in item 1.	Cost is included in item 1
3	4 1/2-in lean in the guard rail	018, 019	High	This item is included in item 1.	Cost is included in item 1
4	9 1/2-in lean in the guardrail of the bottom wood stair flight	022, 023	High	This item is included in item 1.	Cost is included in item 1

5	Concrete spalling on the second step from the bottom	111	Moderate	We recommend saw cutting the spalled portion of the step, drilling and doweling in existing concrete and pouring new concrete in that portion.	\$4,500
Total					\$32,000

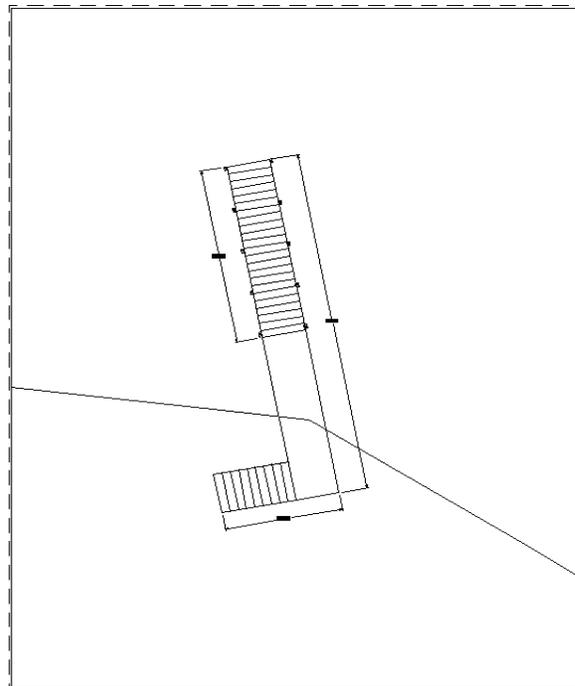
Stair 3

Nb	Deficiency Description	See Picture #	Priority Ranking	Conceptual Remediation	Cost
1	Slight angle between the two stringers that make up the upper flight. The bow is noticeable in the middle or at the splice point. This uneven layout of the stringers affects the nose alignment of the steps.	061	Low	City Assesment: "The stair tread misalignment identified is within the 3/8" allowed by code. The separation of the stringer appears due to slight settlement and wood shrinkage. Proper filler in the gap would be a preventative maintenance item."	T.B.D.
2	Splitting in the upper flight guardrail posts, and heavy rust in bolted post connections	062, 063	Moderate	Replace the guardrail posts as well as the 2x6 intermediate boards and using stainless steel bolted connections. Avoid splicing the 2x6 intermediate boards at the bolted connection as done in picture 062 lower board.	\$1,500
3	Splitting in the 8-in timber pole supporting the upper flight	064, 070 & 087	Low	Replace this pole in kind	\$5,000

4	Rust in the upper flight steel handrail	062 & 067	Moderate	Replace this hand rail with a stainless steel one compliant with the building code requirements.	\$6,500
5	Minor surface rust on the stainless steel angle connecting the lower flight stringer to top of landing.	085 & 086	Low	We will monitor these angles and bolts.	\$0
6	Rusted bolted connection at corner timber pole supporting landing	076	Moderate	Replace bolts and nuts with stainless steel with same size and dimensions	\$1,500
7	Missing 2 bolts in landing guard rail post	075	Moderate	Add stainless steel bolts with same dimensions as the existing bolts.	\$1,300
Total					\$15,800

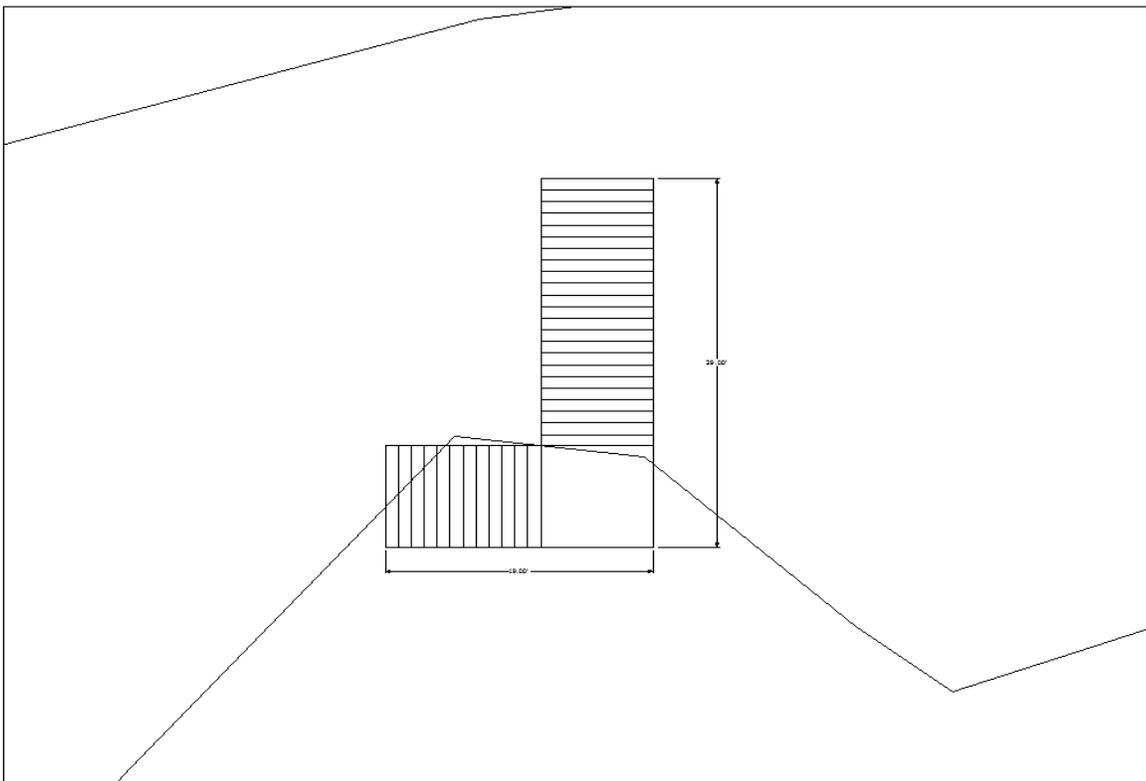
Stair 2

Nb	Deficiency Description	See Picture #	Priority Ranking	Conceptual Remediation	Cost
1	Splitting in guardrail posts, and heavy rust in bolted post connections	009, 013, 024, 025, 030, 031, 032, 033, 037, 039	Moderate	Replace the guardrail posts as well as the 2x6 intermediate boards and using stainless steel bolted connections. Avoid splicing the 2x6 intermediate boards at the bolted connection as done in picture 032 middle board.	\$2,000
2	Heavy rust in the steel handrail.	010, 011, 034	Moderate	Replace this hand rail with a stainless steel one compliant with the building code requirements.	\$4,500
3	Rusted angle iron connecting the lower flight stringer to top of landing	041, 042	Moderate	Replace this angle and its connecting bolts with stainless steel angle and bolts.	\$1,500
4	Deteriorated end of stringer at the end of the lower flight	044, 045	Moderate	replacing the stringer with pressure treated one having same size and length	\$3,500

5	We noticed minor splitting at the bottom end of the upper flight stringer	-	Low	We will monitor this split on yearly basis.	\$0
Total					\$11,500

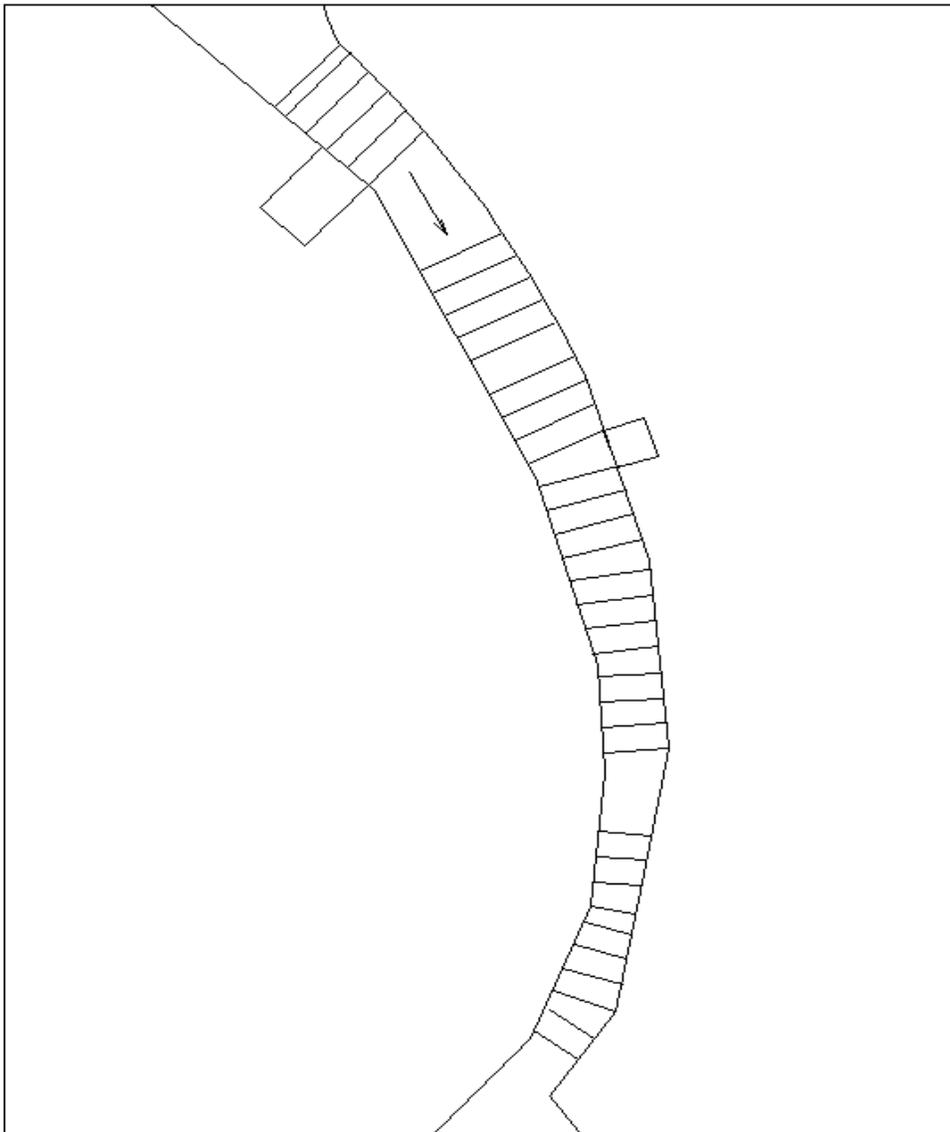
Stair 1

<u>Nb</u>	<u>Deficiency Description</u>	<u>See Picture #</u>	<u>Priority Ranking</u>	<u>Conceptual Remediation</u>	<u>Cost</u>
1	The 8.83-ft landing appears to slope about 9-in in the 8.83-ft run which is approximately 1:12, see picture 001. This slope appears to exceed the maximum slope allowed by the building code	001	High	Reconstruct the landing and insert one 6-in step as necessary.	\$20,000
2	The West free standing trash enclosure wall (towards the beach side) appears to have an undermined footing	001, 010, 011	Moderate	Pour a new 1.5-ft wide x 2-ft deep concrete footing along the undermined footing. The new footing shall be connected to the existing footing using #4 epoxy dowels at 2-ft. The new footing shall be reinforced w/ #4 top and bottom with #3 links at 16-in maximum spacing.	\$6,500
3	The drain in the wash area seems to be clogged	002	Moderate	Clean the drain	City of Carmel
4	All the steps are uneven and sloping down	001	Moderate	Reconstruct excessively sloping steps	\$20,000

5	There are missing stones in the bottom retaining wall	012, 013	Low	Replace the missing stones in kind with high strength mortar.	\$750
Total					\$47,250

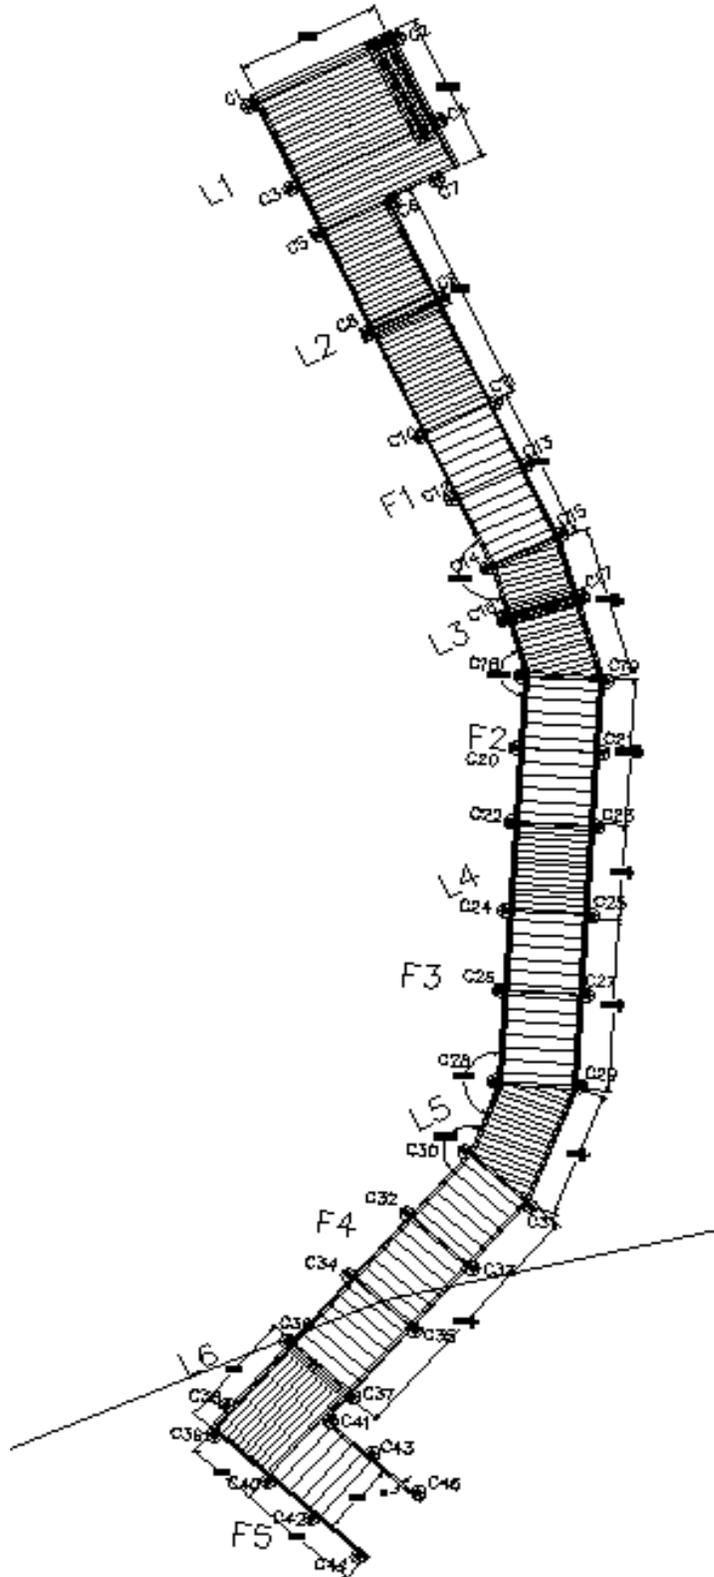
Stair 0

Nb	Deficiency Description	Picture #	Priority Ranking	Conceptual Remediation	Cost
1	The soil around the stair footings is eroding at the south side of flight F4 around column C33.	see pictures 45, 46, 47, 48, 65, 66, 67, 68, 69.	High	We recommend adding missing soil in the eroded / over excavated areas and planting vegetation similar to the opposite side.	City of Carmel
2	Rusted screws on corroded bearing angles	see pictures 30 & 78.	Moderate	We recommend to Brush off loose rust on the corroded bearing angles and apply a minimum of three thin coats of an approved Cold Galvanize Corrosion Inhibitor with ASTM standard per manufacturer specifications.	\$2,500
3	Rust on handrail welds at splice points;	see pictures 41, 89, 90, 95, 96, 98.	Moderate	We recommend to Brush off loose rust and apply a minimum of three thin coats of an approved Cold Galvanize Corrosion Inhibitor with ASTM standard per manufacturer specifications.	\$2,500

4	Checks in top 2x6 pressure treated handrail board.	see picture 57.	Low	We recommend replacing the board in kind.	\$500
5	Cracked concrete caisson in flight F4.	see picture 88.	Low	Fill crack with an approved low-viscosity crack injection epoxy, designed to repair cracks in concrete.	\$200
6	The bottom flight terminates in sand for an approximate distance of 9-ft.	see pictures 58, 59, 71, 72, 73, 74.	Low	We recommend exposing the buried members and replacing them with pressure treated lumber in case they turn out to be deteriorated.	\$2,500
Total					\$8,200
