CARMEL-BY-THE-SEA POLICE DEPARTMENT ASSESSMENT REPORT

Prepared by: Indigo | Hammond + Playle Architects, LLP.

Date: 10/26/2023

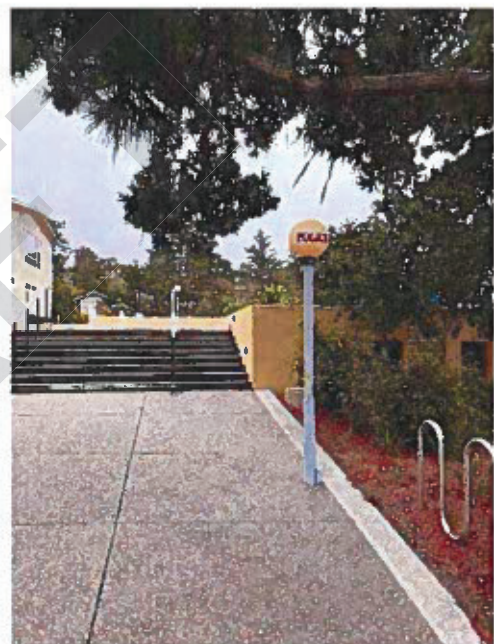
- ◆ *Make main public and staff paths of travel to and from the public way accessible, including the Police lobby front door and the staff entry front door. Provide new entry doors and landings, permanent ramps and walks meeting accessible grades, and update planters to maintain the look and feel of the site.*

Figure 1 – Existing Plaza Entry Path & Steps

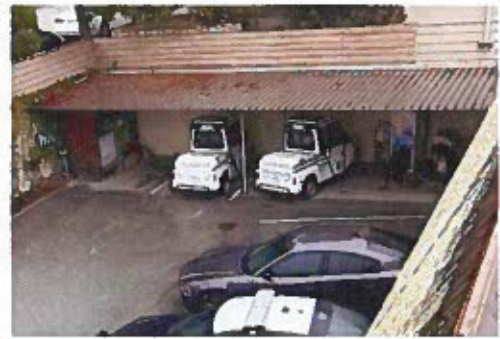
Figure 4 – View into Existing Non-Secure Patrol Covered Parking from Roof

- ◆ *Security fencing / wall at the perimeter.*
- ◆ *Motorized vehicular gate.*
- ◆ *New site lighting.*
- ◆ *New site security system.*
- ◆ *Maintain the cloud-based camera system at this facility.*

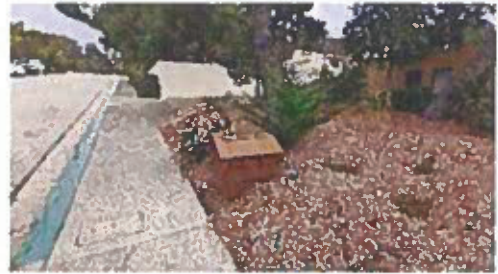
The water service that provides only domestic water is adequate (Fig. 1).

Figure 5 – Existing Water Service

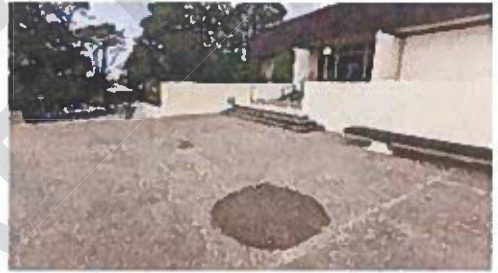
The storm drainage system serving the courtyard and roof of the Public Works Service Garage needs inspection to determine the source of water leaks into the garage below (Figs. 2-3).

Figure 6 – Existing Garage Roof Paving

The city should have the garage roof and courtyard drainage system inspected to see if it can be determined how water may be entering the garage below and make necessary repairs.

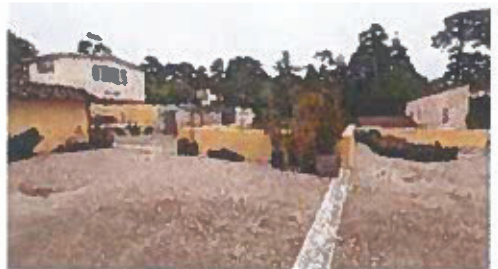
Figure 7 – Existing Garage Roof Paving

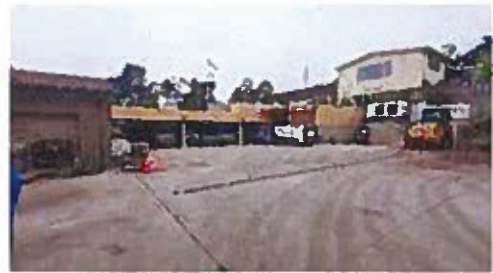
The site paving is in good condition, with only minor surface cracks (Figs. 4-6).

Figure 8 – Existing site paving

- ◆ Site Paving - No immediate action is to be taken at this time. Regularly monitor all areas of site paving and take remedial action when warranted by changed site conditions that may present a hazard for people and/or operations.

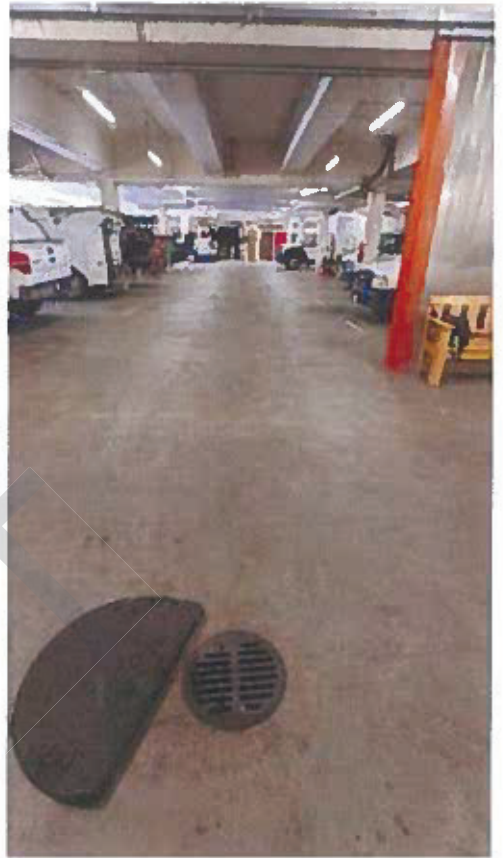
Figure 11 – Existing garage floor drains

- ◆ Run a color dye test of the garage floor drains to confirm that they discharge to the sewer system and not the onsite storm drain recycled water system as such a connection would be a violation of public health code.

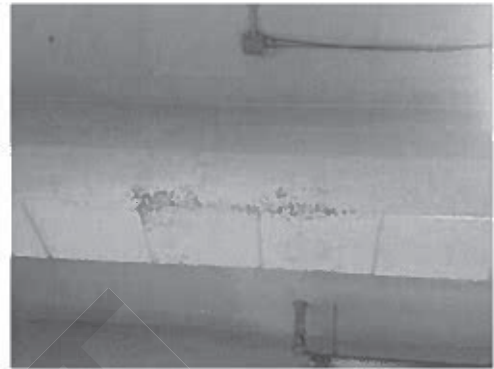
Figure 13 – Rock Pockets in Existing Parking Structure

- ◆ Conduct additional testing to determine the extent of damage to the garage roof structure and the north concrete retaining wall.
- ◆ Remove loose concrete and patch the concrete roof beams of the garage.
- ◆ Repair the cracks in the north concrete retaining wall.

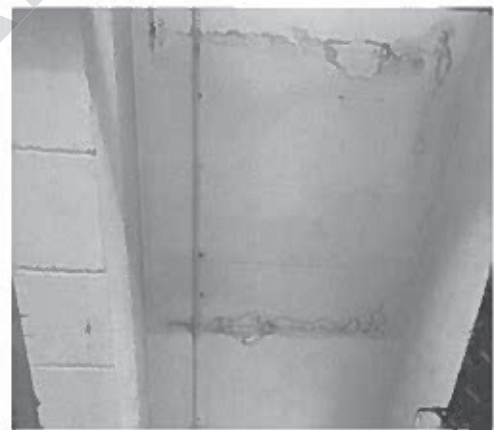
- ◆ The structure of the 2nd floor PD concrete and wood roof structure is in good condition with no evidence of structural deterioration or damage.
- ◆ Numerous cracks were observed in the concrete slab at the roof (1st floor suspended slab) of the garage along with staining near cracks that might be indicative of water infiltration in the concrete. (See Figures)
- ◆ Significant rock pockets were observed in concrete roof beams of garage and evidence of lack of adequate consolidation of concrete during original construction. (See Figures)
- ◆ Multiple full height vertical cracks with widths between 1/16" to 1/8" were observed in the North

Figure 14 – Moisture stains through cracks in existing concrete slab

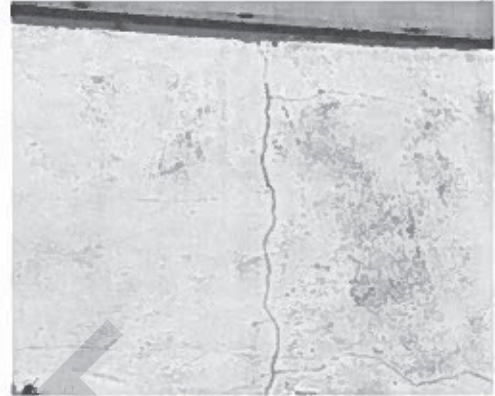
Figure 15 – Cracking in Existing Retaining Wall

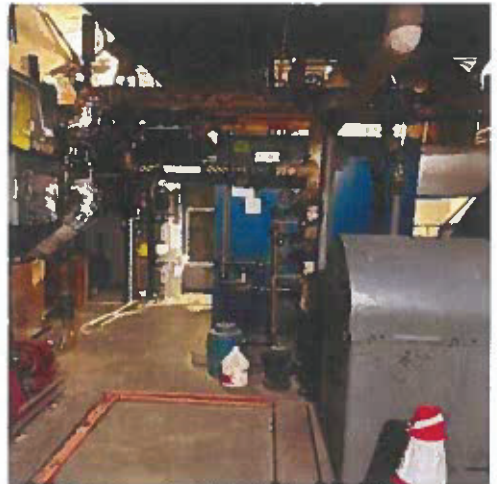
The following are the key recommendations listed into three categories (Repairs & Replacements; Needed Renovations (per code). Hot water heating boiler is 50+ years old and needs to be replaced.

Figure 17 - Existing Hot Water Boiler (Mechanical Room)

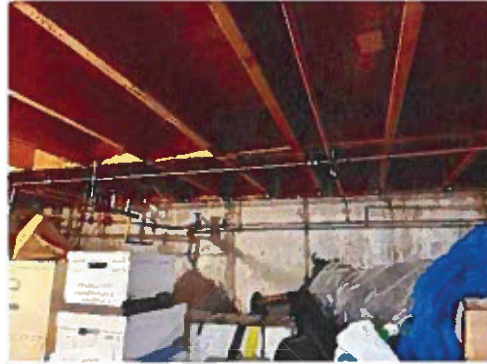
Figure 19 – Garage Storage - Existing Uninsulated Hydronic Piping

Heating hot water piping not insulated. To provide improved, more energy efficient heating for the building the hot water piping for hydronic heating needs to be insulated as soon as possible.

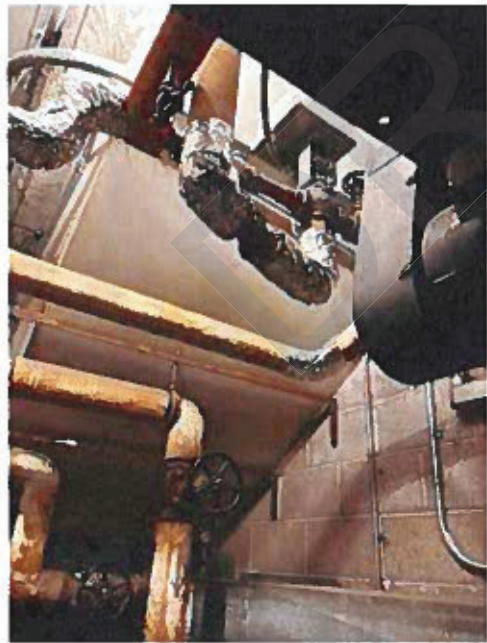
Figure 20 – Existing (Damaged) Hot Water Heating Piping Insulation

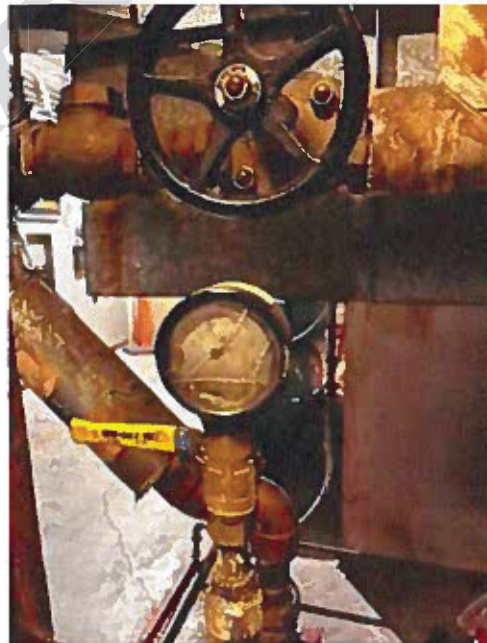
Figure 21 – Existing (Damaged & Non-Functional) Pressure Gauge

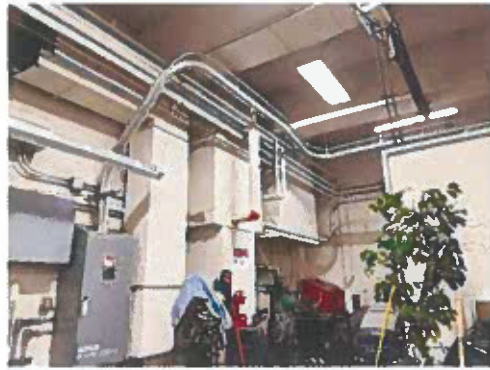
Heating hot water pipes in the Garage are located almost directly above electrical panels and generator ATS. These pipes need to be relocated for safety.

Figure 23 – Existing Hot Water Pipes Over Transfer Switch

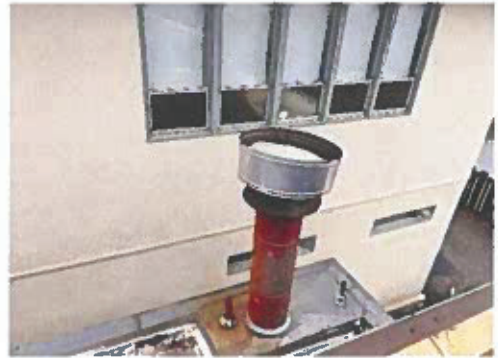
The boiler flue pipe location does not meet code and needs to be extended to the proper height and location.

Figure 22 – Existing Hot Water Boiler Flue

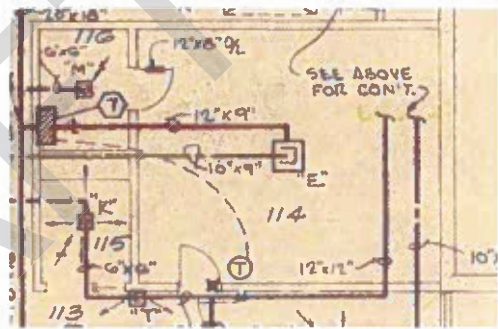
The evidence room does not have acceptable room conditions or exhaust. Recognized standards recommend a room temperature of no higher than 75°F, Relative Humidity \leq 60% and a minimum exhaust rate of 12 air changes per hour (ACH) and be under a negative pressure related to adjacent spaces. The room needs to have a dedicated 100% outside air unit with all the air exhausted to the exterior. This prevents dangerous materials from recirculating back into the HVAC system.

Figure 24 – Existing Evidence Room

The existing evidence room needs to have additional exhaust due to the products stored. The room needs to be negative and 100% exhausted at a rate no lower than 12 air changes per hour.

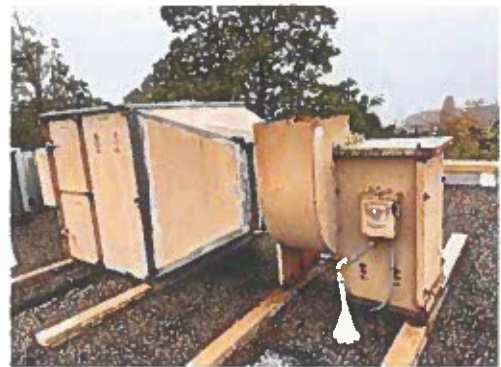
The indoor shooting range ventilation and exhaust system needs to be replaced to meet OSHA and NIOSH requirements for air quality in the space, how air is distributed and exhausted and how it is filtered at the exterior.

Figure 25 – Existing Shooting Range Exhaust Fan/Filtration Unit

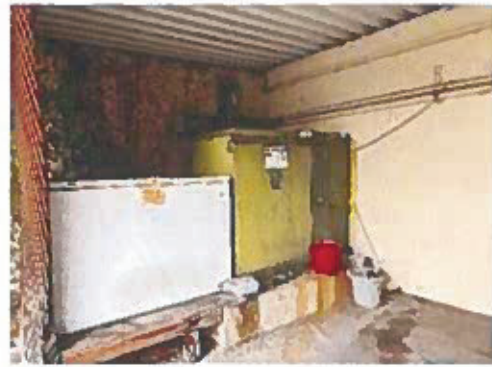
The existing power utility service transformer location in corner under a canopy is not compliant with current PG&E standards. The existing location would cause a substantial delay in a timely replacement if an equipment failure were to occur.

Figure 30 – Existing utility company transformer location

If the existing service size remains as-is then the existing transformer and location may be able to remain unless specifically directed otherwise by PG&E. If the electrical service is upsized then the utility company transformer will need to be replaced and relocated to meet current standards.

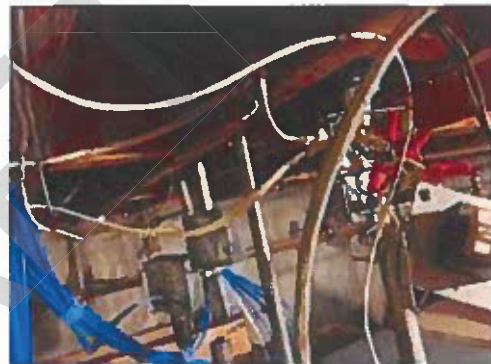
Figure 31 – Electrical box missing cover

All electrical boxes are required to have covers and wire splices need to be remade and located in electrical boxes as required.

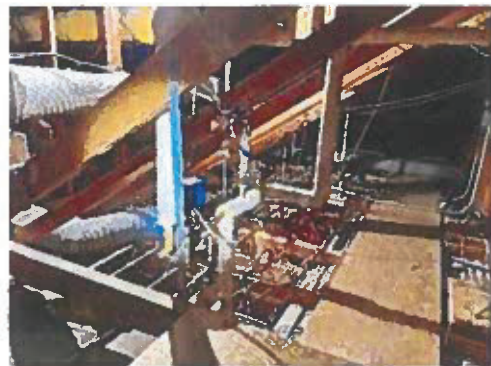
There are existing non-code compliant and exposed wire splices in the attic.

Figure 32 – Electrical splices not in electrical box.

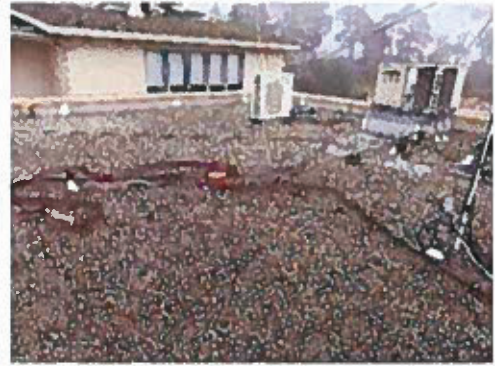
The roof top lightning protection system has failed. The installation is antiquated and no longer complies with NFPA 780, the standard reference by the electrical code for lightning protection. This presents a current safety risk to life and property.

Figure 33 – Existing disconnected lightning protection

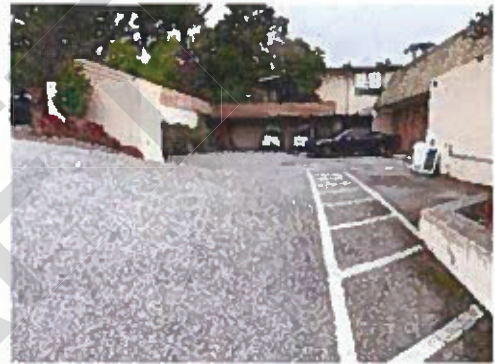
The lighting in the Police parking area is insufficient and is a safety risk. The existing lighting needs to be replaced and supplemented.

Figure 34 – Existing parking area

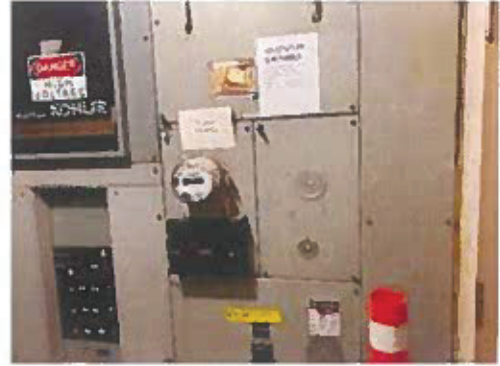
The existing 400-amp main switchboard installed in 1966, per the nameplate, is clean and in fair condition. The switchboard is at the end of its useful life. After 50 years the grease in the breakers is usually hardened, creating the potential for the breakers to not operate properly. The insulated bracing supporting the bussing tends to become brittle and starts to lose its resistive properties after 50 years. There are no spaces for future breakers. There is no evidence of maintenance testing as recommended by NETA, International Electrical Testing Association and ANSI, American National Standards Institute. The main switchboard should be replaced.

Figure 36 – Existing Switchboard

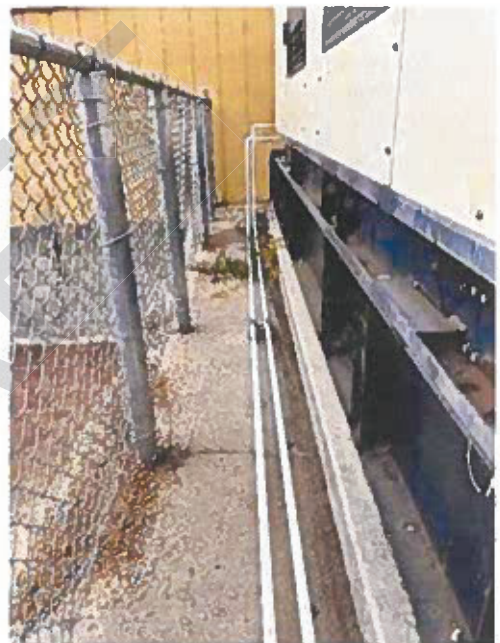
The building is supported by an emergency generator, automatic transfer switch and emergency power distribution switchboard. The system is fairly new. The generator's weatherproof enclosure tends to leak moisture when it rains. The raised platform for the generator has insufficient working clearance along the sides. An extension of the platform is required to meet working space requirements per the manufacturer and OSHA.

Figure 37 - Clearance in front of existing generator

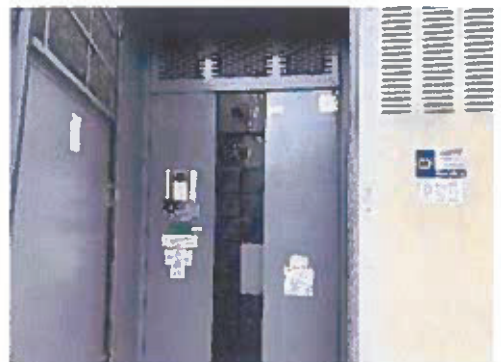
The breakers in the emergency power distribution switchboard are not labeled for the loads supported as required by the electrical code.

Figure 38 - Existing power distribution switchboard

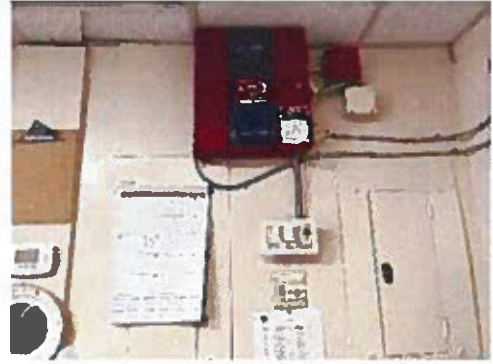
The mounting heights of the existing fire alarm control panel and manual pull station do not meet code.

Figure 39 - Existing Fire Alarm Control Panel

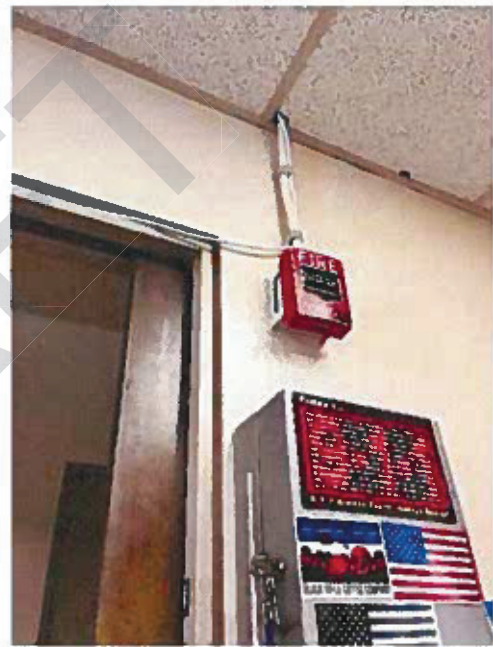
Figure 40 - Existing Manual Pull Station

There is no remote annunciator located in the lobby. The remote annunciator listed for the existing fire alarm control panel is no longer available. Recommend the replacement of the existing fire alarm panel with a listed remote annunciator, placing the fire alarm panel at the code required height. Relocate pull station to meet current requirements.

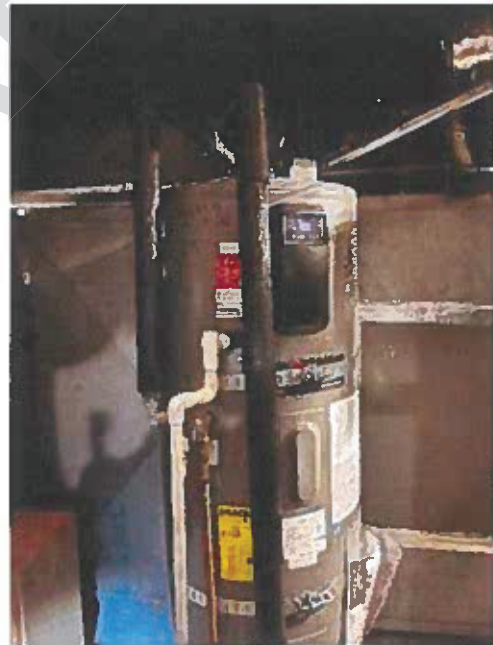
The water heater in the mechanical room was replaced recently but, there was no expansion tank installed. This is code requirement and if not installed could result in pipe leaks when the water is heated and expands.

Figure 41 – Existing Hot Water Heater (No Expansion Tank)

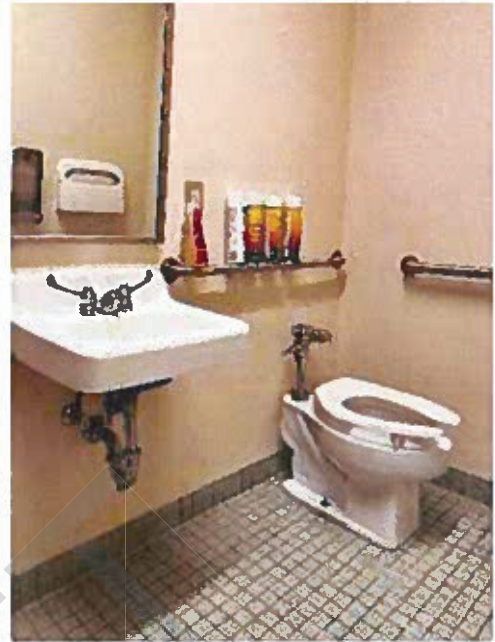
*The restroom plumbing fixtures need replacement.
Also, additional restroom facilities are needed.*

Figure 42 – Existing Restroom

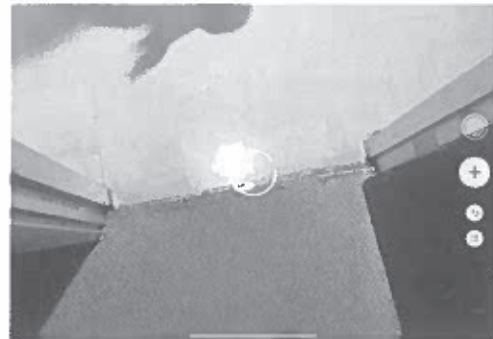
Virtually all interior partition walls encroach on horizontal accessibility requirements, whether on the circulation clearance side or the interior room clearance side, or both. Most doors are at least slightly narrower than the 32-inch minimum clear opening width. Hardware on those doors generally

Figure 43 – Existing 31.5-inch opening

- ◆ *To meet horizontal circulation requirements, all existing partition walls shall be demolished and replaced new walls, including accessible doors, hardware, and signage.*
- ◆ *To meet vertical circulation requirements, insertion of an elevator assembly is required to provide accessibility to all three floors of the Police Building. Assembly shall include pit, shaft and control room. Assembly shall include structural interventions to accommodate the shaft and pit installation.*
- ◆ *To meet vertical circulation requirements, insertion of stairs is required to meet or exceed minimum standards for width, rise, run, and landing depth.*

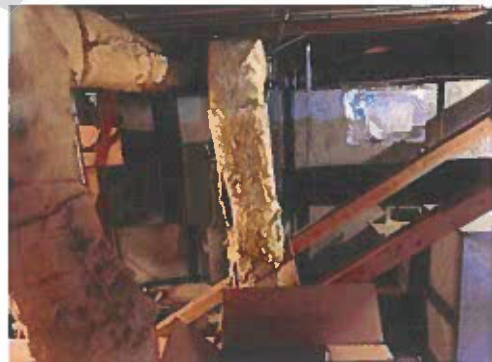
Figure 48 – Existing Duct Insulation

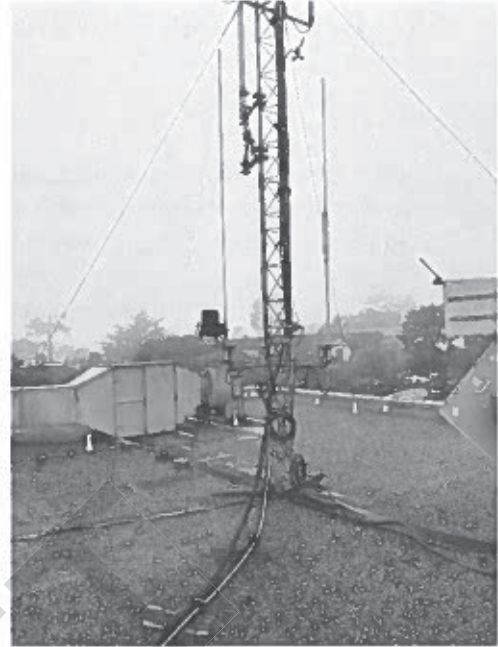
- ◆ *The exterior walls are uninsulated.*
- ◆ *The single-paned glazing fails to meet current energy code and has poor acoustic properties.*
- ◆ *The built-up roofing and coping is in poor condition.*
- ◆ *The original mansard shingles are beyond failing and some are now missing, exposing bare roof deck.*
- ◆ *Hazardous materials like lead and asbestos are present in the building.*
- ◆ *Water intrusion is causing damage to equipment and creating environmental hazards.*

Figure 49 – Existing Roof

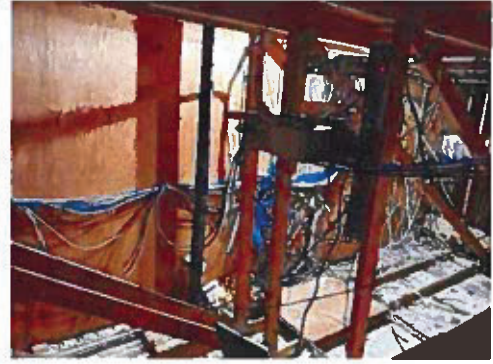
Figure 52 - Existing attic IDF with unsafe floor

This location can be re-used for new cabling and patch panels, but it is highly recommended that additional plywood flooring be placed for easier / safer access.
