NOTICE OF APPROVAL

Planning Case #: Design Study 23255
Owner Name: CHRISTENSEN DOUGLAS L TR ET AL
Case Planner: Evan Kort, Associate Planner
Date Posted:
Date Approved: 02/20/2024
Project Location: Torres 3 SE of 1st Avenue
APN #: 010101017000 BLOCK/LOT: 14/ALL LOT 6
Annlicant: Samuel Pitnick

Project Description: Approval of Design Study, DS 23-255 (Christensen), authorizes an amendment to a previously approved Design Study, DS 20-082, for the replacement of seven (7) existing wood framed windows and replacement of one (1) window with a new sliding glass door on the historic "Harry Turner Jr. House". The project maintains an active building permit (BP 20-336) and is located at on Torres 3 southeast of 1st Avenue in the Single Family (R-1) Zone District and shall be constructed consistent with the application materials dated prepared by Samuel Pitnick dated approved by the Community Planning and Building Department on February 20, 2024 as well as the Phase II Historic Evaluation prepared by Margret Clovis dated February 2, 2024, on file in the Community Planning & Building Department, unless modified by the conditions of approval.

TORRES RESIDENCE TORRES 3 S.E. OF 1ST **AVENUE**

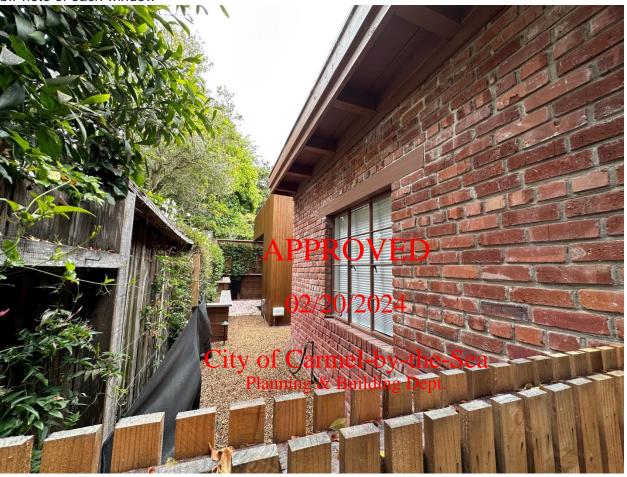
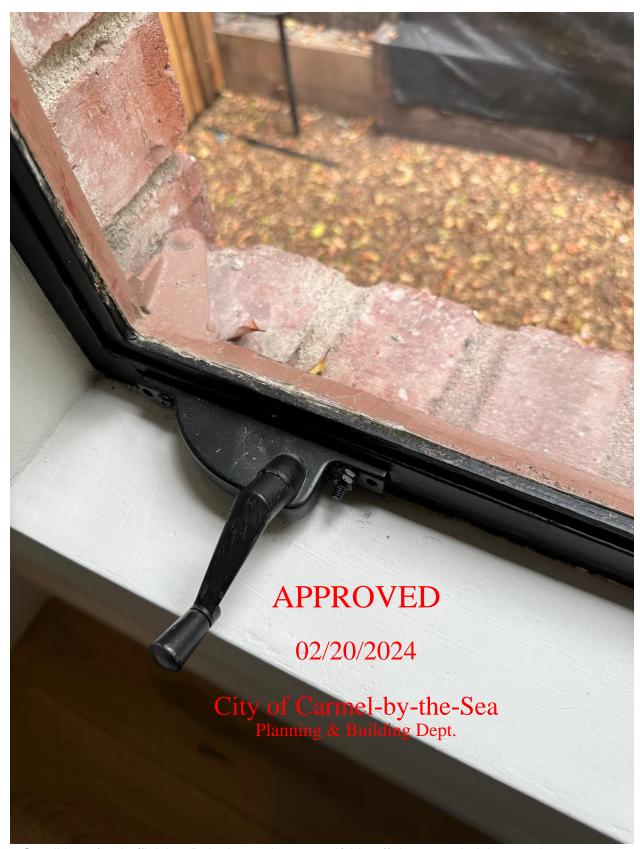
a.Window location - Bedroom #1, north elevation.

c.Condition of paint/finish – Paint is starting to peel/chip off due to underlying rust issues. d.Condition of the frame and sill – Frame is warped preventing window from opening. Rust is visible and causing paint to peel.

e.Condition of the sash (frame, rails, and stiles) - Sash is warped preventing window from opening. Rust is visible and causing paint to peel.

Condensation accumulates inside of glazing which ultimately will lead to damaged sills and jambs. Home experiences major heat loss due to single pane glass.

g.Condition and inventory of hardware – Window crank is stripped and does not work. Exterior hinges show signs of rust making operation difficult.

h.The overall condition of the window - Poor. Contractor recommends replacement. The current window creates a major safety concern as egress from the bedroom is not possible.

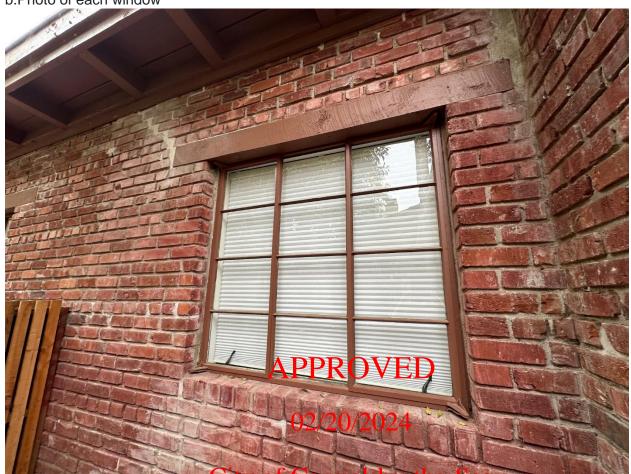
a. Window location – Living room, north elevation.

- c.Condition of paint/finish Paint is starting to peel/chip off due to underlying rust issues.
- d. Condition of the frame and sill Rus Playsible and Building paints peel.
- e.Condition of the sash (frame, rails, and stiles) Rust is visible and causing paint to peel.
- f.Glazing problems Single pane glass is not tempered creating safety issues.

Condensation accumulates inside of glazing which ultimately will lead to damaged sills and jambs. Home experiences major heat loss due to single pane glass.

- g.Condition and inventory of hardware Windows are difficult to open due to rust issues.
- h.The overall condition of the window Poor. Contractor recommends replacement.

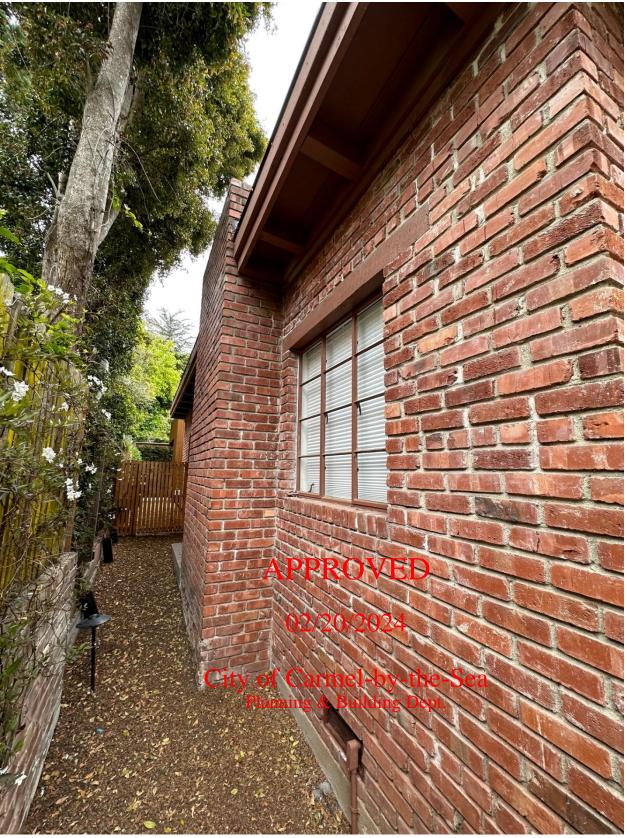
a. Window location – Living room, north elevation.

c.Condition of paint/finish - Paint is starting to peel/chip off due to underlying rust issues.

- d.Condition of the frame and sill Frame is warped preventing window from opening. Rust is visible and causing paint to peel.
- e.Condition of the sash (frame, rails, and stiles) Sash is warped preventing window from opening. Rust is visible and causing paint to peel.
- f.Glazing problems Single pane glass is not tempered creating safety issues.
- Condensation accumulates inside of glazing which ultimately will lead to damaged sills and jambs. Home experiences major heat loss due to single pane glass.
- g.Condition and inventory of hardware Hardware is not able to open window due to issues mentioned above.
- h.The overall condition of the window Poor. Contractor recommends replacement.

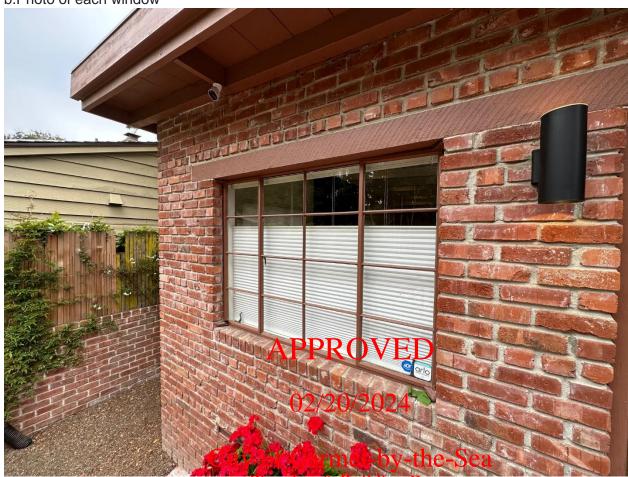
- a.Window location Living room, west elevation.
- b.Photo of each window

- c.Condition of paint/finish Paint is starting to the excelled the tent derlying rust issues.
- d.Condition of the frame and sill Rust is visible and causing paint to peel.
- e.Condition of the sash (frame, rails, and stiles) Rust is visible and causing paint to peel.
- f.Glazing problems Single pane glass is not tempered creating safety issues.
- Condensation accumulates inside of glazing which ultimately will lead to damaged sills and jambs. Home experiences major heat loss due to single pane glass.
- g.Condition and inventory of hardware Windows are difficult to open due to rust issues.
- h.The overall condition of the window Poor. Contractor recommends replacement.

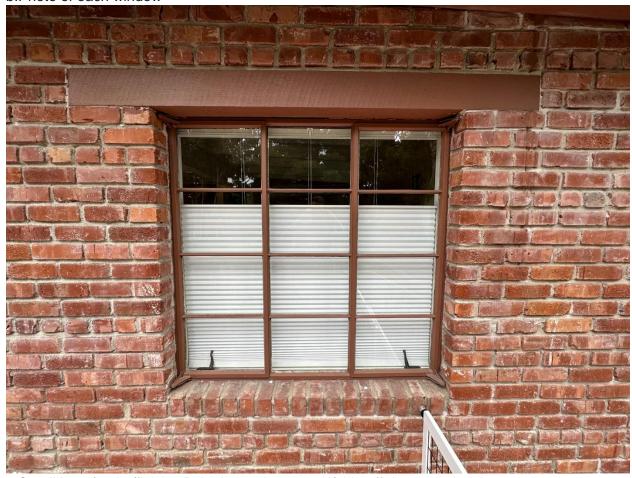
- a.Window location Dining room, west elevation.
- b.Photo of each window

- c.Condition of paint/finish Paint is starting to peel/chip off due to underlying rust issues.
- d.Condition of the frame and sill Rust is visible and causing paint to peel.
- e.Condition of the sash (frame, rails, and stiles) Rust is visible and causing paint to peel.
- f.Glazing problems Single pane glass is not tempered creating safety issues.
- Condensation accumulates inside of glaz Ag Mici Rulina by will be ad to damaged sills and jambs. Home experiences major heat loss due to single pane glass.
- g.Condition and inventory of hardware Windows are difficult to open due to rust issues.

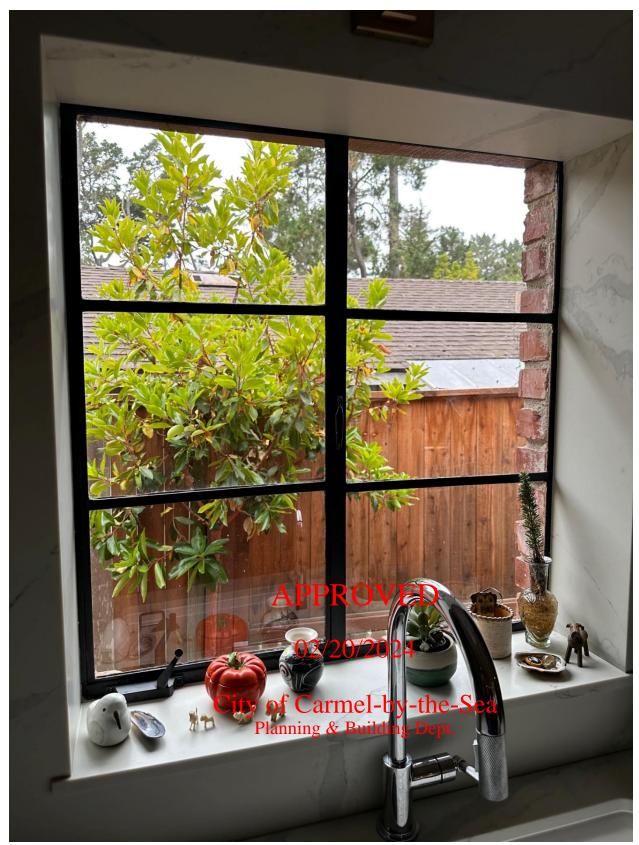
a.Window location – Kitchen, south elevation Carmel-by-the-Sea b.Photo of each window

c.Condition of paint/finish - Paint is starting to peel/chip off due to underlying rust issues.

d.Condition of the frame and sill - Rust is visible and causing paint to peel.

e.Condition of the sash (frame, rails, and stiles) - Rust is visible and causing paint to peel.

f.Glazing problems - Single pane glass is not tempered creating safety issues. Condensation accumulates inside of glazing which ultimately will lead to damaged sills and jambs. Home experiences major heat loss due to single pane glass.

g.Condition and inventory of hardware – Window is seized and unable to open.

h.The overall condition of the window - Poor. Contractor recommends replacement.

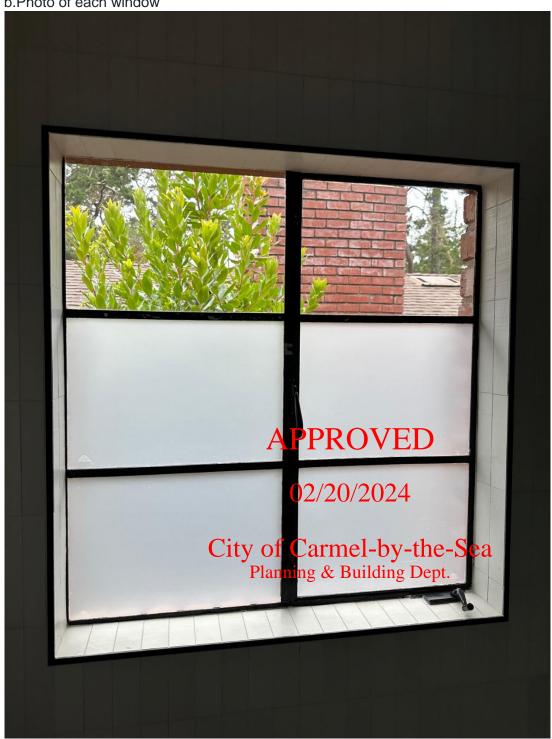
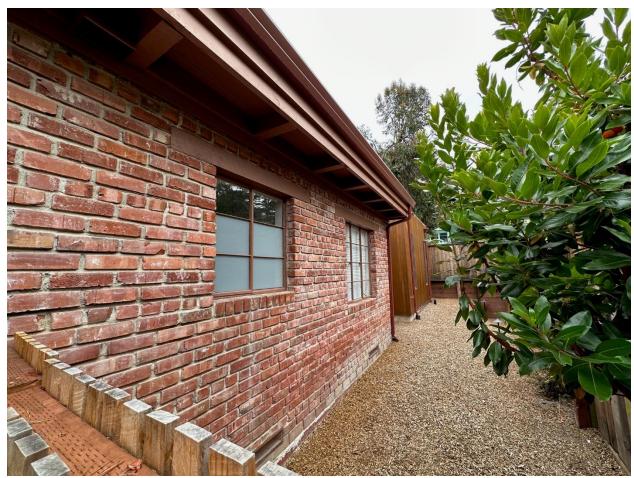
a.Window location - Bathroom #1, south elevation.

c.Condition of paint/finish - Paint is starting to peel/chip off due to underlying rust issues.

- d.Condition of the frame and sill Rust is visible and causing paint to peel.
- e.Condition of the sash (frame, rails, and stiles) Rust is visible and causing paint to peel.
- f.Glazing problems Condensation accumulates inside of glazing which ultimately will lead to damaged sills and jambs. Home experiences major heat loss due to single pane glass.
- g.Condition and inventory of hardware Window is seized and unable to open.
- h. The overall condition of the window Pear Pontrado recommends replacement.

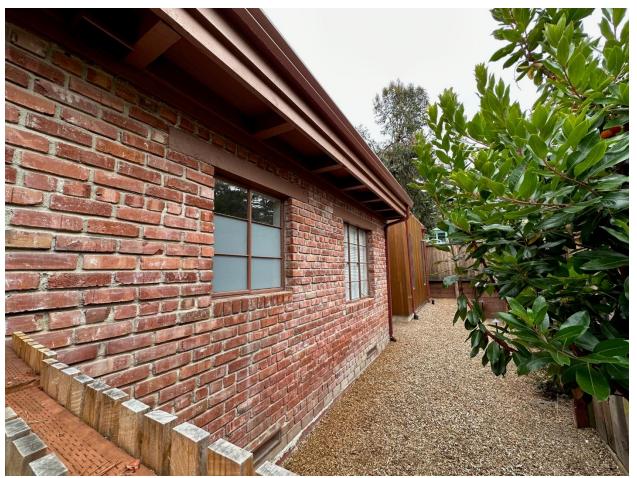
a.Window location – Bedroom #2, south elevation / 20/2024 b.Photo of each window

c.Condition of paint/finish - Paint is starting to peel/chip off due to underlying rust issues.

d.Condition of the frame and sill - Rust is visible and causing paint to peel.

e.Condition of the sash (frame, rails, and stiles) - Rust is visible and causing paint to peel.

Condensation accumulates inside of glazing which ultimately will lead to damaged sills and jambs. Home experiences major heat loss due to single pane glass.

g.Condition and inventory of hardware - Wanks Predized and In ble to open.

h.The overall condition of the window – Poor. Contractor recommends replacement. The current window creates a major safety concern as egress from the bedroom is not possible.
