HAZARDOUS MATERIAL REPORTS
FOR
SUNSET CENTER
AND
HARRISON MEMORIAL LIBRARY
CARMEL-BY-THE-SEA

Re: Limited Exterior Asbestos and Lead Inspection for the Exterior Painting Project at the Sunset Center Located on San Carlos Street in Carmel, California.
M³ Project No. 22089.0 Task 1

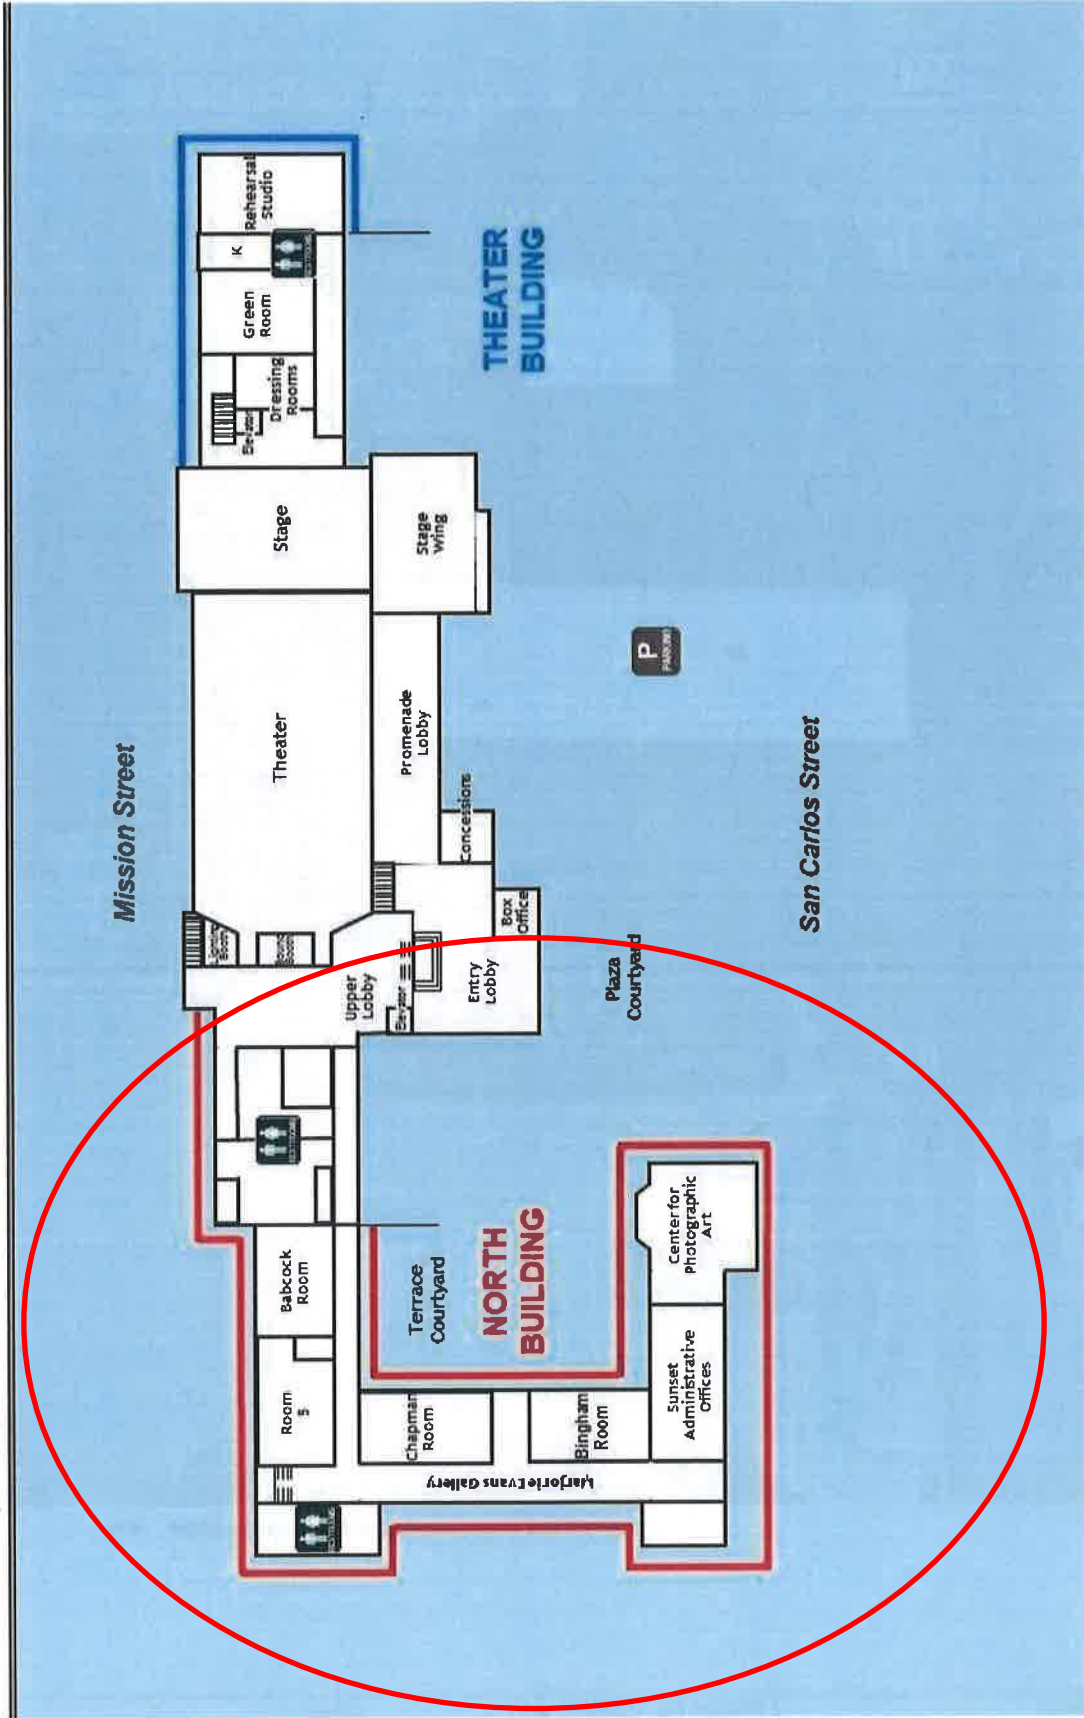
Hazardous Materials Testing Areas

Client: City of Camel	Project No. 22089.0 - T1	Key:	M ³
Project Name: Exterior Lead and Asbestos	Date: February 3/16/22	Asbestos sample	1A
Location: Sunset Center		Lead sample	L1
Floor: Main Building (North and South)		Positive material	1A L1

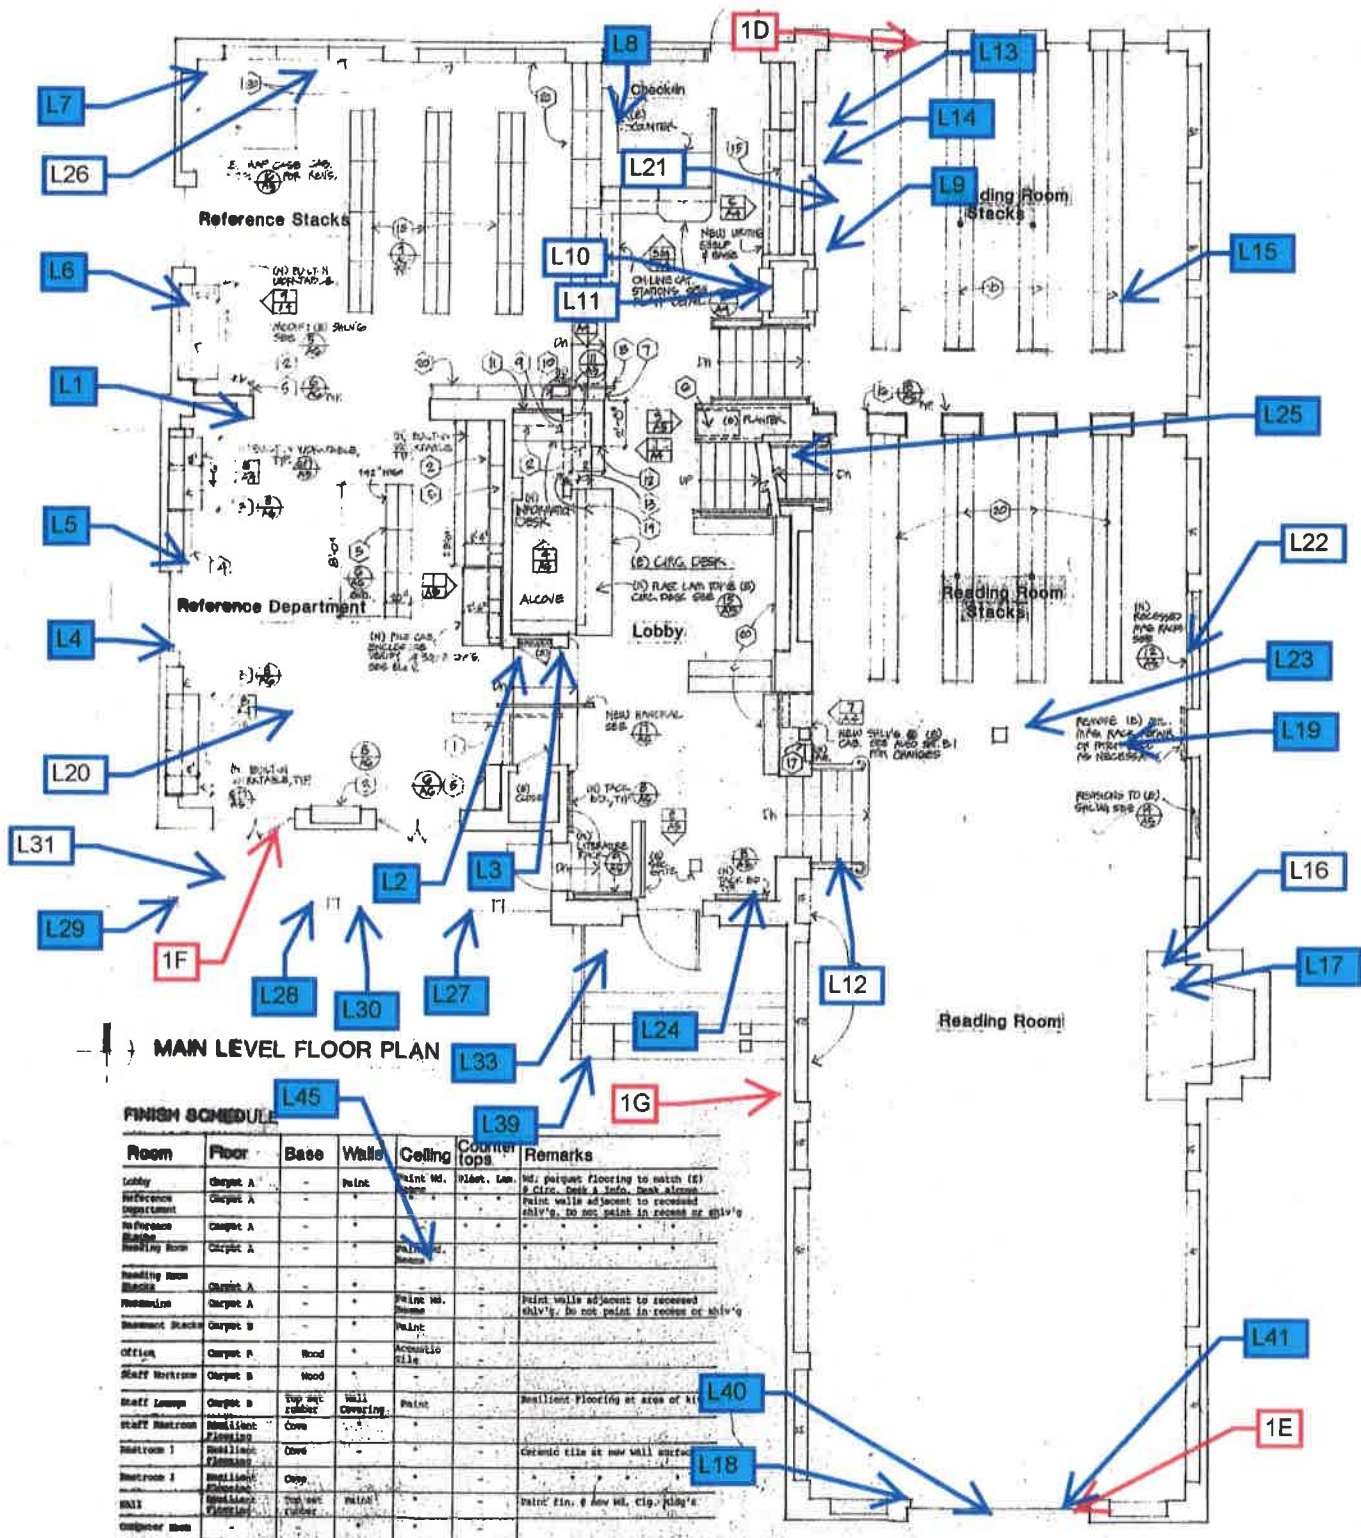
SAMPLE LOCATION MAPS

Client: City of Carmel
 Project Name: ACM/Pb Reno
 Location: Harris Library
 Floor: Upstairs
