## Structural Evaluation Memo

KE Project No.: 24-044

**Project:** Carmel Beach Existing Stairs: Preliminary Structural Evaluation  
**Location:** North of 10<sup>th</sup> Ave & 12<sup>th</sup> Ave Carmel-By-The-Sea, CA 93923  
**Subject:** Structural Observations and Evaluation of Stairways 4 & 7 at Carmel-By-The-Sea

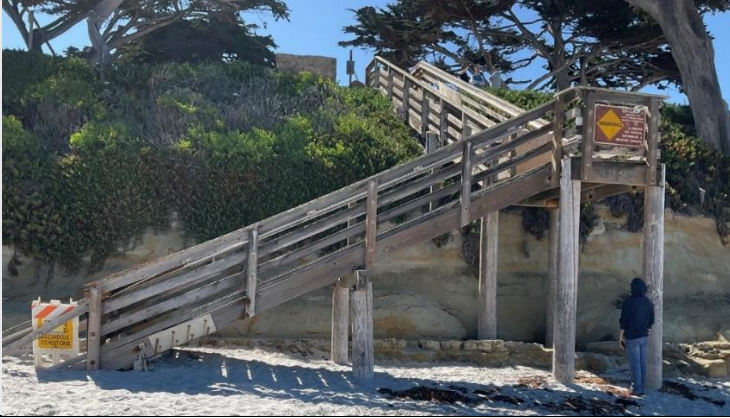
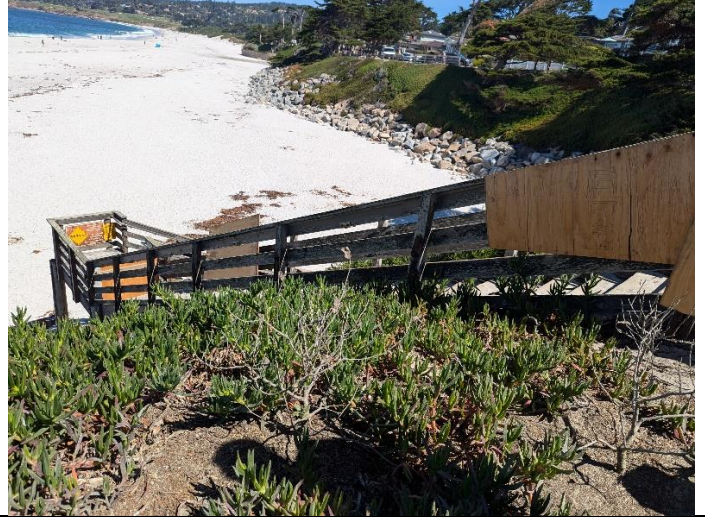
**Figure 1: Stairway #4 from Below and Above**

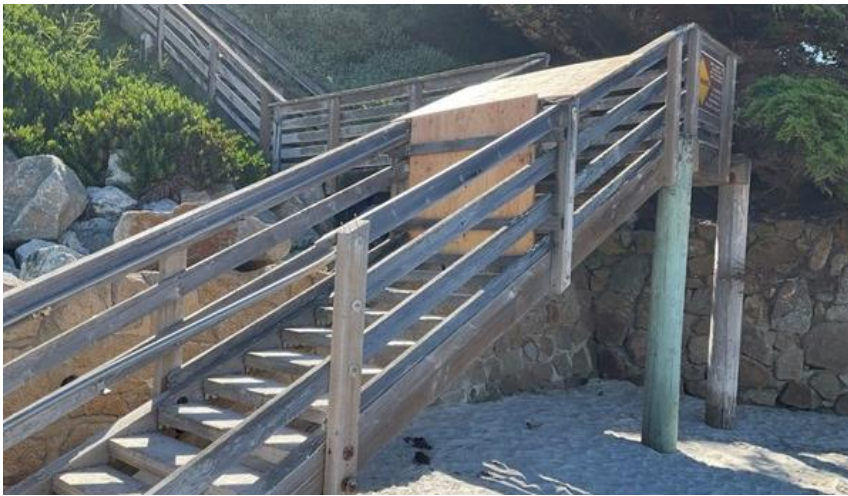
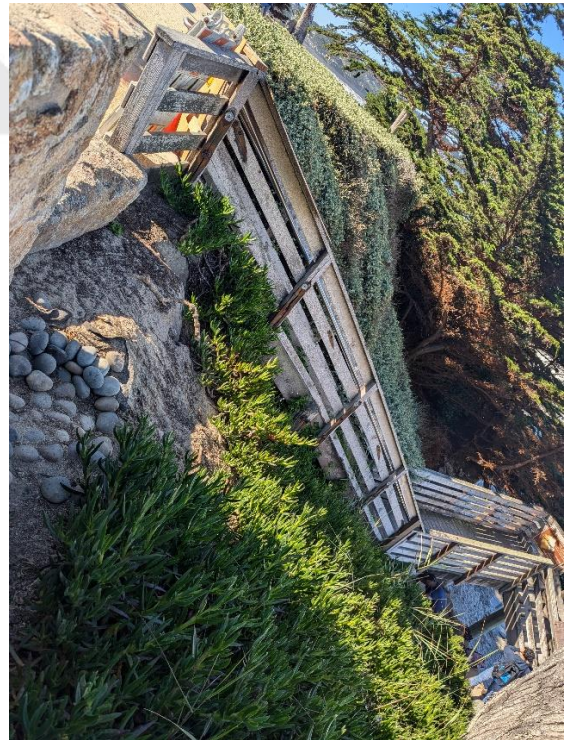
**Figure 2: Stairway #7 from Below and Above**

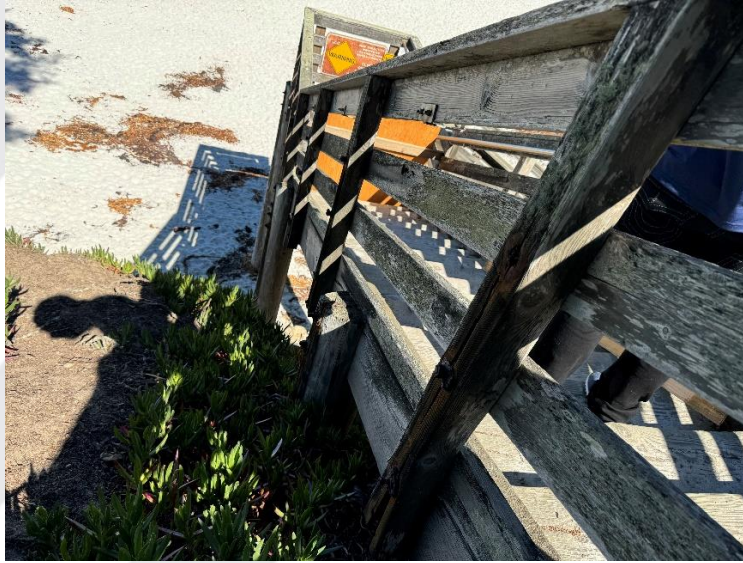
In stairway 4, the 4x4 guardrail posts for the upper flight of the stairs are heavily split. Bolts from the guardrail post and handrails at the top of the flight of stairs to the landing can no longer support the required loading, see Figure 3. Each of the 4x4 posts (approximately 12 posts) and bolts at the upper flight shall be replaced with a 4x6 post per detail 1/SSK1. Some bolts connecting the guardrail post to the stringer at the lower flight of stairs show signs of heavy rust, see Figure 4. Bolts showing high corrosion levels shall be replaced per detail 1/SSK1. Angles and bolts that connect treads to the upper stair stringers are heavily rusted, see Figure 5. Replace all Angles and bolts used for connecting treads to stringer per detail 1/SSK2. Stringers at the top and lower flight of stairs show signs of splitting at the connection points of the guardrail posts and angles for the treads; see Figures 5 and 6. Stringers shall be replaced per detail 1/SSK1. Bolts used to connect posts to the landing and lower flight of stairs show high levels of corrosion. Field-verify all posts for splitting and replace per 1/SSK1 as required. Several support posts are split at notched portions. Field-verify locations and reinforce with SDWH structural screws per 1/SSK3; rusted bolts shall be replaced per detail 1/SSK1. The handrail connection is insufficient to support required loads; it shall be replaced per 1a/SSK1.

**Figure 3: Stair #4: Guardrail Post Upper Flight to Landing**

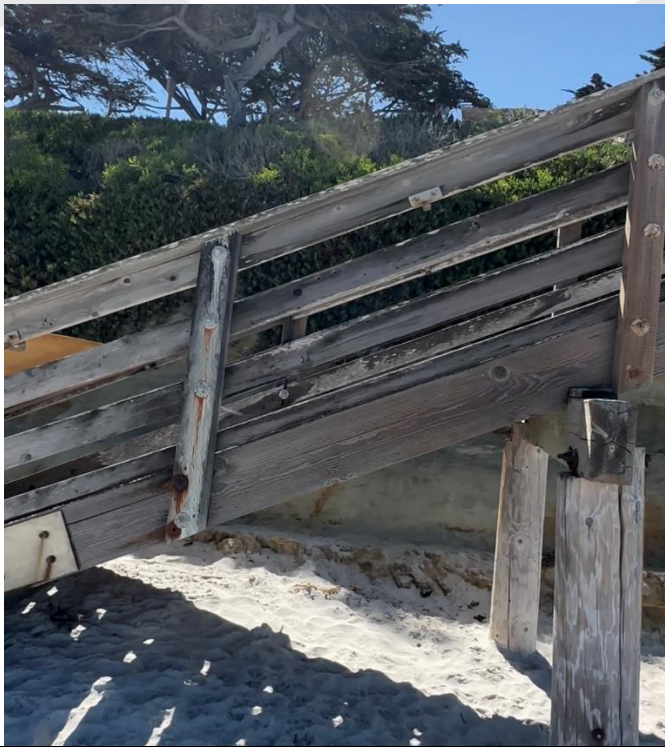
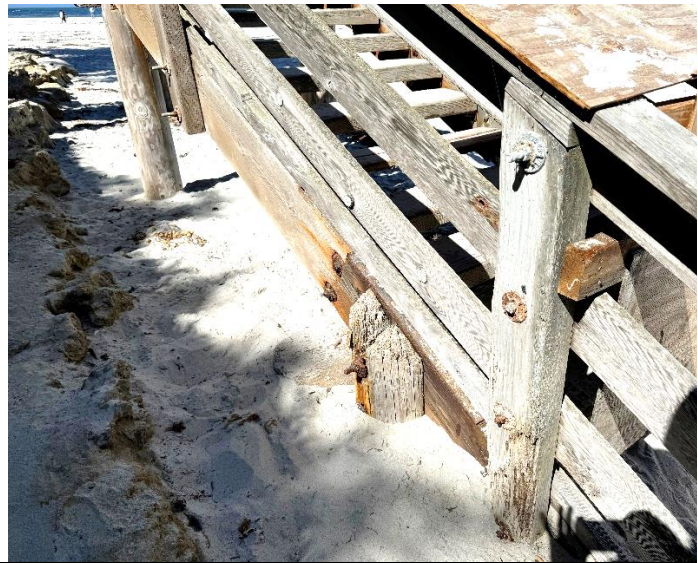
**Figure 4: Stair 4 Guardrail Post/Split Stringer from Landing to Bottom of Stairway**

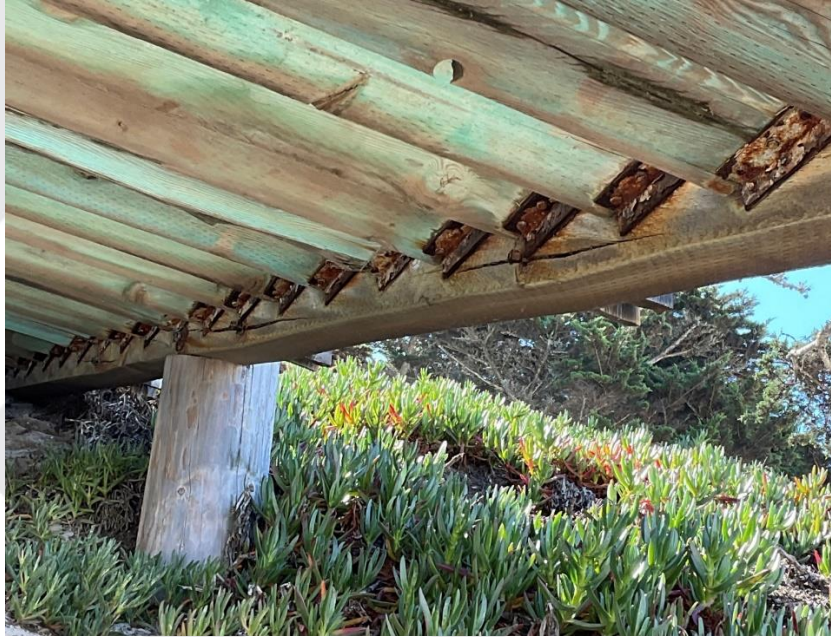
*Figure 5: Stair 4 Stringer from Top of Stairway Upper Landing*

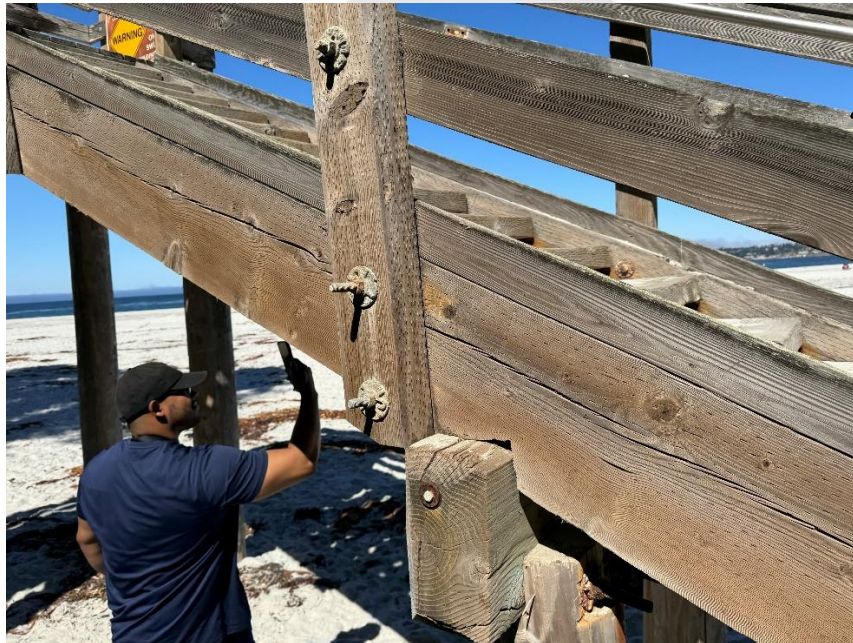
*Figure 6: Stairway 4 Split Stringer from Middle Landing to Beach*

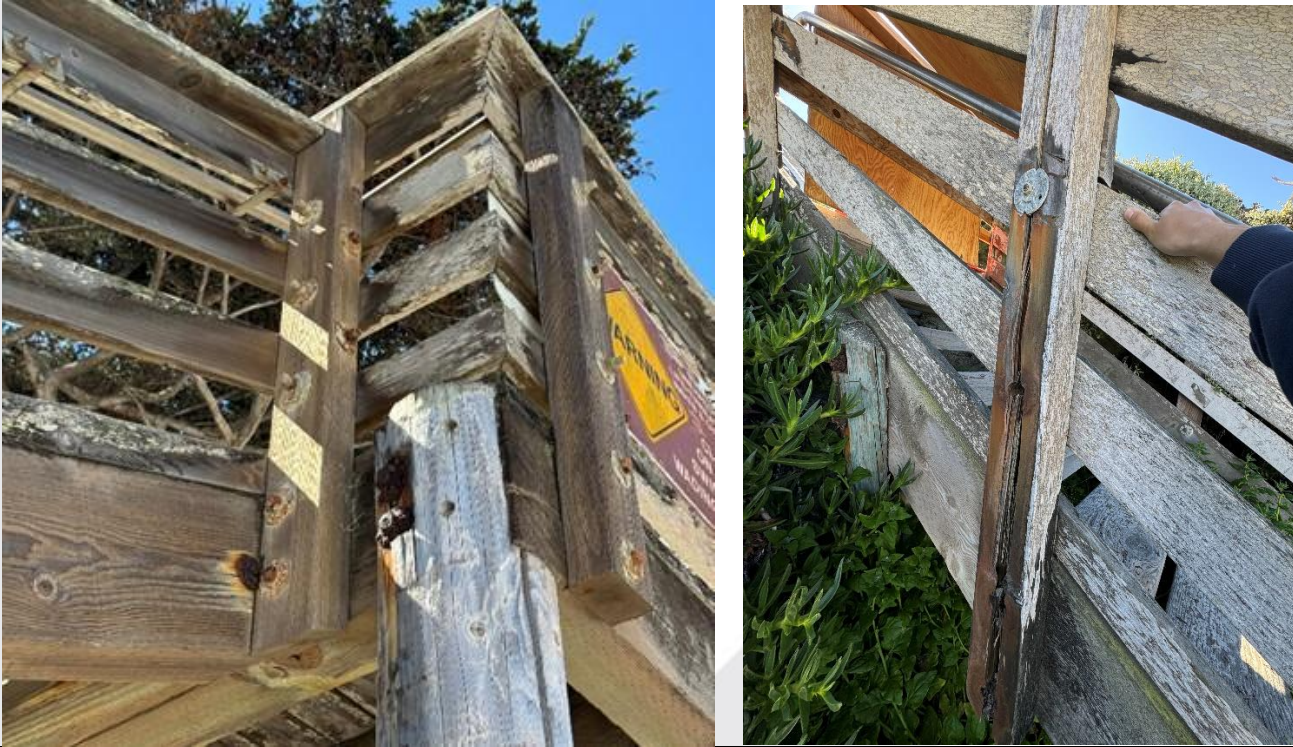
**Figure 7: Post to Landing Bolted Connection**

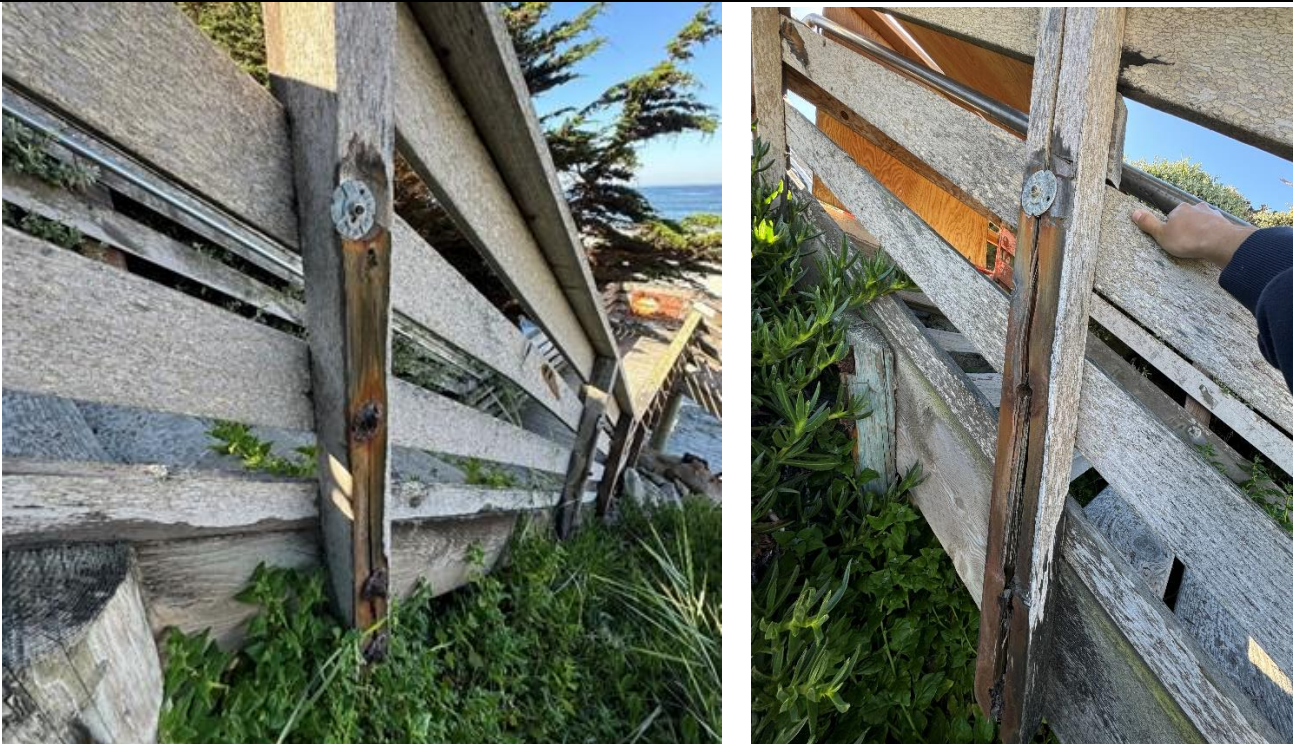
In stairway 7, all guardrail posts at the north of the upper flight of stairs are splitting, and the connection bolts that connect the posts and railing are severely rusted, see Figure 8. Please note that our team did not review the 4x4 posts on the southern side of the upper landing due to interference from the landscaping. These posts shall be reviewed by the City of Carmel-by-the-Sea maintenance personnel to check for splitting. All 4x4 posts that are splitting shall be replaced per detail 1 /SSK1. The handrail attached to the guardrail shall be modified per detail 1a/SSK1. Stringers at the bottom of the flight of stairs show signs of splitting at connection points where guardrail posts and stairway angles are bolted through [Refer to Figure 9]. Stringers shall be replaced per detail 1/SSK1 and 1/SSK2. The splitting in the stringer appears to be caused by the handrail post connection. The MIW was recessed into the stringer to allow for the stainless steel tread support, resulting in localized weakness at each handrail support resulting in the stringer failure; therefore, it is our opinion this stringer is not eligible for strengthening. Bolts used to connect steps to the stringer show light corrosion and are relatively loose [Refer to Figure 9]. Bolts shall be replaced per details 1/SSK2. Bolts used to connect posts to the stair landing show high levels of corrosion; some posts show signs of splitting [Refer to Figure 10]. Posts shall be reinforced with SDWH structural screws, and corroded bolts shall be replaced with hot dip galvanized (HDG) bolts and new malleable iron washers (MIWs) as required per 1/SSK3.

**Figure 8: Guardrail Posts-Stringer Bolted Connection**

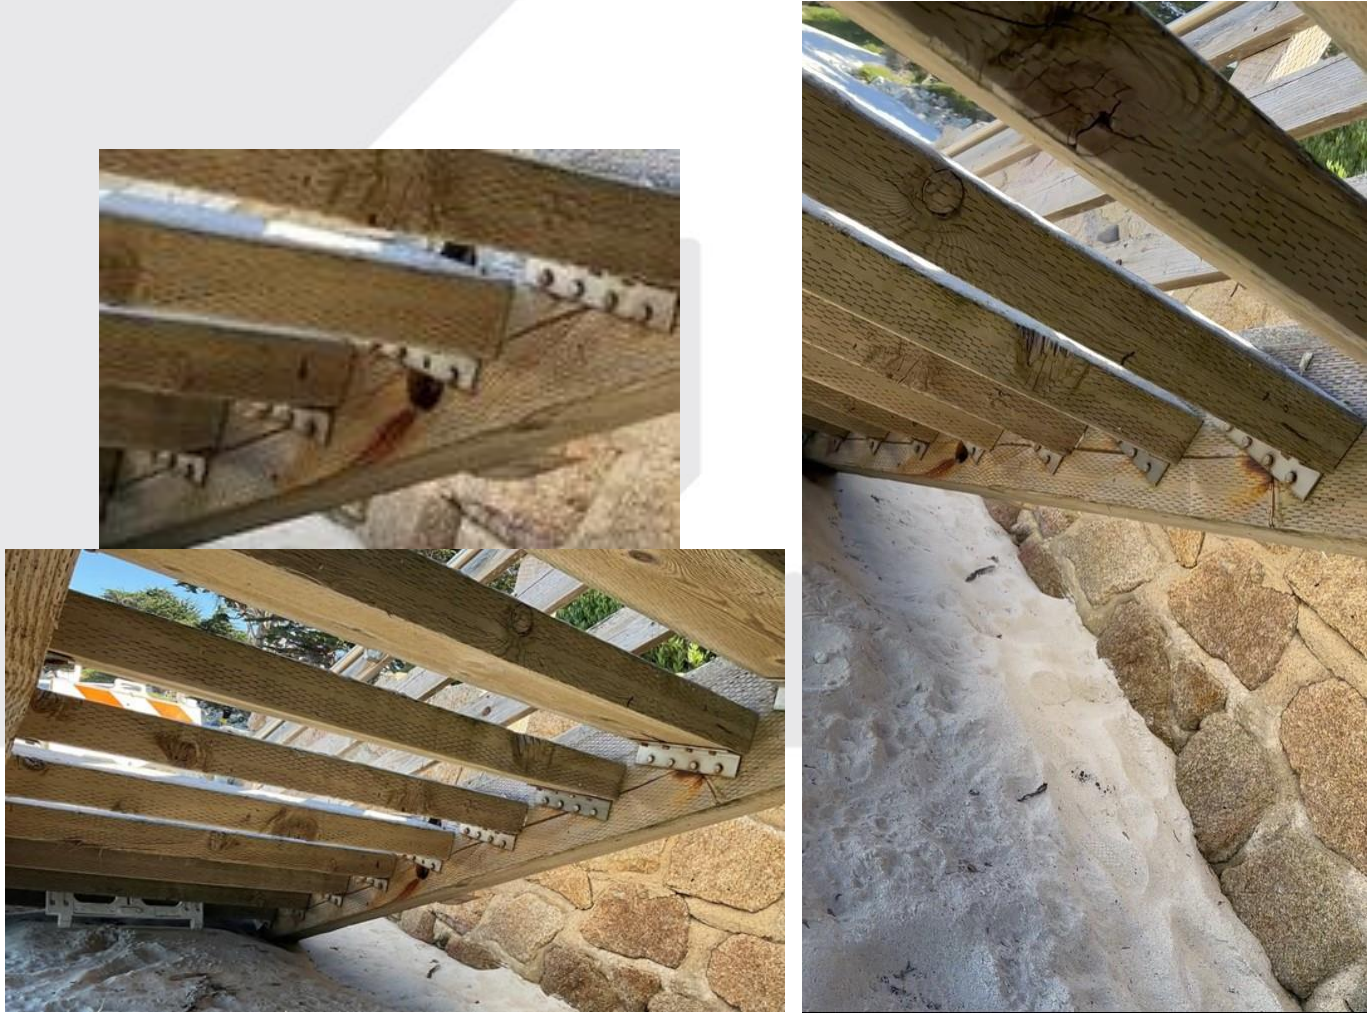
***Figure 9: Stair 7 Split Stringer at Countersunk Post Connections Replace (2) 6x12 Stringers***

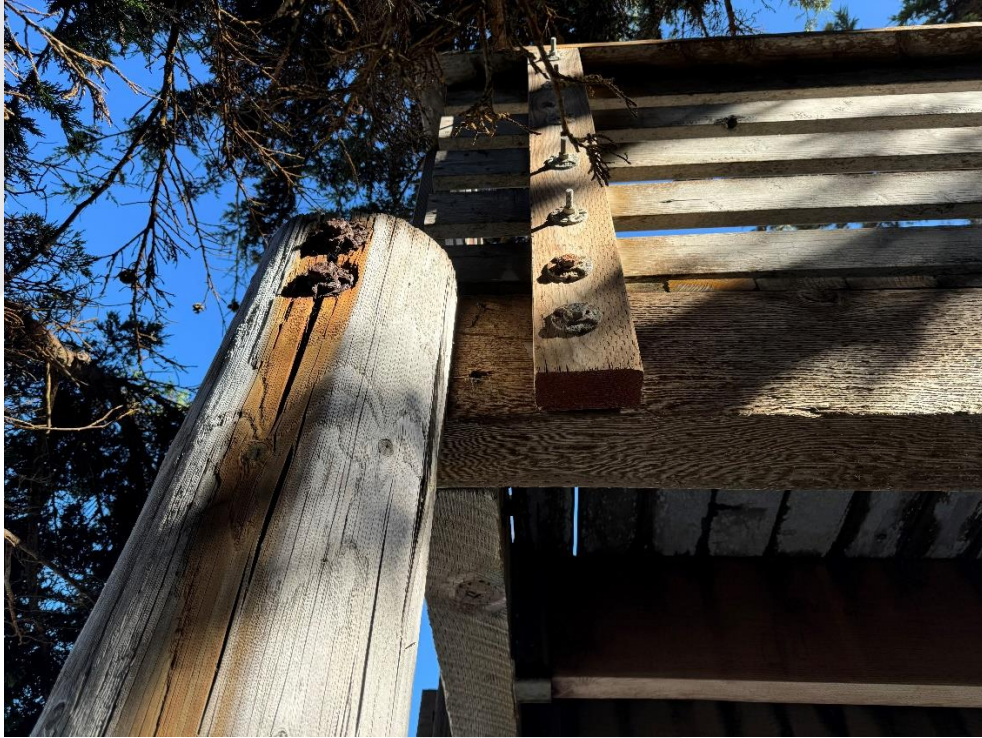
*Figure 10: Post to Landing Bolted Connection*
