G. A. Graebe & Associates, Inc.

Pursuant to our contract with the City of Carmel-by-the-Sea, dated November 12, 2014 which covers stairs "1" through "9", and our first amendment to the contract dated February 13, 2015, which covers beach access stair "0", we are pleased to submit the requested work for Structural Preventive Maintenance Program for the ten Carmel Beach Stairways at Carmel Beach, in Carmel, CA 93923.

STRUCTURAL BEACH STAIR MAINTENANCE
FOR
CARMEL BEACH STAIRS
CARMEL BY THE SEA, CALIFORNIA
OVERALL SITE PLAN

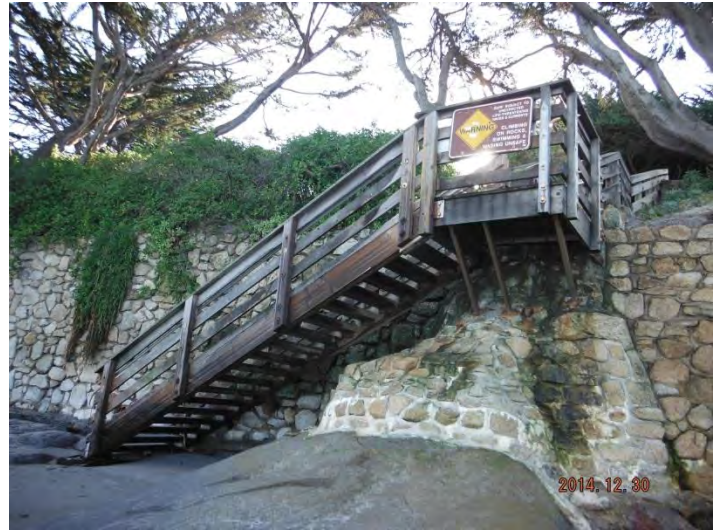
046

9	Rusted angle bolts at guard rail posts toward the ocean side.	see pictures 046, 088, 097.	Moderate	We recommend replacing the lower wood flight with concrete stairs and stone veneered retaining walls similar to lower flight of stair 4; see pictures 112 & 114 in stair 4.	Cost is included in item 2
10	Rusted / perforated hand rail at the bottom flight.	see pictures 082, 090, 091.	Moderate	Replace rusted / perforated hand rail at the bottom flight with stainless steel one, compliant to building code requirements.	\$6,500

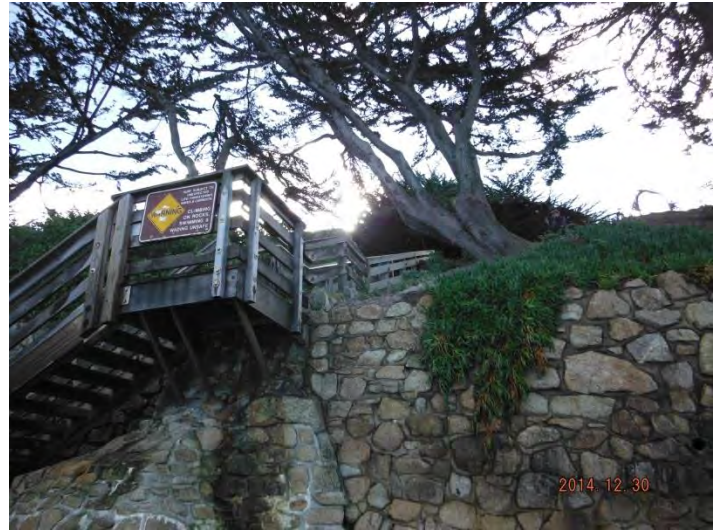
084

4	We noted deteriorated 2 - 6x 12 wood base at the bottom of the stair.	see pictures 087, 094	Moderate	We recommend replacing the lower wood flight with concrete stairs and stone veneered retaining walls similar to lower flight of stair 4; see pictures 112 & 114 in stair 4.	Cost is included in item 2

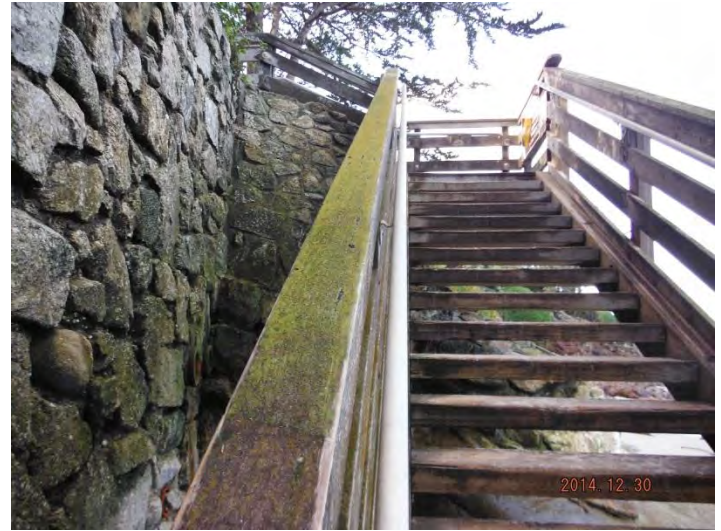
092

11	We noted green moss at the top of 2x6 rail cap.	see picture 092.	Low	We recommend replacing the lower wood flight with concrete stairs and stone veneered retaining walls similar to lower flight of stair 4; see pictures 112 & 114 in stair 4.	Cost is included in item 2
12	Spalling in concrete steps	see picture 101	Moderate	Saw cut concrete in spalled area, pour high strength non shrink concrete, drill and dowel to repair broken step.	\$1,500
13	Broken 2x6 rail cap.	see picture 057	Moderate	We recommend replacing it with naturally durable wood.	\$1,000
14	White growth appeared on guard rail posts at landing.	see picture 075	Low	We recommend replacing the lower wood flight with concrete stairs and stone veneered retaining walls similar to lower flight of stair 4; see pictures 112 & 114 in stair 4.	Cost is included in item 2
15	Crack in bottom 4x12 stair steps	see picture 096	Low	We recommend replacing the lower wood flight with concrete stairs and stone veneered retaining walls similar to lower flight of stair 4; see pictures 112 & 114 in stair 4.	Cost is included in item 2

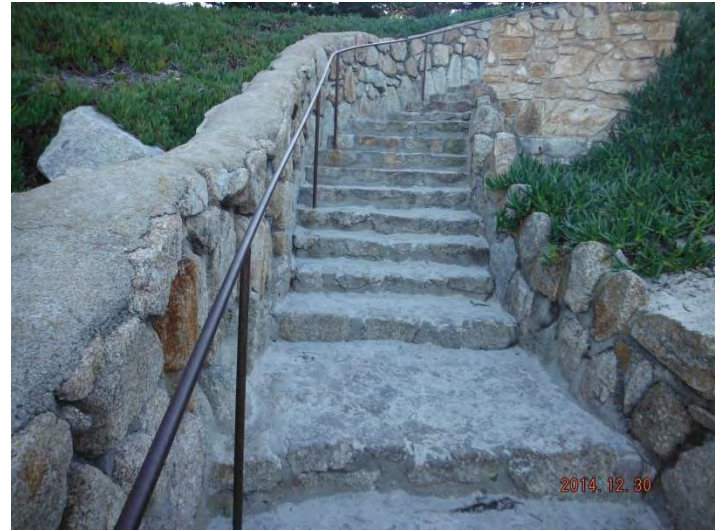
<u>Nb</u>	<u>Deficiency Description</u>	<u>Picture #</u>	<u>Priority Ranking</u>	<u>Conceptual Remediation</u>	<u>Cost</u>
1	Surface rust on loose guardrail	see picture 010	Moderate	We recommend replacing the guardrail with code compliant stainless steel.	\$2,500
2	The drain in the wash appeared open with some sand on the side.	see picture 14	Moderate	We recommend periodically cleaning it to prevent flooding.	City of Carmel
Total					\$2,500

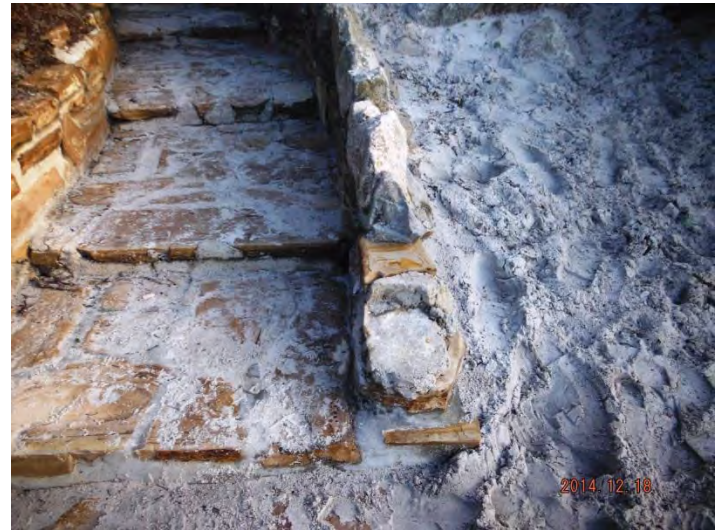
5	There are missing stones in the bottom retaining wall	012, 013	Low	Replace the missing stones in kind with high strength mortar.	\$750
Total					\$47,250
