JAYSON
ARCHITECTURE

The City of Carmel-By-The-Sea

LIBRARY MASTER PLAN PROJECT
FINAL REPORT

August 25th, 2023

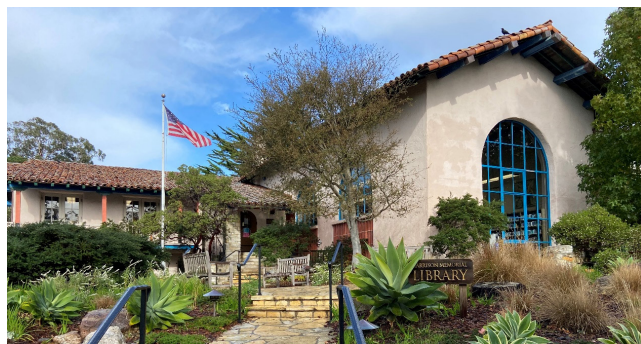
Architectural Figure 1: Existing Library - Exterior

The exterior of the Harrison Memorial Library shows signs of deterioration typical of a public library that has undergone multiple small renovations over the years, but has never undergone a wholistic architectural upgrade. The exterior of the building is in need of new paint, and exposed wood shows signs of weather exposure and mild non-structural deterioration. The clay tile roofing appears to be in generally adequate condition, with no issues of water intrusion noted by City staff. A small portion of roofing tiles appeared to be out of alignment and/or damaged, and may require replacement. Roof eaves lack uniform flashing and gutters, resulting in elevated levels of wood deterioration at the roof edges. Drainage at depressed walkways and lightwells along the perimeter of the building appeared to be functional, but the location and configuration leaves these locations vulnerable to future intrusion. In addition, a buildup of trash, debris and leaves was observed. The original wood windows are intact, but show sign of deterioration, particularly in locations where the paint has peeled and left the natural wood surface exposed. Due to the historic designation of the exterior of the library, any exterior improvements should be limited to rehabilitation of the original construction or limited careful upgrades that will improve the exterior envelope without a significant impact on the exterior aesthetic character.

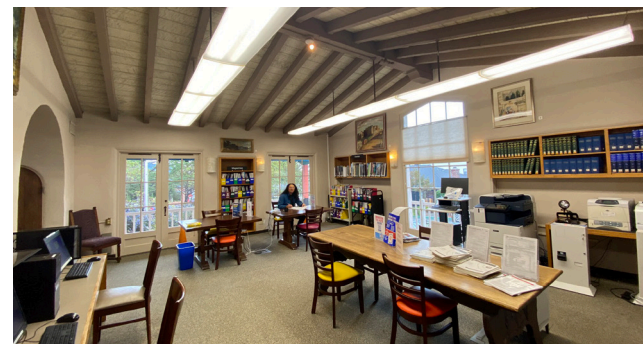
Architectural Figure 1: Existing Library - Interior

The interior of the Harrison Memorial also shows signs of deterioration typical of a public library that has undergone multiple small renovations over the years, but has never undergone a wholistic architectural upgrade. Finishes subject to regular wear and tear, such as carpeting and resilient flooring show significant damage and deterioration. Countertops are not level and are damaged due to ongoing use and water exposure, and the restroom tile is cracked and in need of replacement. The lighting is of poor quality throughout, primarily provided by surface mounted fluorescent fixtures. Surface mounted conduit is visible on walls and ceilings in all spaces, negatively impacting the appearance of the interiors. Acoustic ceiling tiles are worn, dingy, and hanging out of alignment in many locations. Interior wood surfaces need to be refinished and/or painted where appropriate. In addition, the ceiling height under the mezzanine is substandard and not appropriate for a primary public space in a library. The furniture upholstery and finishes are inconsistent, lacking a cohesive aesthetic and material palette, although several original Maybeck tables remain and should be refinished and restored for continued use. Based on our site evaluation we recommend a comprehensive replacement of interior flooring, finishes, lighting, and furniture to address maintenance issues, functionality, and aesthetics.

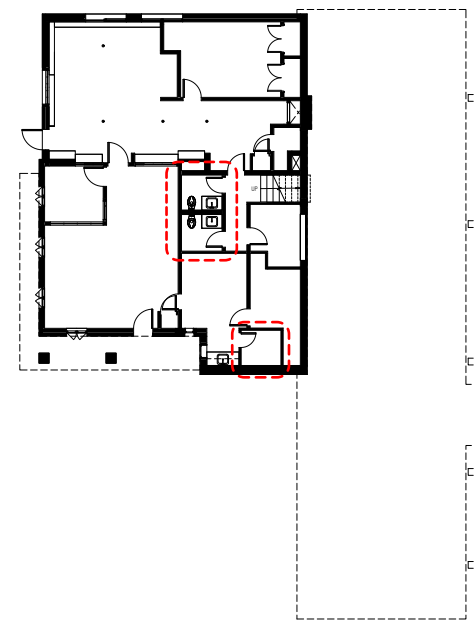
Accessibility Figure 1: Existing Library - Basement Level

Located in the basement level, the existing restrooms are also in need of a comprehensive accessibility update to meet code requirements. These deficiencies include restroom fixtures, accessories, accessory mounting heights, and turning areas.

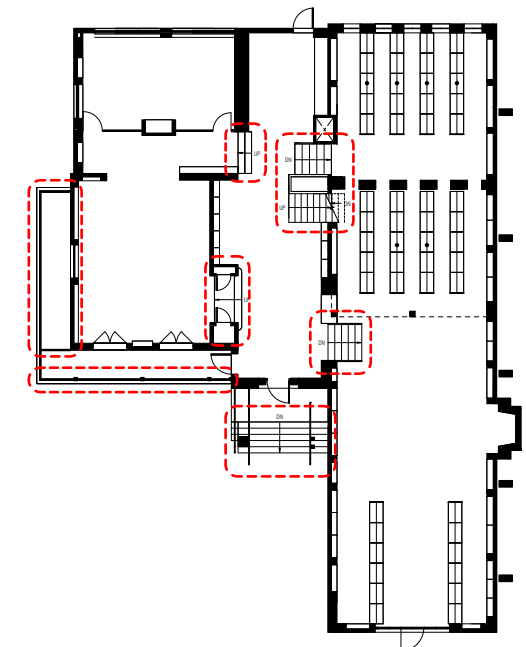
Accessibility Figure 2: Existing Library - Main Level

First, the primary entrance was observed to be inaccessible from the public sidewalk with several elevation changes along the stone path and stairs leading up to the entry door. Upon entering the building there are several elevation changes within the library, splitting the building between full and half levels, as well as an intermediate level along the west wing of the library. These multiple levels are an immediate accessibility compliance issue without the presence of a passenger elevator providing direct access to each floor level.

The existing stairs were also observed to be non-compliant, as well as each associated handrail. Lastly, both interior and exterior guardrails were observed to be non-compliant. At the exterior, the balcony along the southwest corner of the library is well below the required minimum height, with its baluster spacing also failing to meet code requirements. And at the interior, the baluster spacing of the mezzanine guardrail is also non-compliant.

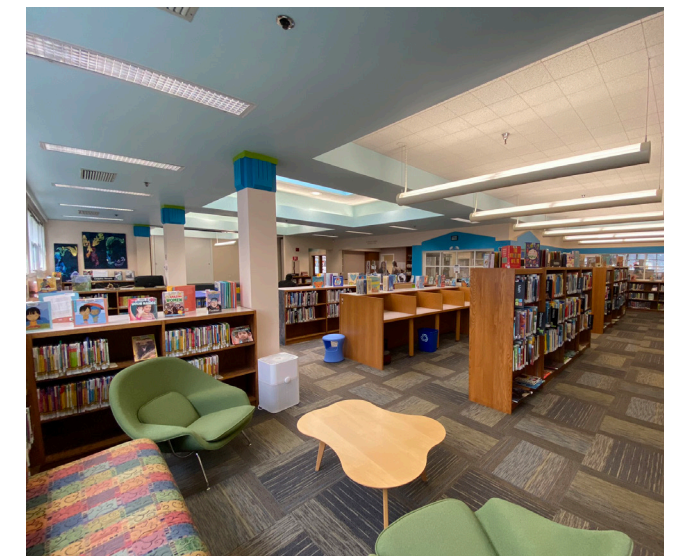
Architectural Figure 4: Existing Library - Interior

Of particular note is the subgrade basement space, which extends from underneath the library to a larger series of rooms under the parking lot. Served by noncompliant stairs, the space shows significant signs of repeated water intrusion, and seriously damaged finishes.

Based on our site evaluation we recommend a comprehensive replacement of interior flooring, finishes, lighting, and furniture to address maintenance issues, functionality, and aesthetics. In addition, we recommend the exterior siding and windows are replaced with new siding and code compliant glazing, to provide both a newly sealed code compliant envelope as well as a revitalized appearance.

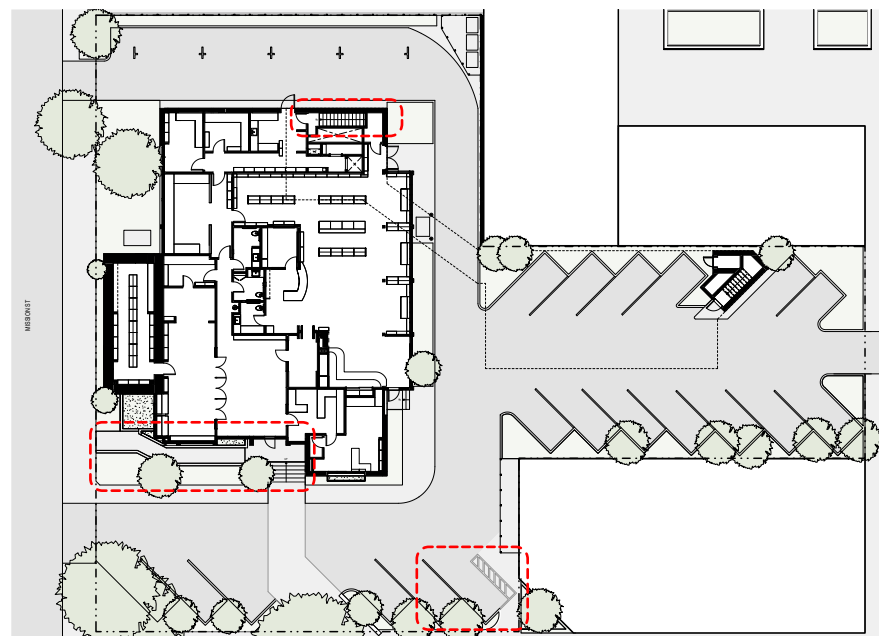
Accessible Figure 3: Existing Library - Main Level

Another notable accessibility deficiency that was observed relates to the accessible parking. The accessible parking stall located along the main entry drive aisle falls short of code-required clearances for angled parking as outlined in CBC Chapter 11B, section 502. Further, a van accessible parking stall is not provided as required by CBC Chapter 11B, section 208.

The interior of the building had a limited number of notable deficiencies, with the stairs leading to the basement area and mechanical rooms were found to be non-compliant.

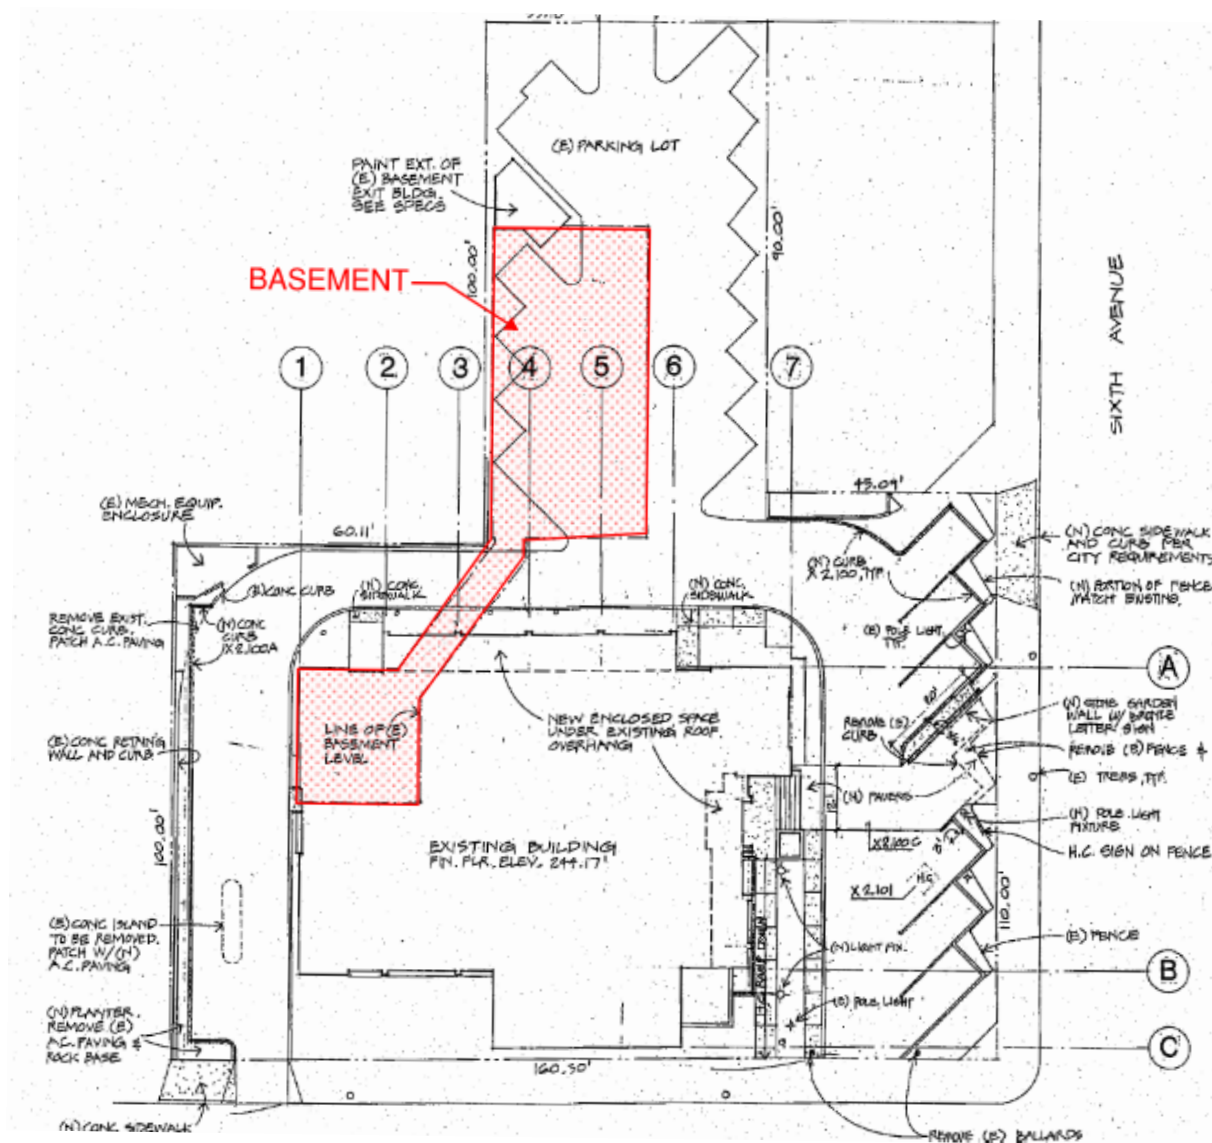
Structural Figure 6: Building Plan

The original building was built in 1971. Since the original construction, it appears that there have not been any seismic upgrades to the building. Today's building codes are considerably more stringent with regard to seismic design than those in effect when the building was constructed. We recommend implementing seismic upgrades as part of any future renovation work.

Proposed renovations will require alterations to both gravity and lateral elements of the existing building. New concrete shear walls and steel framing will be required.
