COASTAL ENGINEERING CONDITION EVALUATION

CARMEL CITY COUNCIL MEETING

9 MARCH 2023

Coastal Engineering Assessment

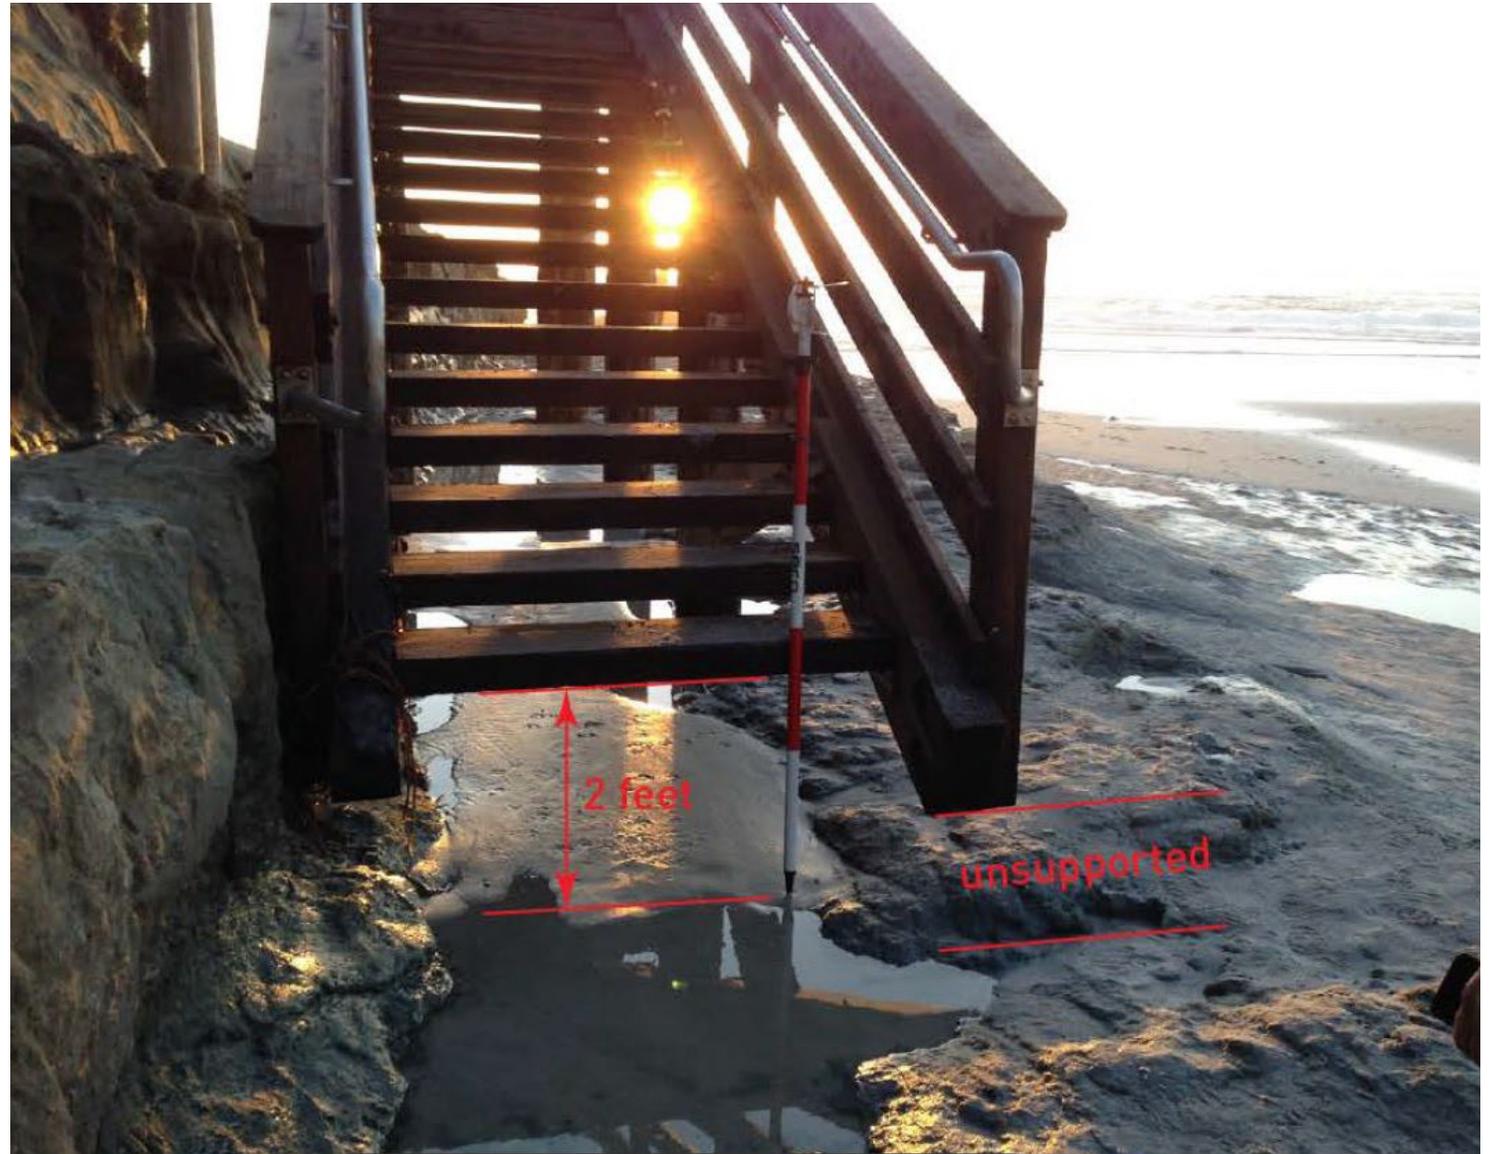
ST4 at 12th Ave. Source: Greg Easton, 2016

- A total of **4** staircases out of **11**
- Right: The beach access stairway at Scenic Rd and 12th Ave has significantly corroded hardware and splitting wood members.

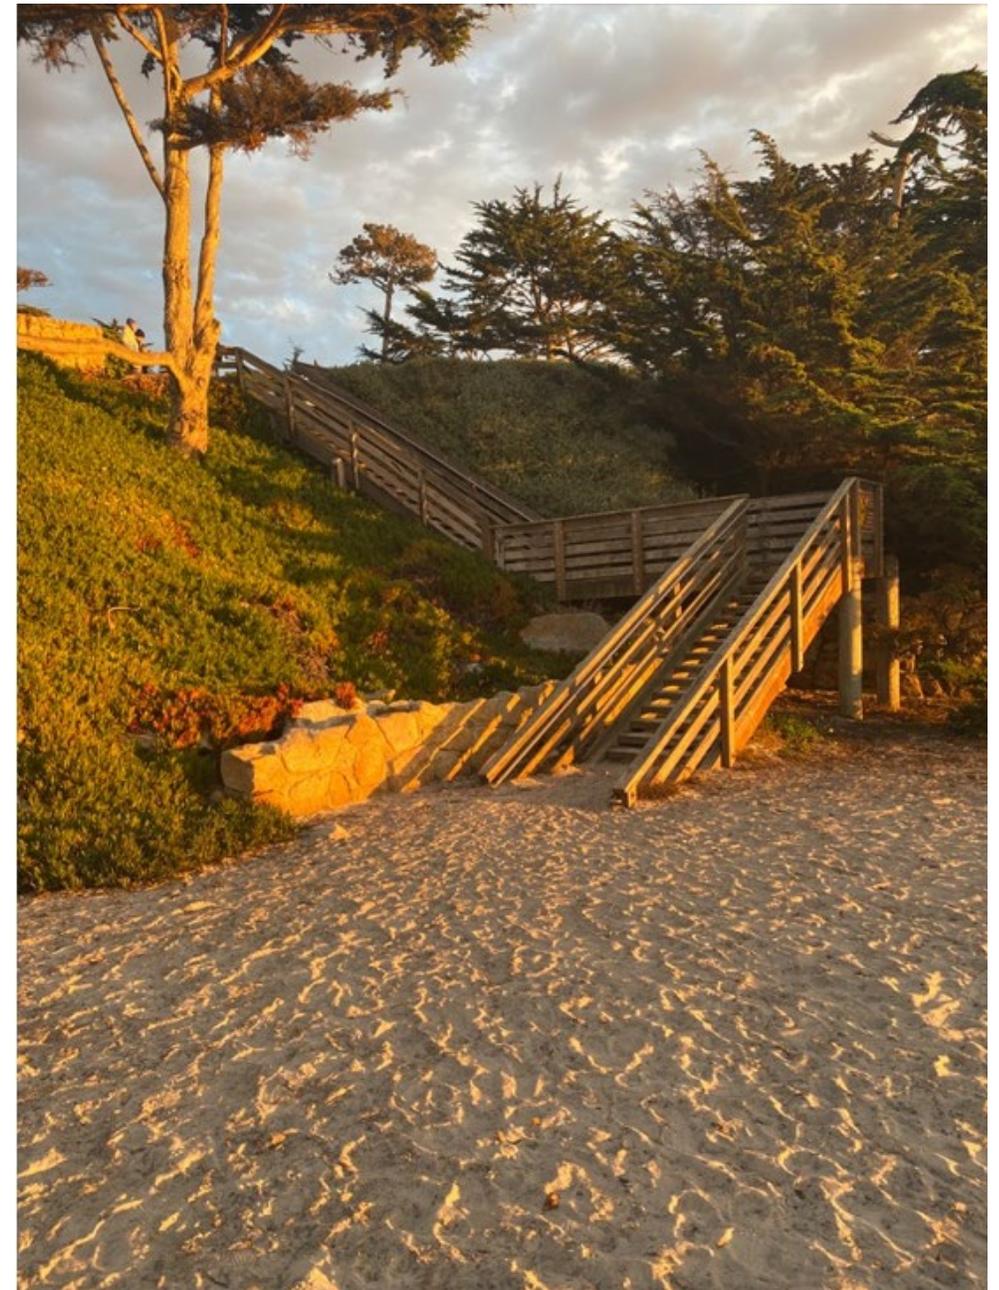
ST 8 between 9th Ave and 10th Ave

- Beach sand at high elevation along the backshore
- Stairs function well

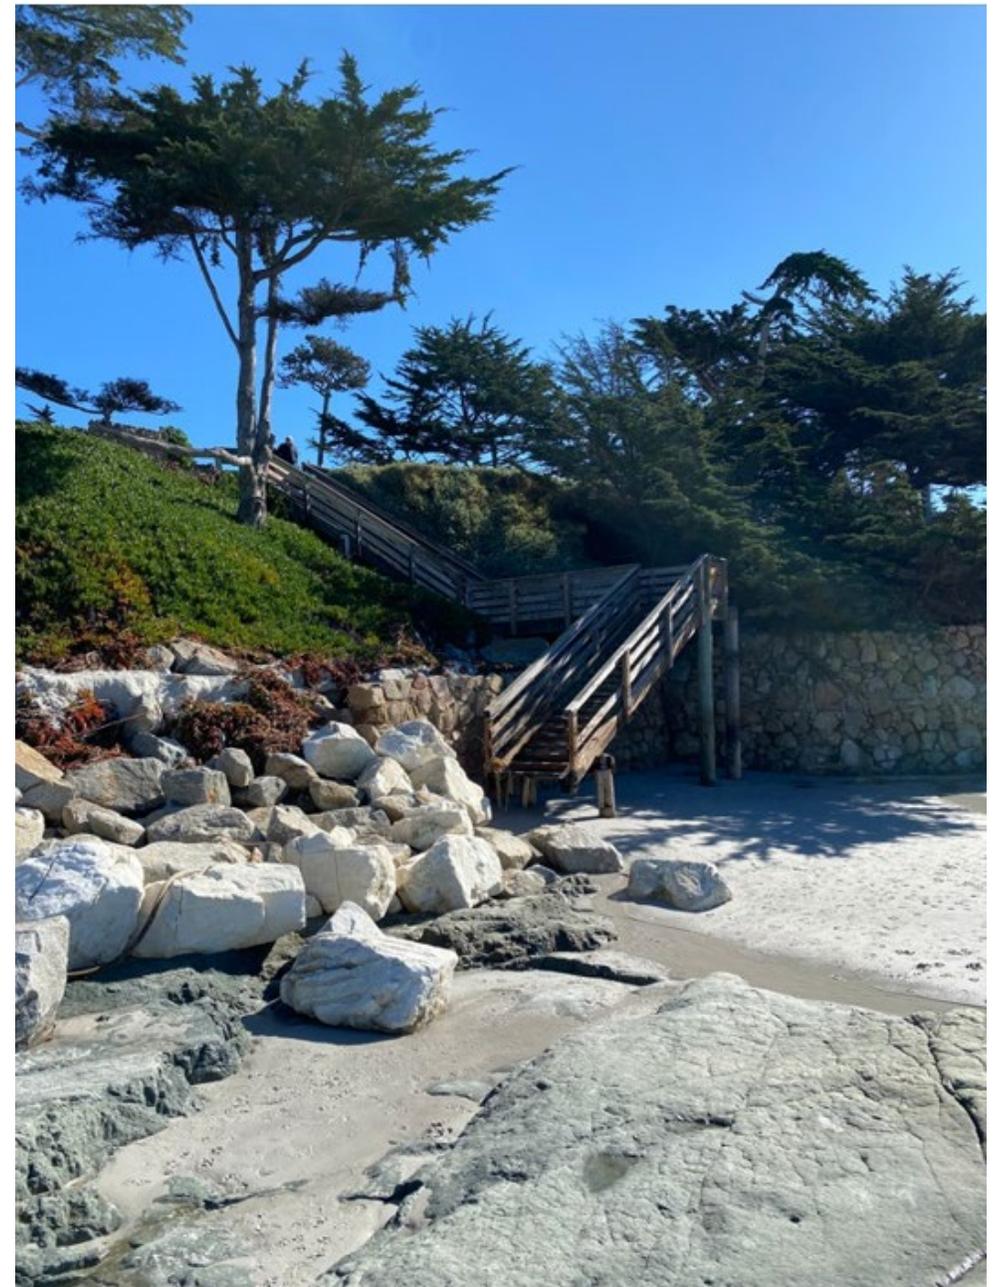
ST7 between 10th and 9th

- Deep sand scour condition along backshore
- Stairs have a several feet vertical drop
- Beachgoers may get stranded or jump
- Needs: additional treads + landing to bedrock platform

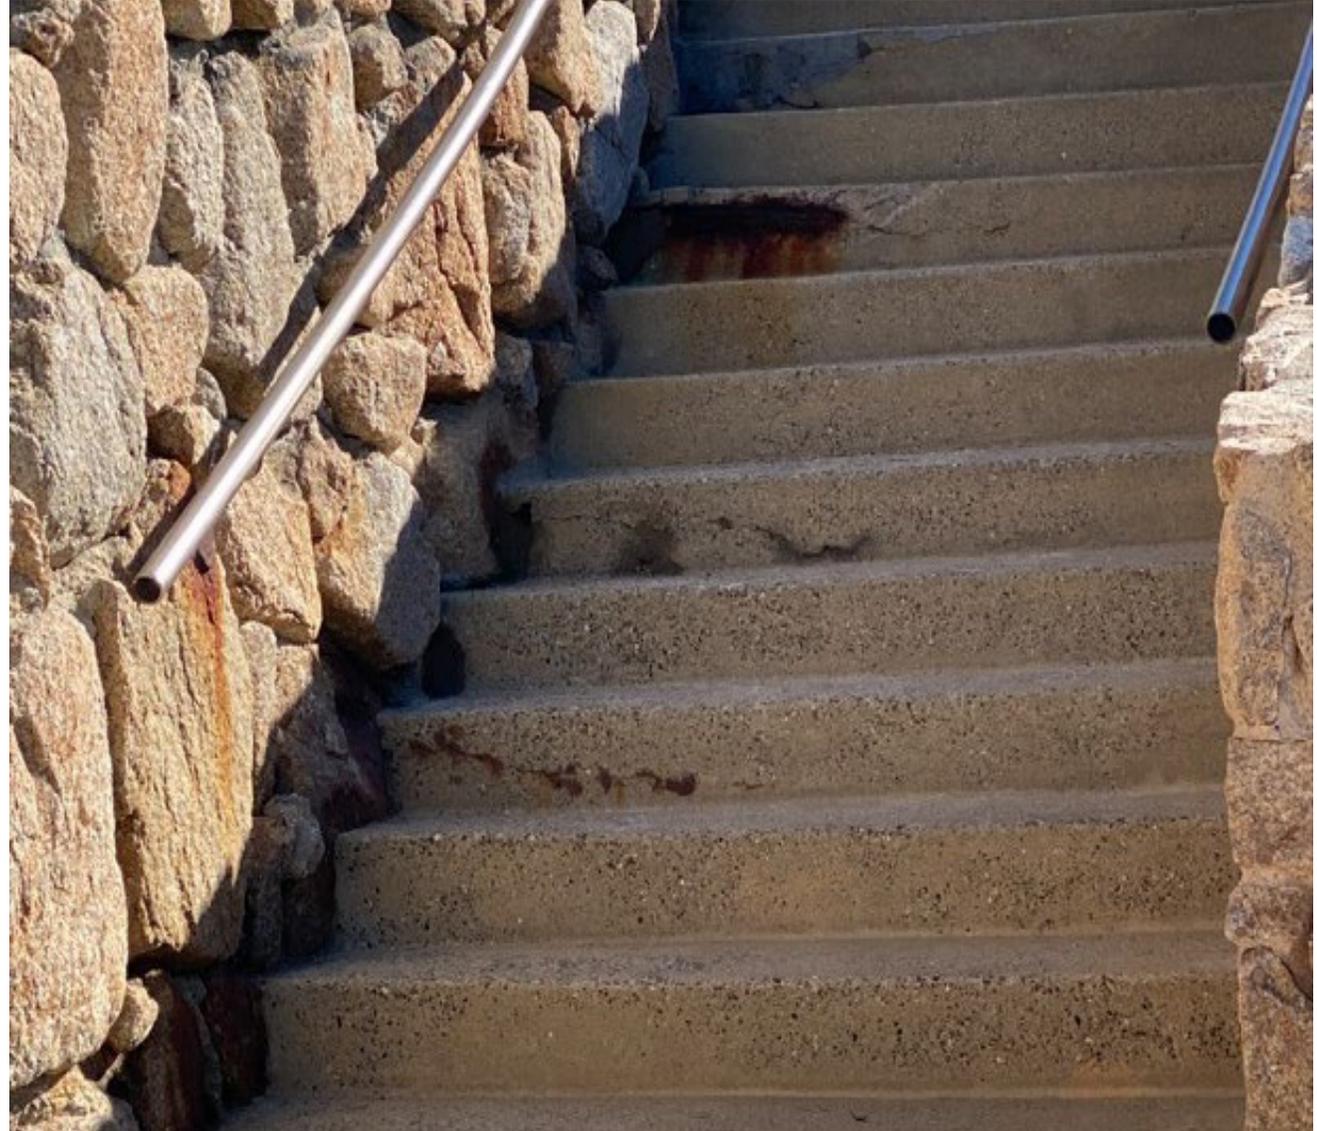
- 4 out of 11 are ranked medium priority
- Worn down or uneven stair treads.
- Minor amounts of corrosion.
- No additional structural or corrosion inspection needed.
- Sand blast steel reinforcement and patch with concrete grout.
- ST6 between 10th & 11th Ave
- ST1 at Martin Way, ST5 at 11th, ST9 at 8th Ave

ST6	S of 10th Avenue	YES	YES	MEDIUM	NA	Needs Minor Tread Work; Corroded Rebar Exposed; Concrete Spalling	Maintenance Is Essential for Pedestrian Safety
ST7	N of 10th Avenue	YES	YES During Scour Events	HIGH**	NA	Toe of Stairs Undermined by Scour 1/2023; Hazardous; Easton (2016?) Said Look at 2008 CRP Photo	Maintenance Is Essential for Pedestrian Safety
ST8	9th Avenue	YES	YES	HIGH	NA	Stairway Terminates Before Reaching Beach During Scour; Needs Seaward Extension	Maintenance Is Essential for Pedestrian Safety
ST9	8th Avenue	YES	YES	MEDIUM	NA	Rock and Mortar Steps; Worn Natural Rock Surfaced Treads Create Slippery Condition	Maintenance Is Essential for Pedestrian Safety
ST10	Ocean Avenue	NO	NO	LOW	NA	Coastal Overlook and Boardwalk; Not Subject to Wave Impact	Maintenance Is Essential for Pedestrian Safety
ST11	Dunes	YES	YES	HIGH	NA	Hazardous; Broken Guard and Handrail on Upcoast Side of lowest Run	Maintenance Is Essential for Pedestrian Safety

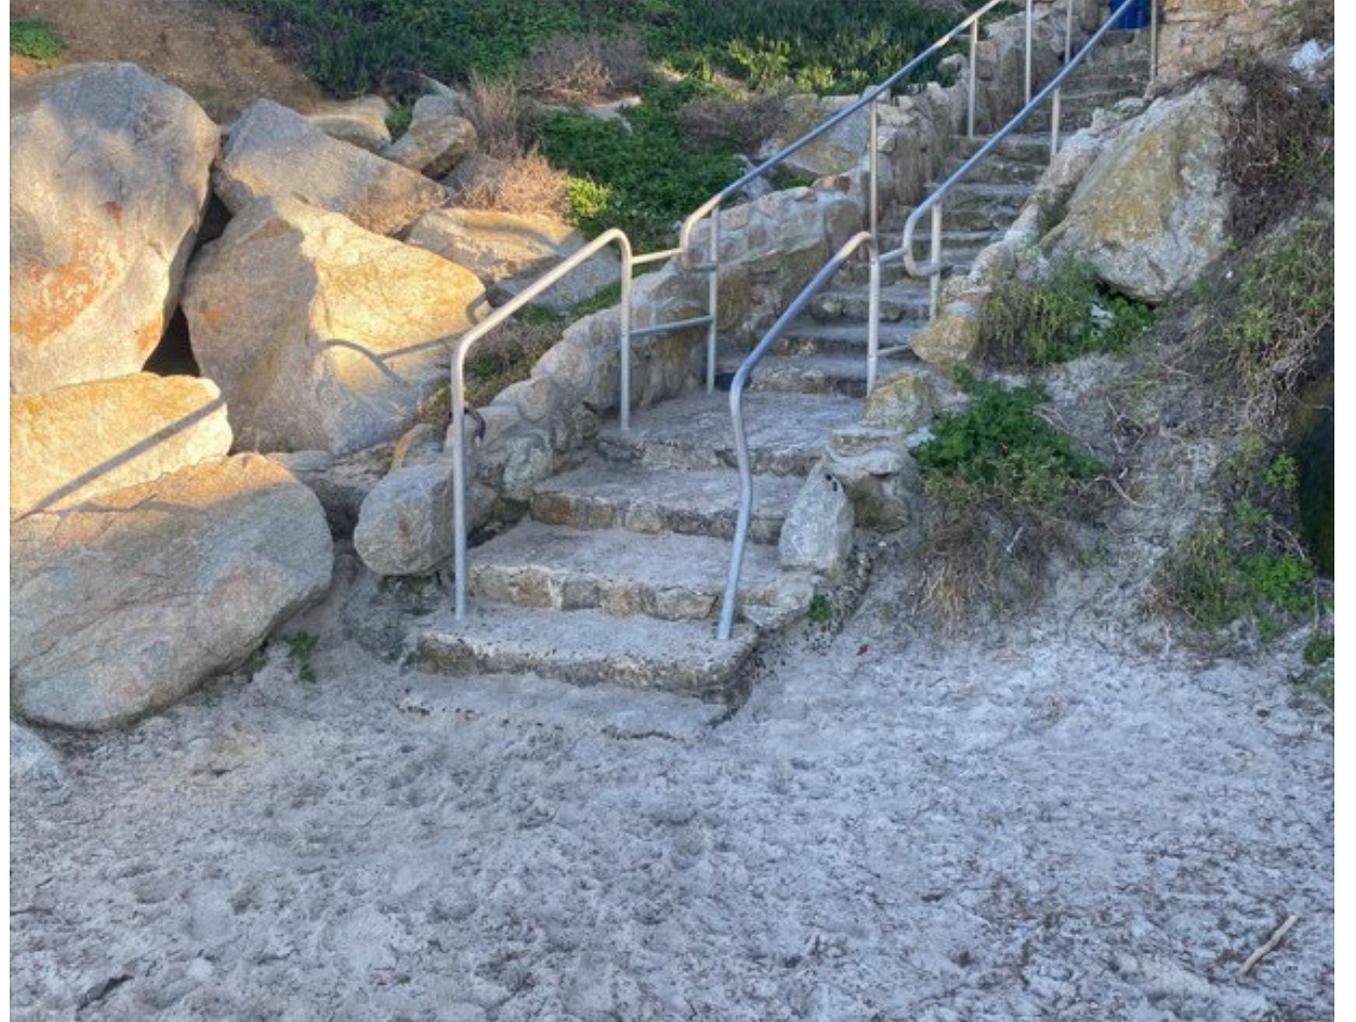
- 3 out of 11 are ranked low priority.
- In general stairs in good shape.
- No noticeable corrosion.
- Treads are uniform
- Some with bent handrails.
- ST2 at Bay View and Santa Lucia

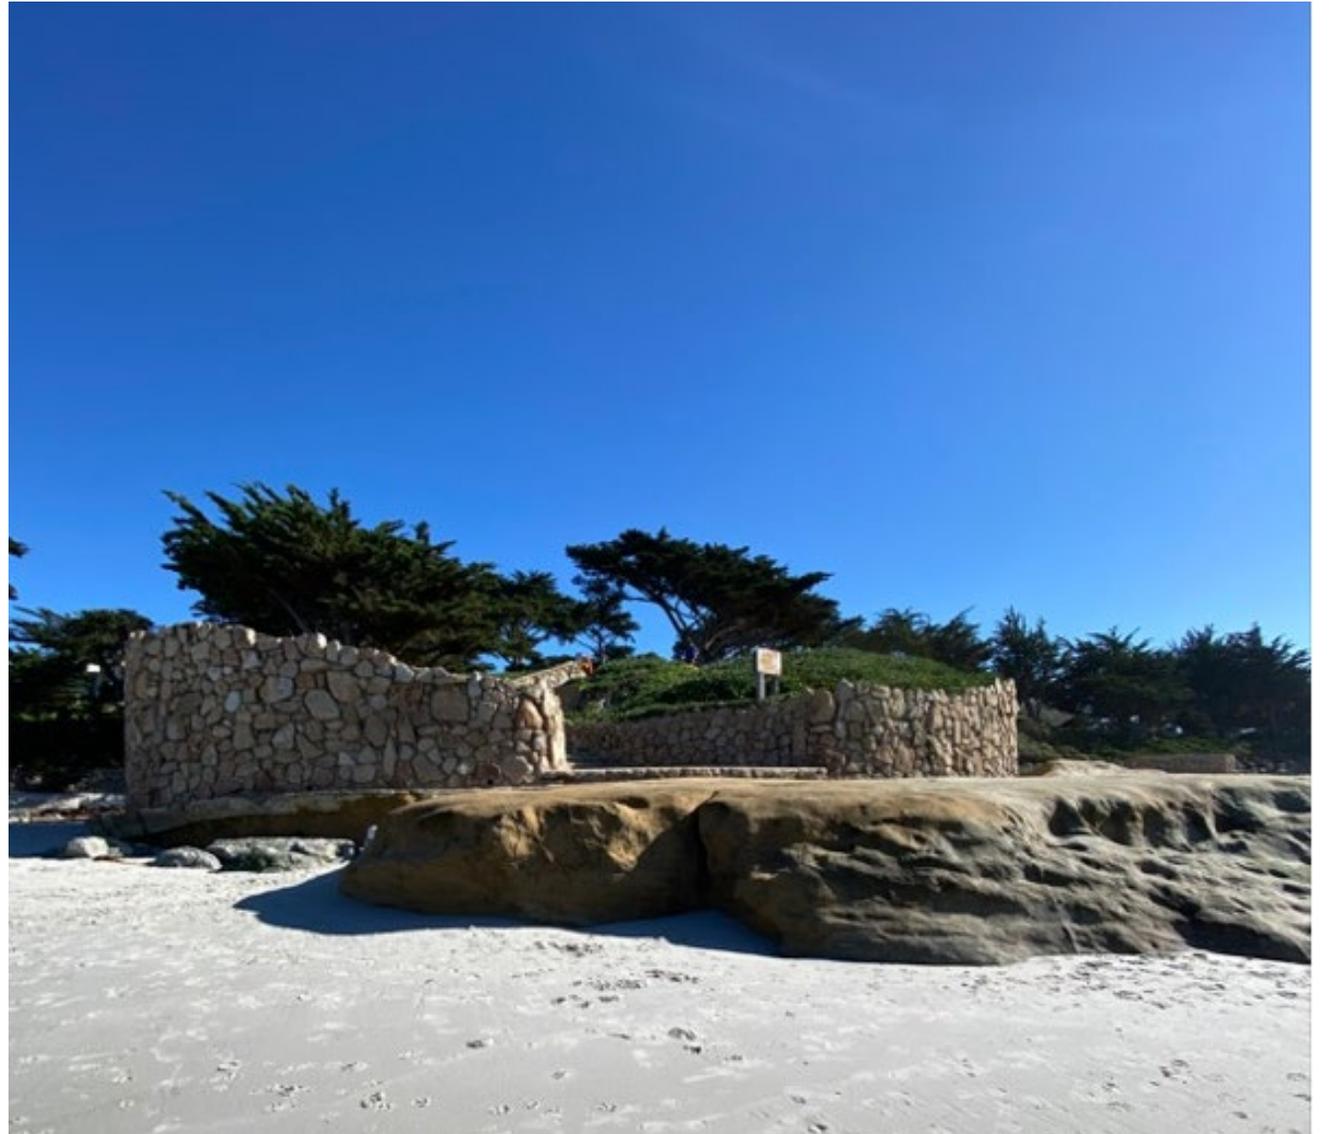
- ST3 near 13th Ave
- Stairs are in good shape
- Example of situation where it is difficult to navigate shoreline during deep scour events.
- Solution is to extend the staircase to long-term scour elevation

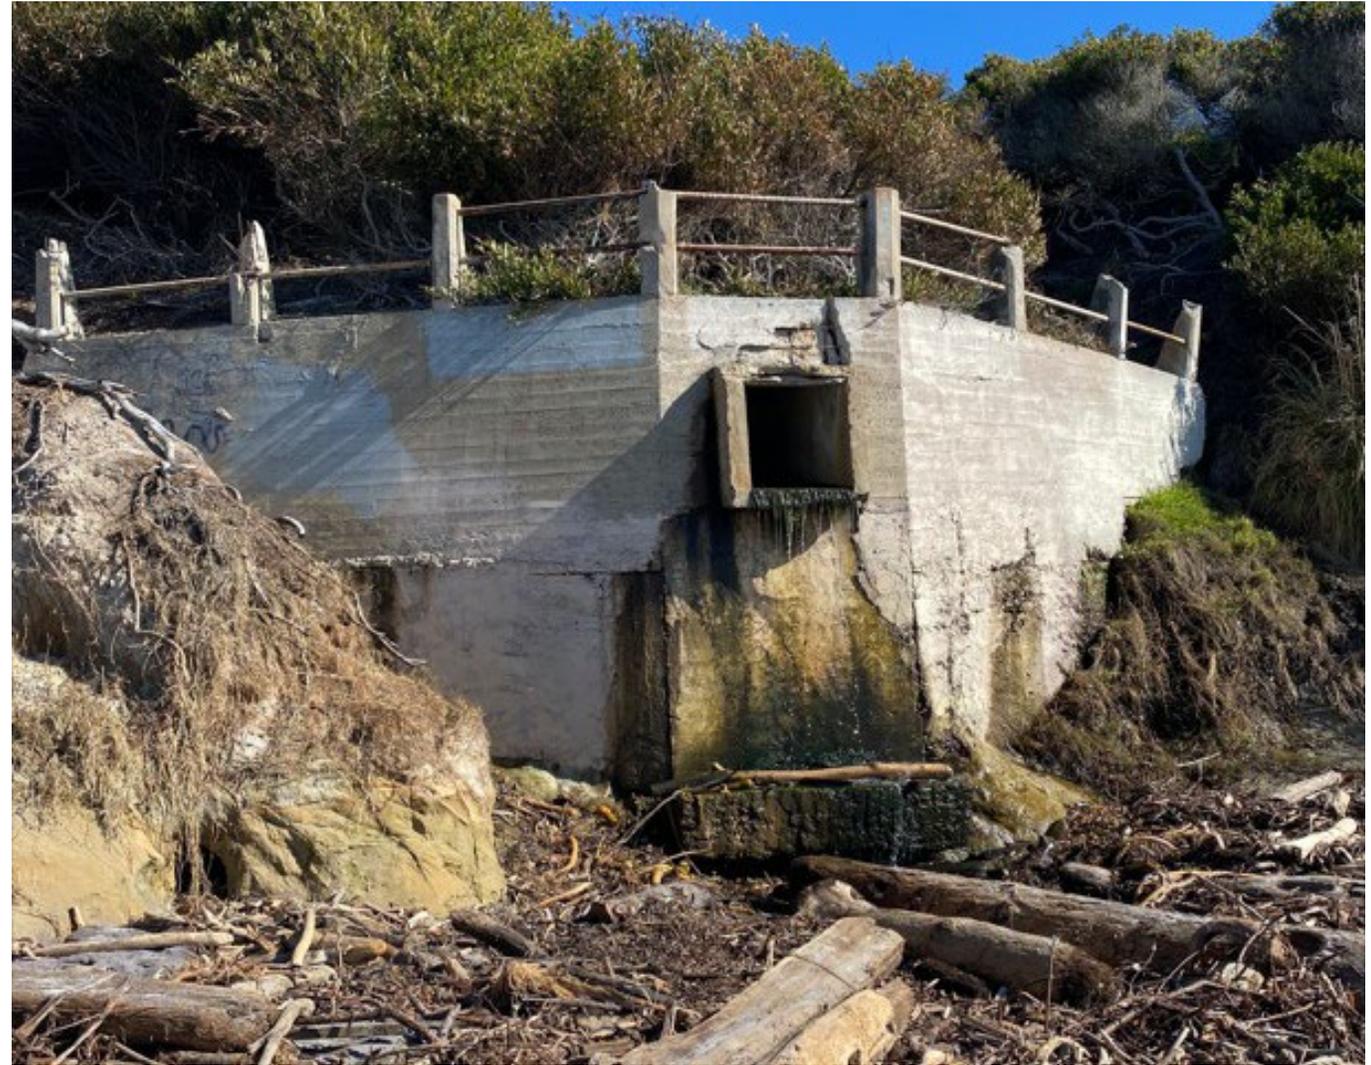
S10 between Carmel Way and Ocean Ave

- Seawall just west of the beach volleyball courts between Ocean Ave and Carmel Way.
- Structure is significantly deteriorated and is unstable.
- Demolish and rebuild.

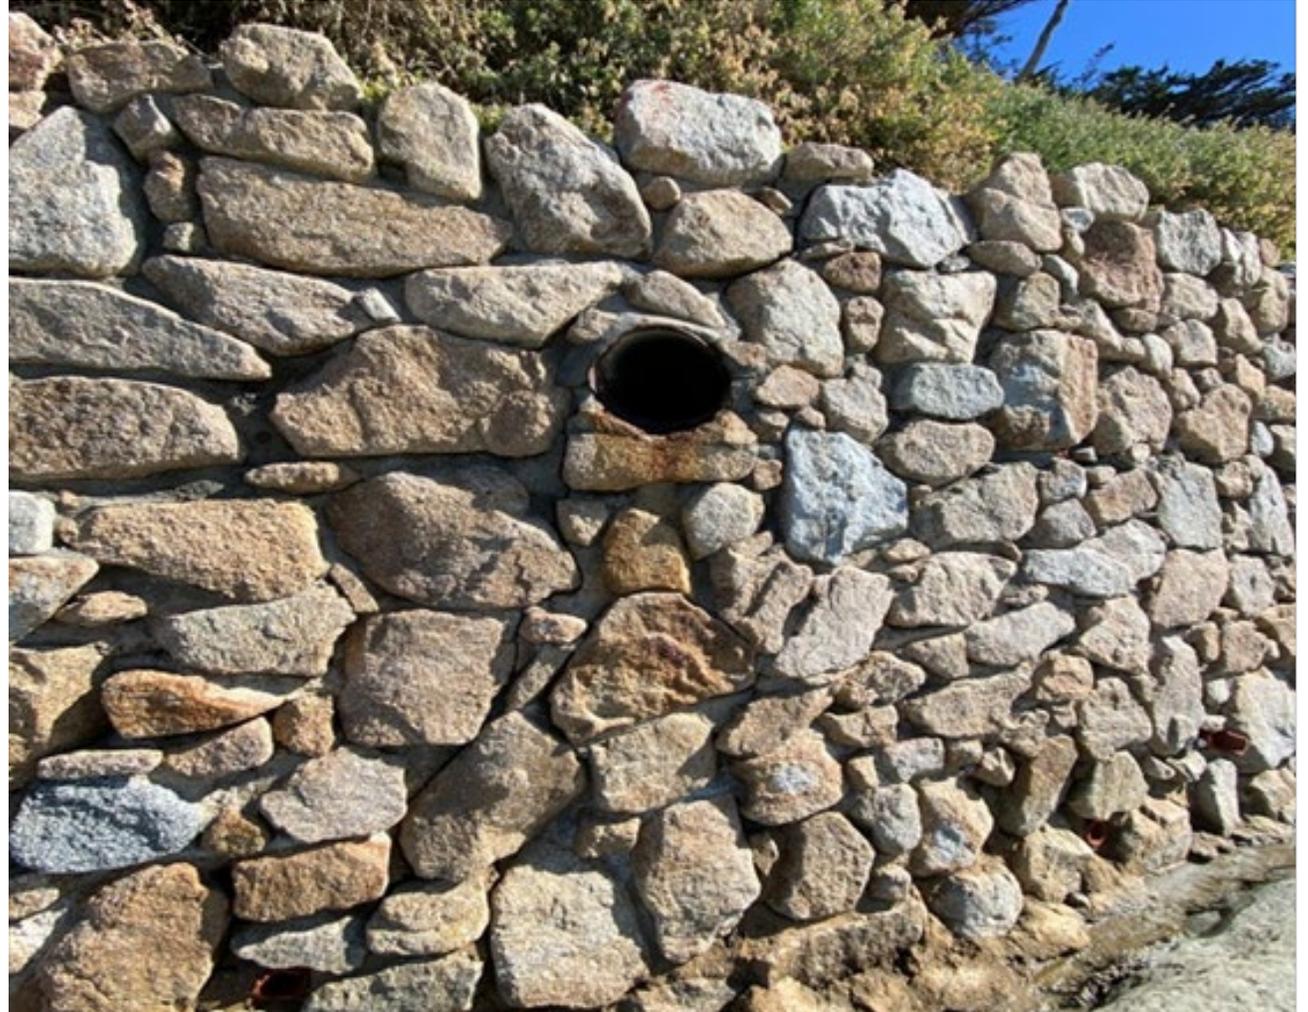
- S7 at 10th Ave
- Drainpipe is corroded and collapsed 3' behind wall

S7	Between Stairways 6 and 7	YES	NO	MEDIUM	30	Wall Crack Below Failed Metal 16" Dia Storm Drain Pipe Thru Seawall; Pipe Replacement Needed	Mortar is starting to deteriorate; tuck pointing maintenance needed
S8	Retaining Wall at 8th Ave	NO	NO	VERY LOW	30+	Blufftop Retaining Wall Around Pump Station	Good Condition
S9	Outfall at 8th Ave	NO	NO	VERY LOW	20	CMP Storm Drain Headwall; 60 LF Scattered Rip-rap Below; Rip-rap Foundation Condition Uncertain	Monitor during Scour
S10	Dunes Outfall	YES	YES	HIGH	0 to 10 Until Collapse	Failing/Failed 3x3' Box Culvert Storm Drain Outfall Wall; Needs Replacement	Concrete Cracked, Undermined, Outflanked, Corroded Rebar, Visually Undesirable
S11	At Pescadero Creek Home	UNKNOWN	NO	NA	30?	Private Property (ADJUST LENGTH ON MAP TO DELETE WOOD WALL)	Private Property
Revetments							
R1	Between S2 and S3	YES; Upcoast 1/3	YES	HIGH	Upcoast 1/3 = 0	Upcoast 1/3 Oversteepened, No Filter Fabric, Unstable, Potentially Unsafe	Public Will Benefit from Replacement

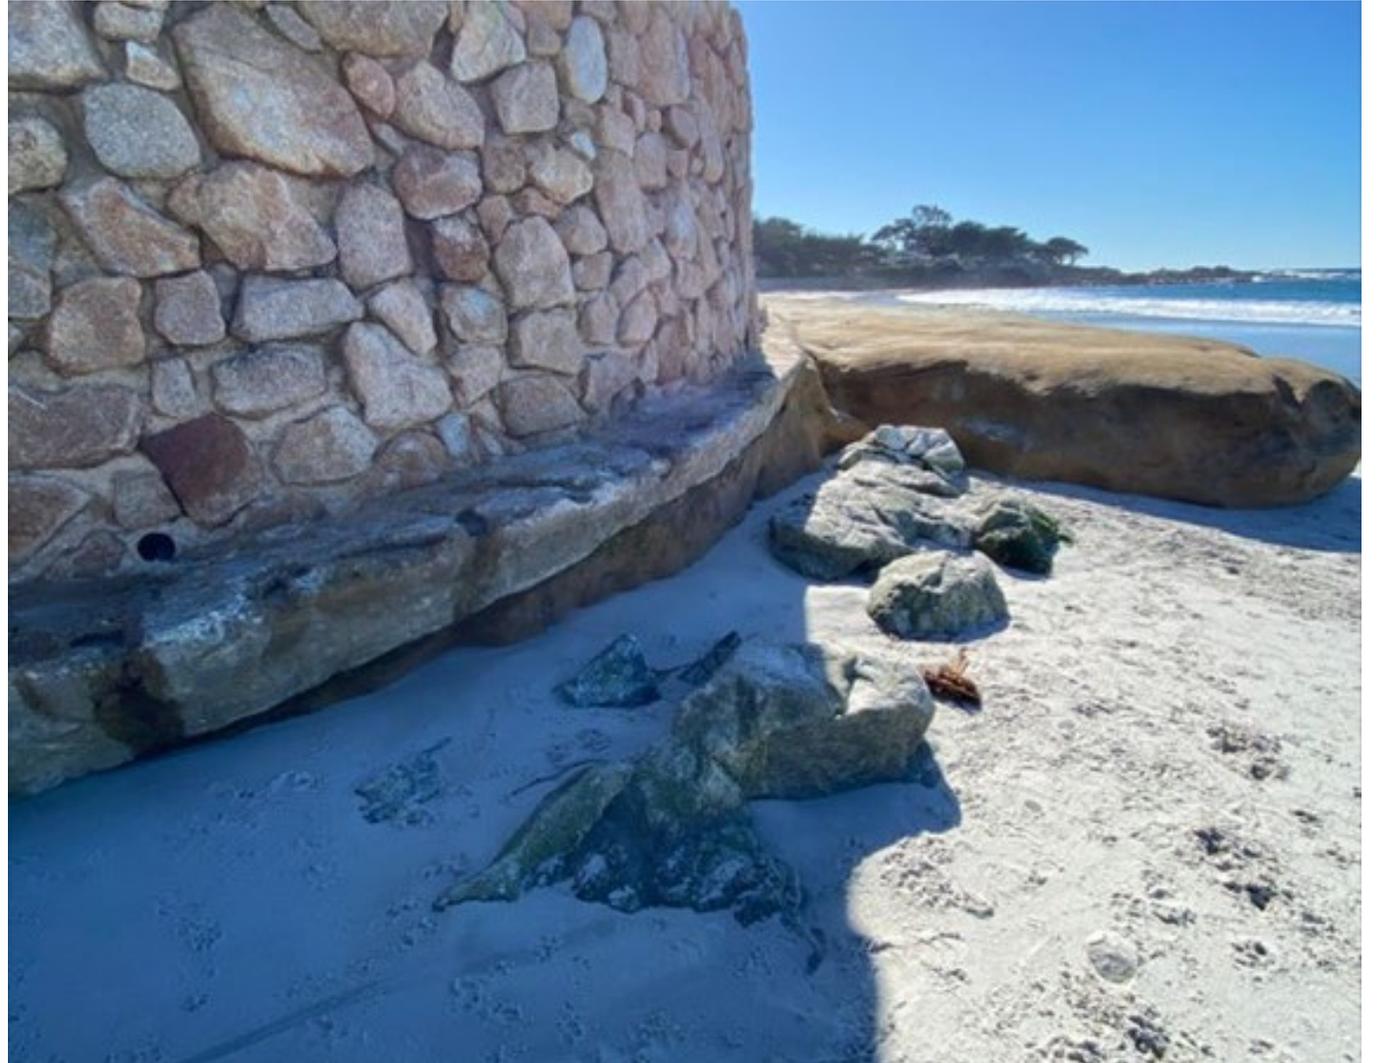
- S3 near 13th Ave
- Seawall stem and foundation in good shape.
- Minor amounts of undermining of seawall foundation from bedrock scour.
- Low rate of bedrock scour due to sand cover protection from wave runnup.

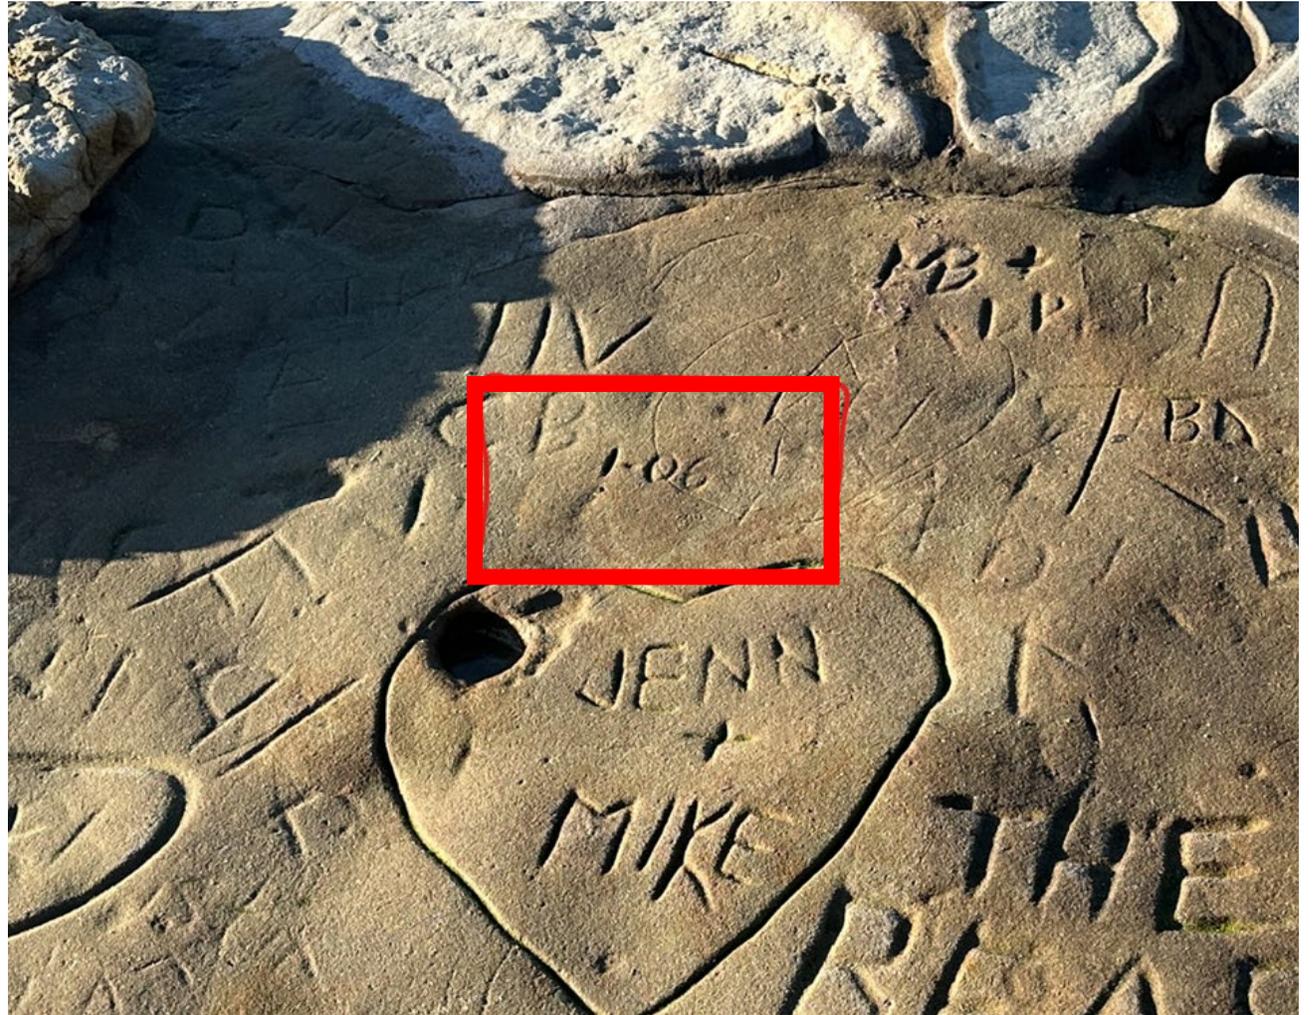
- Carving may be 1 inch deep into sandstone dated January 2006 has not eroded away.

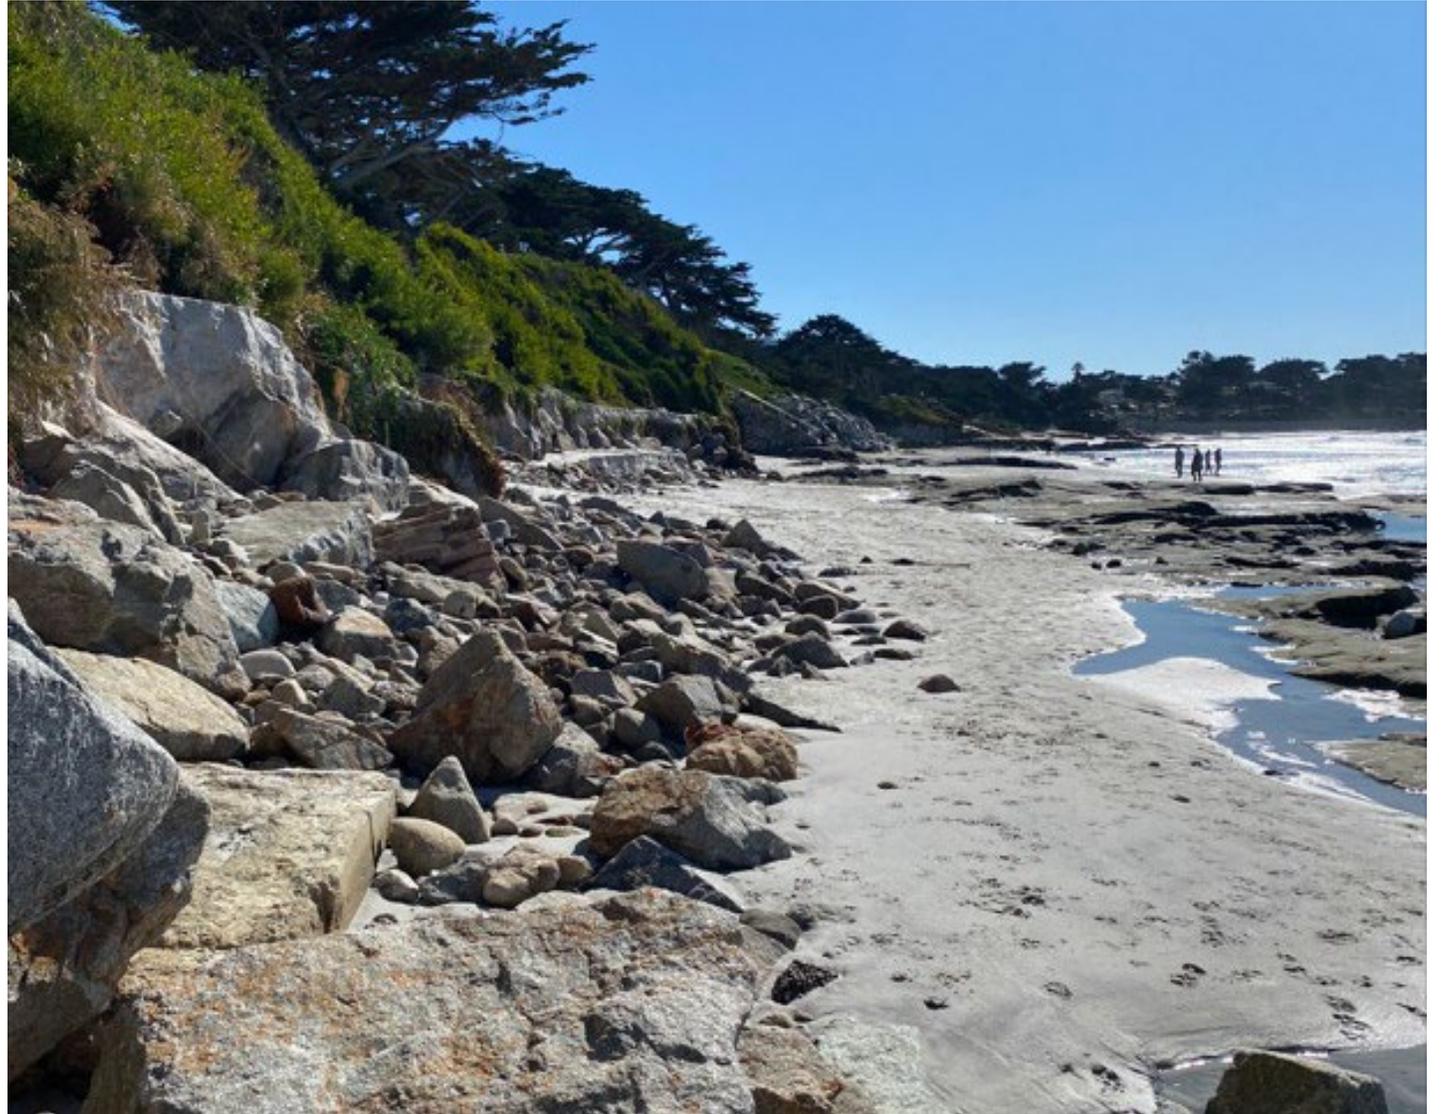
R4a between 10th Ave and 11th Ave

- Only **4** out of **6** rip rap revetments were inspected due to sand cover.
- **3 high priority** ranking and **1 medium to very low**.
- Issues:
 - Rip rap stacked at over steep slope gradient.
 - Undersized rip rap for wave forces.
 - Not properly keyed into bedrock.
- Remove undersize rock and rebuild

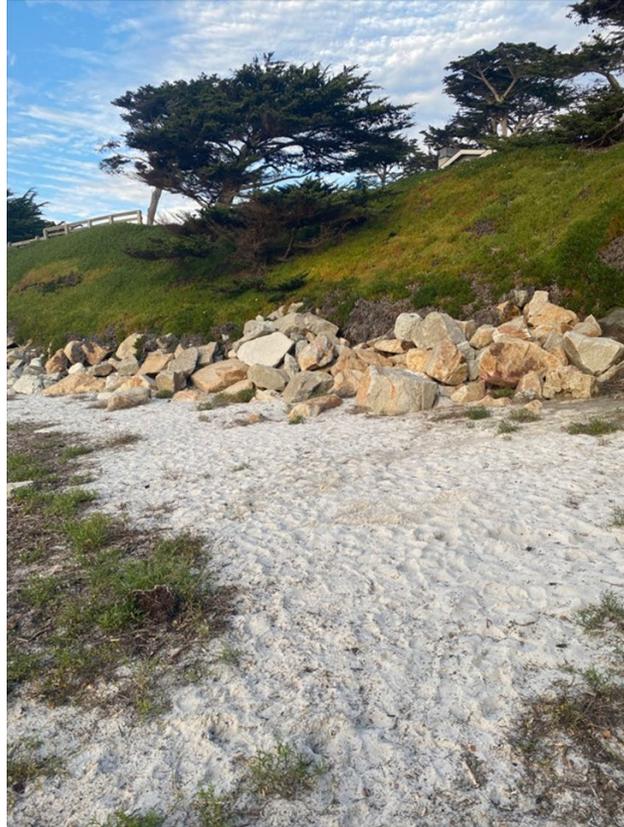
R5 near 10th Ave

Riprap in need of restacking
