CARMEL SHORELINE ASSESSMENT

**FALL 2014**

Draft Report

April 15, 2015

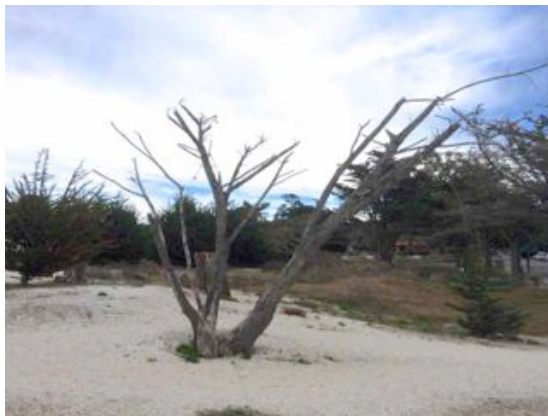
Fig 2#1

- **Condition:** Several dead Monterey Cypress trees have been left standing in the North Dunes area. The City is in the process of deciding what should be done.

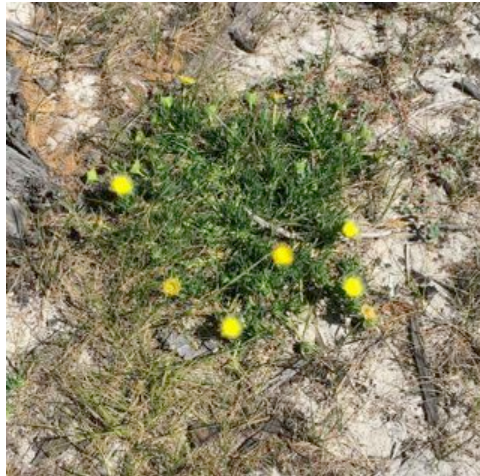
Fig 2#2

- **Condition:** Many stands of the “narrow-leaf ice plant” (*Conicosia pugioniformis*), an invasive plant introduced from South Africa, are growing in the North Dunes. While not as aggressive as the more common South African ice plant (*Carpobrotus edulis*) also growing along the Carmel shoreline, both should be removed as part of any restoration program in the North Dunes.

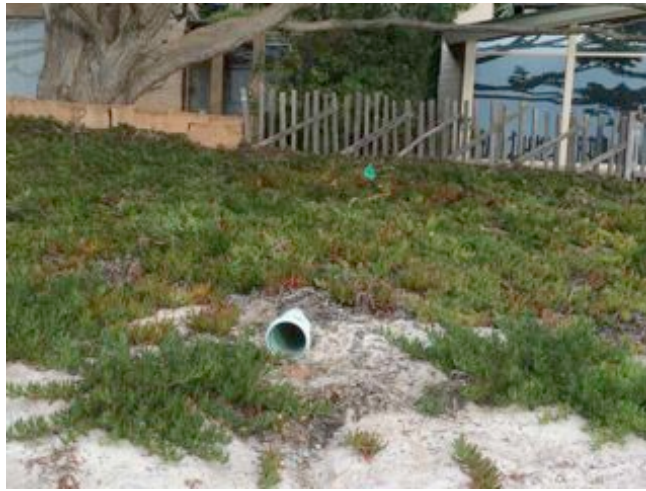
Fig 2#3

- **Condition:** A few of the houses in the Del Mar Dunes have pipes that drain onto the City's dunes. It is likely that these transport drain storm water away from their houses.
- ⇒ **Recommended Action:** CITY SHOULD VERIFY THAT PRIVATE DRAIN PIPES, WHICH DISCHARGE ONTO CARMEL'S DEL MAR DUNES, DO NOT CAUSE EROSION OR OTHER NEGATIVE IMPACTS.

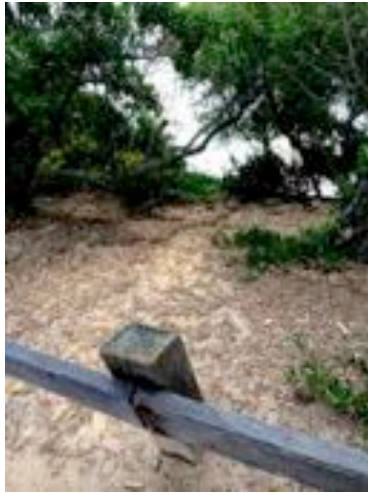
Fig 3#2

3.1.1b **Bluff between 10<sup>th</sup> Ave. Stairway (south) and 11<sup>th</sup> Ave. Stairway**

- WHEN PATHWAY IS RESURFACED, DIP ABOVE BLUFF DAMAGE SHOULD BE RAISED TO MATCH ADJACENT GRADE;
- REPAIR BLUFF EROSION AS PER GENERAL RECOMMENDATIONS LISTED ABOVE.

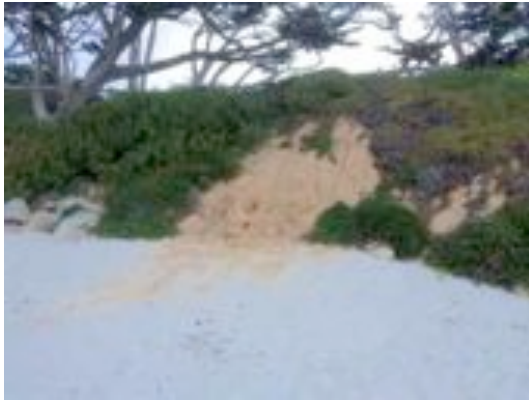
Fig 3#5

3.1.1c **Bluff between 10<sup>th</sup> Ave. Stairway (south) and 11<sup>th</sup> Ave. Stairway**

⇒ **Recommended Action:** REPAIR BLUFF EROSION AS PER THE GENERAL RECOMMENDATIONS LISTED ABOVE.

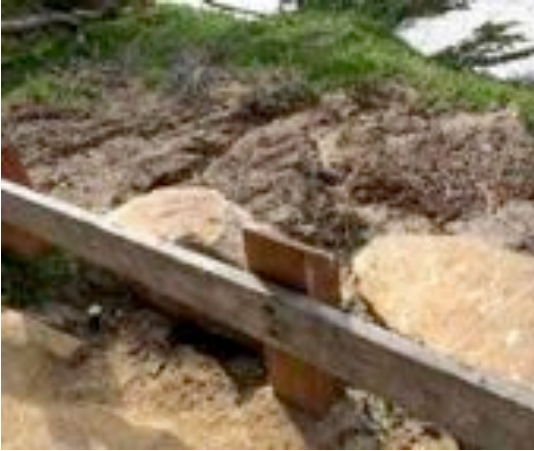
Fig 3#8

3.1.1e **Bluff south of 11<sup>th</sup> Ave. Stairway**

⇒ **Recommended Action:** REPAIR BLUFF EROSION AS PER THE GENERAL RECOMMENDATIONS LISTED ABOVE.

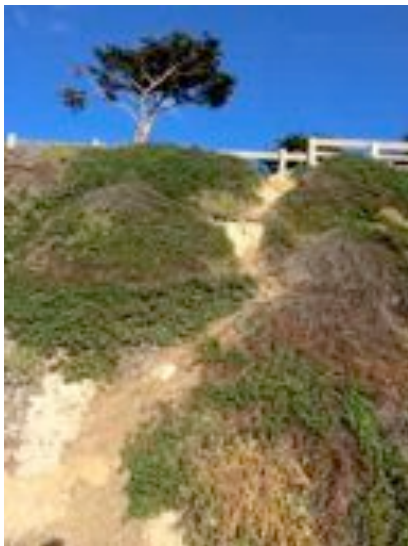
Fig 3#10

3.1.1f **Bluff between 11<sup>th</sup> and 12<sup>th</sup> Ave.s**

- REPAIR BLUFF EROSION AS PER THE GENERAL RECOMMENDATIONS LISTED ABOVE.
- WHEN REPORTED IN PREVIOUS ASSESSMENTS, STAFF COMMENTS INDICATED LACK OF SOIL HINDERED REPLANTING
  - EFFECTIVE RESPONSE SHOULD INCLUDE STEPS TO CREATE BEDS OF AMPLE SOIL.

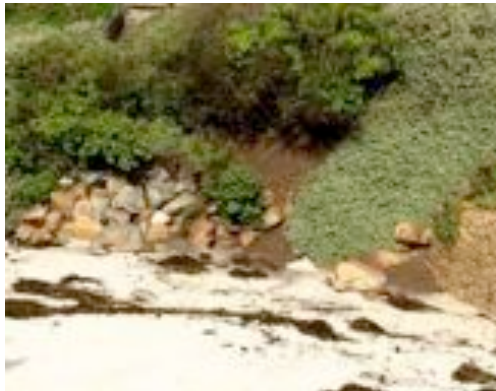
Fig 3#12

3.1.1g **Bluff between 12<sup>th</sup> Ave. and 13<sup>th</sup> Ave. Cove**

- BUILD A NEW STAIRWAY AT SITE  
\*NOTE: The beach at the bottom of this bluff is one of the most popular sites on Carmel Beach; improved access here is imperative!

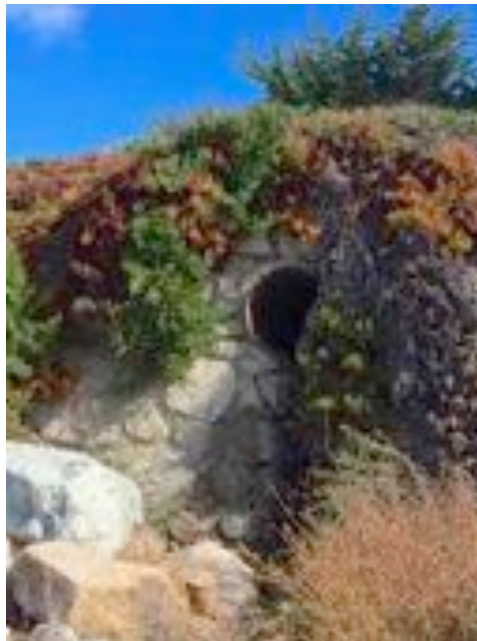
Fig 4#3

#### 4.1.2 **Outfall Obstructions**

- DEVELOP & FOLLOW PROTOCOLS FOR CLEARING/TRIMMING ICE PLANT AT LEAST A FEW FT. FROM OUTFALL'S DISCHARGE END BEFORE ONSET OF STORM SEASON, AS PER GENERAL RECOMMENDATIONS.

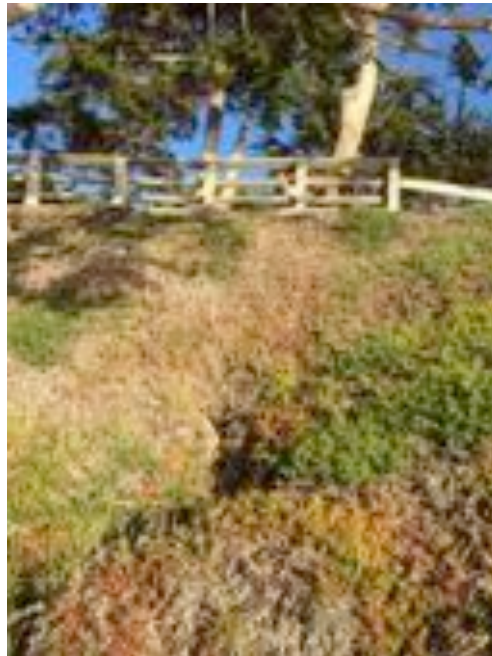
Fig 4#4

4.1.2b **Outfall (between 9<sup>th</sup> and 10<sup>th</sup> Ave.s)**

- DEVELOP & FOLLOW PROTOCOLS FOR CLEARING/TRIMMING ICE PLANT AND OTHER VEGETATION AT LEAST A FEW FT. FROM OUTFALL'S DISCHARGE END BEFORE ONSET OF STORM SEASON, AS PER GENERAL RECOMMENDATIONS.

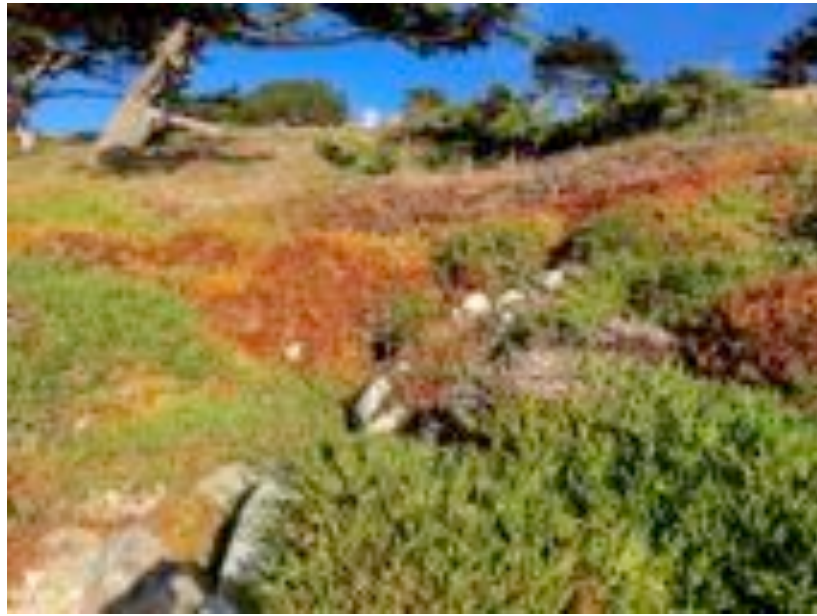
Fig 4#5

4.1.2c **Outfall #9 (South of 10<sup>th</sup> Ave.)**

- DEVELOP & FOLLOW PROTOCOLS FOR CLEARING/TRIMMING ICE PLANT AT LEAST A FEW FT. FROM OUTFALL'S DISCHARGE END BEFORE ONSET OF STORM SEASON, AS PER GENERAL RECOMMENDATIONS.

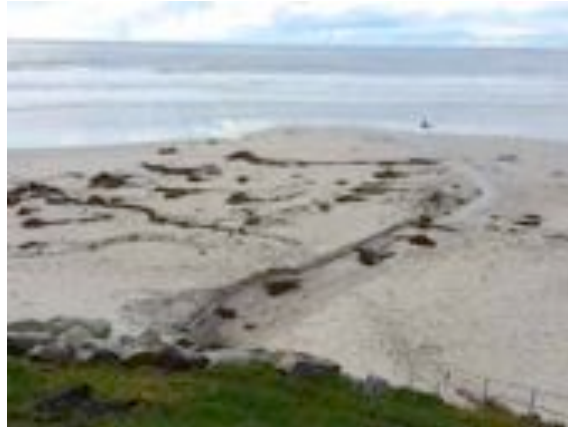
Fig 4#6

#### 4.1.3 Outfall-Generated Erosion

- DEVELOP AND FOLLOW STANDARD STORM WATER DISCHARGE PROTOCOLS, AS PER GENERAL RECOMMENDATIONS:
  - MONITOR OUTFALL DISCHARGES DURING & AFTER STORMS.
  - NOTIFY PUBLIC OF POTENTIAL HAZARD (e.g. WARNING SIGNS, WARNING TAPE, GALVANIZED EYE-ROD & CORD BARRIER, OR OTHER METHOD).

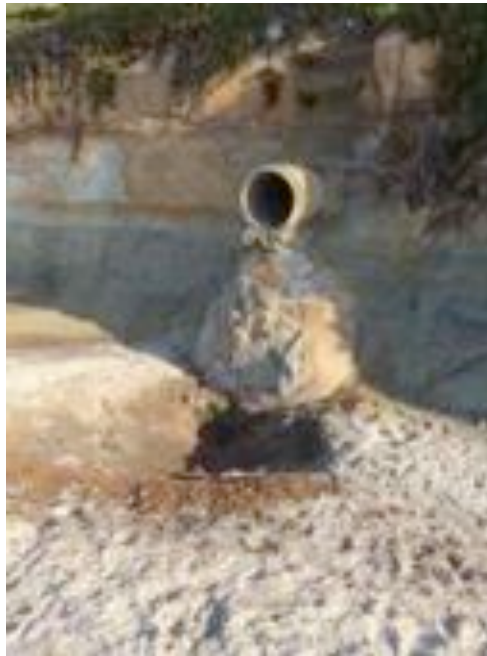
Fig 4#7

4.1.3b **12<sup>th</sup> Ave. North Cove**

- DEVELOP AND FOLLOW STANDARD STORM WATER DISCHARGE PROTOCOLS, AS PER GENERAL RECOMMENDATIONS:
  - MONITOR OUTFALL DISCHARGES DURING & AFTER STORMS.
  - NOTIFY PUBLIC OF POTENTIAL HAZARD (e.g. WARNING SIGNS, WARNING TAPE, GALVANIZED EYE-ROD & CORD BARRIER, OR OTHER METHOD).
- CONSIDER MODIFYING BASE OF OUTFALL TO DEFLECT STORM WATER DISCHARGE.

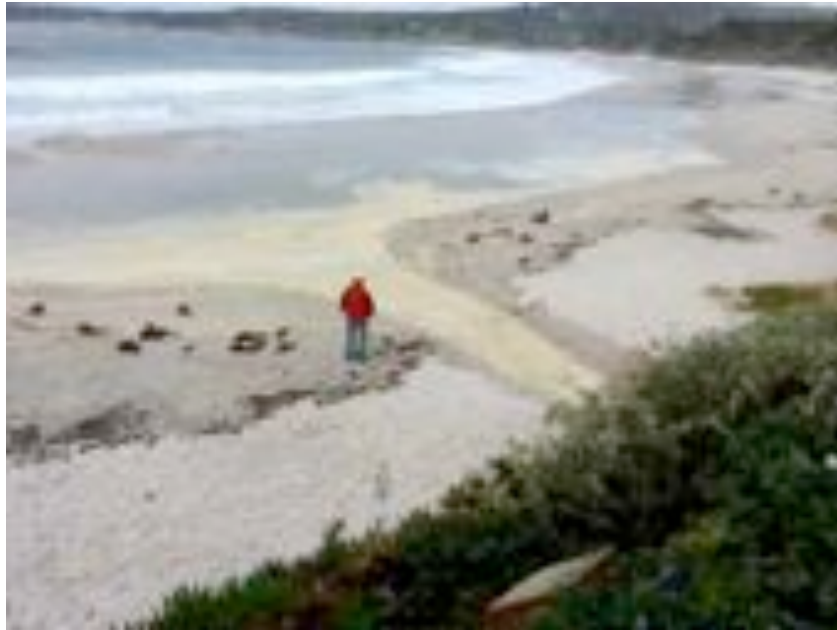
Fig 4#8

4.1.3c **South of Santa Lucia Ave.**

- DEVELOP AND FOLLOW STANDARD STORM WATER DISCHARGE PROTOCOLS, AS PER GENERAL RECOMMENDATIONS:
  - MONITOR OUTFALL DISCHARGES DURING & AFTER STORMS.
  - NOTIFY PUBLIC OF POTENTIAL HAZARD (e.g. WARNING SIGNS, WARNING TAPE, GALVANIZED EYE-ROD & CORD BARRIER, OR OTHER METHOD).

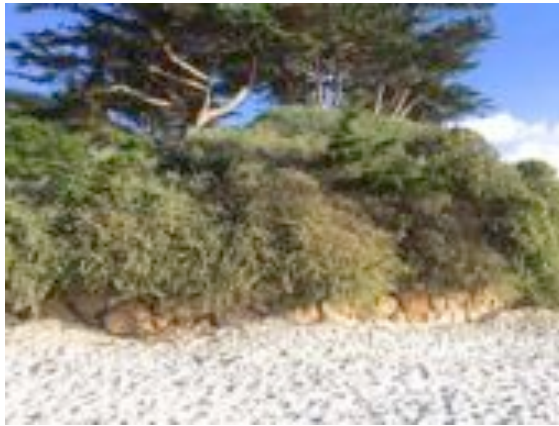
Fig 5#5

- Seawall at 10<sup>th</sup> Ave.

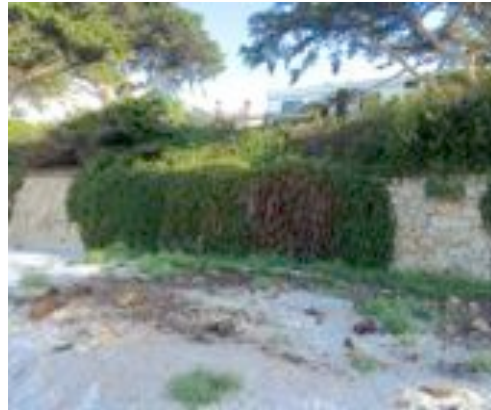
Fig 5#7

- Seawall North of Martin Way

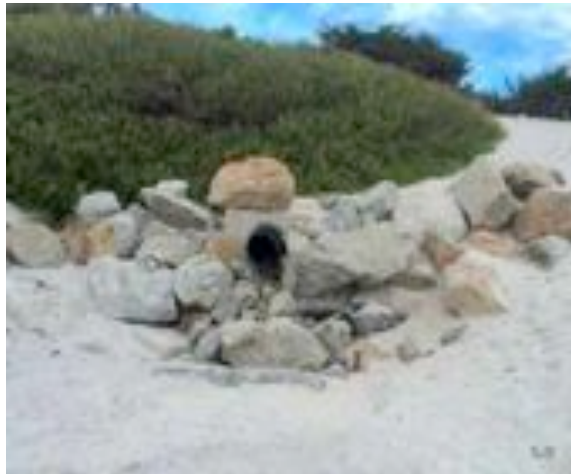
Fig 5#8

- **Condition:** Loose, perched, and/or migrating boulders were observed at the sites listed below. Due to moderate winter conditions, other shoreline revetments could not be assessed because sand levels were unseasonably high.
- Storm Water Outfall #2 (@ Foot of Ocean Ave.)

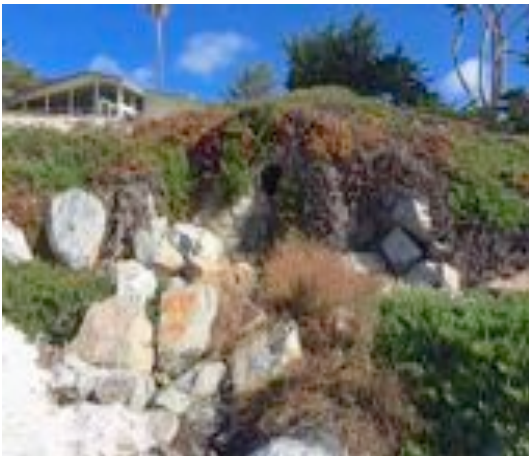
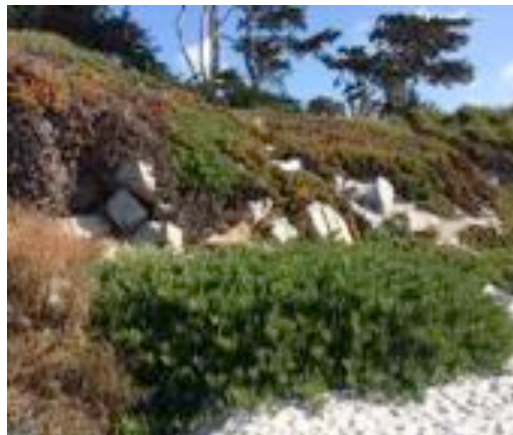
- Revetment/Storm Water Outfall #4 (@ North of 8<sup>th</sup> Ave.)

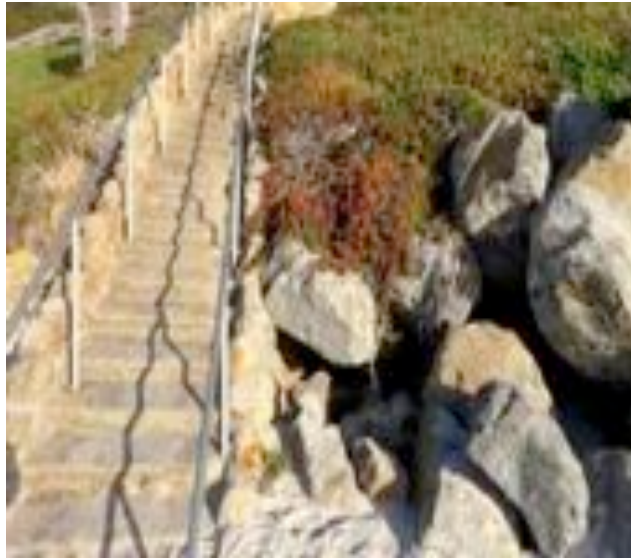
Fig 5#11

- Revetment @ Base of 11<sup>th</sup> Ave. Stairway

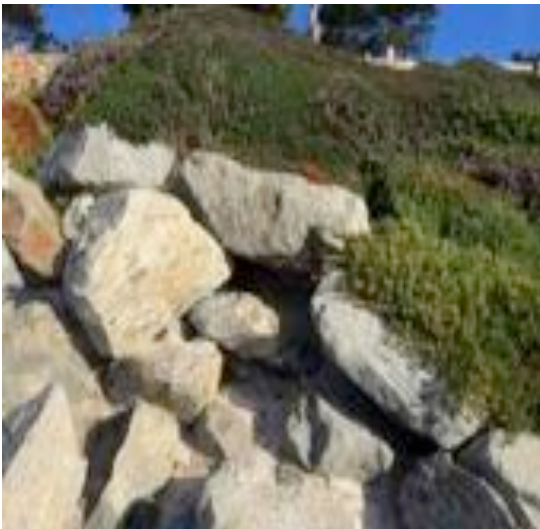
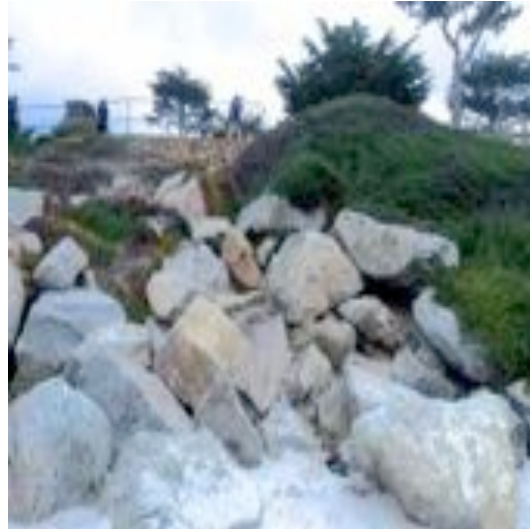
- Revetment @ South of 11<sup>th</sup> Ave.

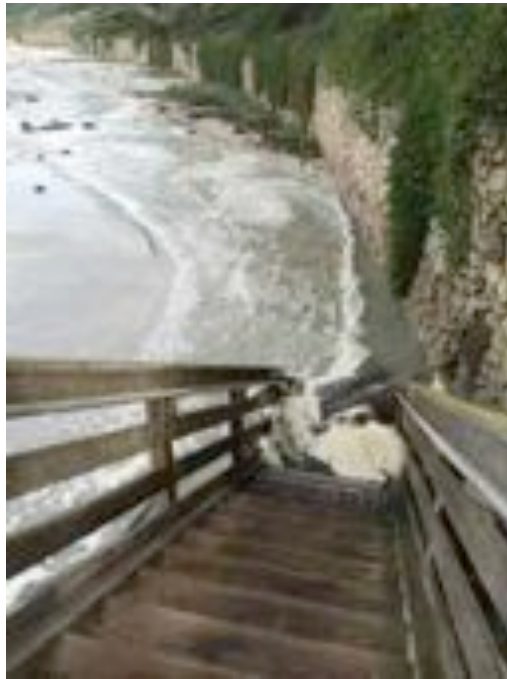
Fig 6#2

6.1.1b **Martin Way Stairway**

- DEVELOP AND FOLLOW STANDARD STORM/HIGH TIDE PROTOCOLS, AS PER GENERAL RECOMMENDATIONS:
  - MONITOR SHORELINE STAIRWAYS DURING SIGNIFICANT HIGH TIDES AND DURING & AFTER STORMS;
  - UTILIZE TIDE PREDICTION TABLES TO PREPARE FOR UPCOMING TIDES, ESPECIALLY THOSE THAT OCCUR DURING THE NIGHT;
  - CLOSE STAIRWAYS UNTIL SAFE CONDITIONS RETURN;
- INSTALL INFORMATION AND WARNING SIGNS TO NOTIFY THE PUBLIC OF POSSIBLE HAZARDS.

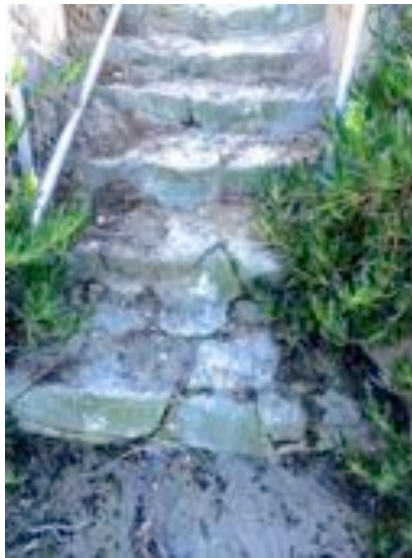
Fig 6#3

6.1.1c **Santa Lucia Stairway**

STEPS WERE RE-POINTED BY PUBLIC WORKS BEFORE NEW RESTROOM WAS OPENED TO PUBLIC

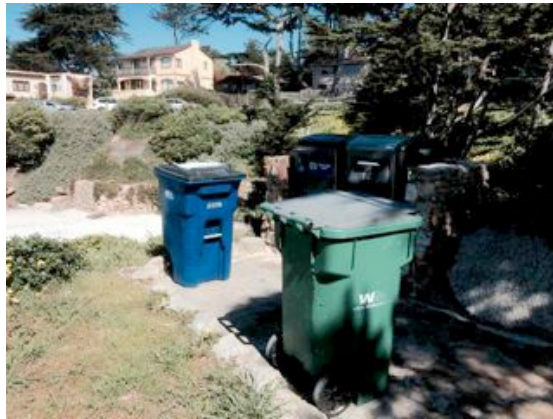
Fig 7#3

7.3.1b **13<sup>th</sup> Ave. Stairway Patio**

- **INSTALL 2<sup>ND</sup> STONE ENCLOSURE AT SITE OF PREVIOUS DUMPSTER**
  - **SHOULD BE LARGE ENOUGH TO HOLD ADEQUATE NUMBER OF SMALLER TRASH/RECYCLING CONTAINERS TO HANDLE VOLUME GENERATED BY VISITORS AT THIS SITE**

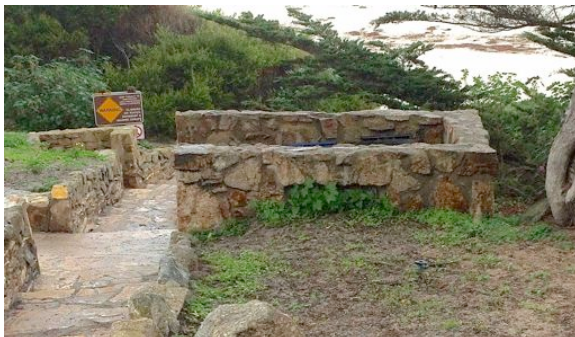
Fig 8#2

8.1.1b **Wash-off Station at 8<sup>th</sup> Ave. stairway**

⇒ **Recommended Action:** MOVE SIGN TO NEARBY LOCATION WHERE IT WILL BE VISIBLE TO THE PUBLIC

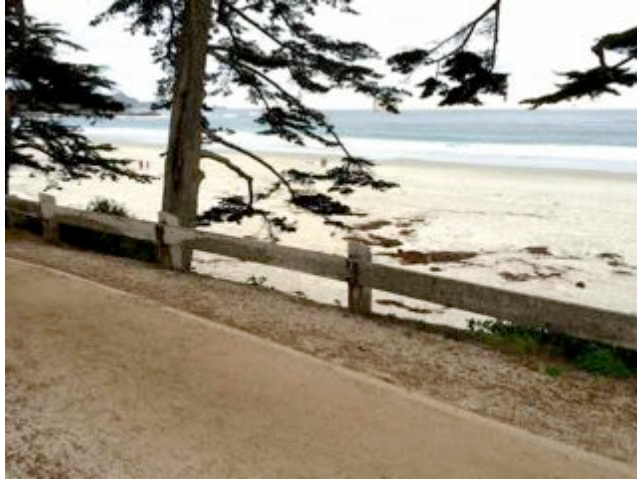
Fig 9#8

- **Condition:** Guardrail posts are wobbly.

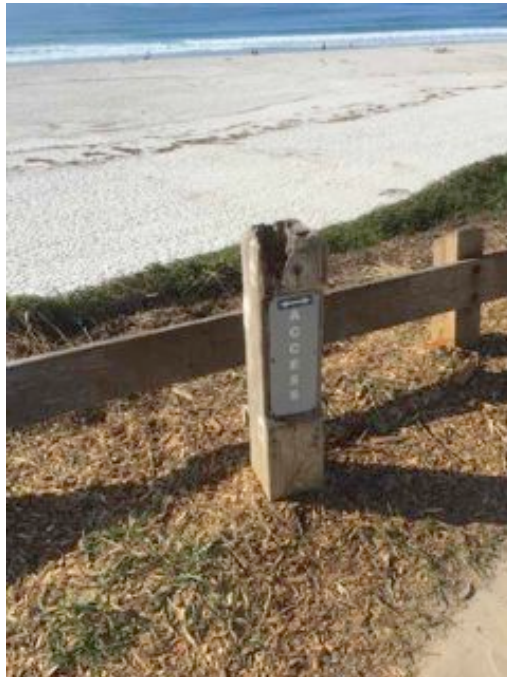
Fig 9#9

- **Condition:** Access-sign post badly decayed.

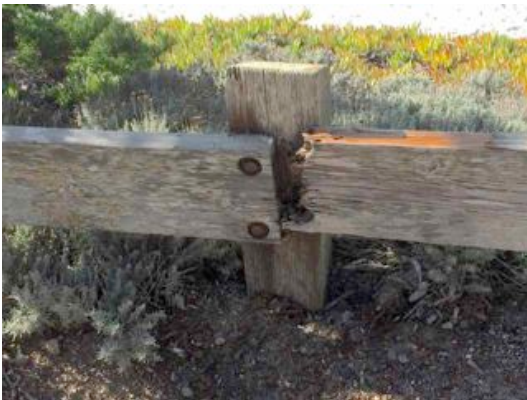
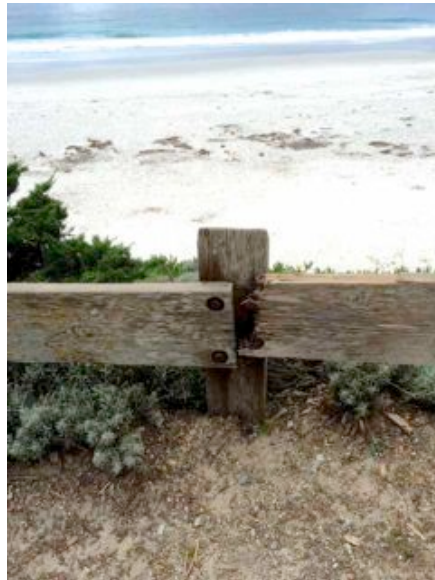
- **Condition:** Guardrails badly decayed and not securely fastened.

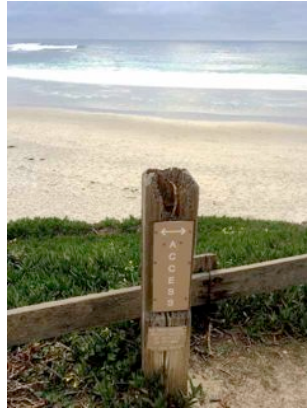
Fig 9#13

- **Condition:** Access-sign post badly decayed.

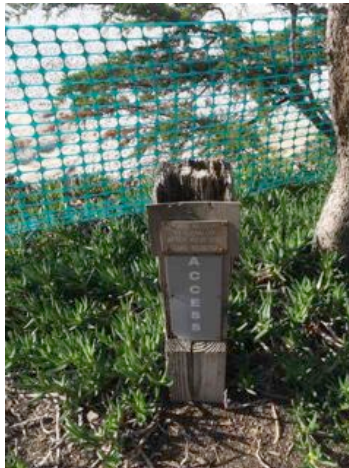
Fig 9#14

- **Condition:** Access-sign post badly decayed.

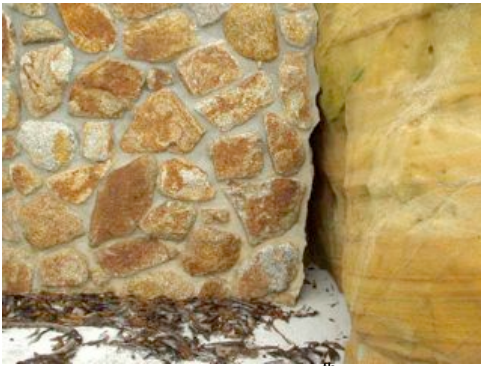
Several years ago, along the beach between 13<sup>th</sup> Ave. and Santa Lucia, the City repaired a gap between a seawall and the adjacent sandstone; its subsequent patch seems to be holding, but will eventually widen as the sandstone continues to erode.

Gap in seawall between 13<sup>th</sup> & Santa Lucia  
(2004)

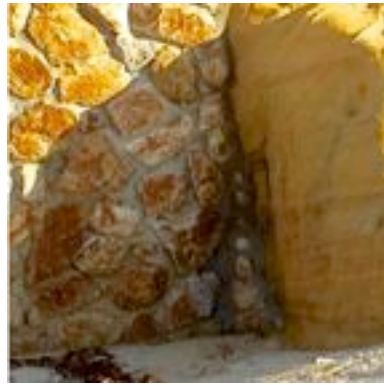
Repaired gap (2009)
