City of Carmel-by-the-Sea

Task 2: Seasonal and Long-term Beach and Shoreline Change Analysis

8/10/2023

Forest and Beach Commission

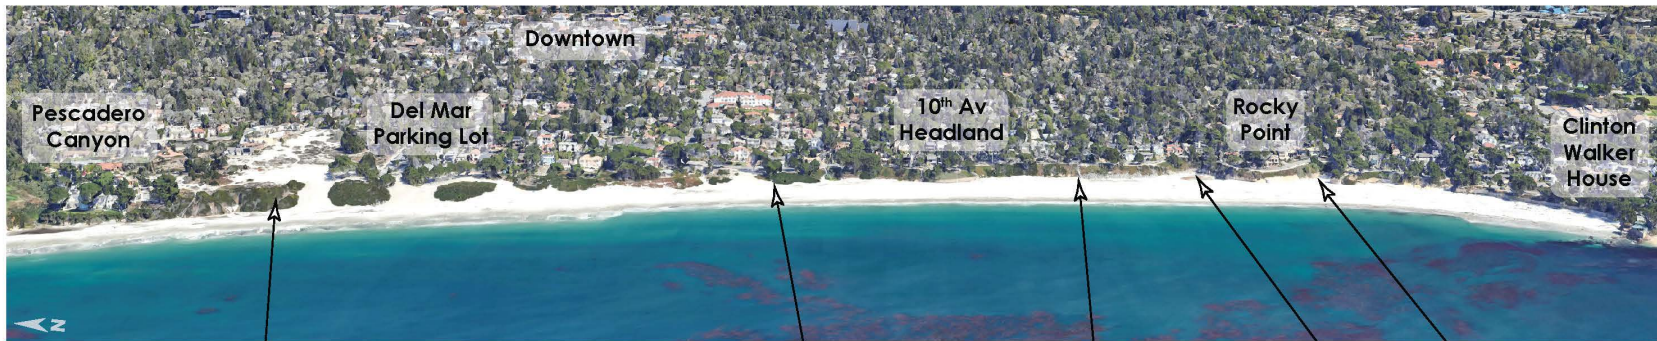
BEACH CHARACTER

Bluffs

Range from 25-48 ft. Contact elevation with underlying sandstone is higher south of 11th Av.

Dunes

Up to 50 ft high. Location and elevation of the underlying sandstone is unknown

Armoring

Seawalls and revetments protect ~68% of the City's shoreline

Armoring is located in areas with the highest variability in beach width

Beach

Most stable beach sections are the Del Mar Dunes and North Dunes. Beach widths (250-300 feet).

Highest beach widths are in the central and northern sections of Carmel Beach, with beach widths ~300 feet.

Sections that experience the greatest scouring also experience the greatest recovery.

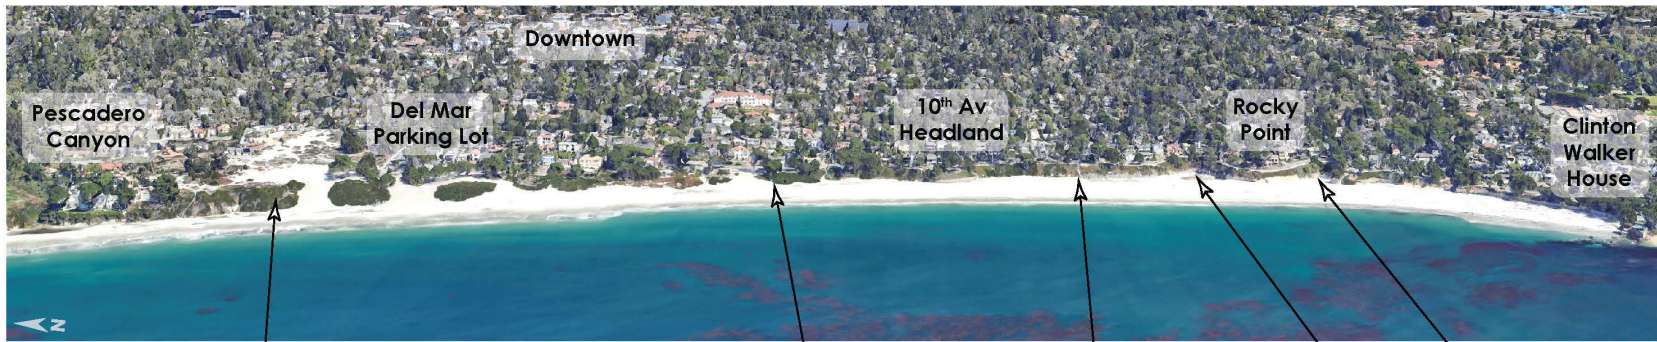
- Vertical Formations**
- Top of Bluff
 - Terrace Deposits & Dune Sands
 - Bluff or Top of Armor Contact
 - Basal Unit/Armor
 - Toe of Cliff
 - Av. Beach Height
 - Average Seasonal Beach
 - Height Range
- Backshore**
- Riprap
 - Buried Riprap
 - Seawall
 - Unarmored

- Beach Widths**
- 75th Percentile
 - Mean
 - 25th Percentile
 - More Stable Beach

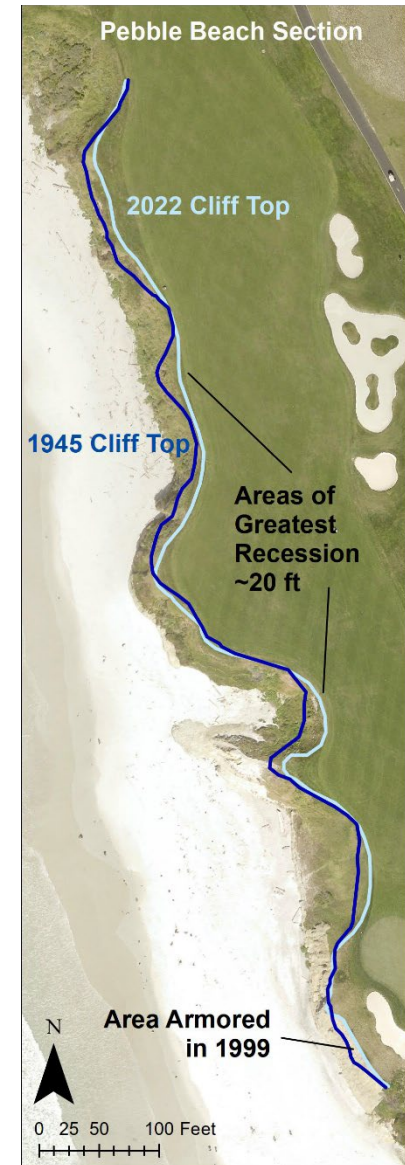
Cliff Erosion Event Observations

› From Rodger E. Johnson and Associates:

- 1982-3 Storm Event Erosion Hotspots:
 - **30 feet** of bluff between 8th-9th Avenues
 - **25-40 feet** of bluff between 9th -10th Avenues
 - **20-40** of bluff between 10th – 11th Avenues
 - **30 feet** of bluff near Santa Lucia Avenue

› From Integral Analysis

- Largest loss observed at Pebble Beach: **20 feet** near 10th Fairway (1945-2022)

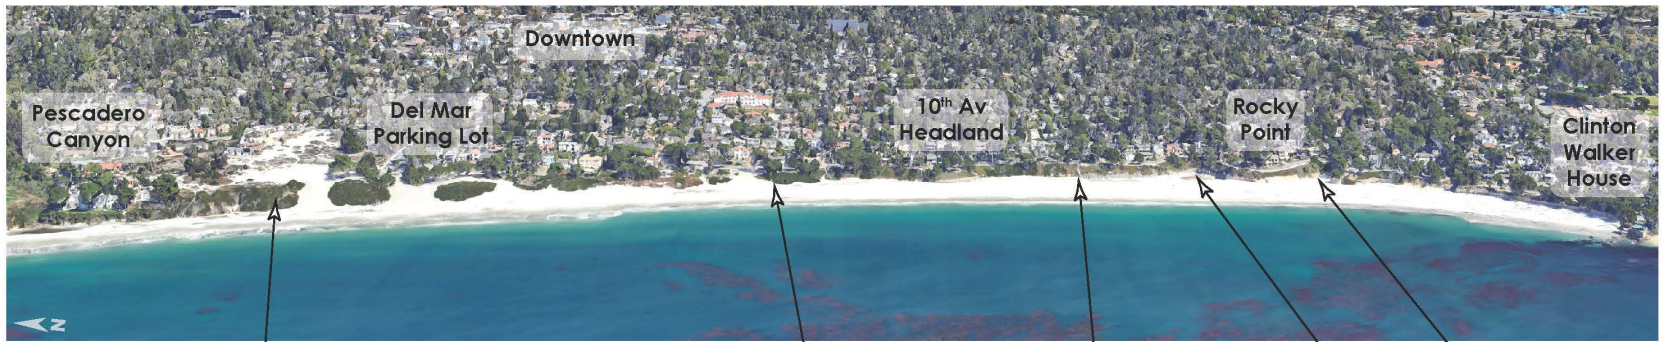
Cliff-backed to Dune-backed Shore Dune-backed to Cliff-backed Shore Buried to Exposed Riprap Pocket Beach Pocket Beach

- Vertical Formations**
- Top of Bluff
 - Terrace Deposits & Dune Sands
 - Bluff or Top of Armor Contact
 - Basal Unit/Armor
 - Toe of Cliff
 - Av. Beach Height
 - Average Seasonal Beach Height Range

- Backshore**
- Riprap
 - Buried Riprap
 - Seawall
 - Unarmored

Section 4 North Carmel Beach Section 3 North Dunes Section 2 Central Carmel Beach Section 1 South Carmel Beach

Pescadero Canyon 4th Av Stairs Northern Dune Ramp Central Dune Ramp Southern Dune Ramp 8th Av Stairs Scenic Rd Dune Ramp 9th Av Stairs 10th Av N. Stairs 10th Av S. Stairs 11th Av Stairs 12th Av Stairs 13th Av Stairs Santa Lucia Av Stairs Martin Way Stairs

- Beach Widths**
- 75th Percentile Mean
 - 25th Percentile
 - More Stable Beach
