Secretary of the Interior's Standards and Guidelines
For
Rehabilitating Historic Buildings

National Park Service

The Secretary of the Interior's Standards for Rehabilitation

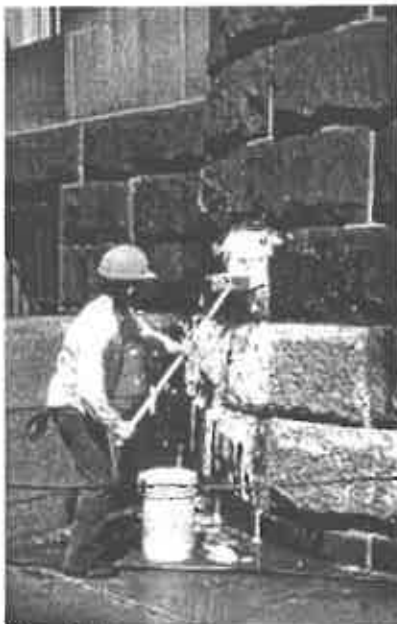
Chemical cleaning to remove dirt from granite.

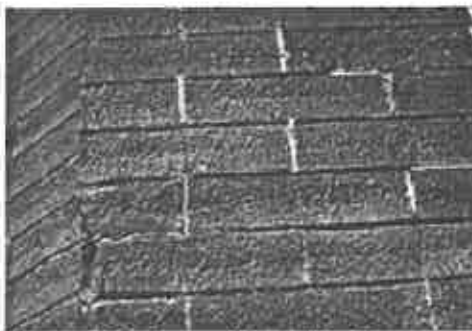
Historic brick damaged by sandblasting.

Sandblasting brick or stone surfaces using dry or wet grit or other abrasives. These methods of cleaning permanently erode the surface of the material and accelerate deterioration.

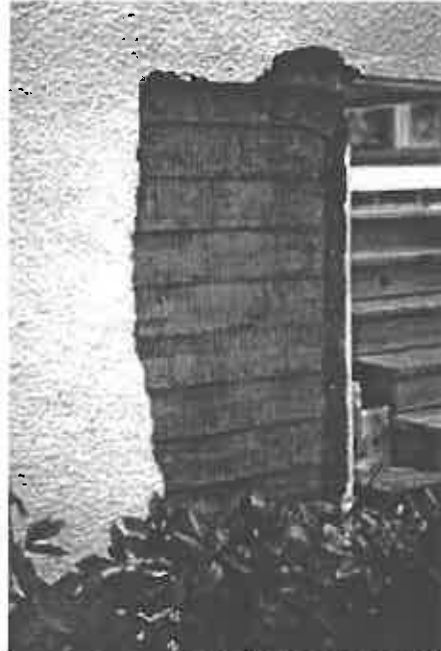
Repairing stucco by removing the damaged material and patching with new stucco that duplicates the old in strength, composition, color, and texture.

Preparation for stucco repair.

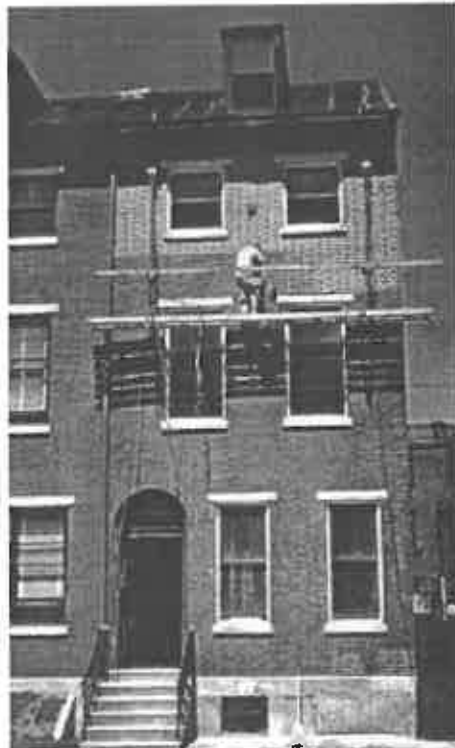
Removing nondeteriorated mortar from sound joints, then repointing the entire building to achieve a uniform appearance.

Loss of the historic character due to insensitive repointing.

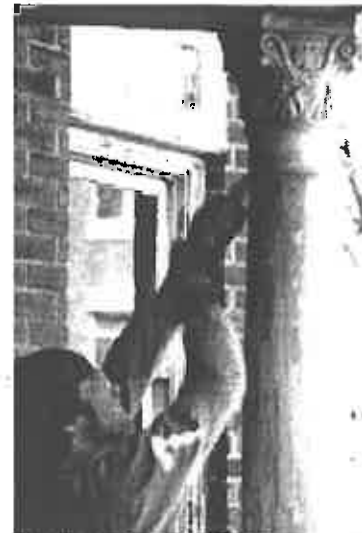
Hand scraping wood column prior to repainting.

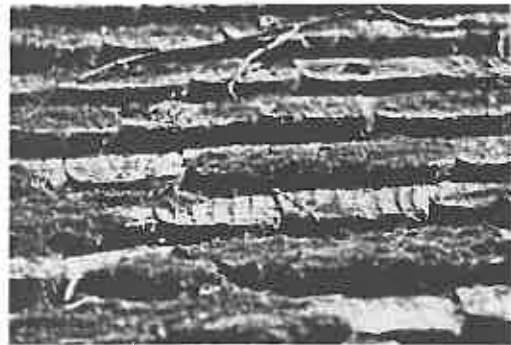
Moss on wood shingles indicative of damaging moisture retention.

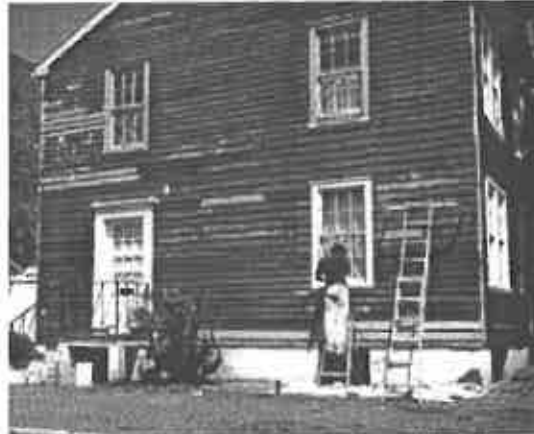
Limited replacement in-kind of deteriorated wood clapboards.

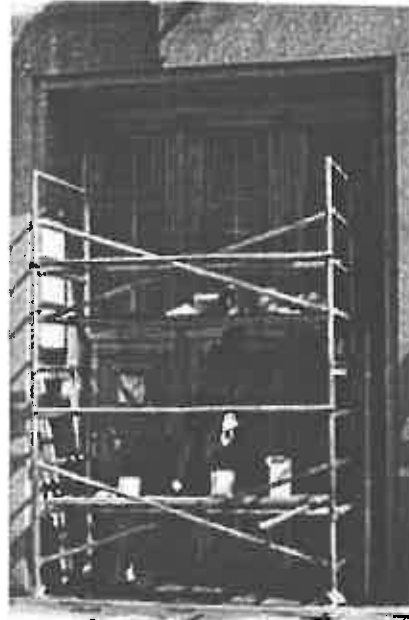
Applying a protective coating to bronze doors after cleaning.

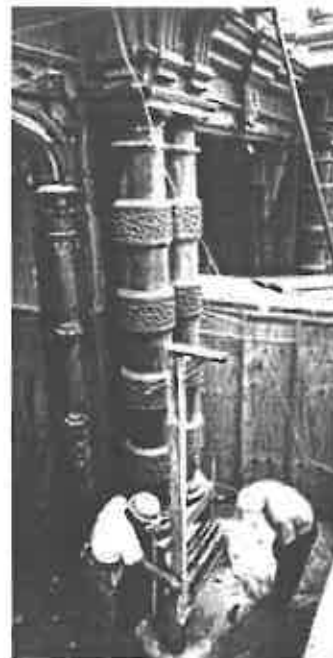
Missing cast-iron elements replaced with cast aluminum.

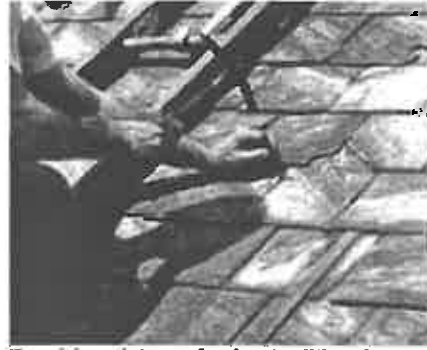
Repairing slate roof using traditional methods.

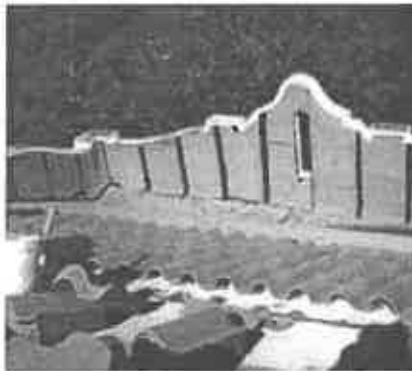
Replacement of damaged clay tile roof.

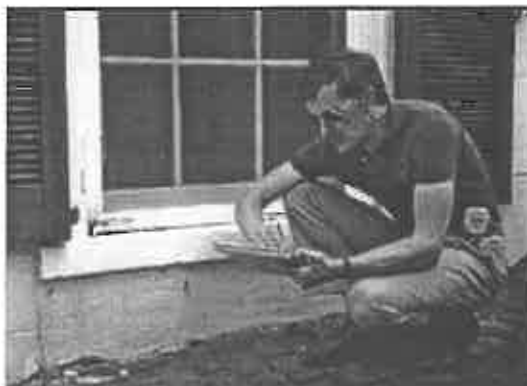
Window condition assessment preceding repair work.

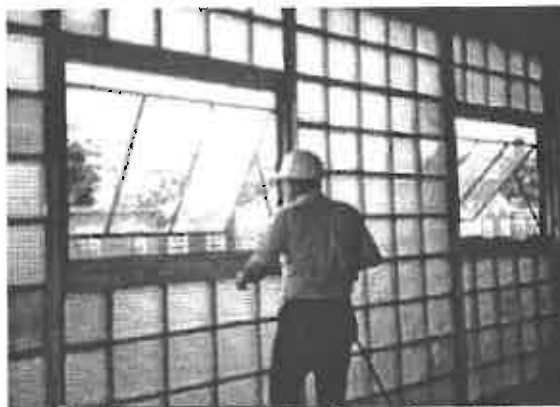
Preparing historic steel windows for repairs and re finishing.

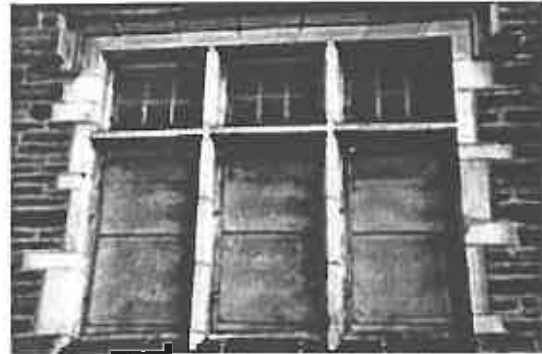
Deteriorated lower window sash shown prior to its replacement in kind.

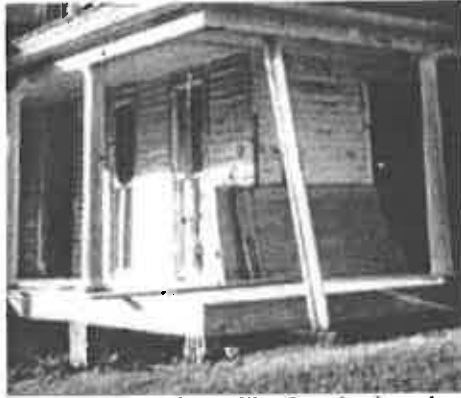
Deteriorated porch resulting from inadequate maintenance requires repair.

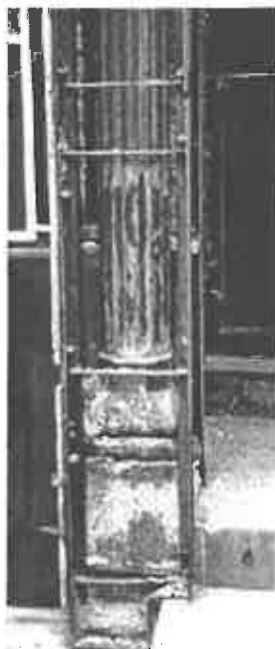
Cast iron column revealed during removal of non-significant storefront.

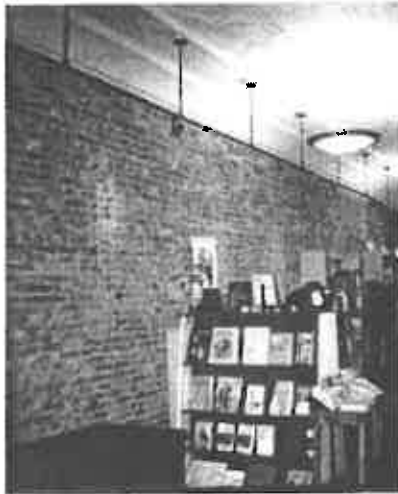
Exposed brick wall after inappropriate removal of historic plaster.

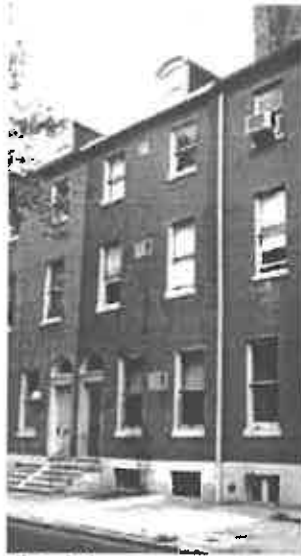
Historic building material destroyed by through-the-wall air-conditioners.

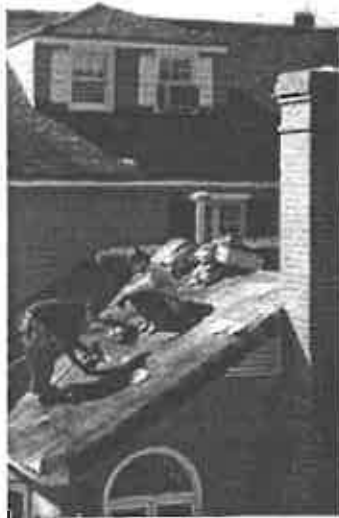
Insulating attic and installing replacement composition roof on 1920s house.

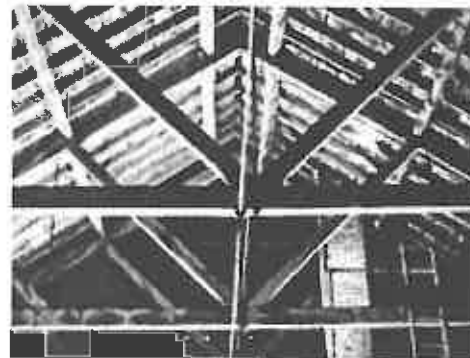
Post-and-beam structural system in 19th century freight station.

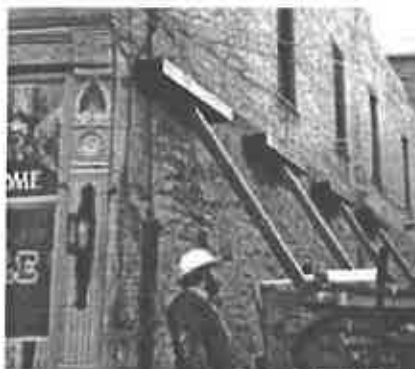
Structural stabilization of masonry walls before rehabilitation.

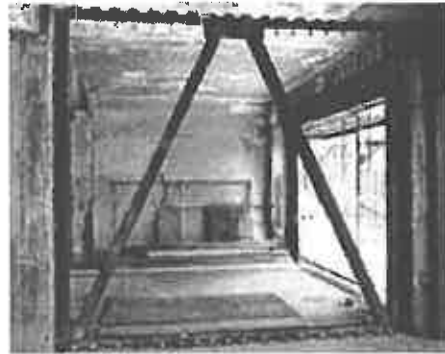
Structural brace installed between piers as seismic reinforcement to be concealed within re-built wall.

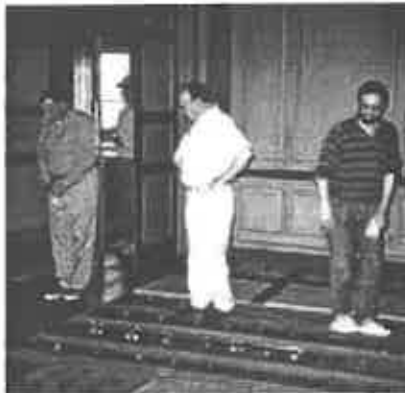
Evaluating floor joists prior to structural strengthening.

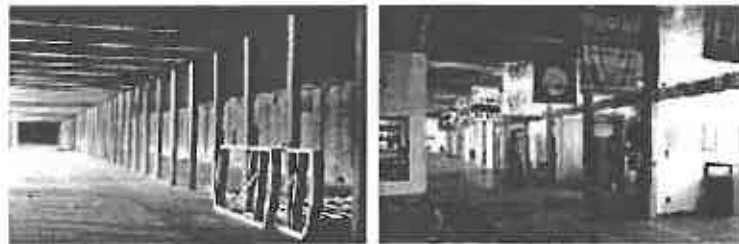
Left: Interior of 19th-century factory before rehabilitation. Right: Exposed structural system retains the historic industrial character after conversion to shops.

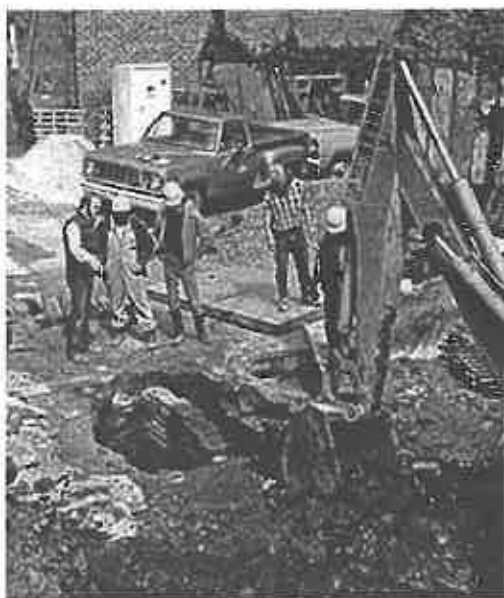
Inappropriate excavation causing damage to historic building foundation.

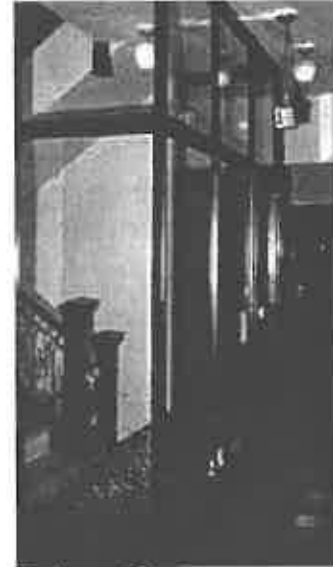
Enclosure that preserves decorative staircase and also meets safety code.
