## 4 THE CARMEL SHORELINE LANDSCAPE

### 4.1 NATURAL LANDSCAPE

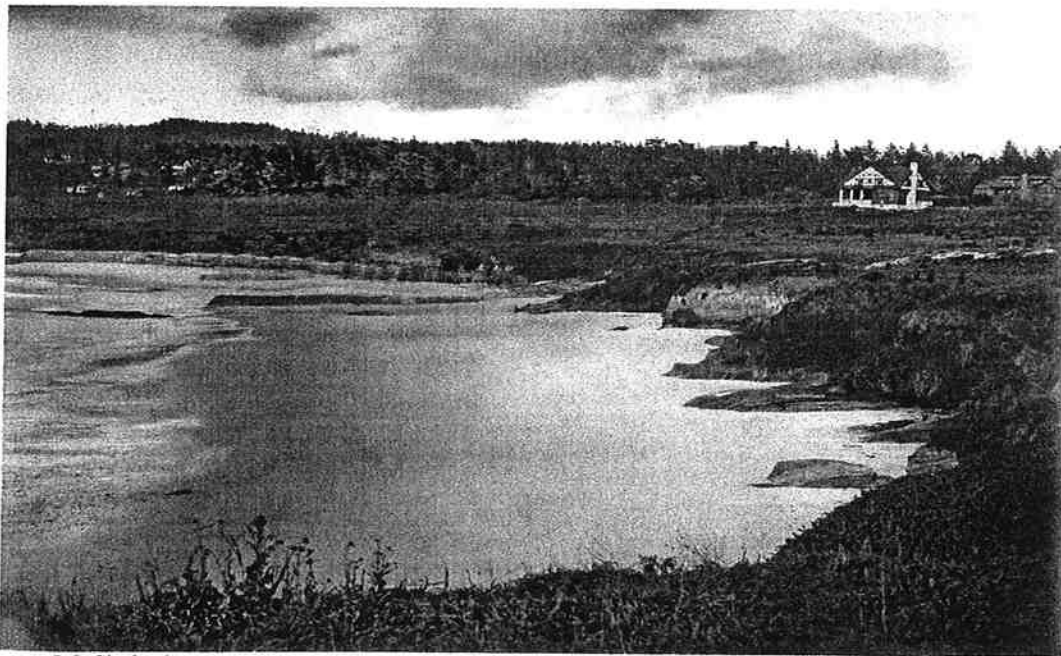
Photo 8 – Southern Carmel Shoreline (from 11<sup>th</sup> Ave. to Martin Way) 1908

During the past one hundred years, people have changed much of Carmel's natural shoreline landscape. Photographs taken in the early 20<sup>th</sup> century depict a shore covered with low native scrub plants and very few trees (Photo 8). As the City of Carmel grew, much of the shoreline was planted with flowers, shrubs, and trees from other parts of the world.

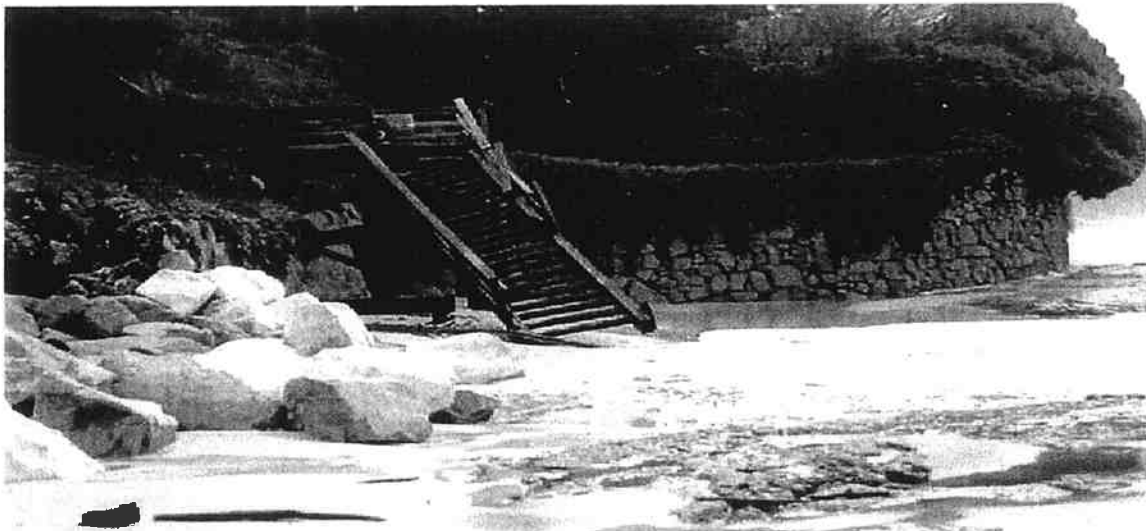
Photo 8 – *Severe Erosion and Boulder Migration at Tenth Avenue (North) Stairway*

Johnson (1984) reviewed reports describing damage from Monterey Bay/central California storms that occurred between 1910 and 1983. Over the past two decades, Carmel's shoreline has been severely damaged by storms associated with the El Niño weather patterns. The most recent El Niño periods (Winters of 1982/83, 1986/87, and 1997/98) were characterized by extended periods of heavy rain, strong winds, and high surf. The extensive damage during these El Niño winters resulted, in part, from the nearly continuous battering of the shoreline by powerful storm waves and the weakening of water-saturated beach bluffs. During the 1982/83 El Niño period, severe winter storms struck Carmel nearly every ten days. More sand was removed from the beach than at any previous time in the memory of long-term residents or documented history.

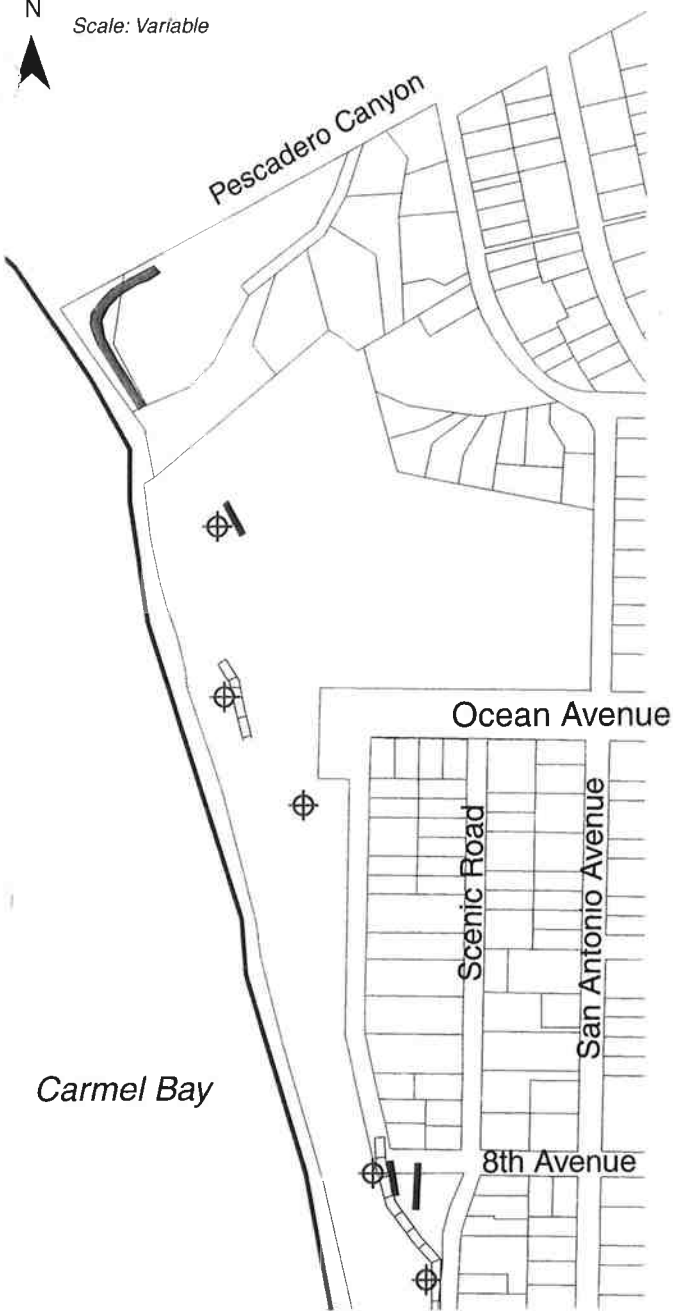
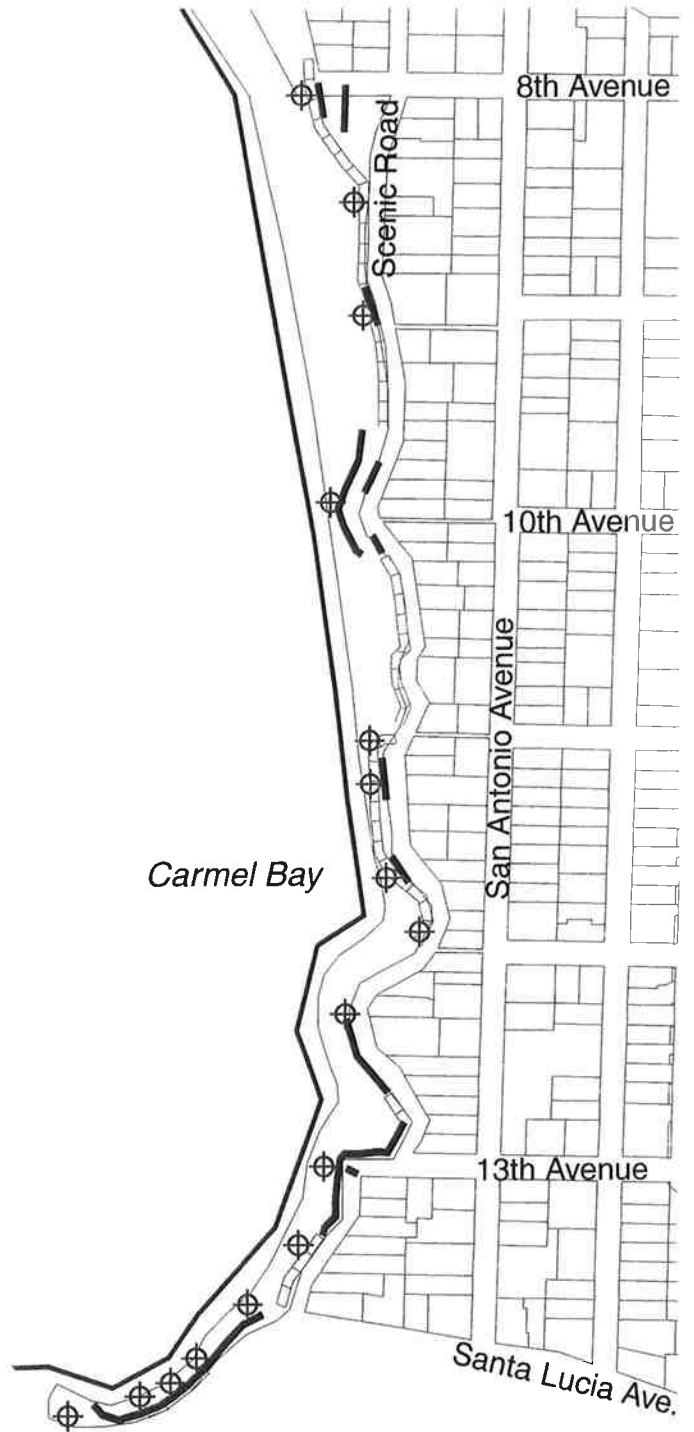
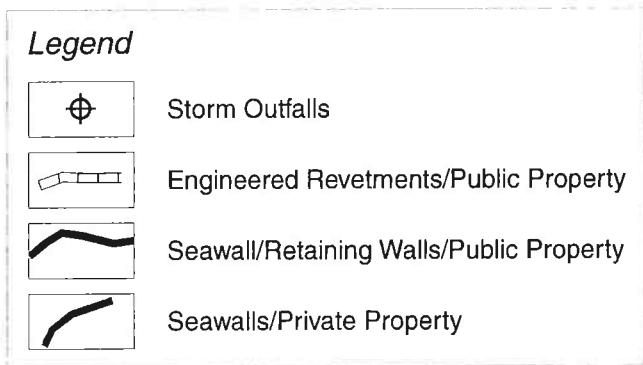
Figure 8  
Coastal Protection Structures

Approximately 50% of the City's shoreline protection structures are seawalls. They are visible at all times, and contribute to the Carmel Beach visual experience. Some of Carmel's earliest shoreline walls were built of local "golden granite" rocks, held together by mortar. More recently, walls have been built of reinforced concrete and faced with golden granite. Many of the City's coastal walls are built upon a foundation sunk deep into the bedrock and some of these walls have "tie-backs" that anchor the wall into the bluff.

All coastal walls are outfitted with ample "weep holes" to promote drainage. This helps relieve the tremendous pressure caused by the build-up of water-laden soils behind the wall, which could cause the wall to lean or collapse.

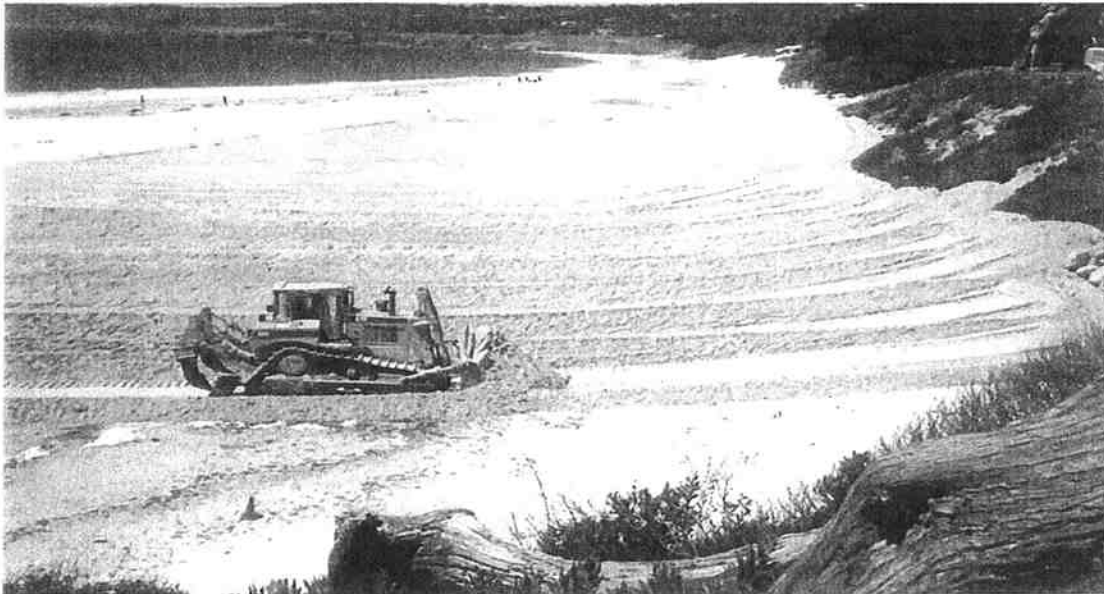
Photo 9 – *Sand Redistribution*

Carmel's use of sand to cover its revetments has, thus far, proven successful. From late spring through early winter, the public has regained the use of beach land that might have otherwise been lost. During severe winter storms, bulldozed sand is rapidly stripped from each revetment, allowing the structure's boulders and voids

Recently, the City began using its sand redistribution program to address problems caused by ponded water on Carmel Beach.<sup>75</sup> In 2001, the City used a bulldozer to cut a channel through the berm, allowing ponded water to drain back out to the ocean. In areas where ponded water had gathered at the base of a stairway, preventing beach access, the water was drained and then sand was moved laterally to level-out these low areas, returning beach access to the public.

During recent years, the City has moved only sand that was located above the high tide line. The actual volume of sand moved each year varies according to several factors, including the amount of sand already on the upper beach, the degree of revetment cover needed, and the amount of lower beach sand available for movement. For example, the need for sand redistribution following a mild winter will be less than after a severe winter. The City estimates that the amount of sand moved varies between 50,000 – 100,000 cubic yards, depending on conditions. Carmel Beach sand redistribution usually requires two to three weeks to complete.

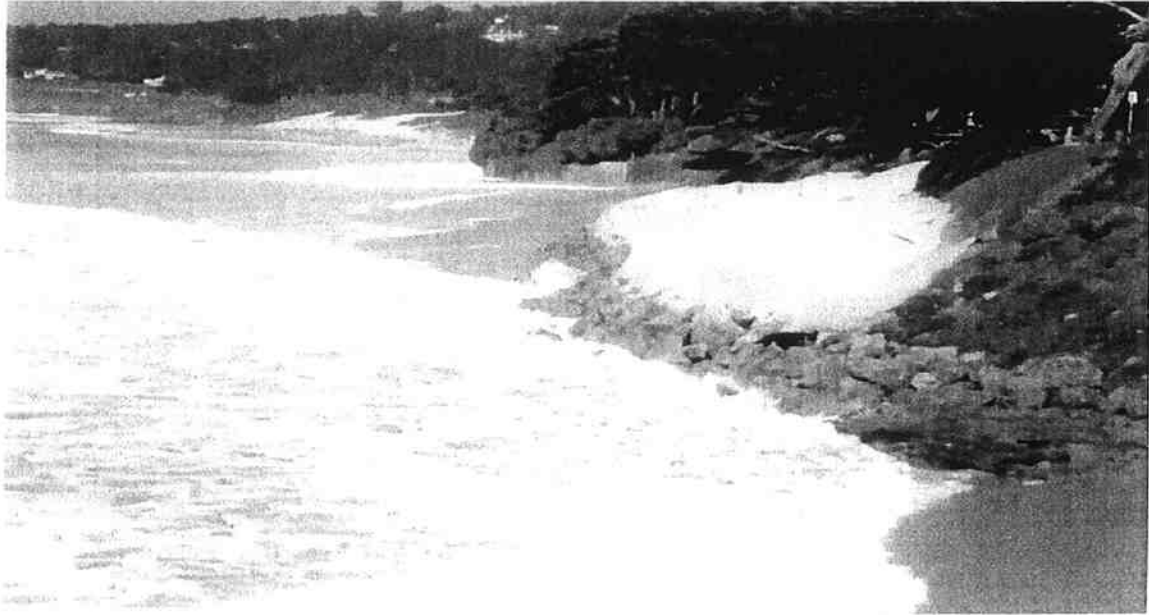
Photo 10 – *Shoreline Armoring Along Carmel Beach*

In 1983, Carmel responded to extensive shoreline bluff damage (from the 1982/83 El Niño storms) by installing several engineered revetments.<sup>80</sup> These were designed by the City's consulting engineering-geologist, Rogers E. Johnson & Associates. Their size, shape, and slope were based on calculations that predicted the size of waves expected to strike the toe of each revetment. The lowest course of boulders was placed into a "keyway" dug into the bedrock at the base of each structure. Filter fabric was laid down before placing the boulders to allow the free flow of water in and out of the structure, and reduce the erosion of sand or bluff soils.<sup>81</sup> Within two summers, these structures were completely covered by sand as a result of the beach's natural sand deposition processes and the City's extensive sand redistribution-bulldozing efforts. In the years since their installation, these revetments have remained mostly hidden from view. During most years, few Carmel Beach visitors are aware of their presence.
