Secretary of the Interior's Standards and Guidelines
For
Rehabilitating Historic Buildings

National Park Service

The Secretary of the Interior's Standards for Rehabilitation

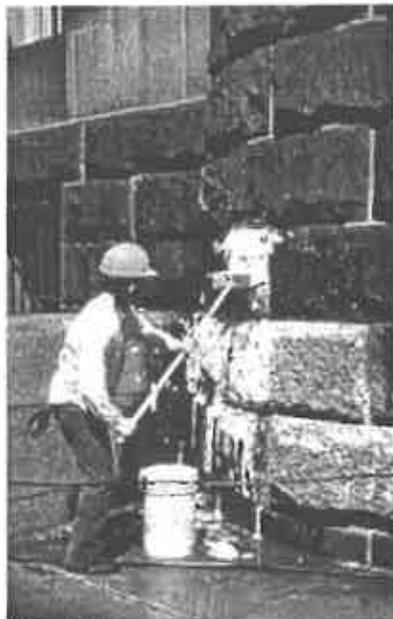
Chemical cleaning to remove dirt from granite.

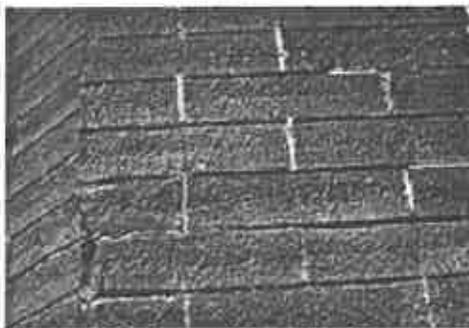
Historic brick damaged by sandblasting.

Sandblasting brick or stone surfaces using dry or wet grit or other abrasives. These methods of cleaning permanently erode the surface of the material and accelerate deterioration.

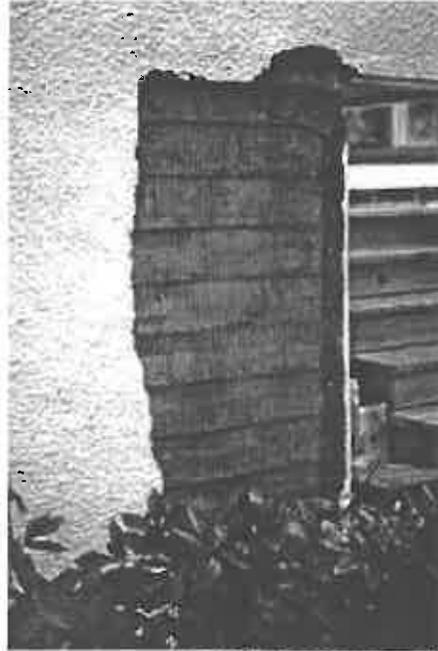
Preparation for stucco repair.

Repairing stucco by removing the damaged material and patching with new stucco that duplicates the old in strength, composition, color, and texture.

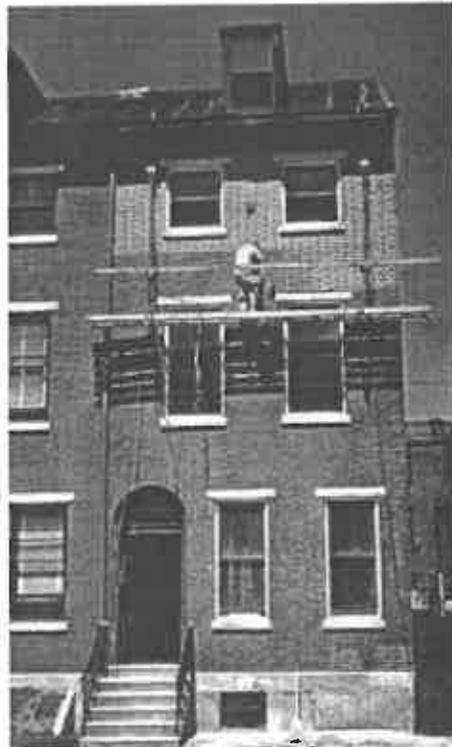
Loss of the historic character due to insensitive repointing.

Removing nondeteriorated mortar from sound joints, then repointing the entire building to achieve a uniform appearance.

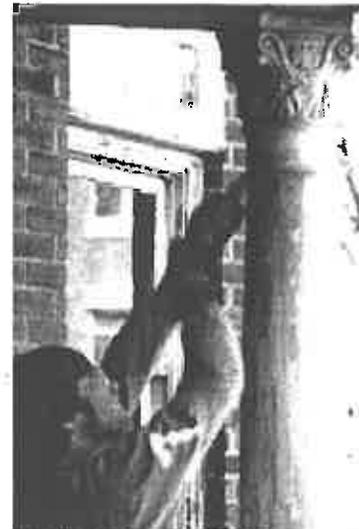
Hand scraping wood column prior to repainting.

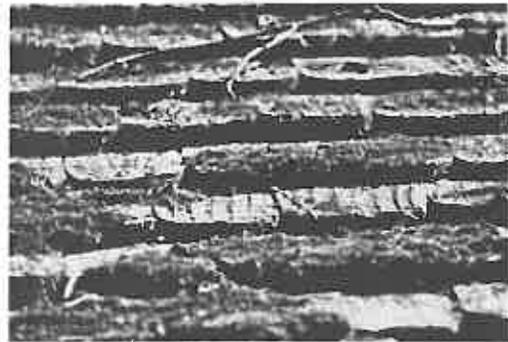
Moss on wood shingles indicative of damaging moisture retention.

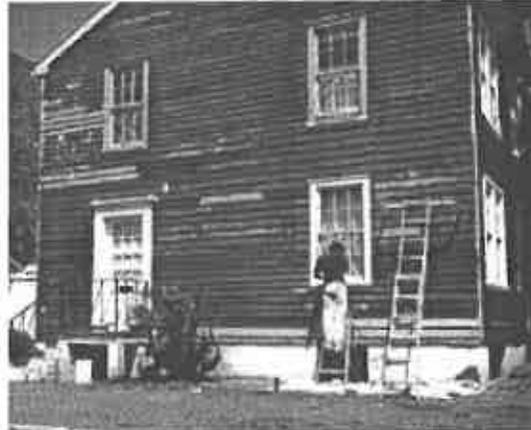
Limited replacement in-kind of deteriorated wood clapboards.

Repairing wood features by patching, piecing-in, consolidating, or otherwise reinforcing the wood using recognized preservation methods.

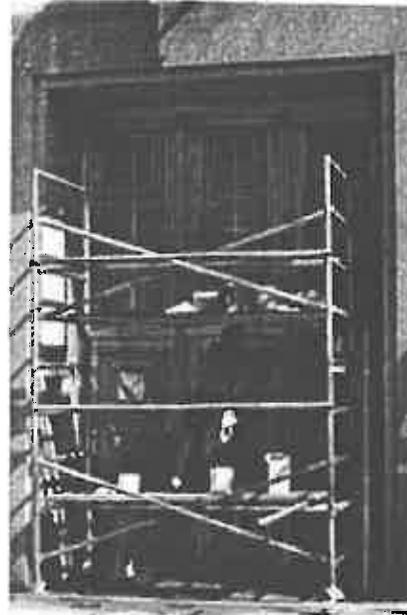
Applying a protective coating to bronze doors after cleaning.

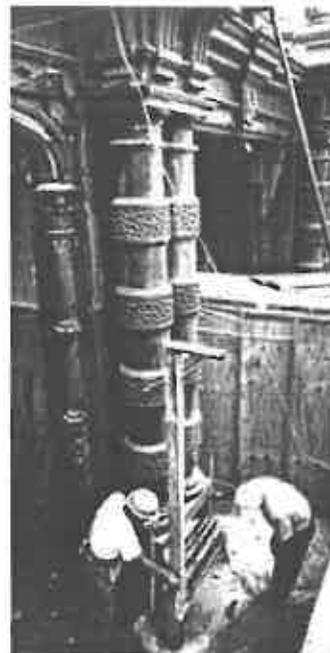
Missing cast-iron elements replaced with cast aluminum.

If using the same kind of material is not technically or economically feasible, then a compatible substitute material may be considered.

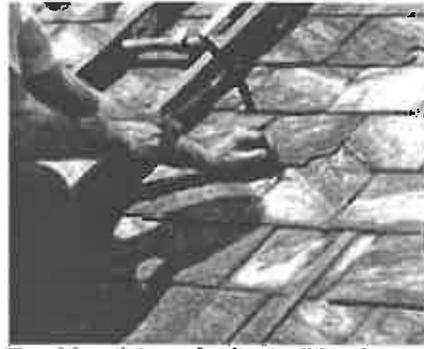
Repairing slate roof using traditional methods.

Repairs will also generally include the limited replacement in kind--or with compatible substitute material--of those extensively deteriorated or missing parts of features when there are surviving prototypes such as cupola louvers, dentils, dormer roofing; or slates, tiles, or wood shingles on a main roof.

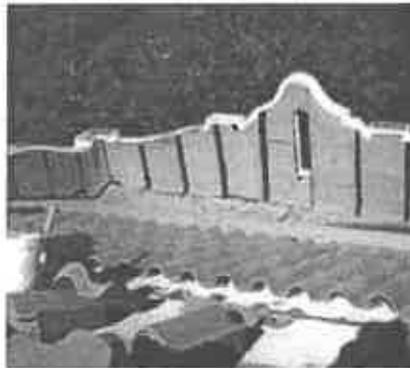
Replacement of damaged clay tile roof.

Replacing in kind an entire feature of the roof that is too deteriorated to repair--if the overall form and detailing are still evident--using the physical evidence as a model to reproduce the feature.

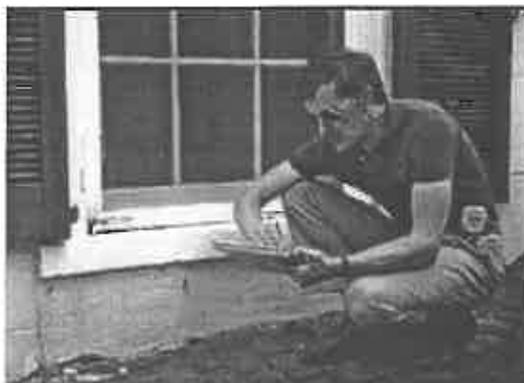
Window condition assessment preceding repair work.

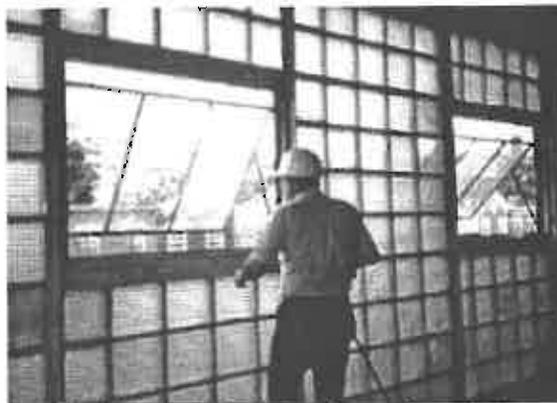
Preparing historic steel windows for repairs and re finishing.

Repairing window frames and sash by patching, splicing, consolidating or otherwise reinforcing.

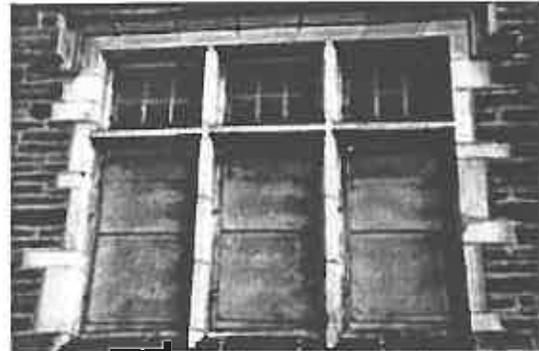
Deteriorated lower window sash shown prior to its replacement in kind.

Replacing in kind an entire window that is too deteriorated to repair using the same sash and pane configuration and other design details. If using the same kind of material is not technically or economically feasible when replacing windows deteriorated beyond repair, then a compatible substitute material may be considered.

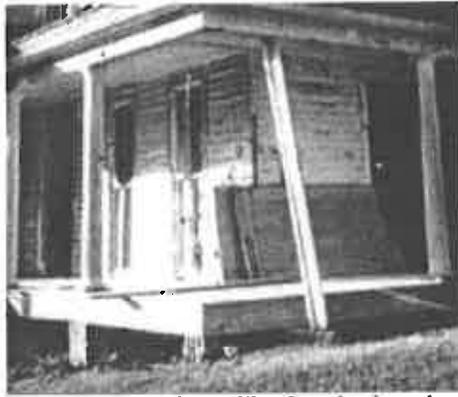
Deteriorated porch resulting from inadequate maintenance requires repair.

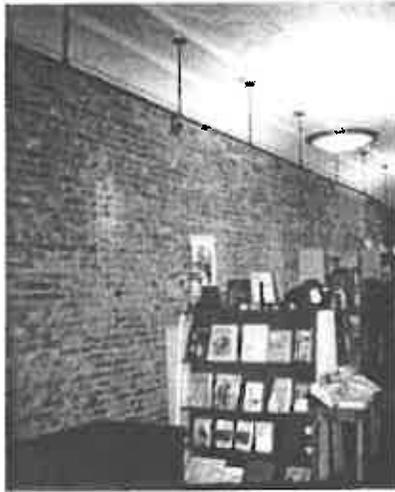
Exposed brick wall after inappropriate removal of historic plaster.

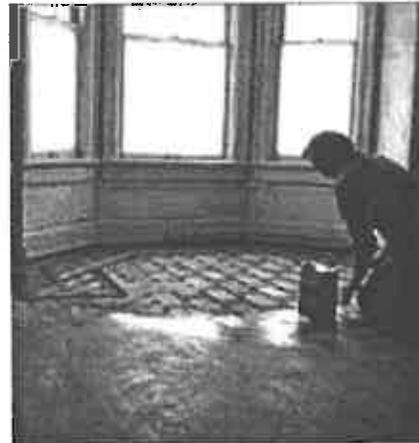
Applying a protective finish to historic flooring.

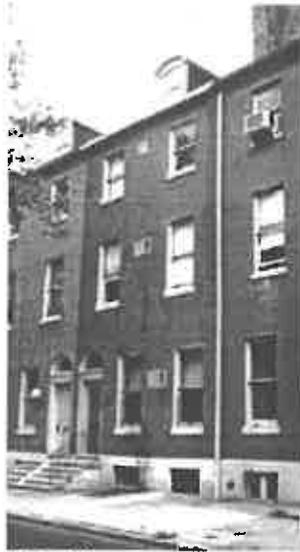
Historic building material destroyed by through-the-wall air-conditioners.

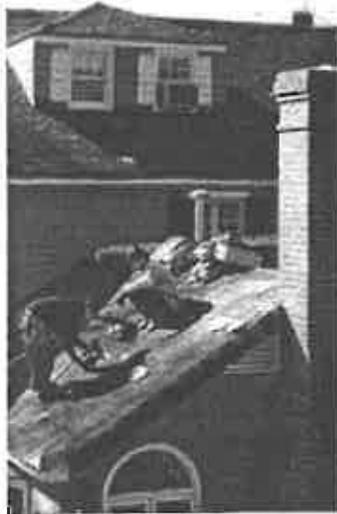
Insulating attic and installing replacement composition roof on 1920s house.

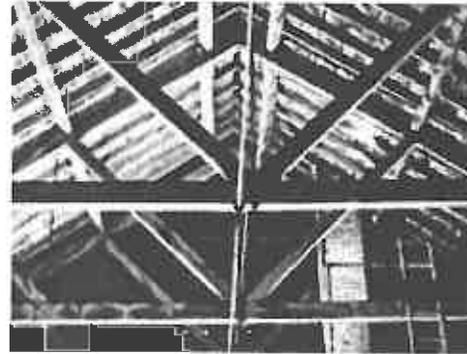
Post-and-beam structural system in 19th century freight station.

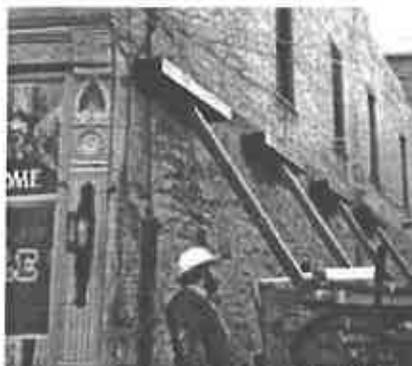
Structural stabilization of masonry walls before rehabilitation.

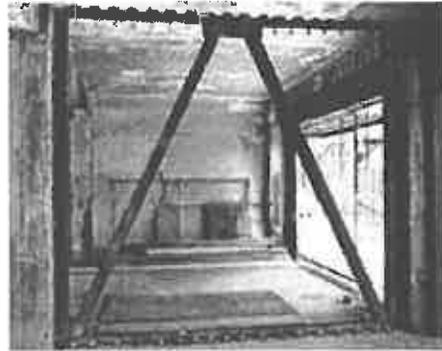
Structural brace installed between piers as seismic reinforcement to be concealed within re-built wall.

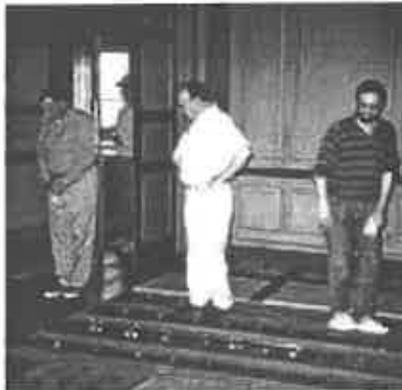
Evaluating floor joists prior to structural strengthening.

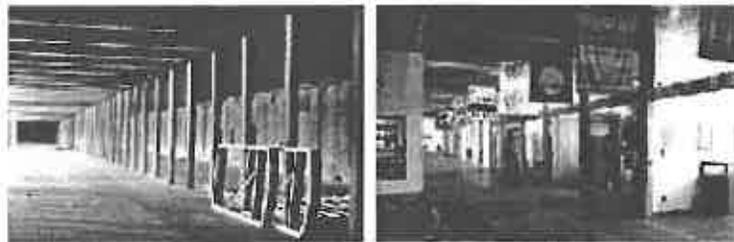
Left: Interior of 19th-century factory before rehabilitation. Right: Exposed structural system retains the historic industrial character after conversion to shops.

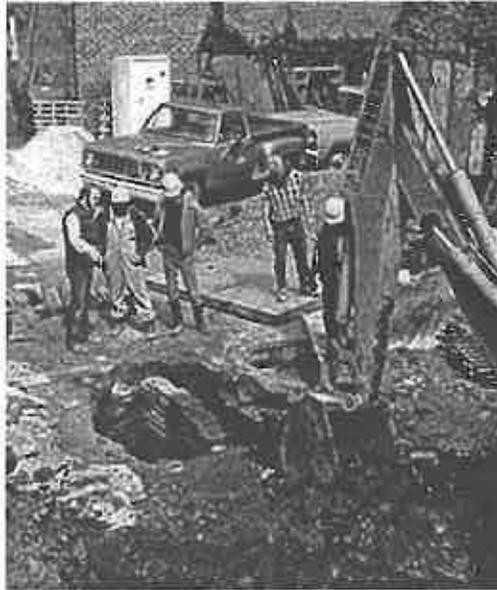
Inappropriate excavation causing damage to historic building foundation.

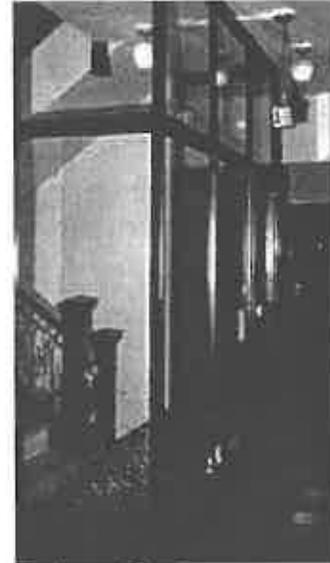
Enclosure that preserves decorative staircase and also meets safety code.
