**CITY OF CARMEL-BY-THE-SEA
HISTORIC RESOURCES BOARD
MEETING AGENDA**

Monday, September 17, 2012
3:30 p.m. Tour
4:00 p.m., Open Session

1. MA 12-1
Buff LaGrange
2552 Santa Lucia
Blk Z, Part 14 & 16

1. DS 12-19
Leidig-Draper
E/s Dolores bet. Ocean & 7th
Blk 76, Lots 6, 7, 8

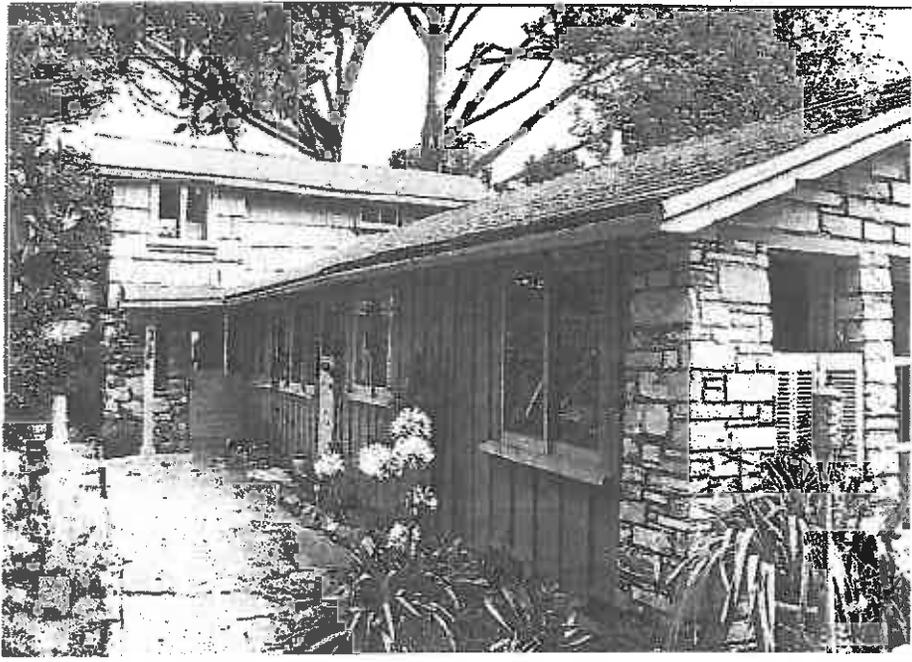
P5b. Description of Photo: (View, date, accession #)
(View toward). Photo No: 5030-.

A one-and-two-story vernacular residence, slightly ell-shaped in plan, resting on a stone foundation. The exterior wall cladding is a combination of vertical board-and-batten and Carmel stone on the one-story section, and wood shingle and Carmel stone on the two-story portion, to the north. The low-pitched cross-gabled roof system is covered in composition shingle. There is one Carmel stone interior chimney. It is located toward the east, on the north side-elevation of the two-story section of the house. An exterior wooden staircase with simple horizontal railing, recently rebuilt, rises from West to East along the North side-elevation accessing the second floor. Fenestration is irregular with a combination of fixed, plate-glass, wood casement type and sliding wood windows in varying sizes. Some of the wood casement type form a band along the West side of the one-story wing. There is a narrow, fixed stained-glass window, flanking the principal entry, which faces south on the slightly projecting two-story ell. The gable end of the one-story wing has large, multi-paned glazed sliding doors centered in the wall, which is covered in coursed ashlar Carmel stone. The North end of the detached, 1939 flat-roofed Carmel stone garage creates an interior garden wall for the property which has extensive Carmel stone patios, as well as an outdoor stone fireplace in the NW cr. of the parcel. The house is sited in an informal landscape setting of mature pines and cypress with vine-covered walls and fences and several flower beds.

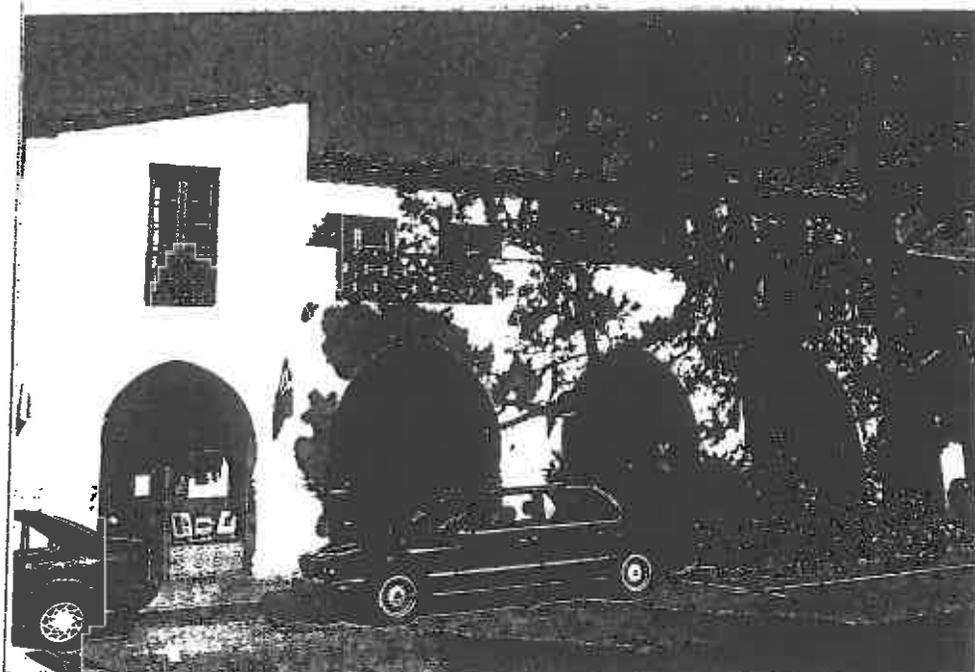
A white stucco building consisting of a two-story front section and a one-story rear section having concrete foundations. A Spanish tile roof covers the front section and a residential patio is over the rear section. The ground floor of the front section includes four Moorish arches with green canvas canopies fronting the retail stores. The second story of the front section is a residence occupied by the owner. The left portion of the front section has a shed roof sloping northward. The remaining portion of the front section has a gable roof with a north-south ridgeline. Elaborate decorative cornice work of brick and red tile shows under the eaves. The upstairs apartment has a large vaulted ceiling living room and french doors leading to a grand balcony overlooking Dolores Street.
