CARMEL WAY TRUST RESIDENTIAL DEVELOPMENT INITIAL STUDY

Project Title:	Carmel Way Trust Residential Development
Project Location:	7 and 9 Carmel Way, Carmel, Monterey County
Date Prepared:	September 15, 2016
Lead Agency:	City of Carmel P.O. Box G Carmel, California 93921
Project Sponsor:	Jeff and Wendy Hines
Assessor's Parcel Number(s):	010-321-020 and 010-321-021
Acreage of Property:	Three parcels: 1.48 acres combined (0.53 ac. 0.22 ac. and 0.73)
Zoning District:	R1 Single-Family Residential
General Plan Designation:	Single-Family Residential
Coastal Land Use Plan:	Single-Family Residential
Contact Person:	Matthew Sundt, City Planner (831-620-2023)

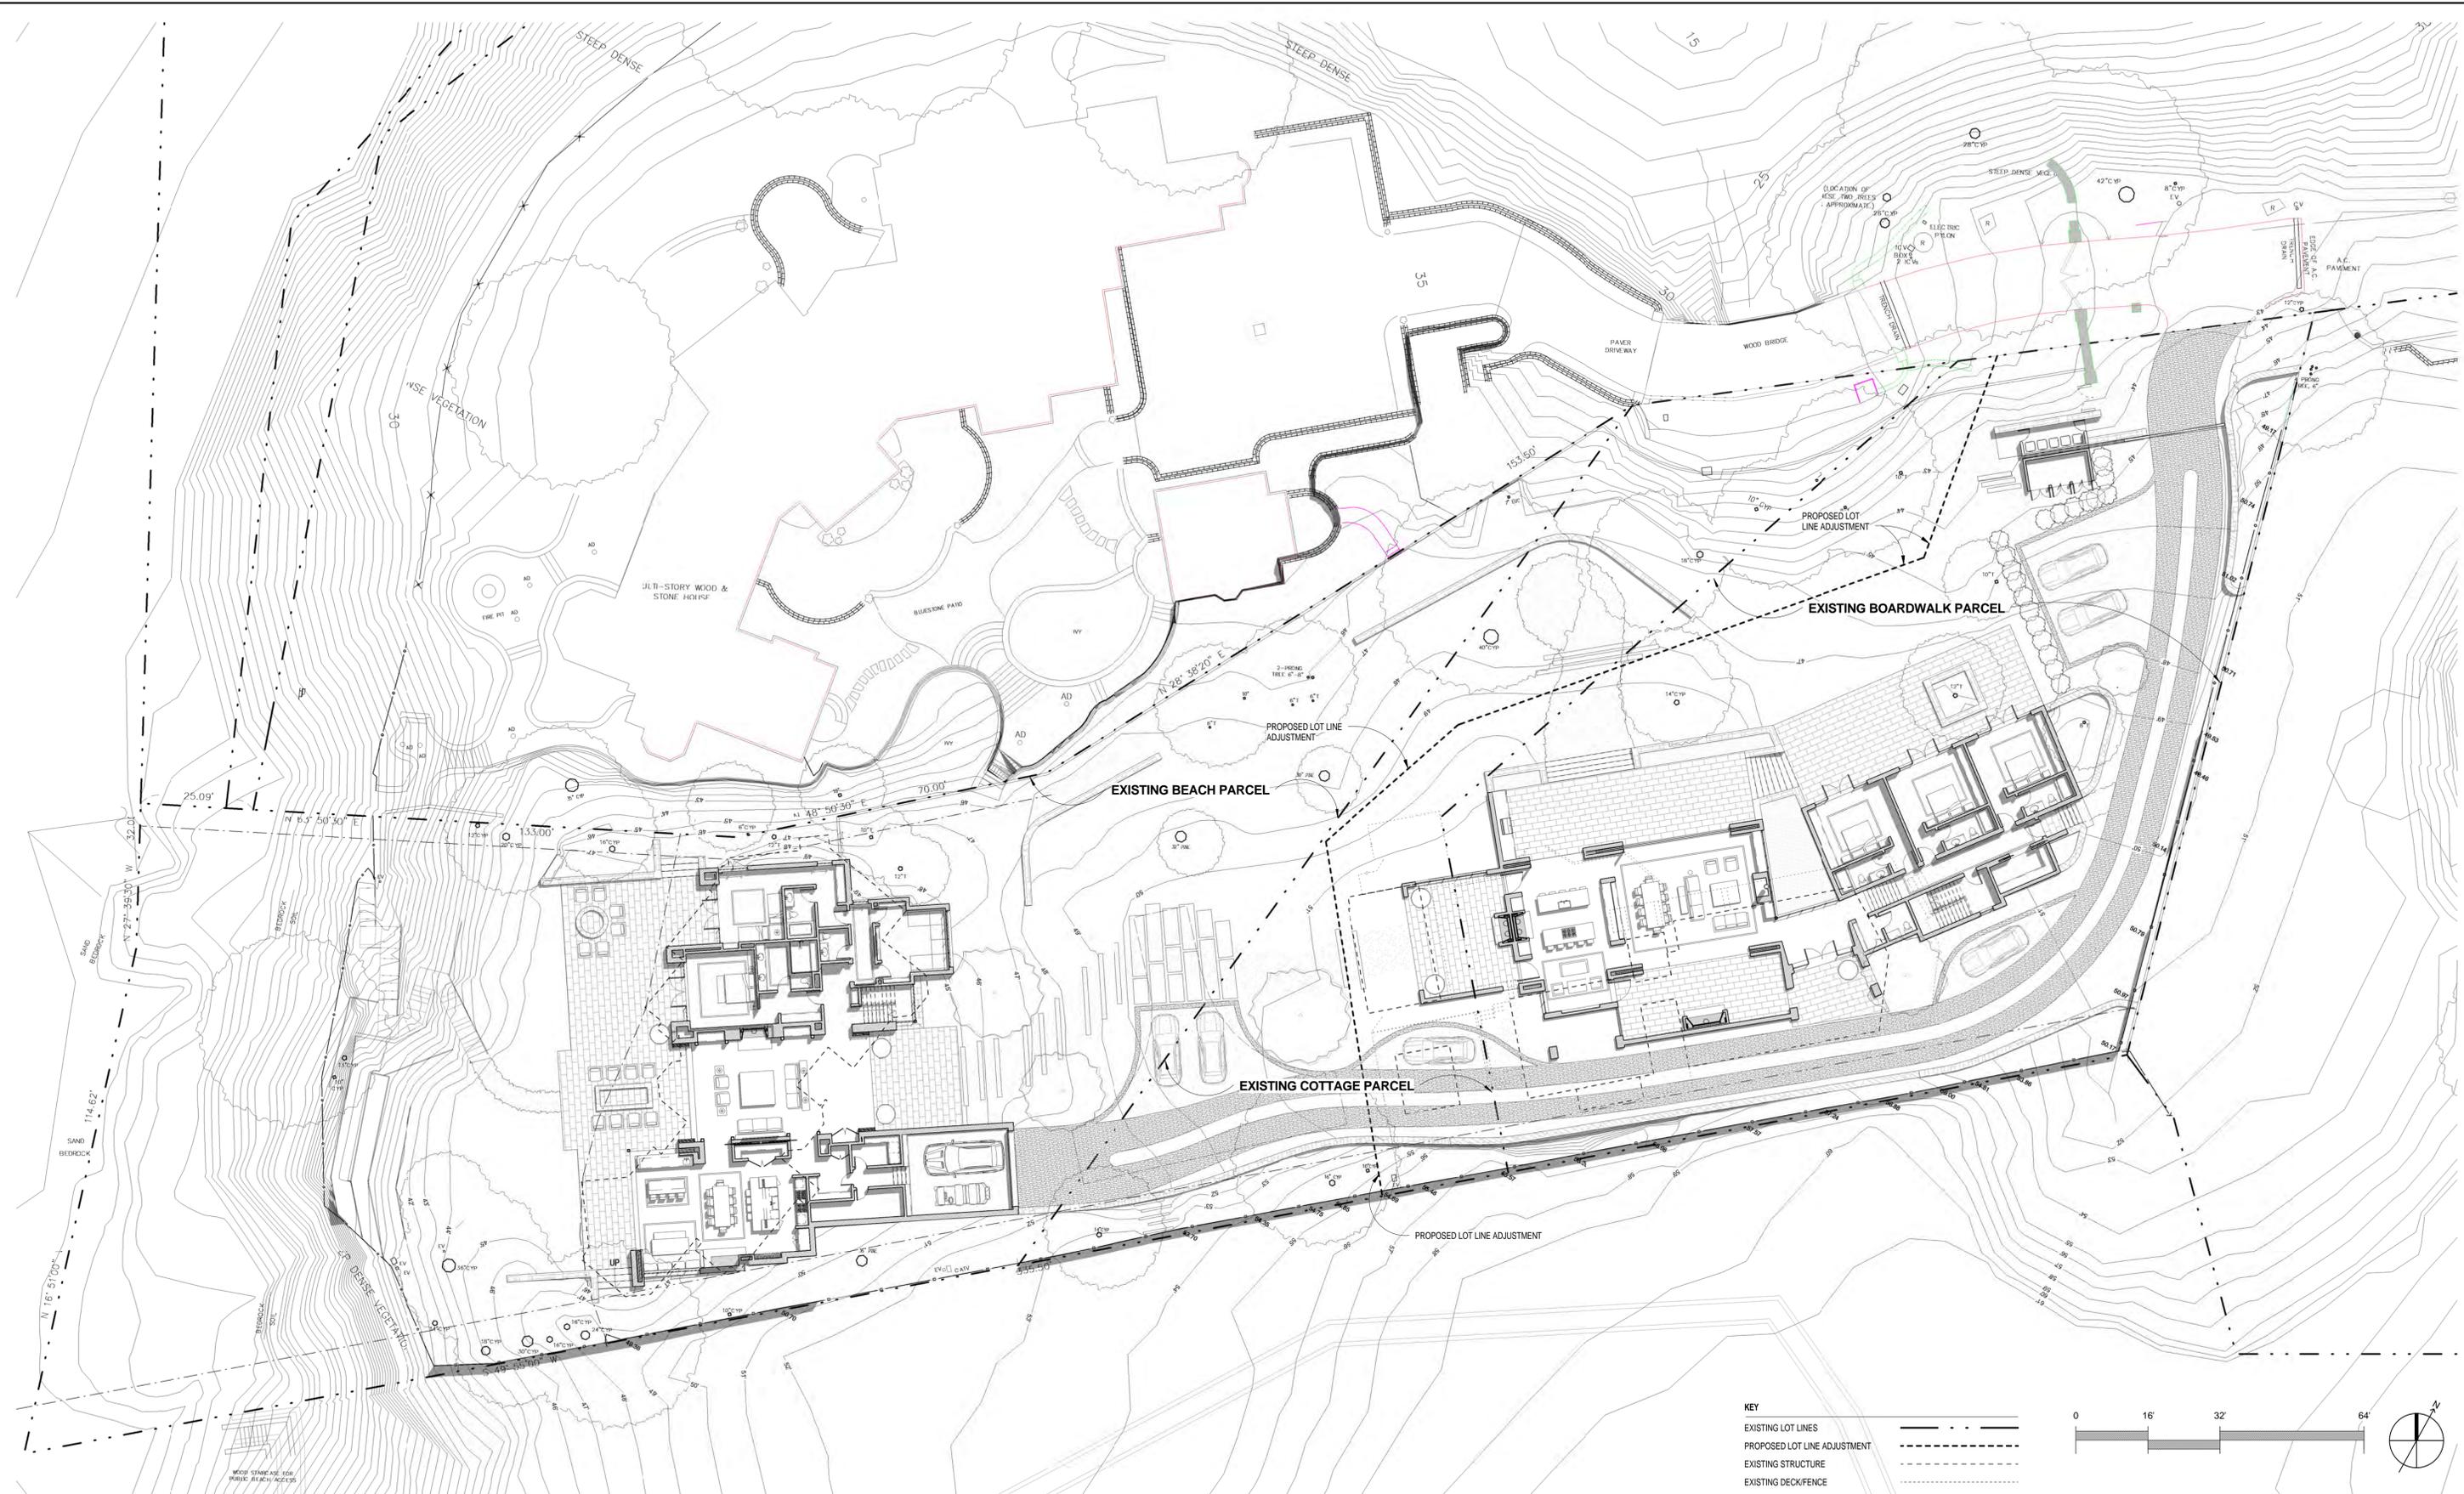
PROPOSED SITE PLAN, GROUND FLOOR

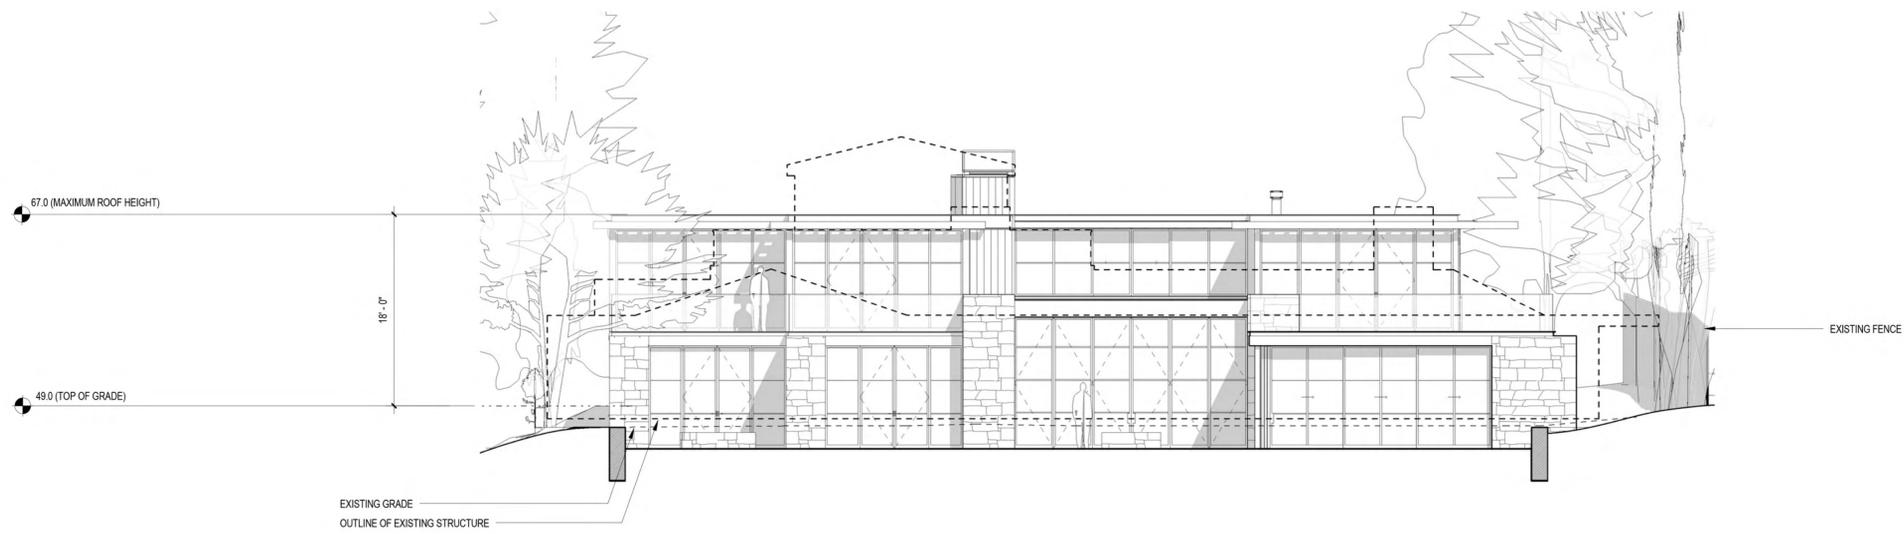
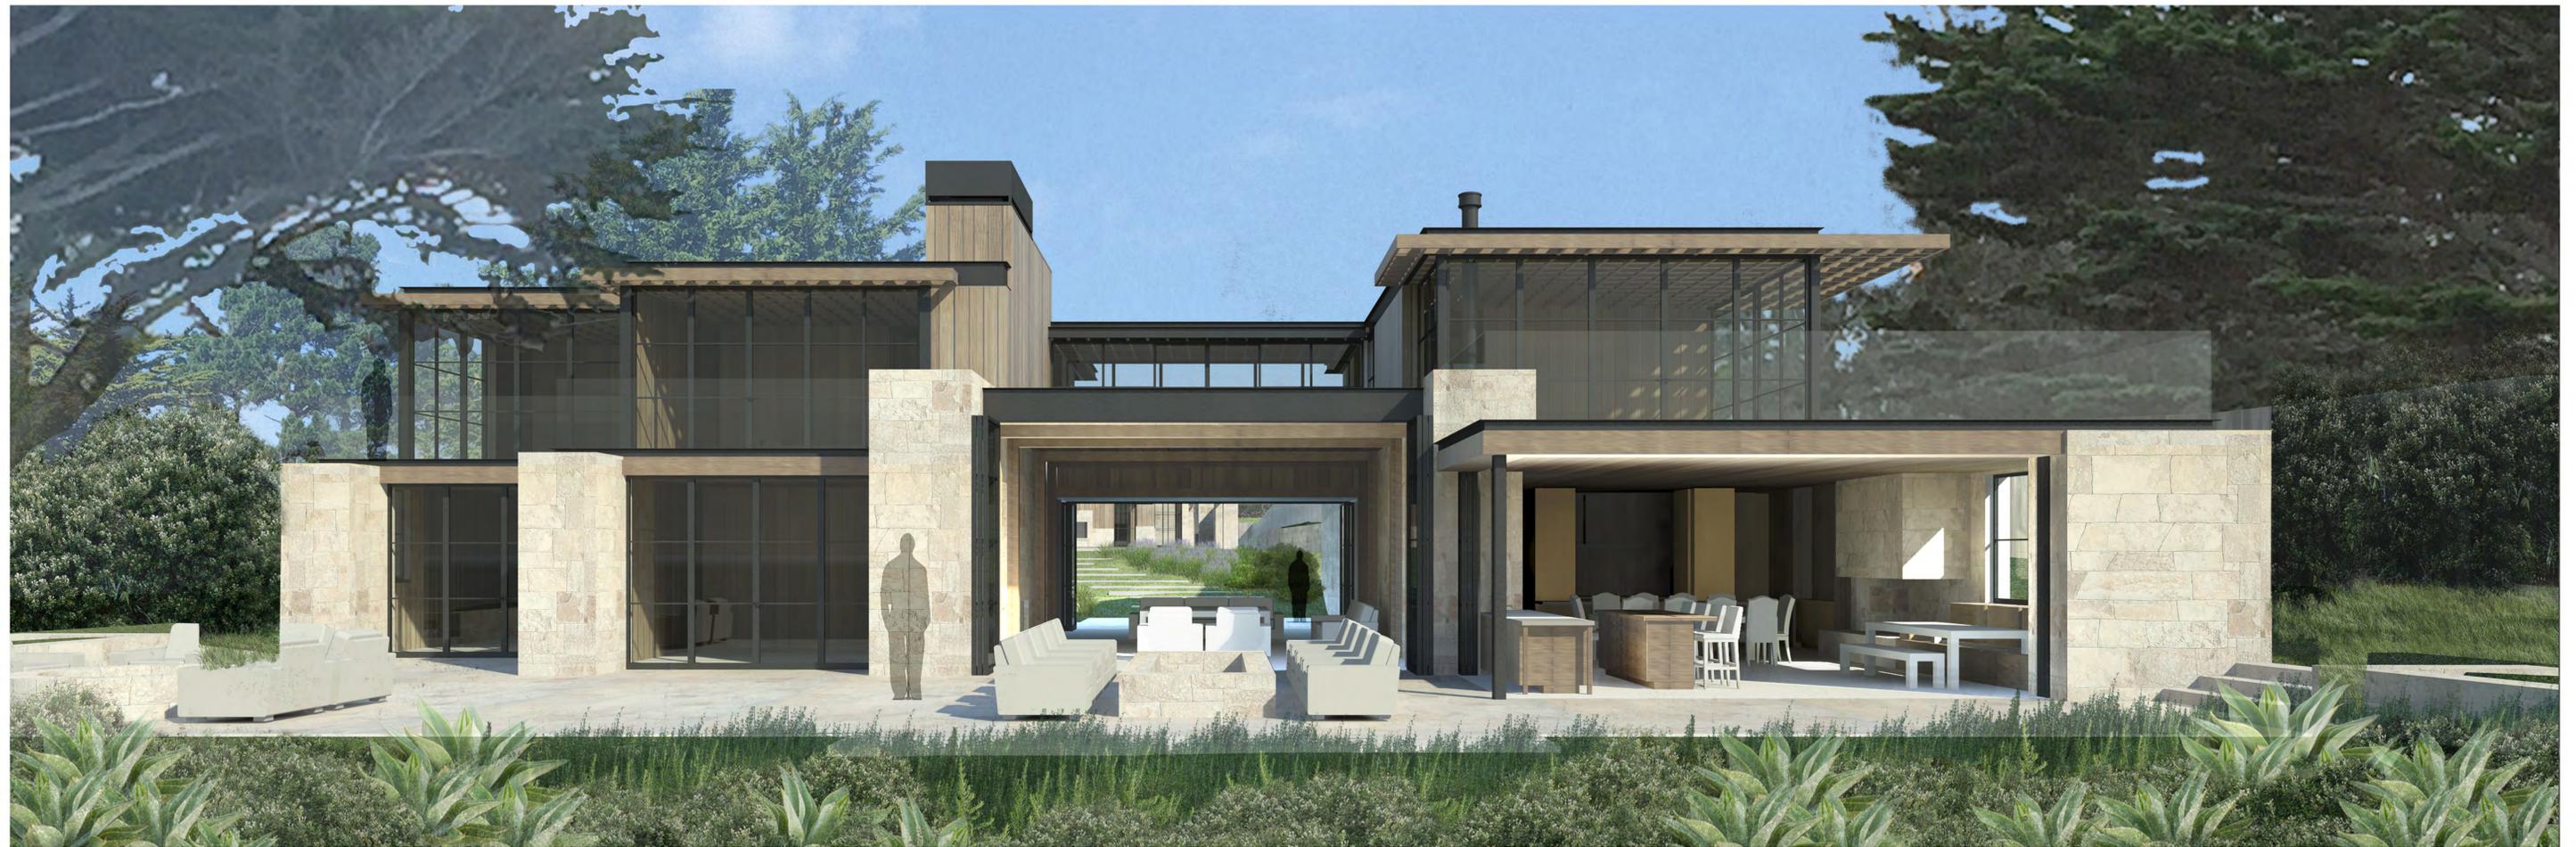
Figure 5

1
P3.01 BUILDING ELEVATION - WEST
SCALE : 1/8" = 1'-0"

Building Elevations

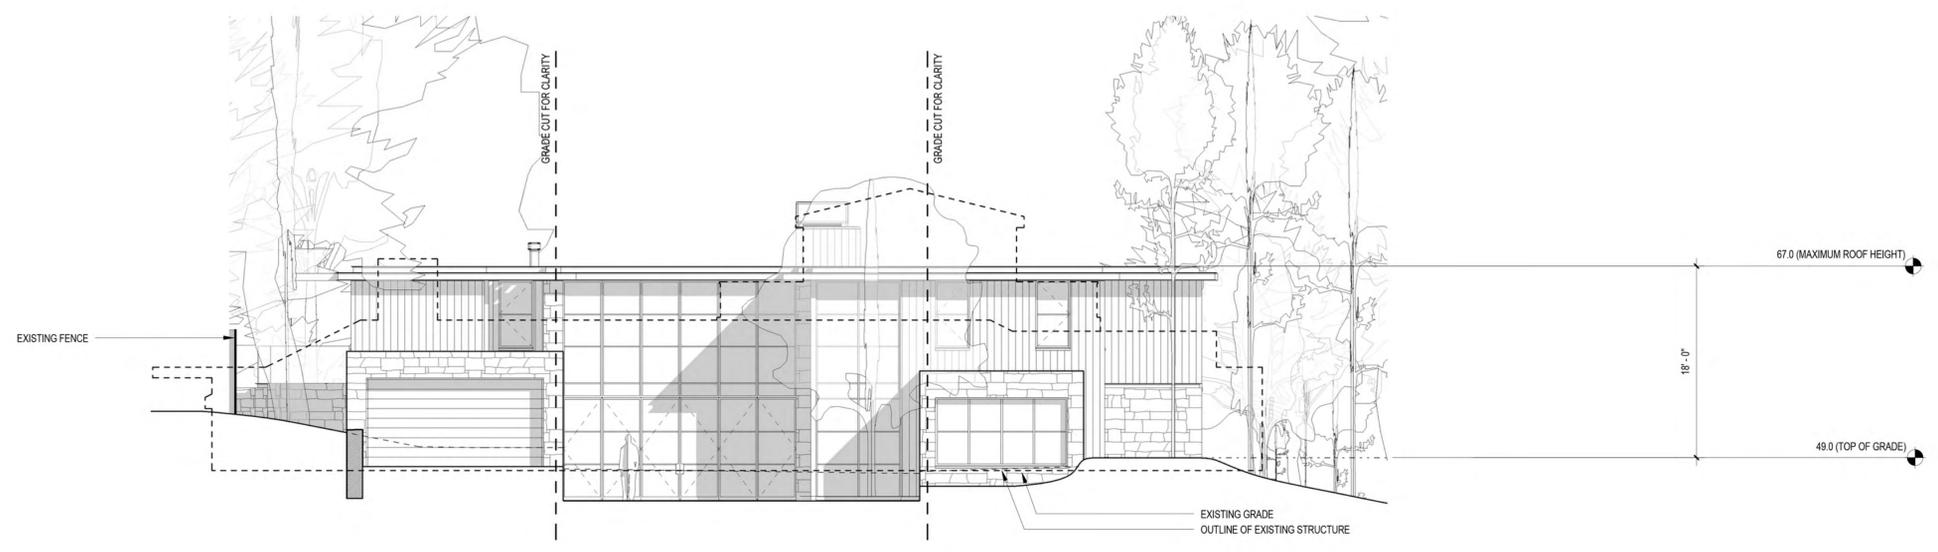
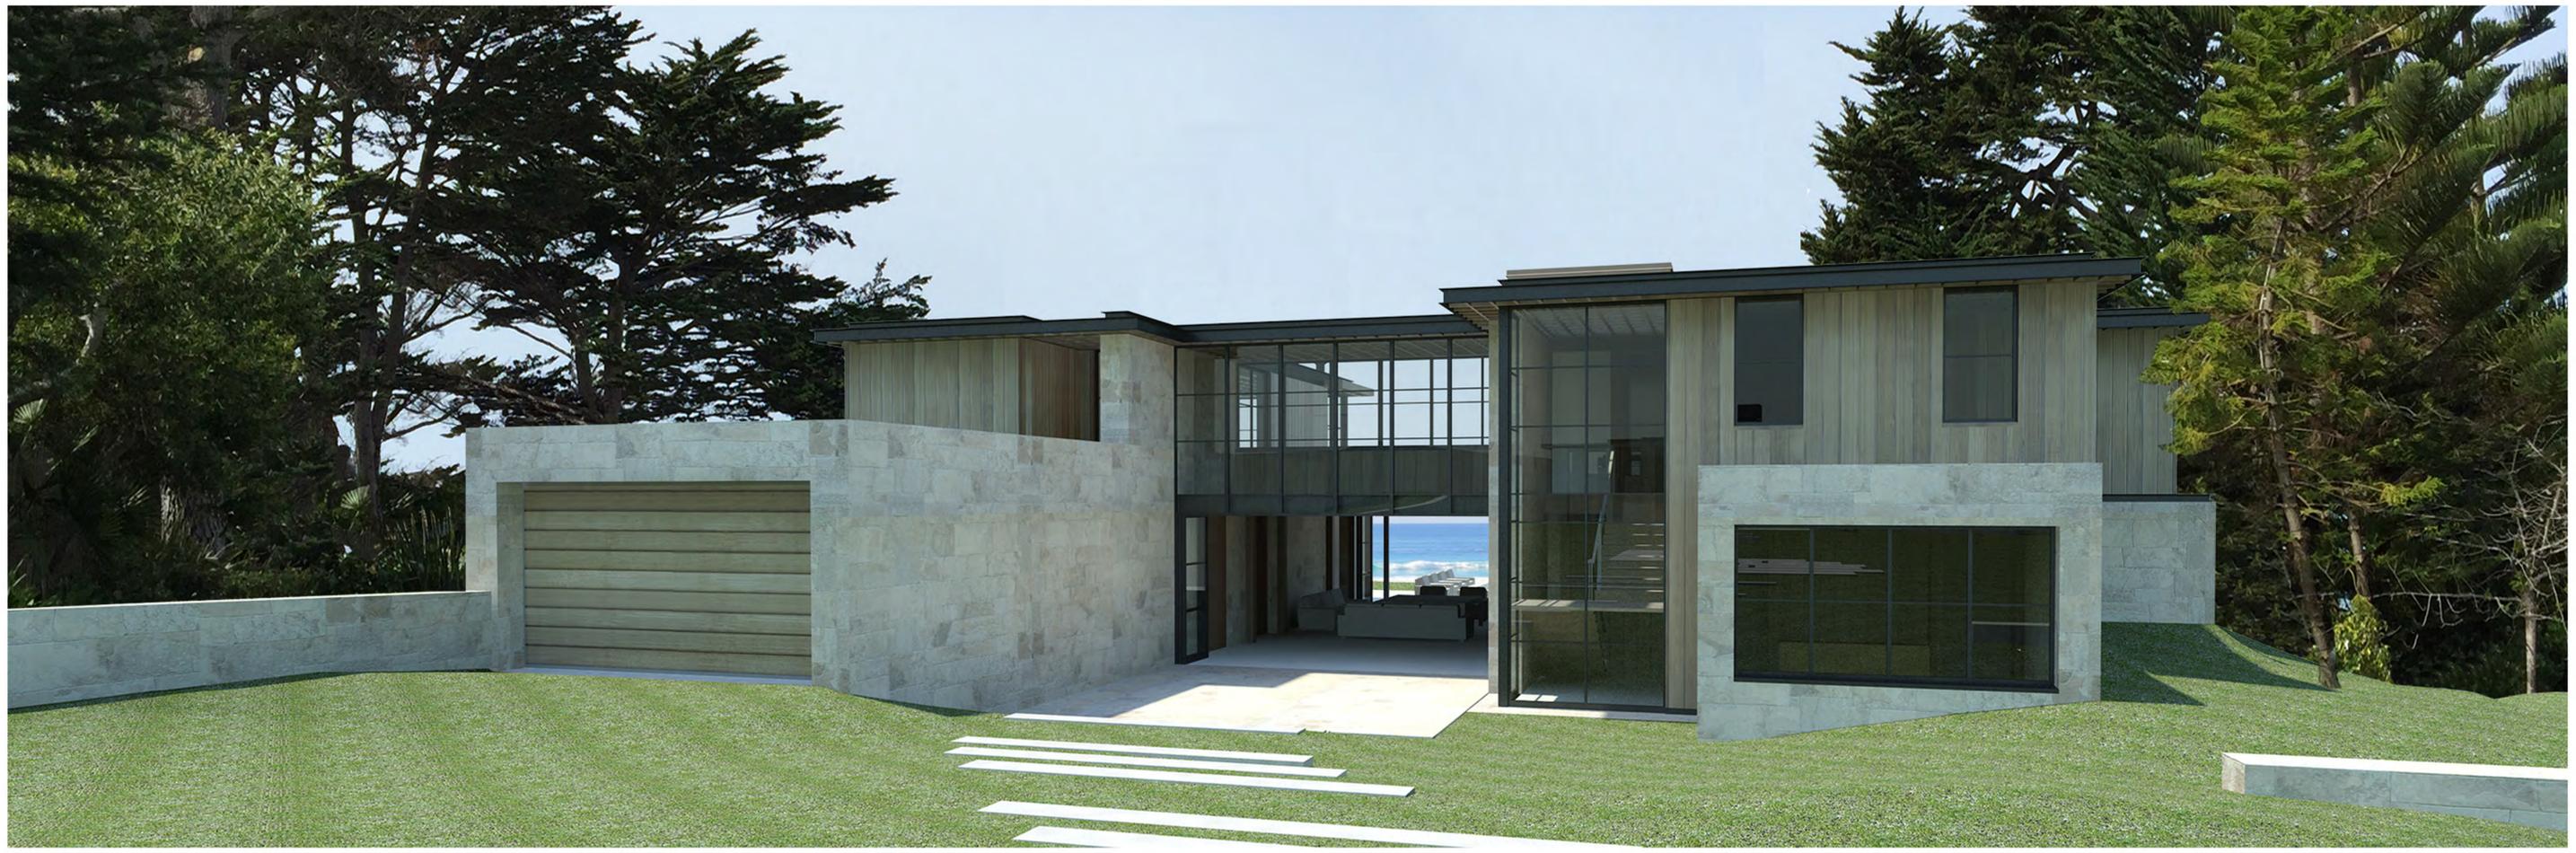
Figure 6

1 BUILDING ELEVATION - EAST
SCALE : 1/8" = 1'-0"

Building Elevations

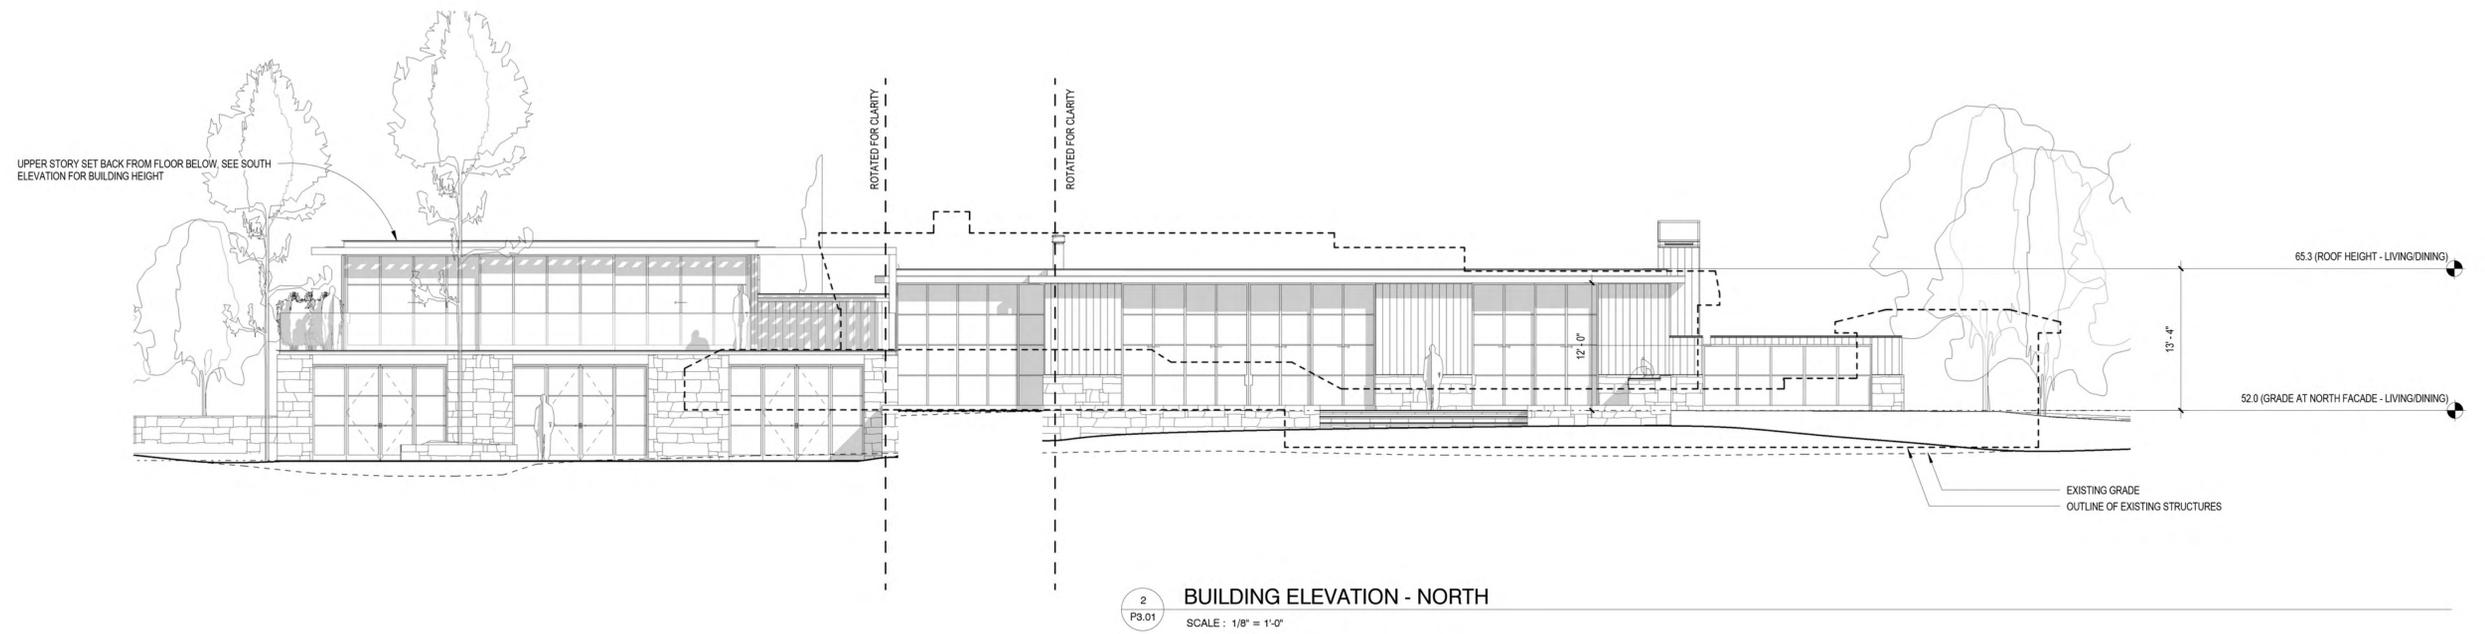
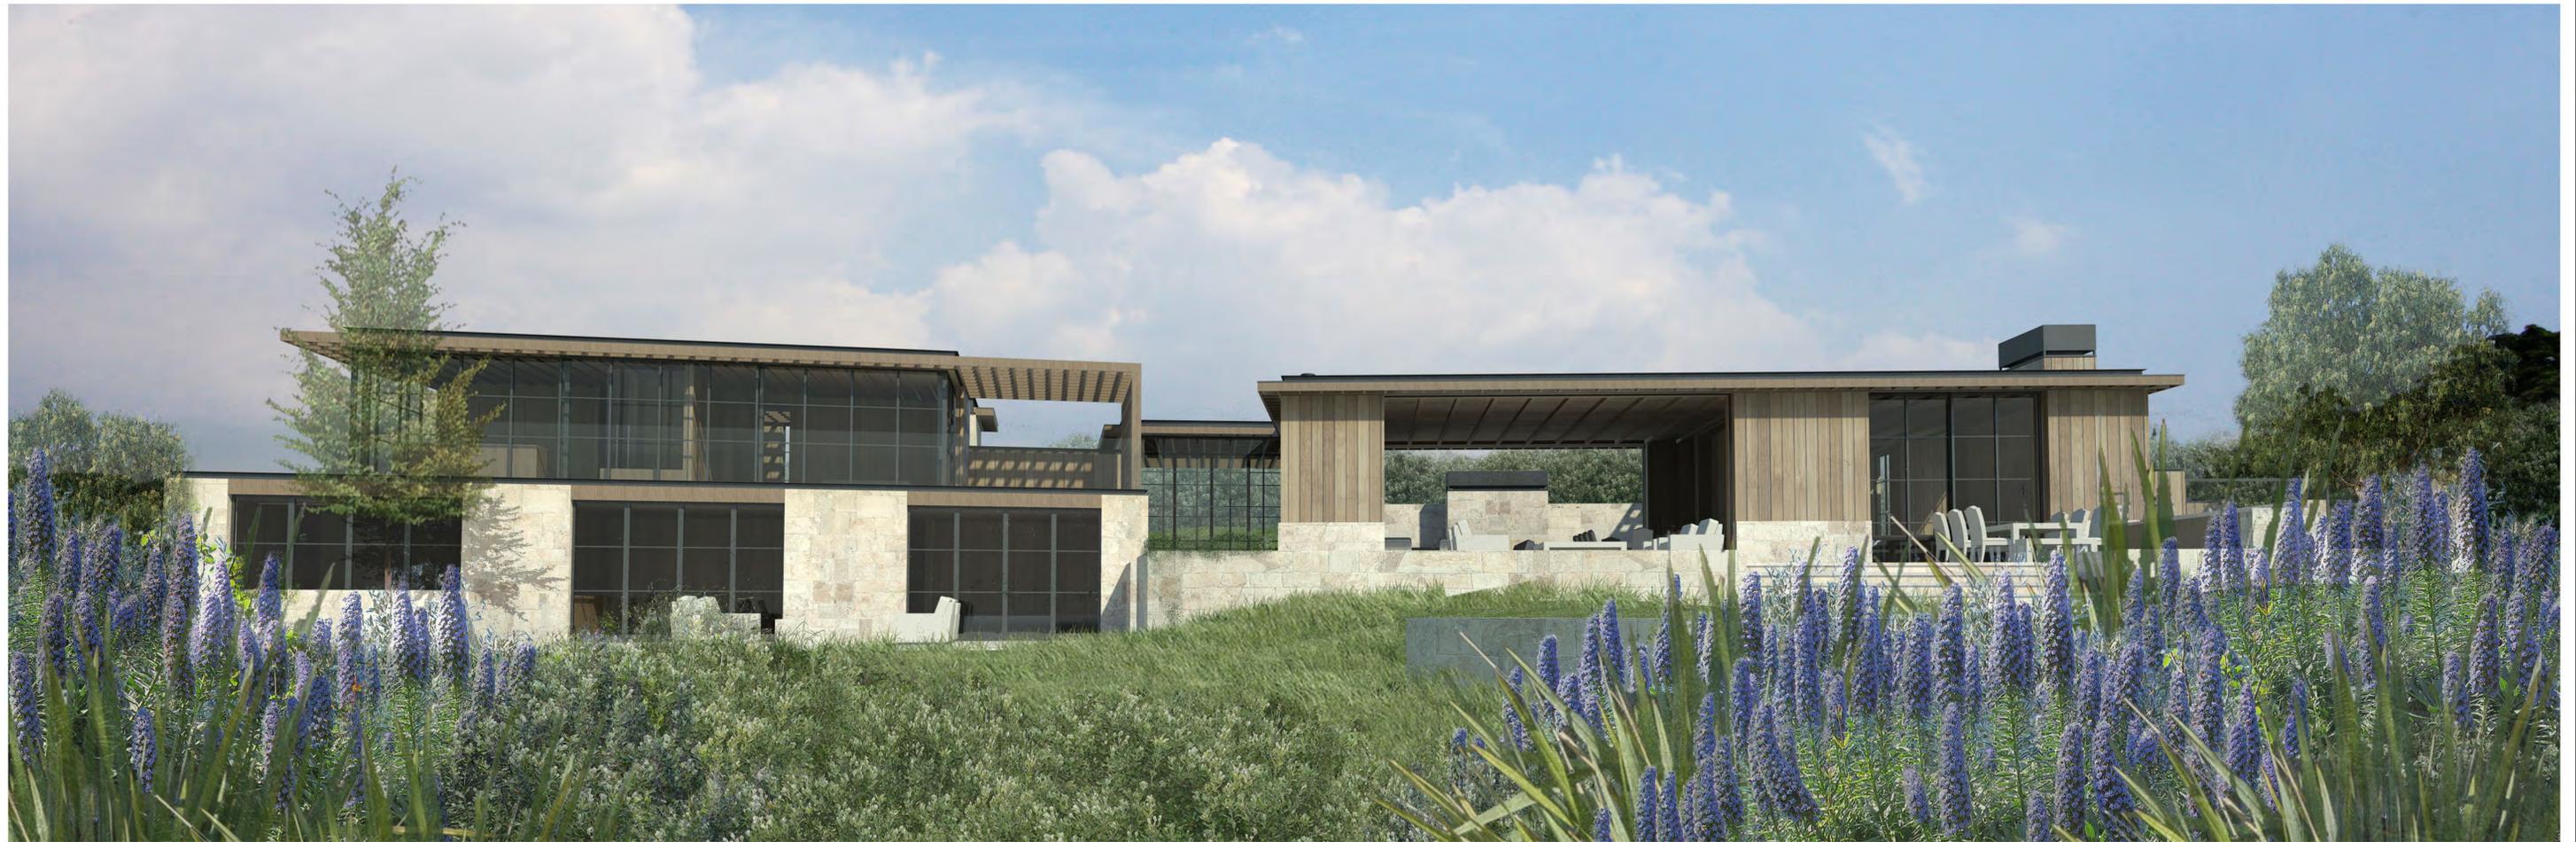
Figure 7

Building Elevations

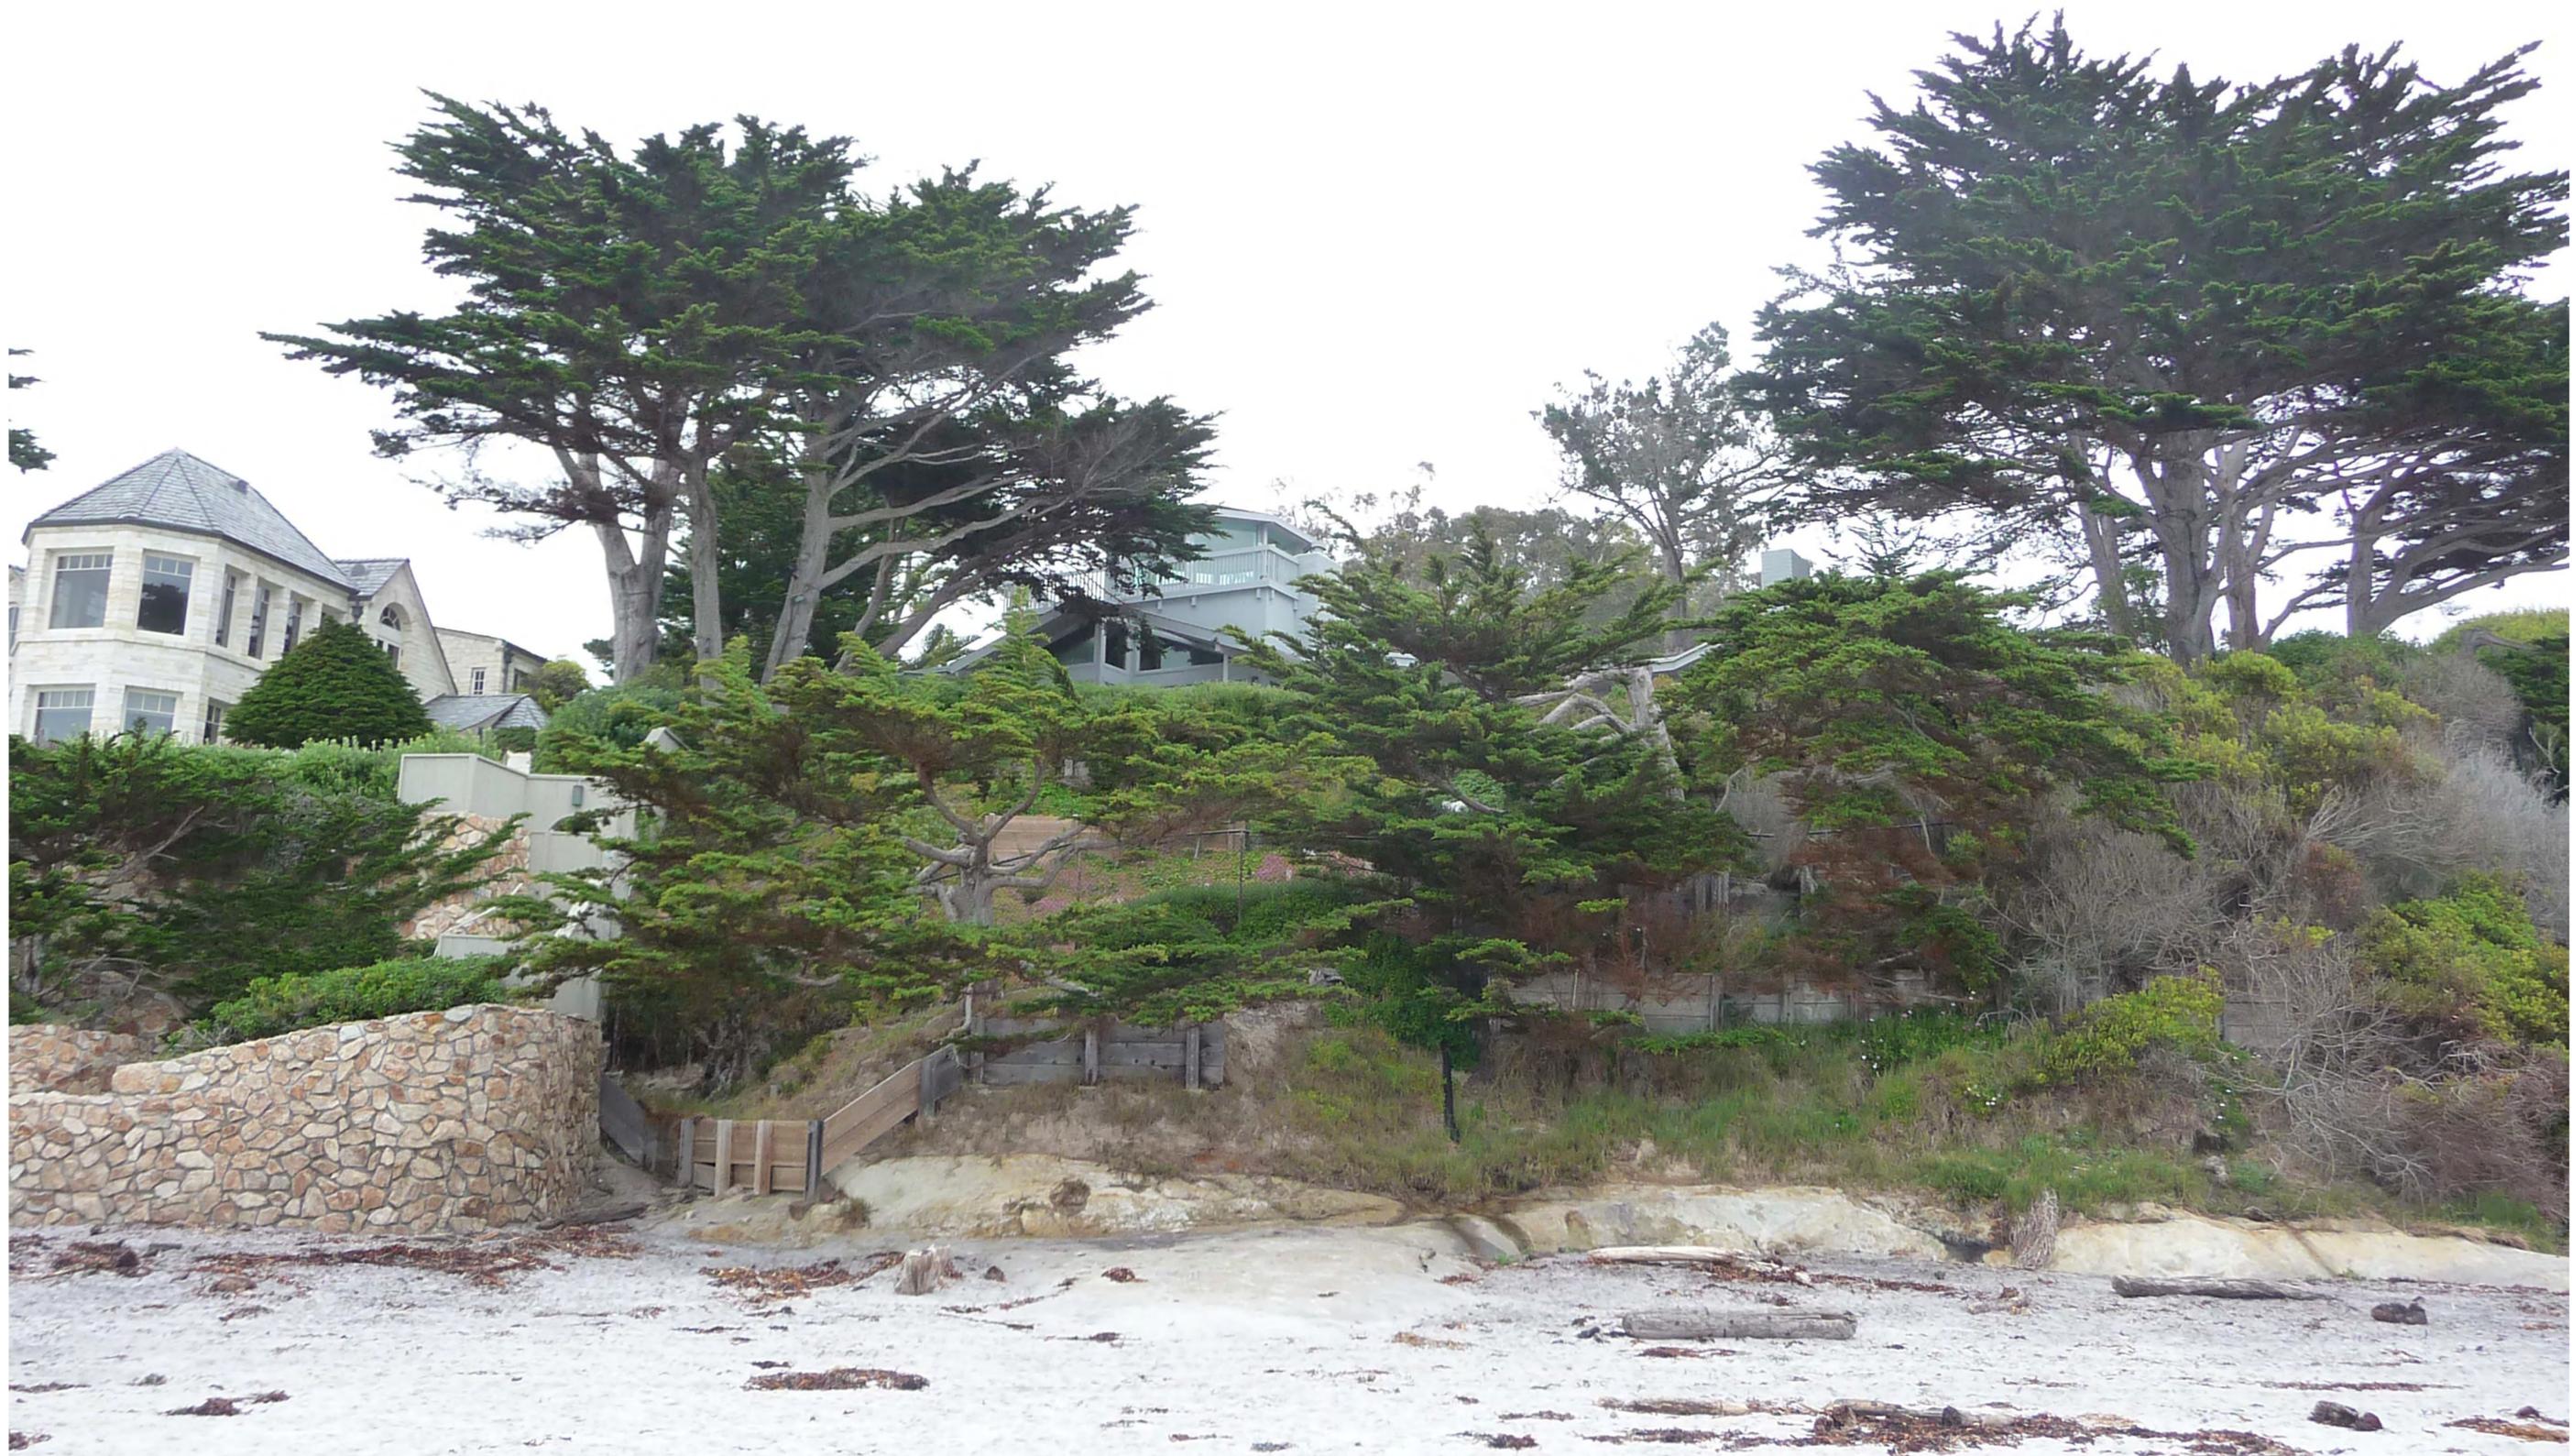
Figure 11

View From Beach at Bluff - Existing

Discussion: 3D visualizations were prepared by the project architect and are included herein. These visualizations show that the project’s visual impact, as seen from the public view points at Carmel Beach and North Carmel Dunes, will be less than that of existing conditions. The project would not have an adverse impact on any existing views from the property and the design of the building would be consistent with the surrounding residences and the City of Carmel’s Design Guidelines for Single Family Residences.

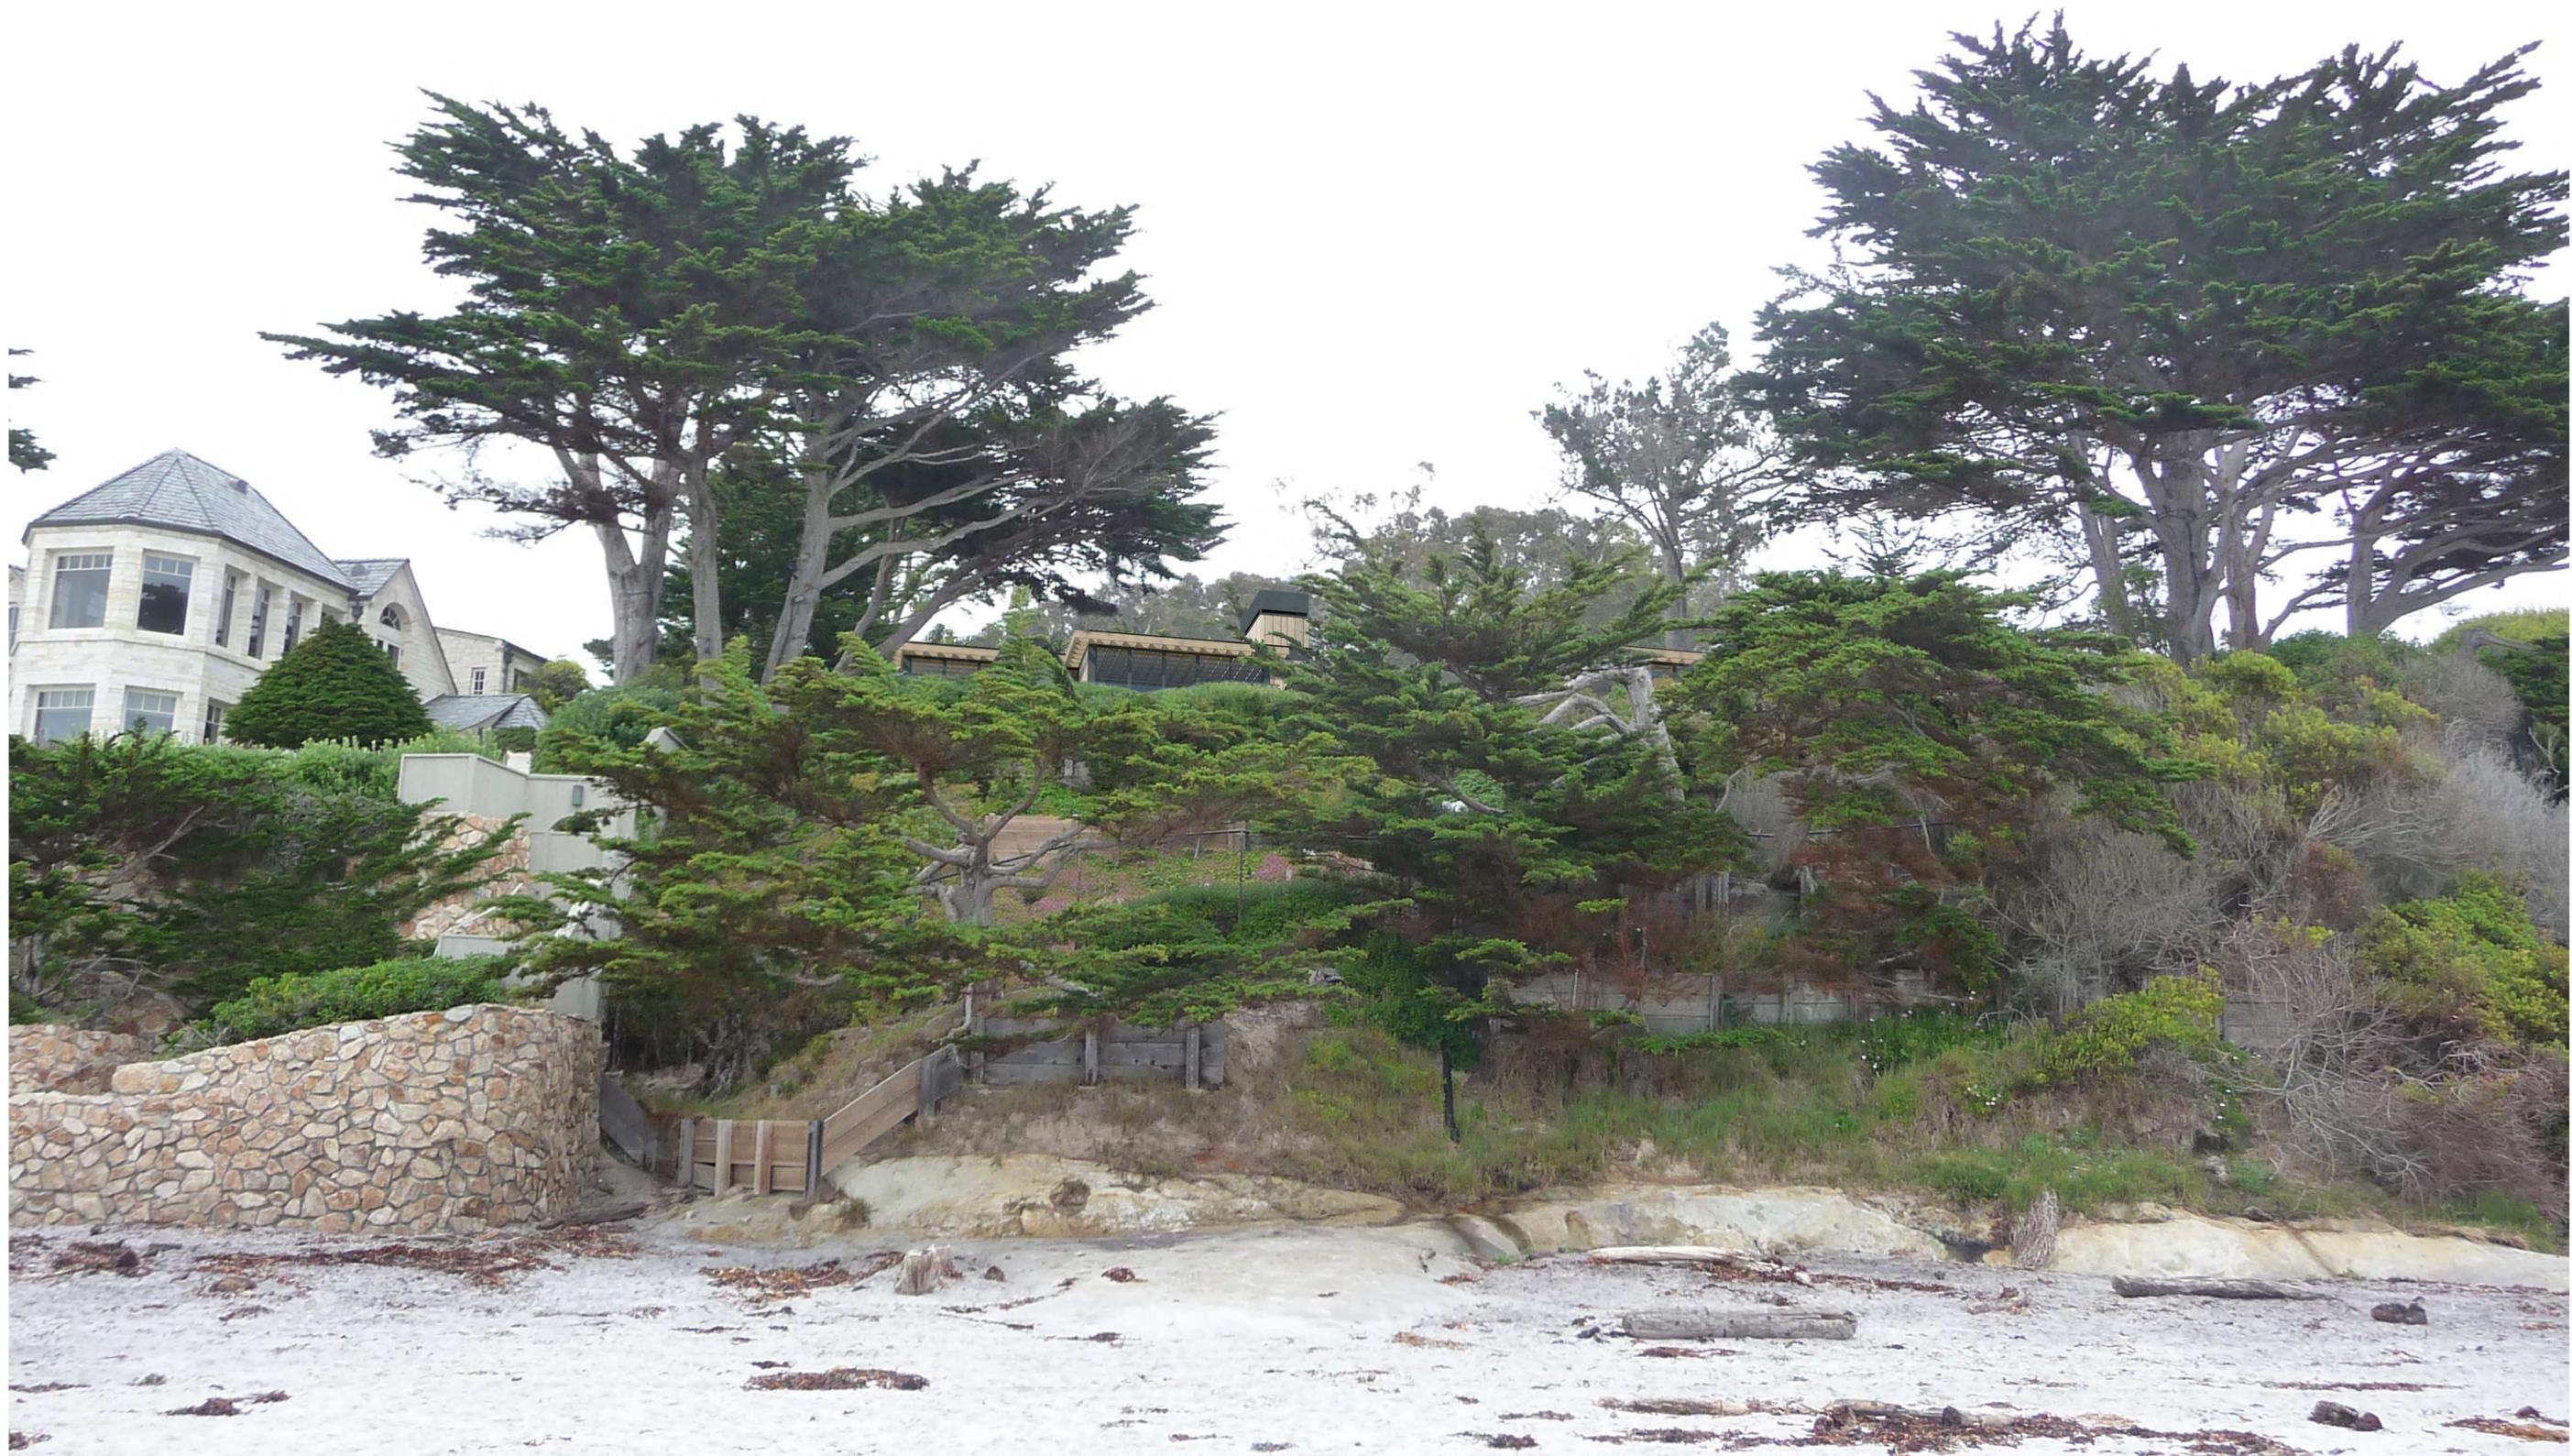
Figure 12

View From Beach at Bluff - Proposed
