CARMEL WAY TRUST RESIDENTIAL DEVELOPMENT INITIAL STUDY

Project Title:	Carmel Way Trust Residential Development
Project Location:	7 and 9 Carmel Way, Carmel, Monterey County
Date Prepared:	September 15, 2016
Lead Agency:	City of Carmel P.O. Box G Carmel, California 93921
Project Sponsor:	Jeff and Wendy Hines
Assessor's Parcel Number(s):	010-321-020 and 010-321-021
Acreage of Property:	Three parcels: 1.48 acres combined (0.53 ac. 0.22 ac. and 0.73)
Zoning District:	R1 Single-Family Residential
General Plan Designation:	Single-Family Residential
Coastal Land Use Plan:	Single-Family Residential
Contact Person:	Matthew Sundt, City Planner (831-620-2023)

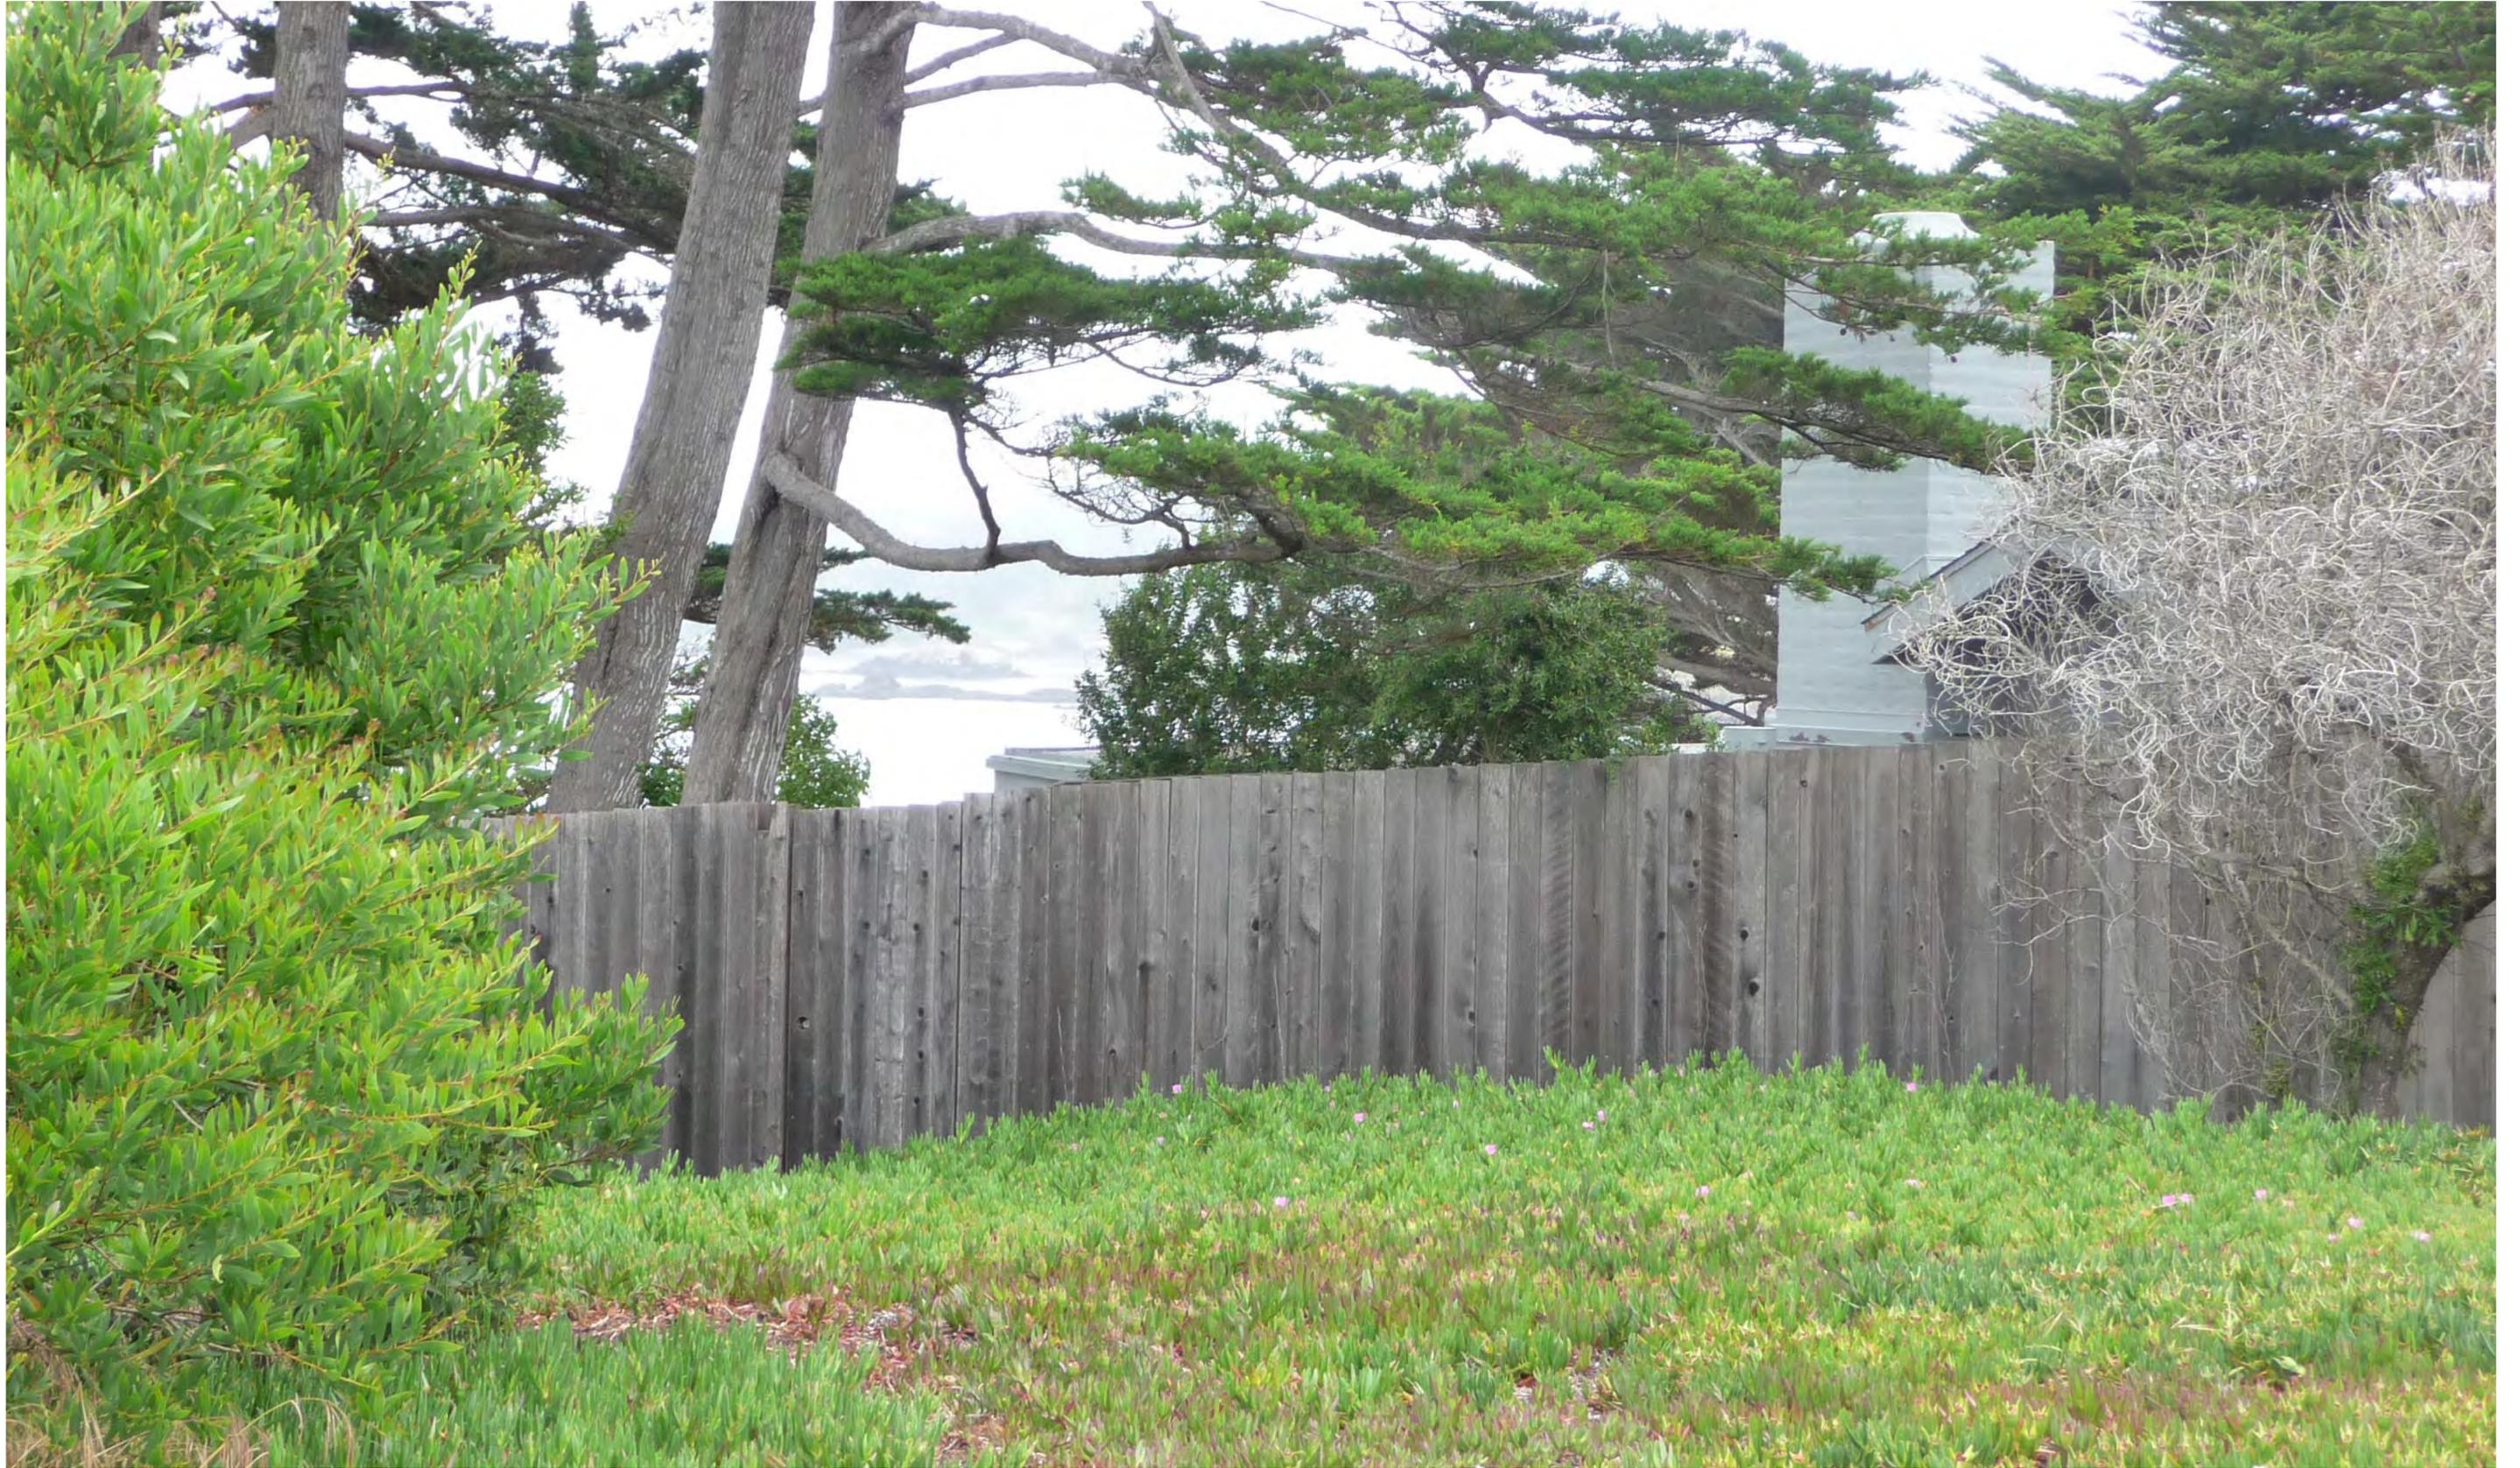
Figure 17

View from Boardwalk - Existing

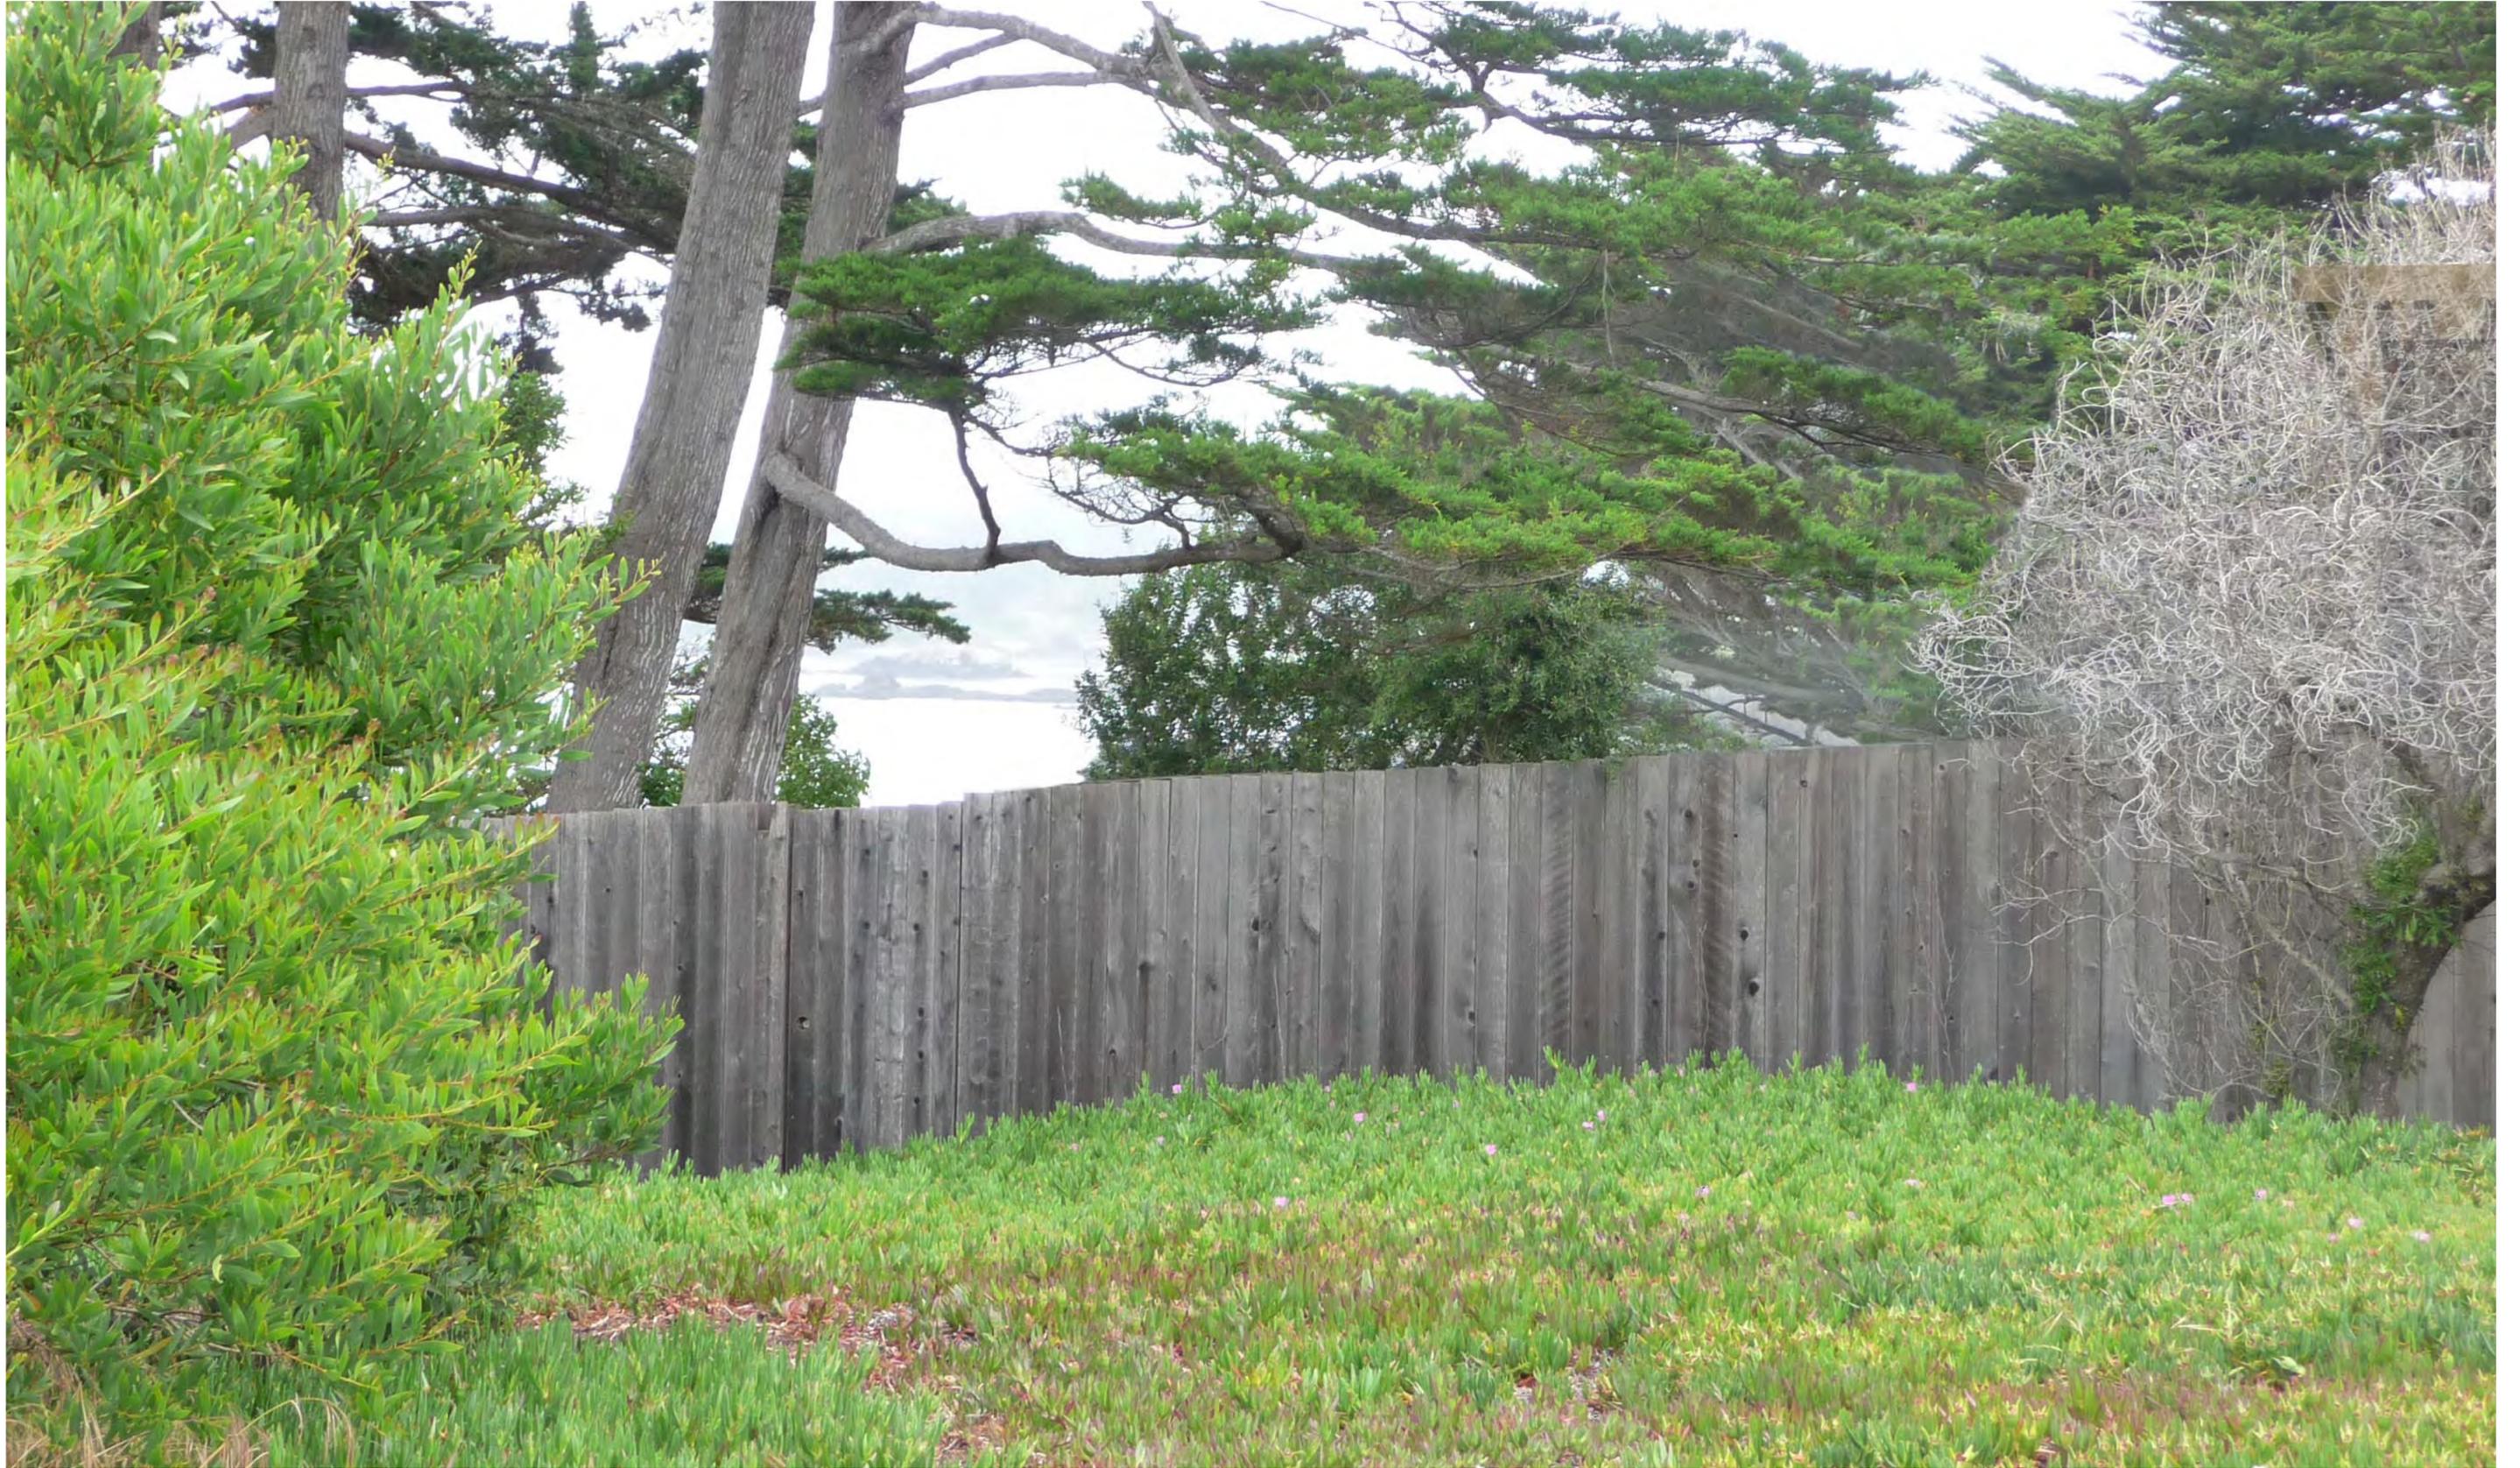
Figure 18

View from Boardwalk - Proposed

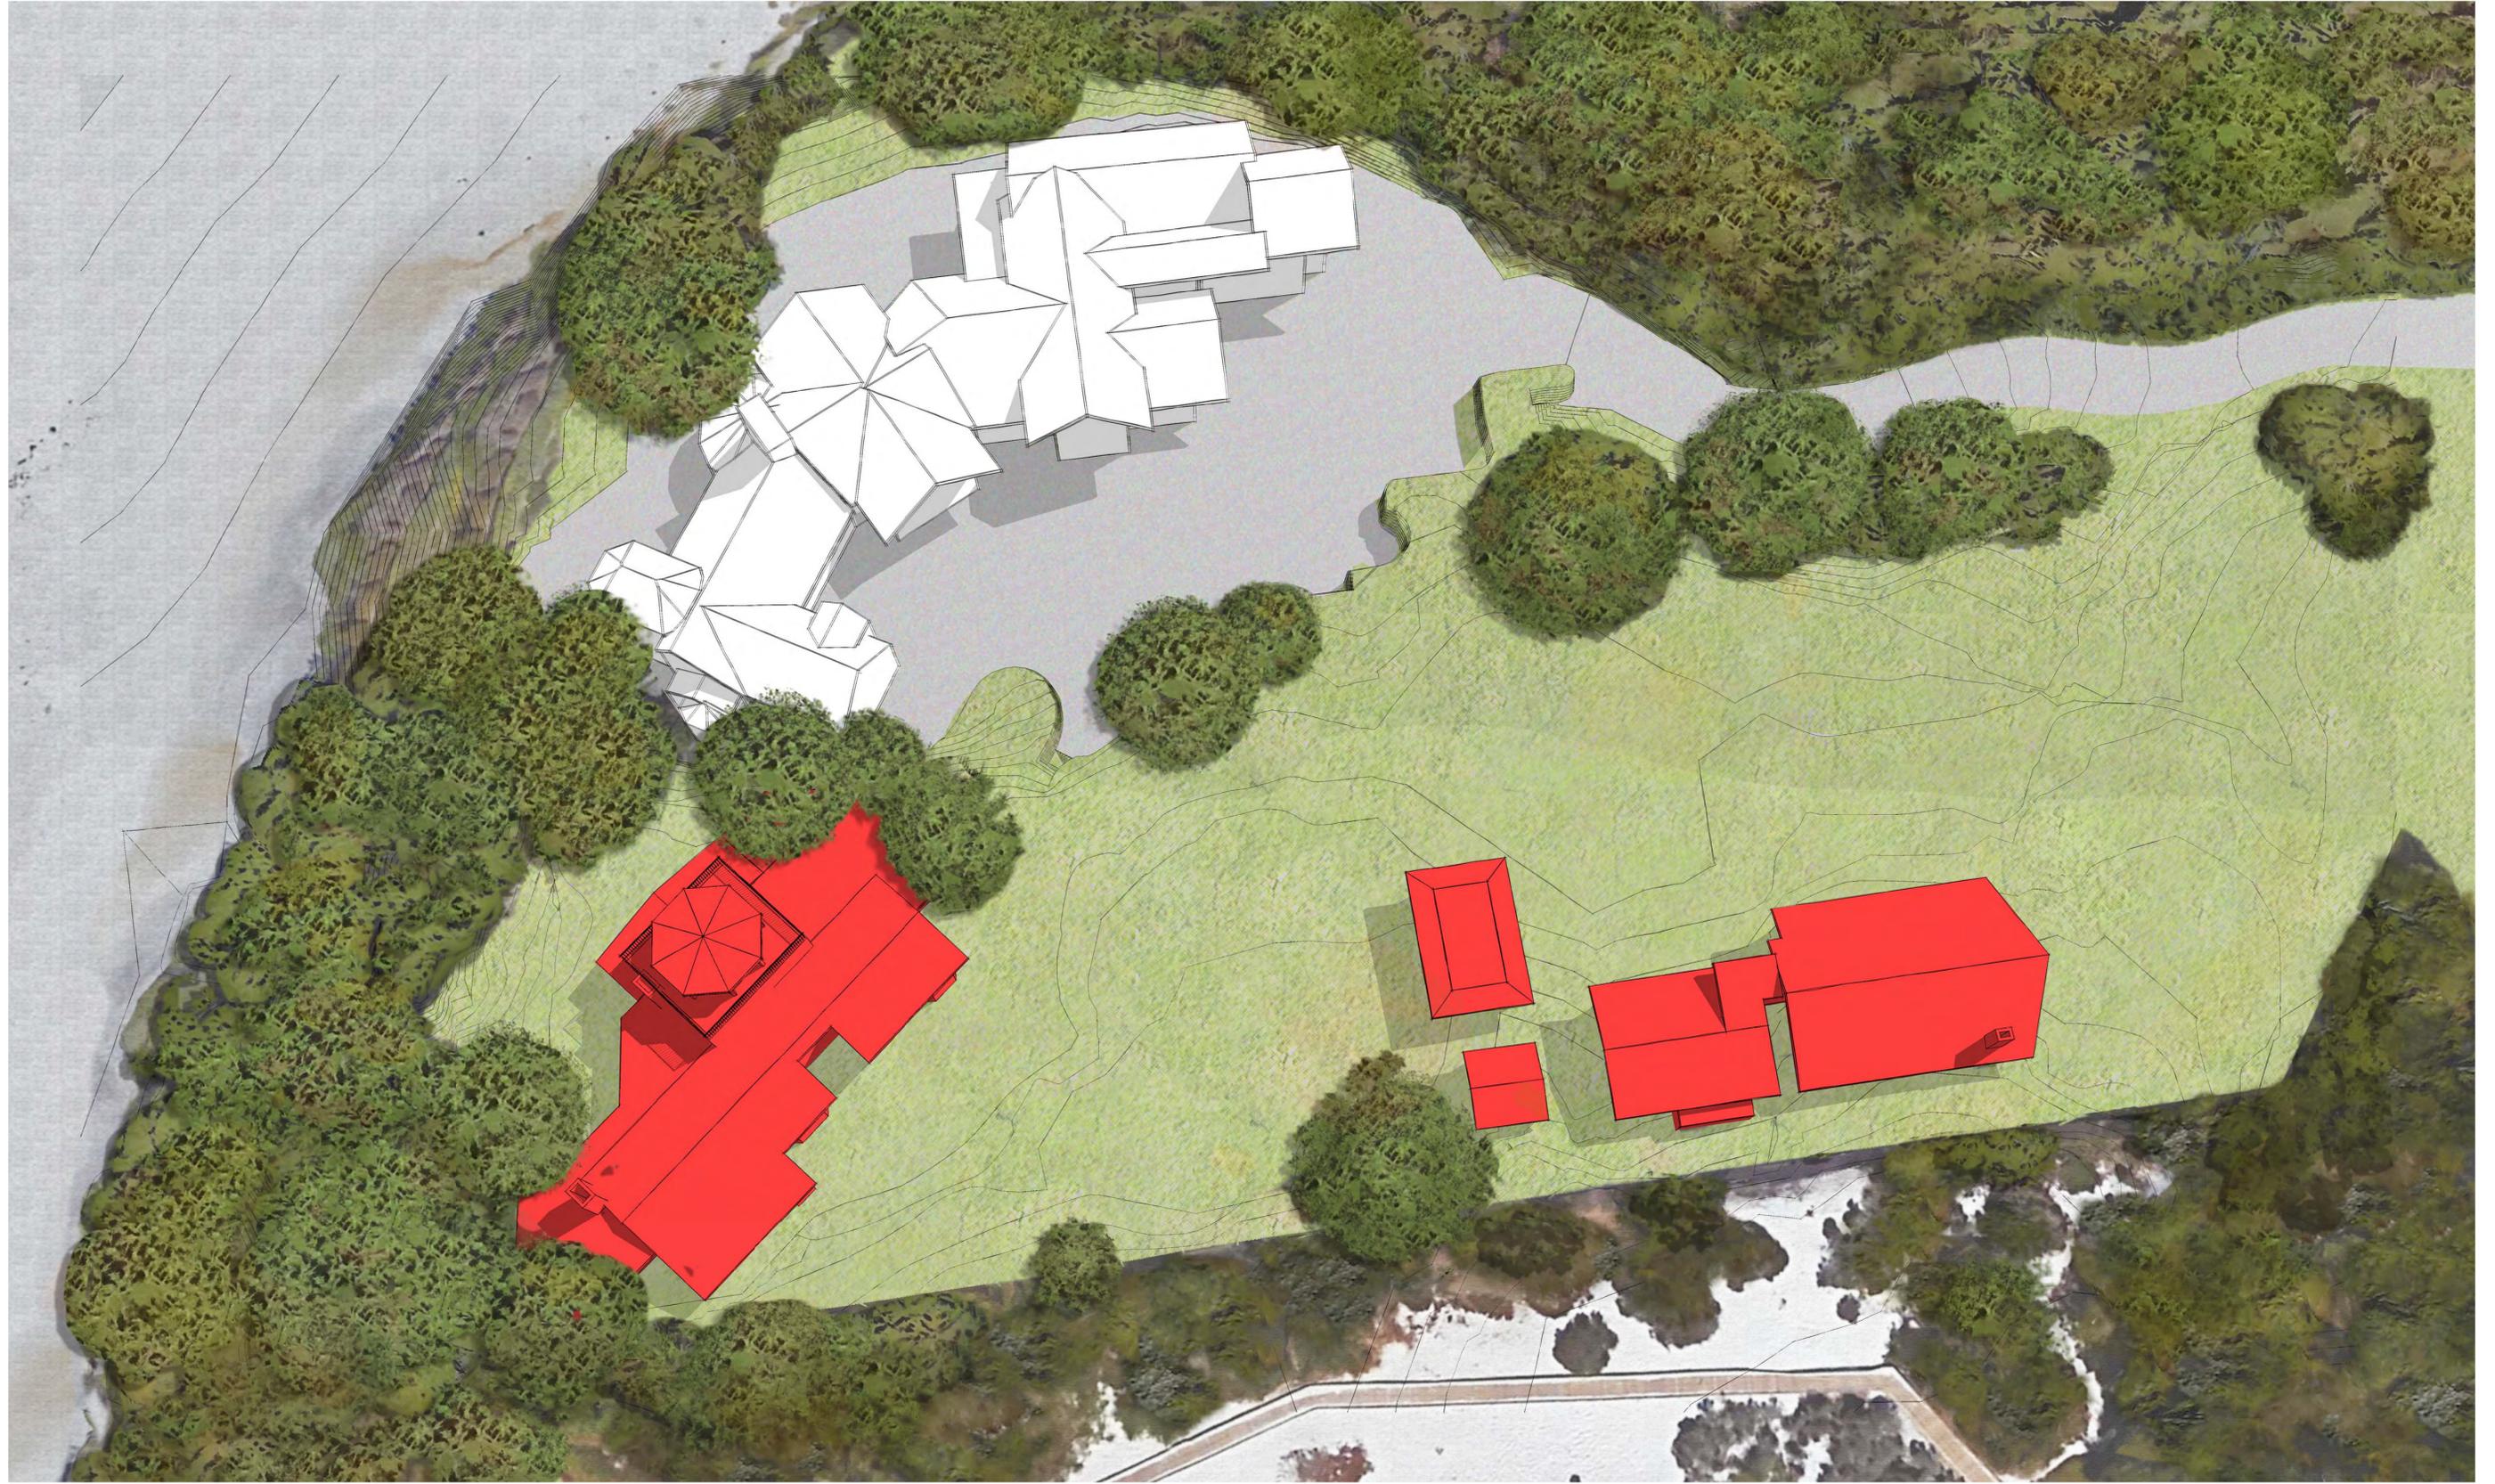
Site - Bird's Eye - Existing Structures

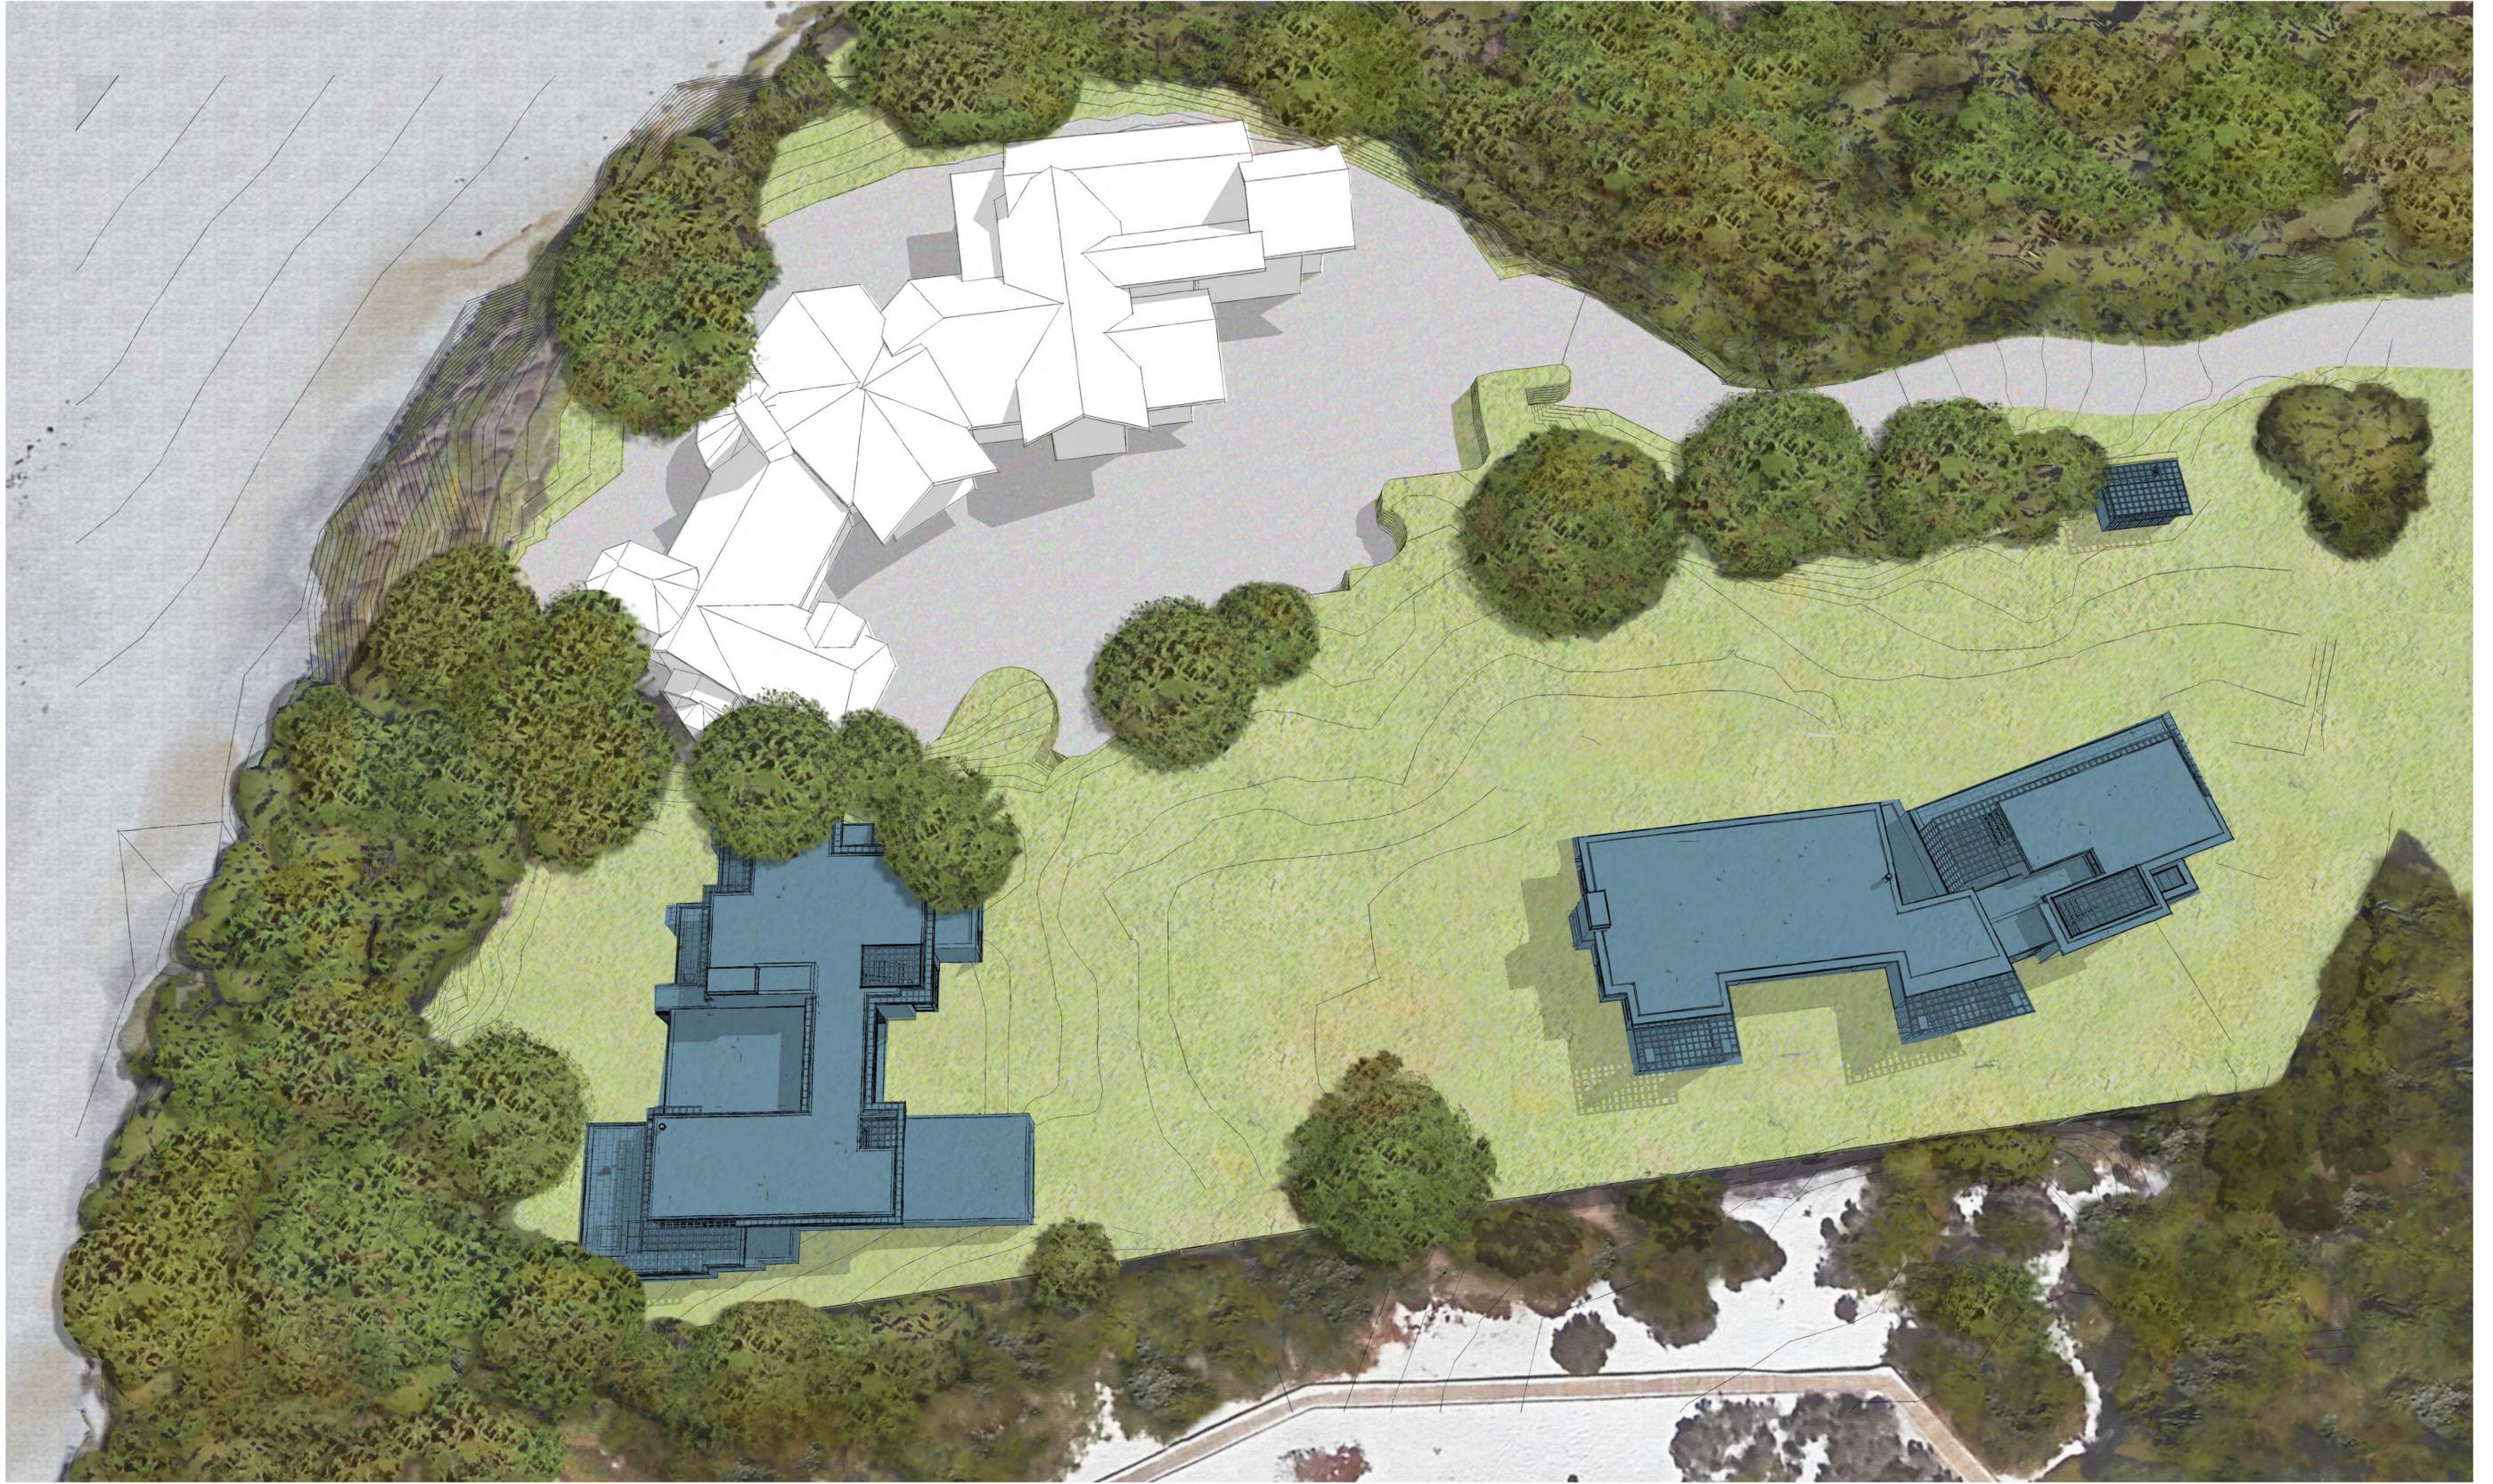
Site - Bird's Eye - Proposed Structures

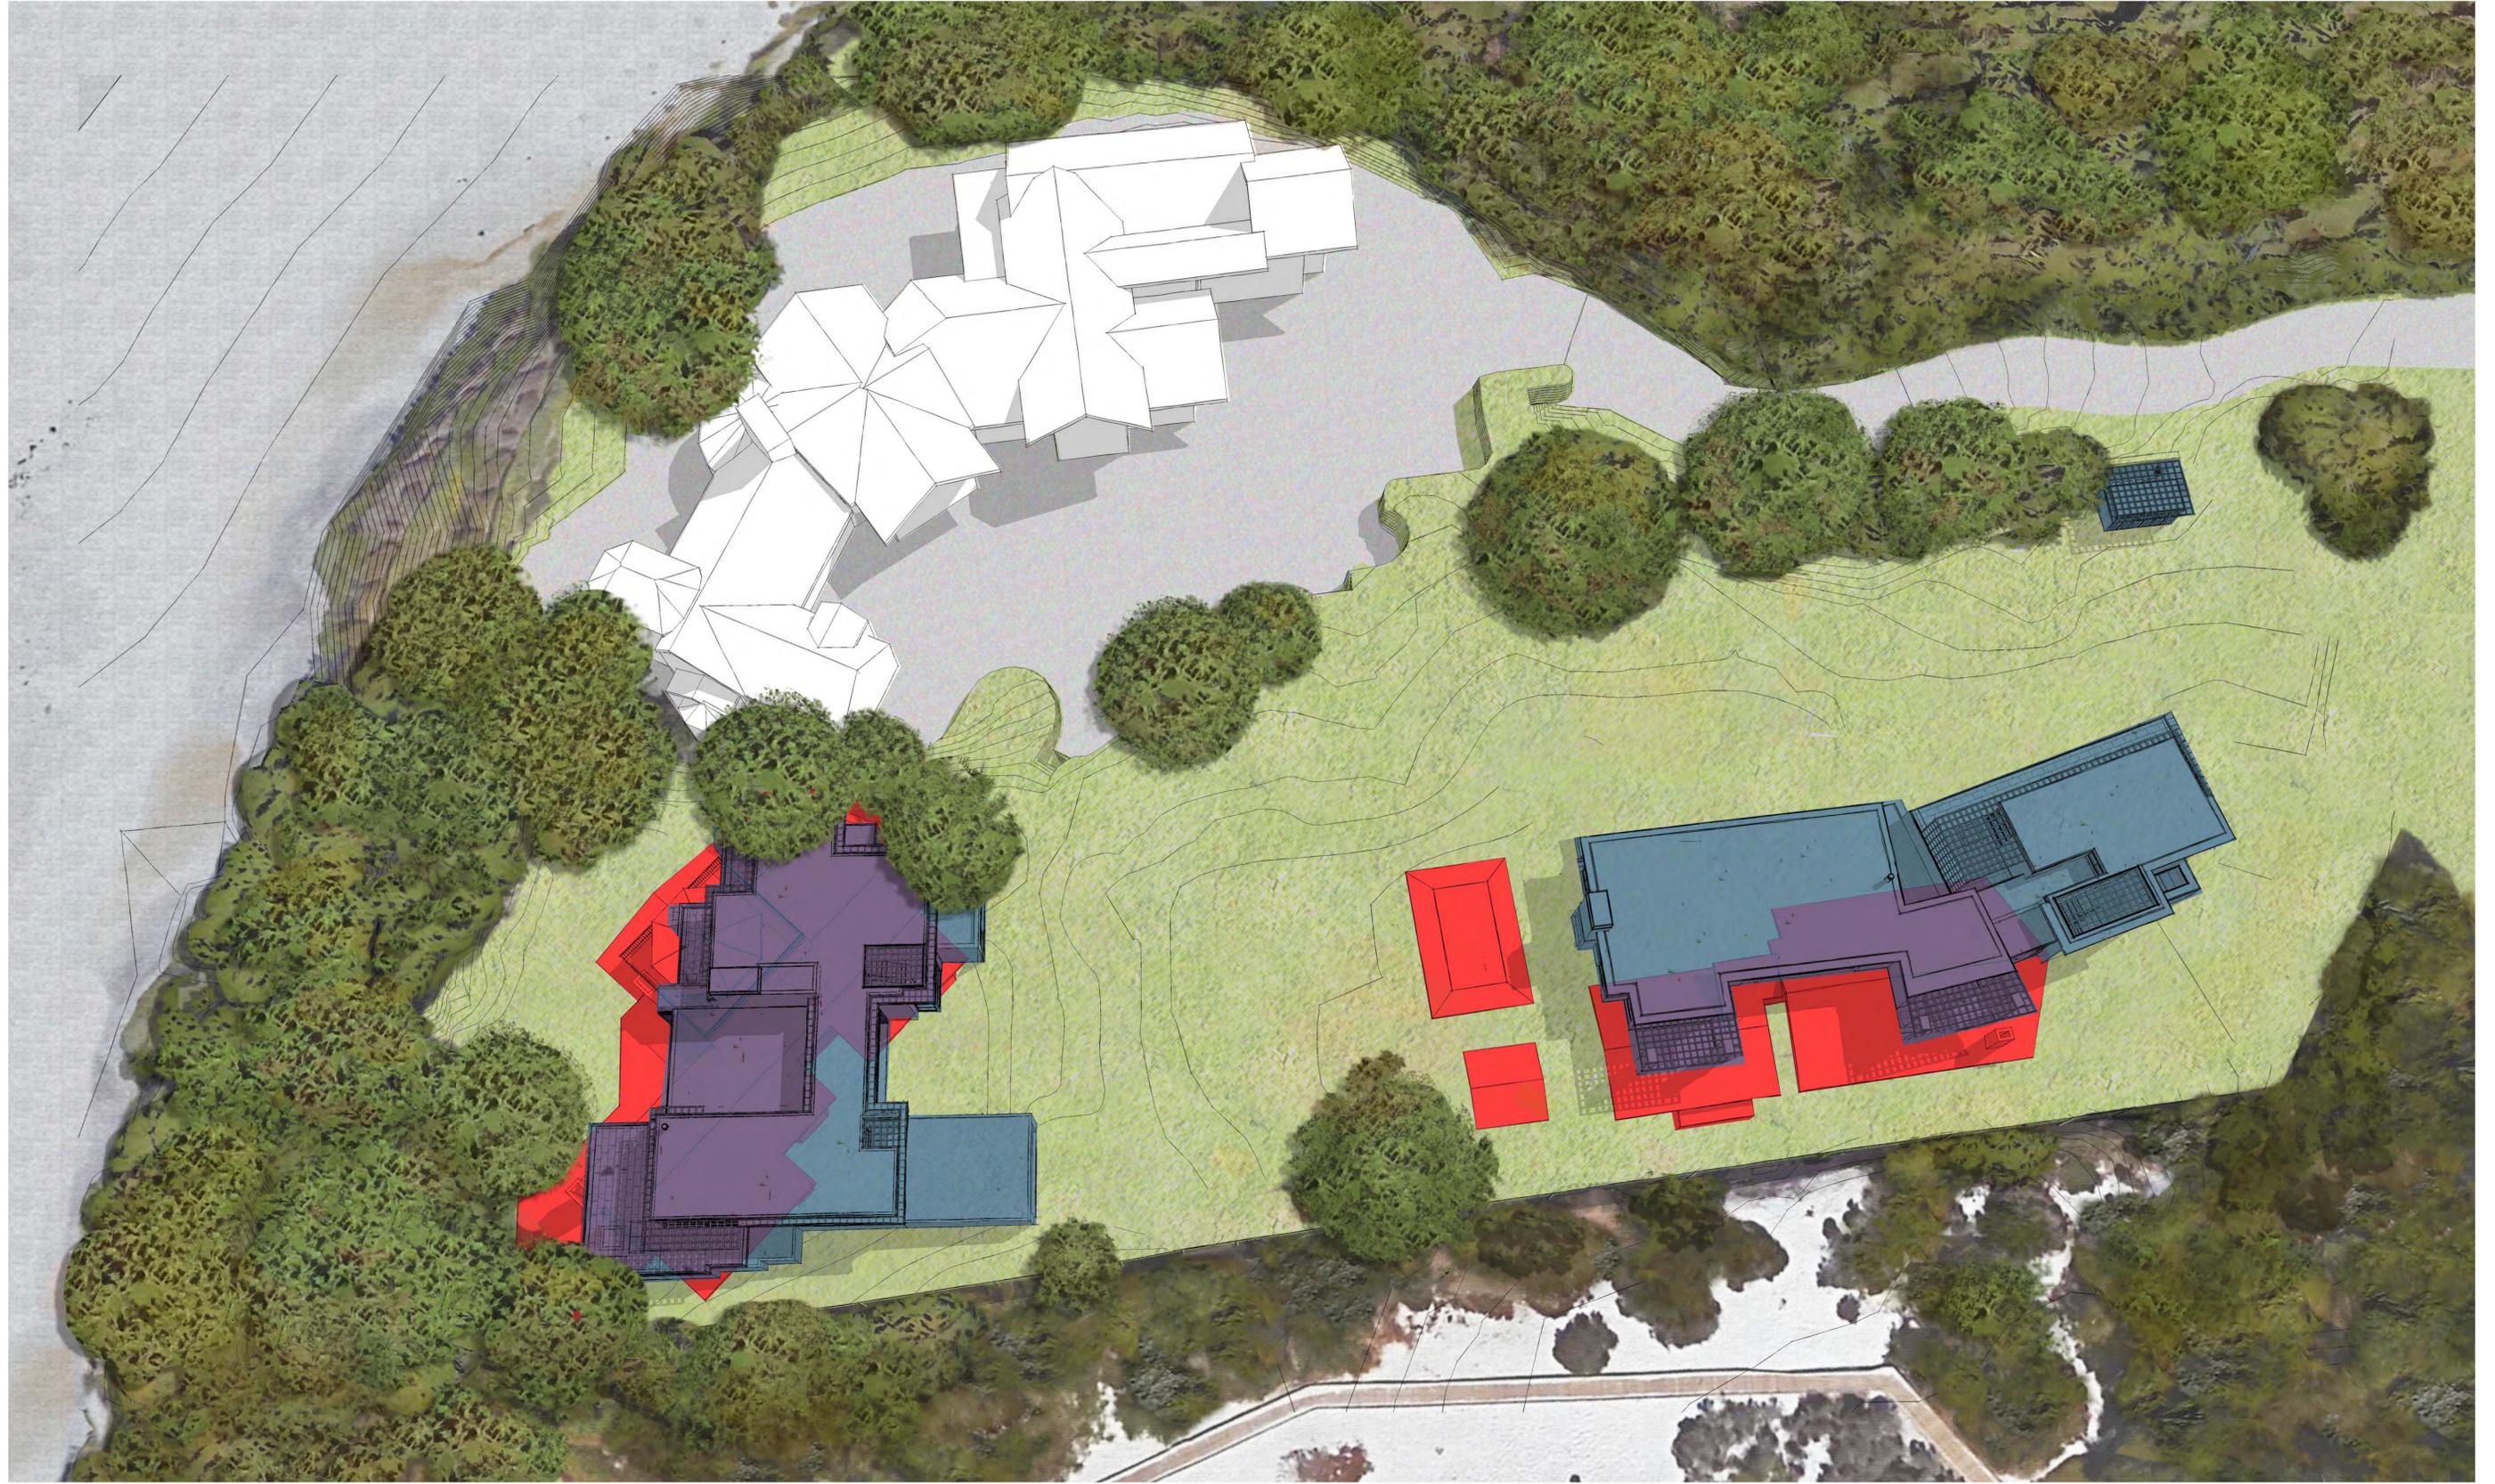
Site - Bird's Eye - Existing/Proposed Structures

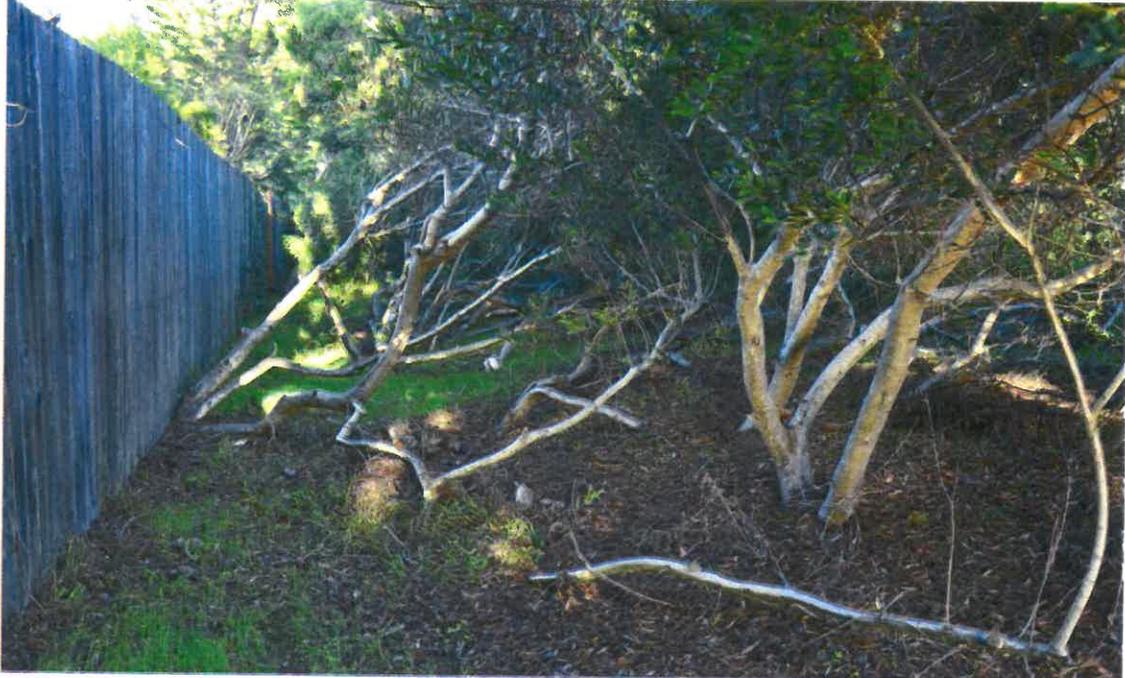
Photo 4. A dense thicket of acacias occurs outside the southern fenced property line, planted on a cut-bench that extends about 6 feet into the Boardwalk House parcel.

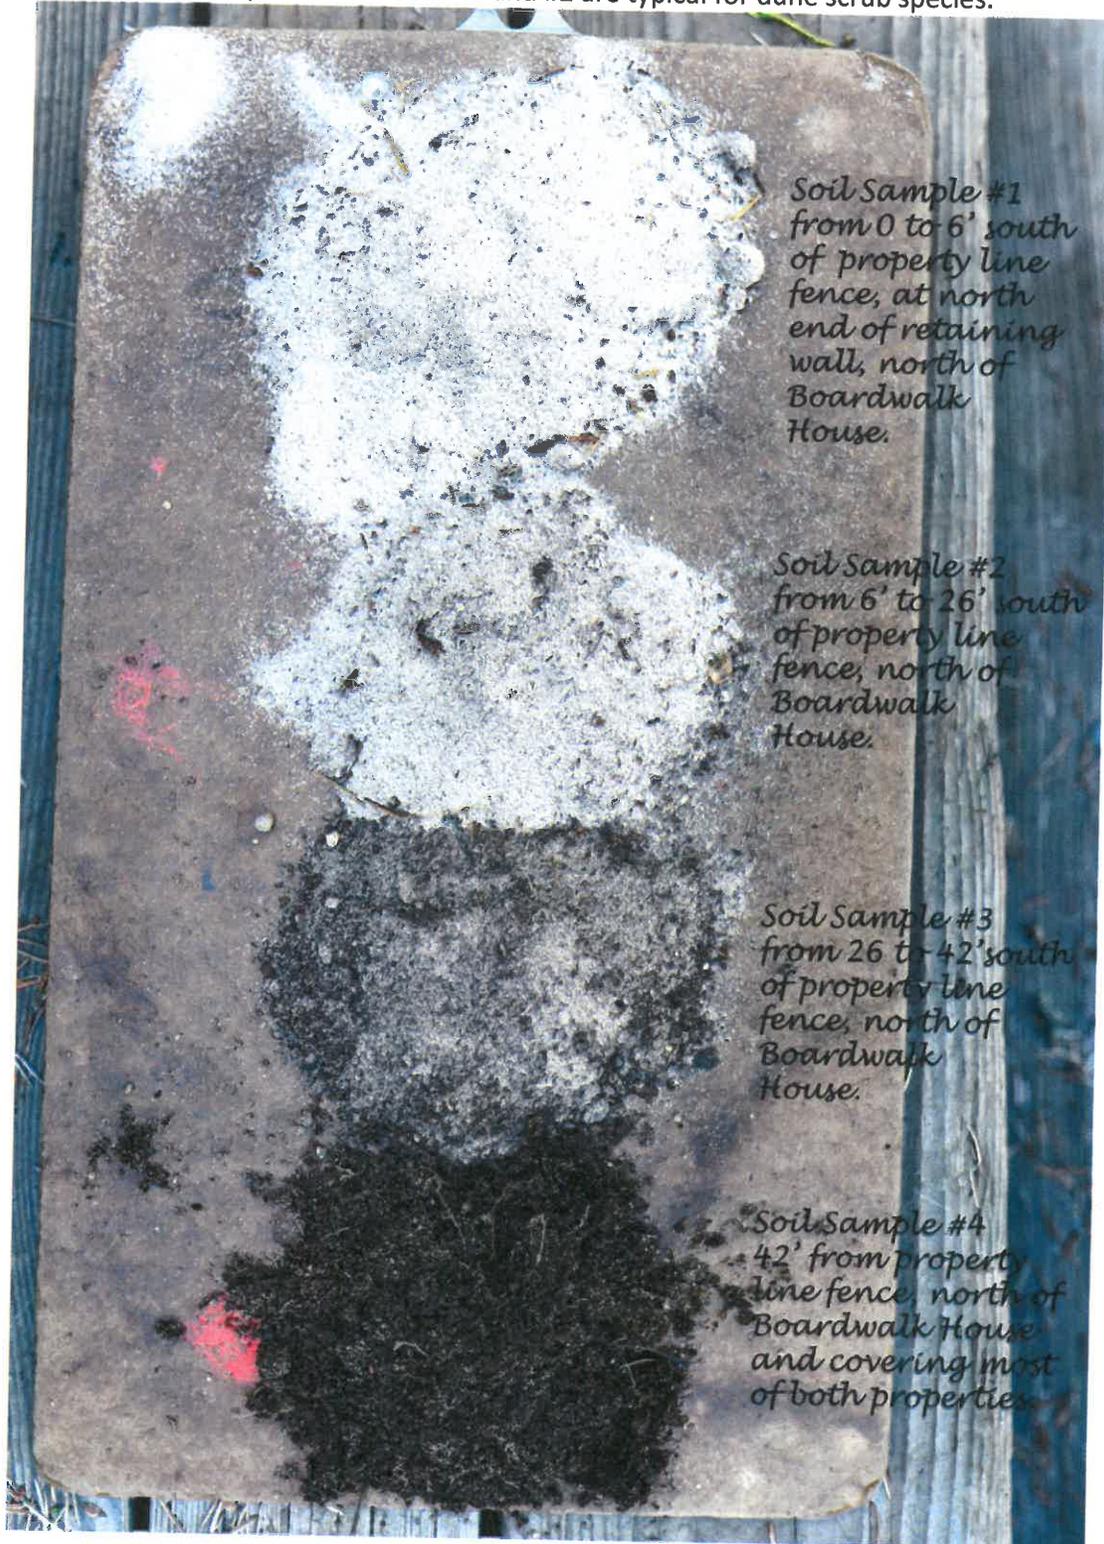
Photo 7. Soil samples onsite. Soils #1 and #2 are typical for dune scrub species.

Determining the actual boundary of ESHA in or near the Upper Estate properties is key to reviewing potential impacts of its proposed development. To confirm the ESHA boundary along the Upper Estates southern property line, as mapped in the City of

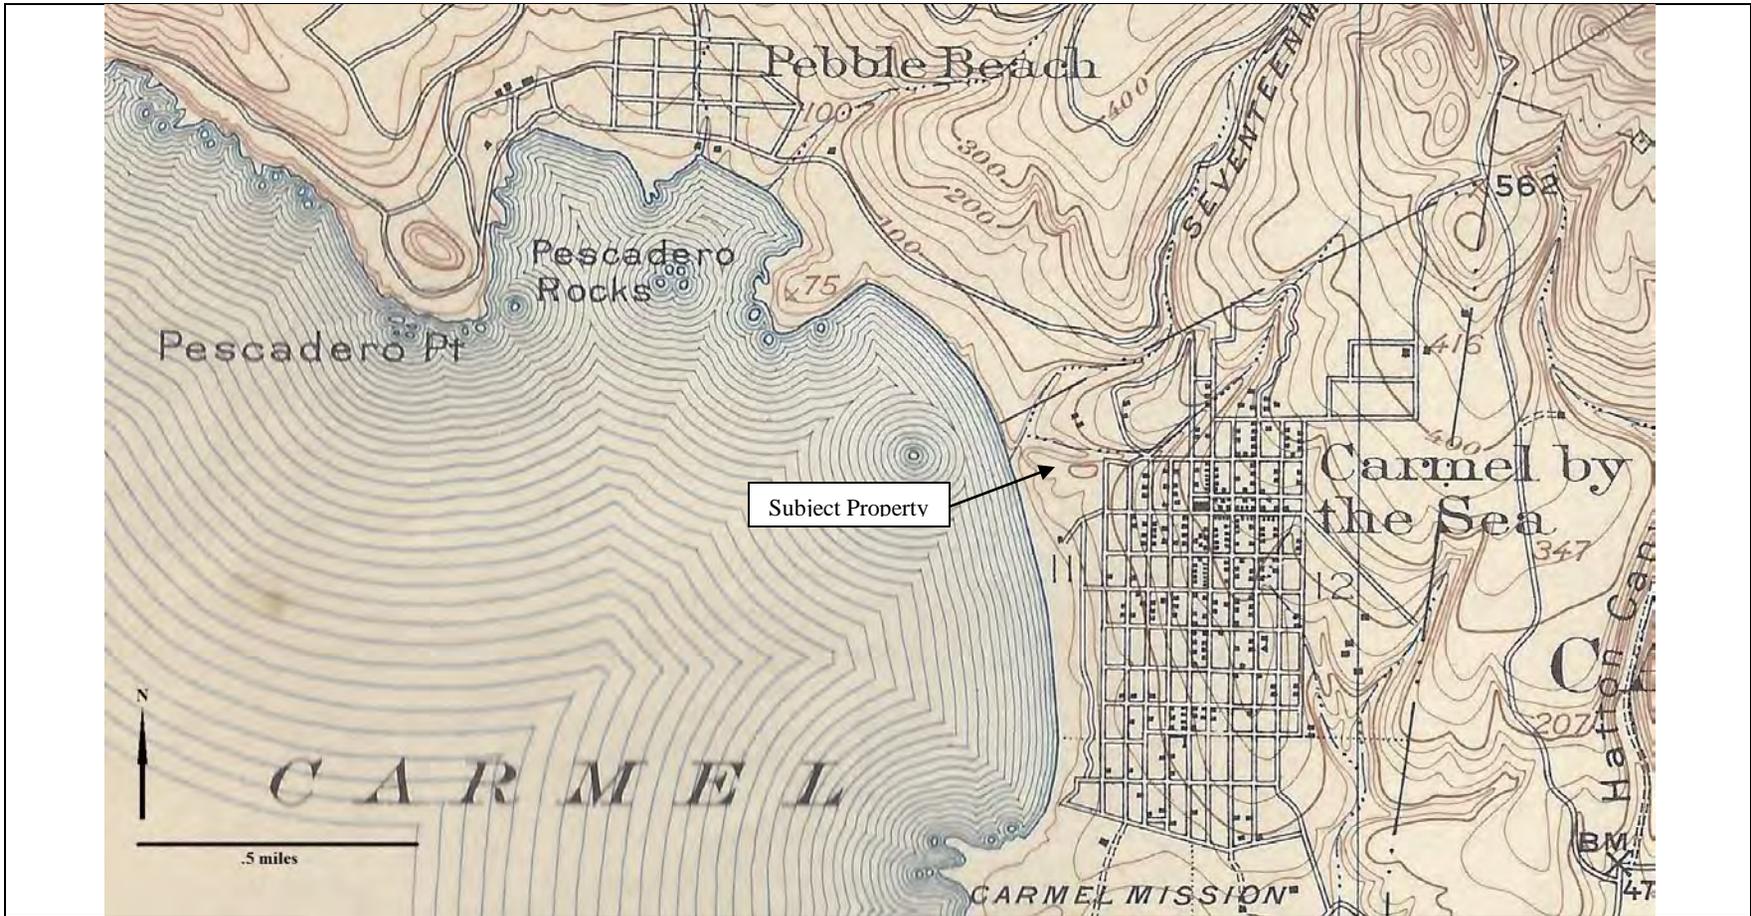
Figure
2

Historic Topographic Map -1913 USGS
 10 Carmel Way, Carmel, CA
 Reference # 4922-01

Another indicator that the pre-development elevation of the property was higher than today was found on USGS 15 minute topographic map of Monterey Quadrangle, 1913, which shows the highest elevation on the subject property as falling between 75 and 100 feet above sea level.
