CARMEL WAY TRUST RESIDENTIAL DEVELOPMENT INITIAL STUDY

Project Title:	Carmel Way Trust Residential Development
Project Location:	7 and 9 Carmel Way, Carmel, Monterey County
Date Prepared:	September 15, 2016
Lead Agency:	City of Carmel P.O. Box G Carmel, California 93921
Project Sponsor:	Jeff and Wendy Hines
Assessor's Parcel Number(s):	010-321-020 and 010-321-021
Acreage of Property:	Three parcels: 1.48 acres combined (0.53 ac. 0.22 ac. and 0.73)
Zoning District:	R1 Single-Family Residential
General Plan Designation:	Single-Family Residential
Coastal Land Use Plan:	Single-Family Residential
Contact Person:	Matthew Sundt, City Planner (831-620-2023)

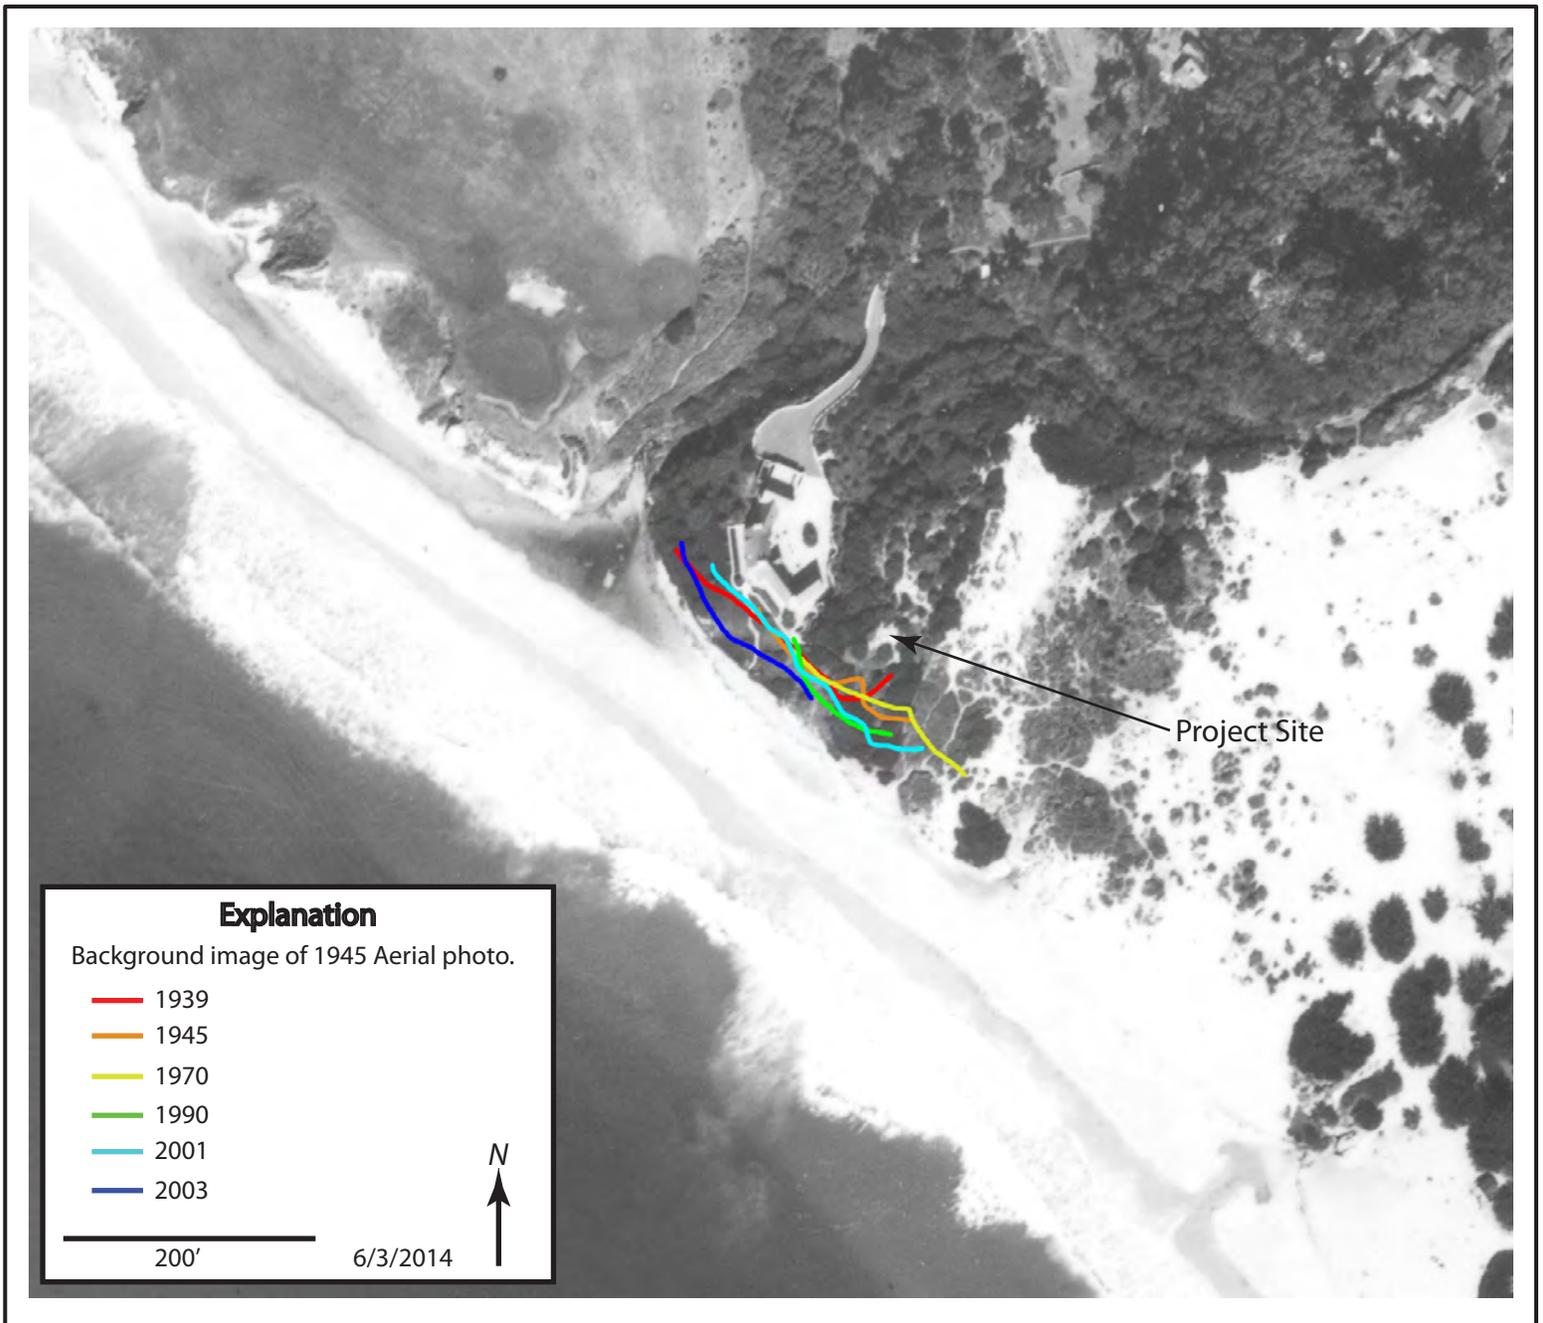
Figure 3

Historical Coastal Bluffs: Aerial Photograph Analysis

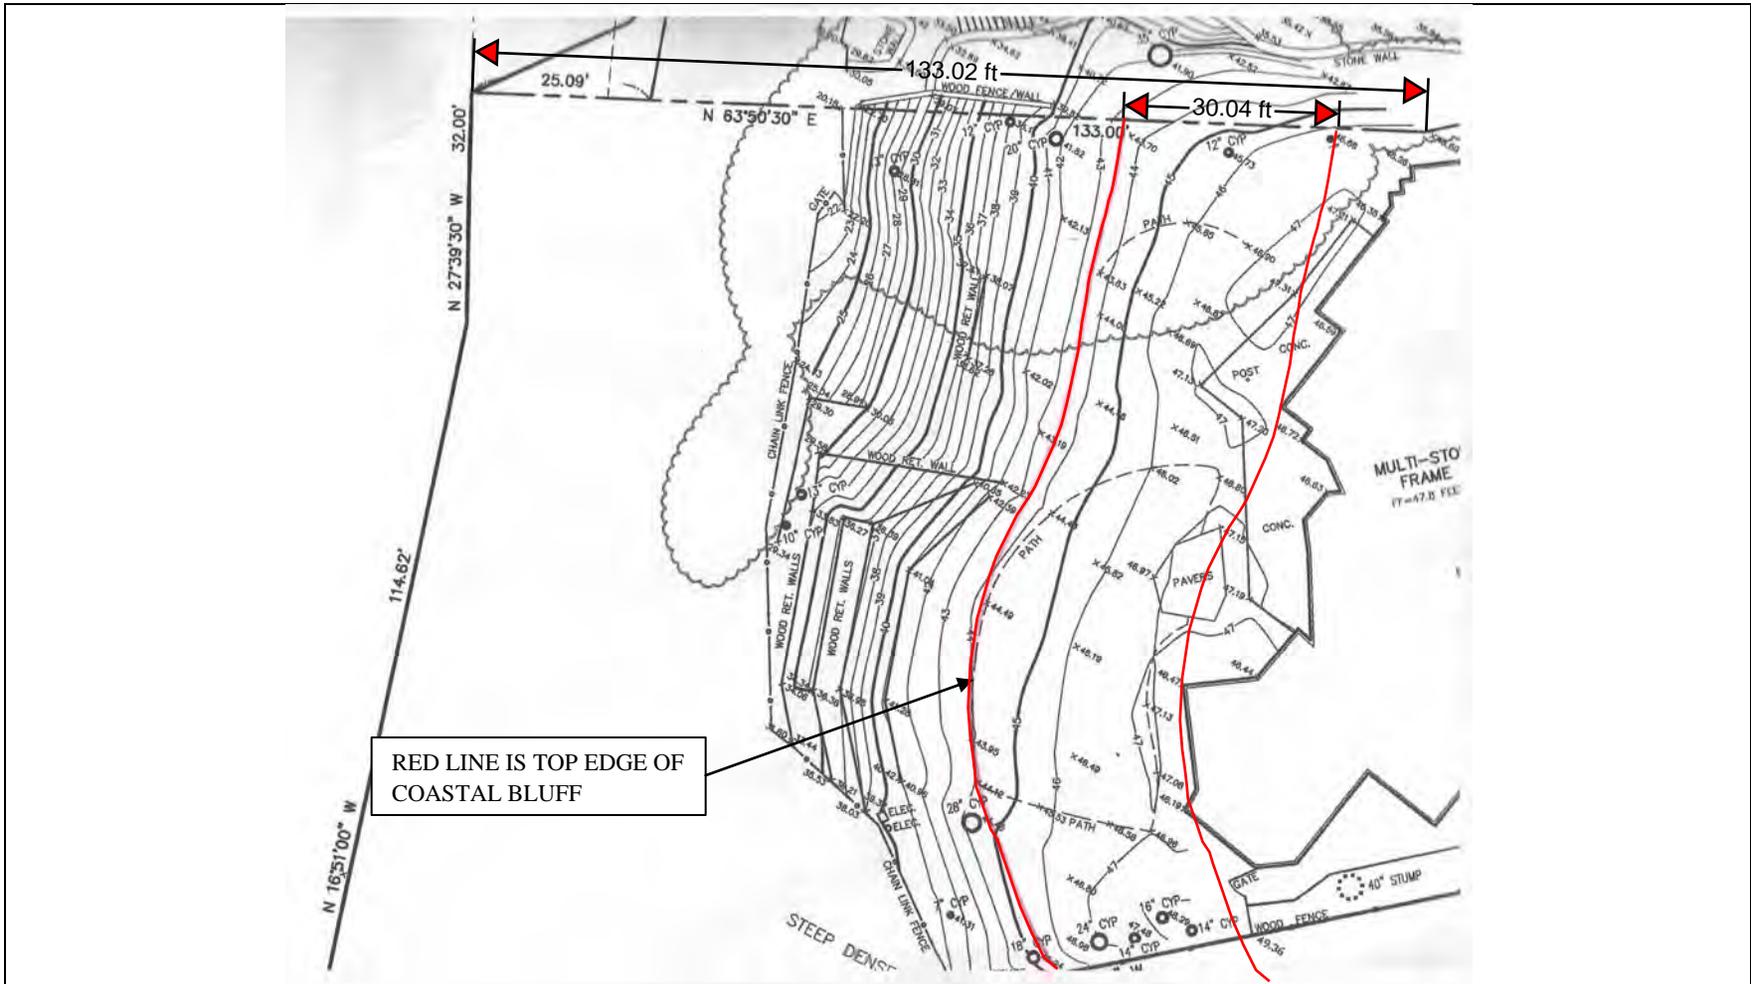
Figure
 4

RED LINE IS TOP EDGE OF COASTAL BLUFF

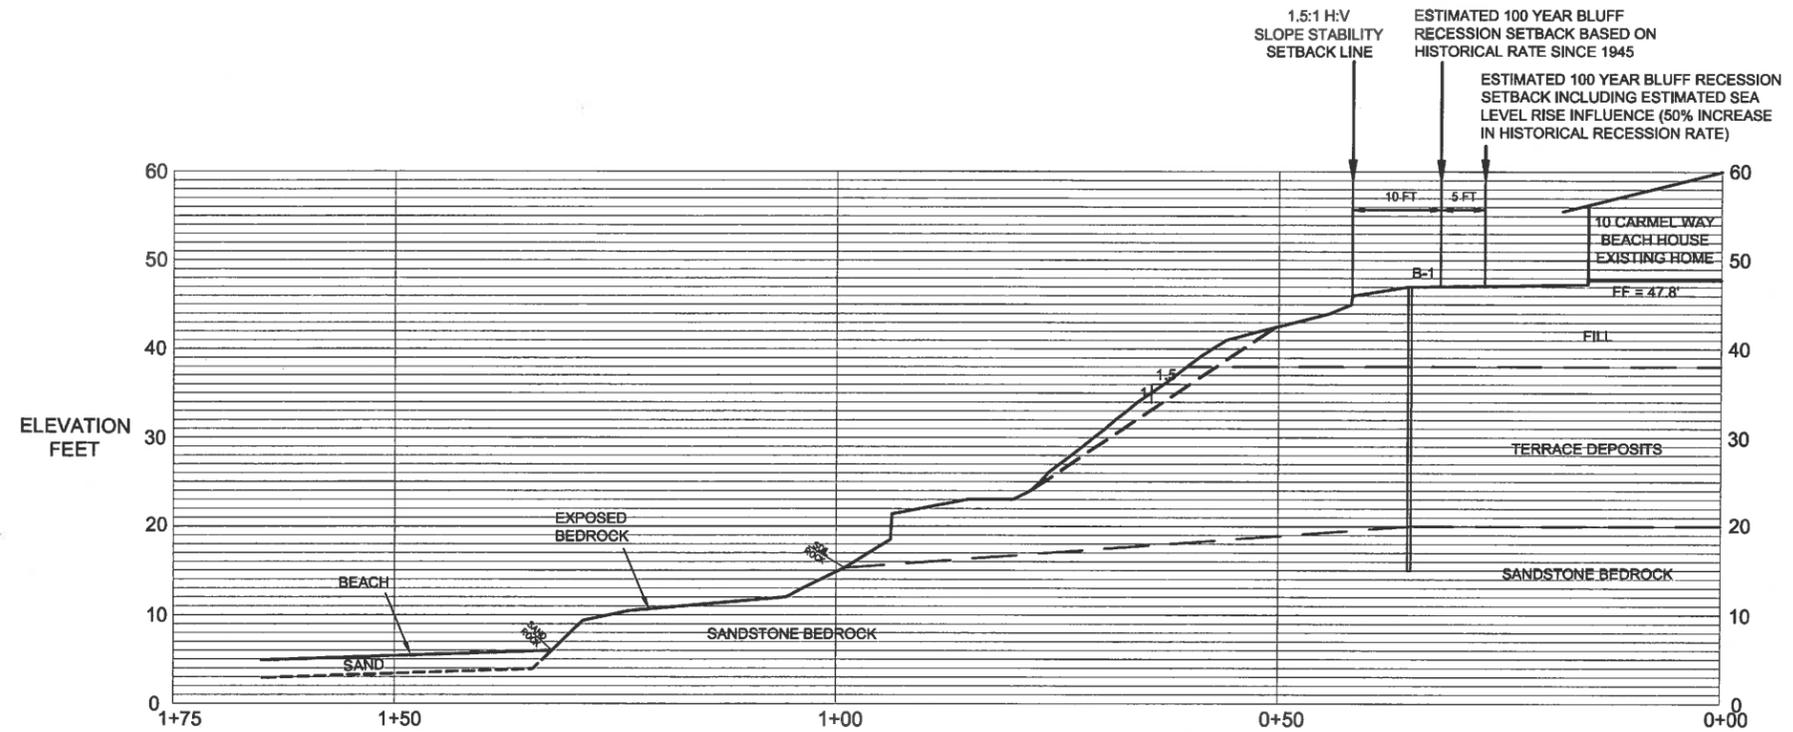
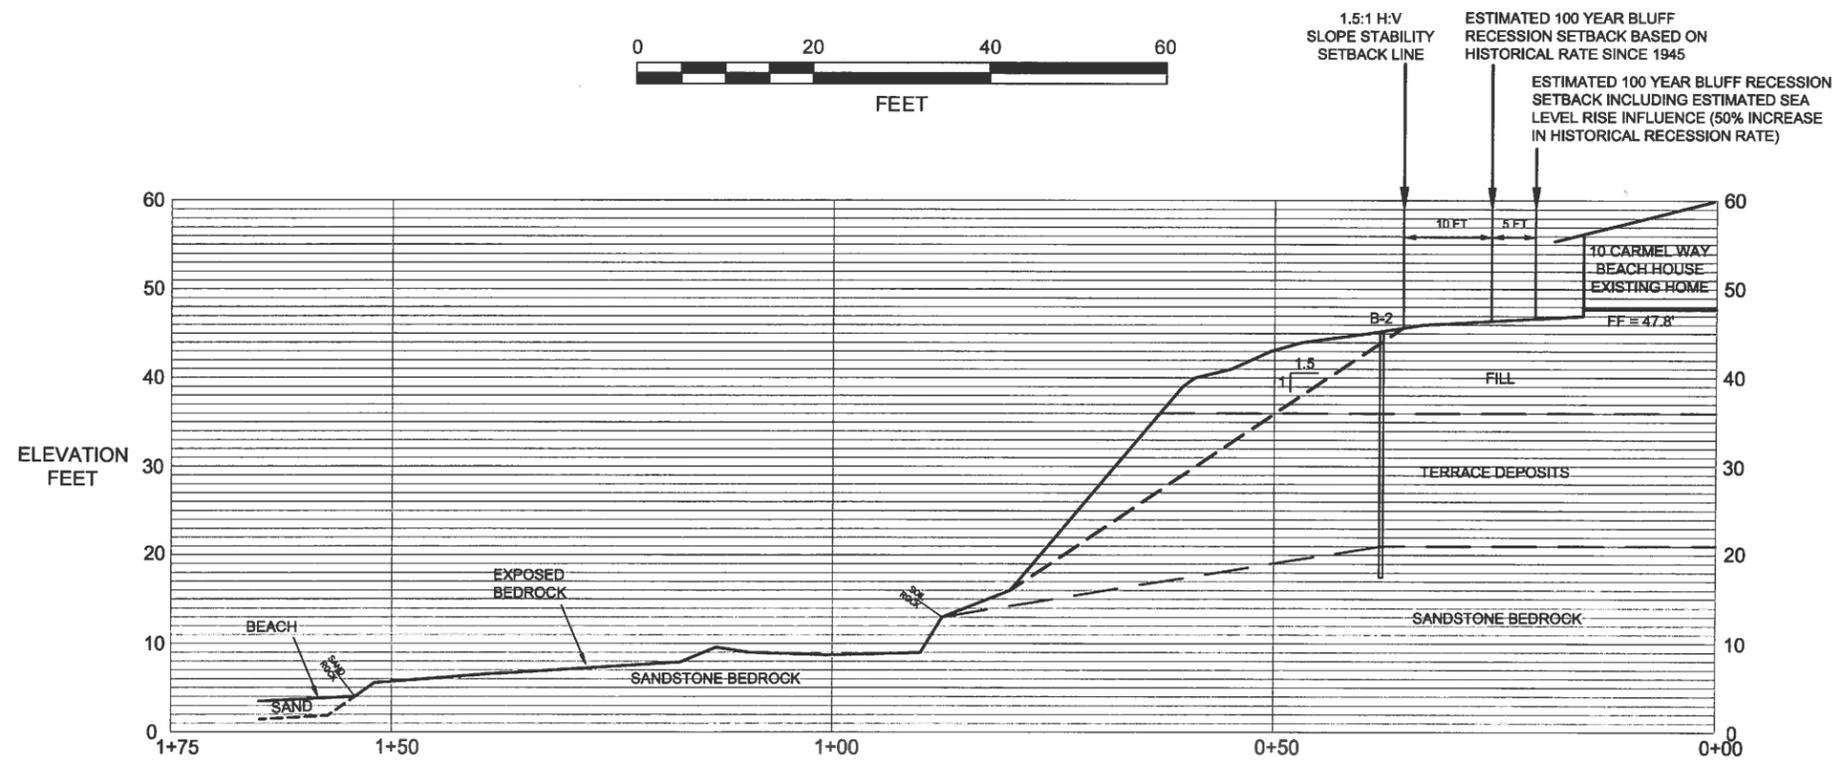
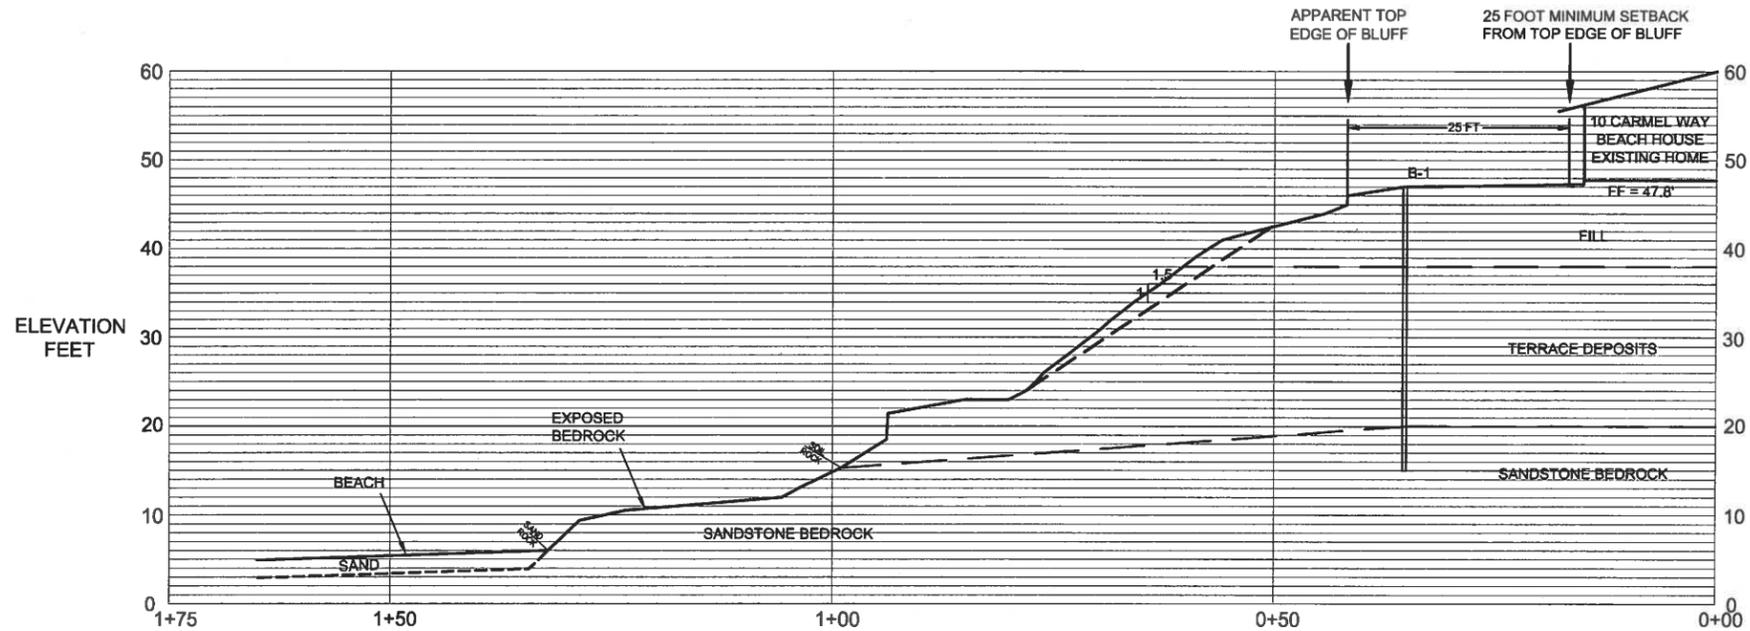
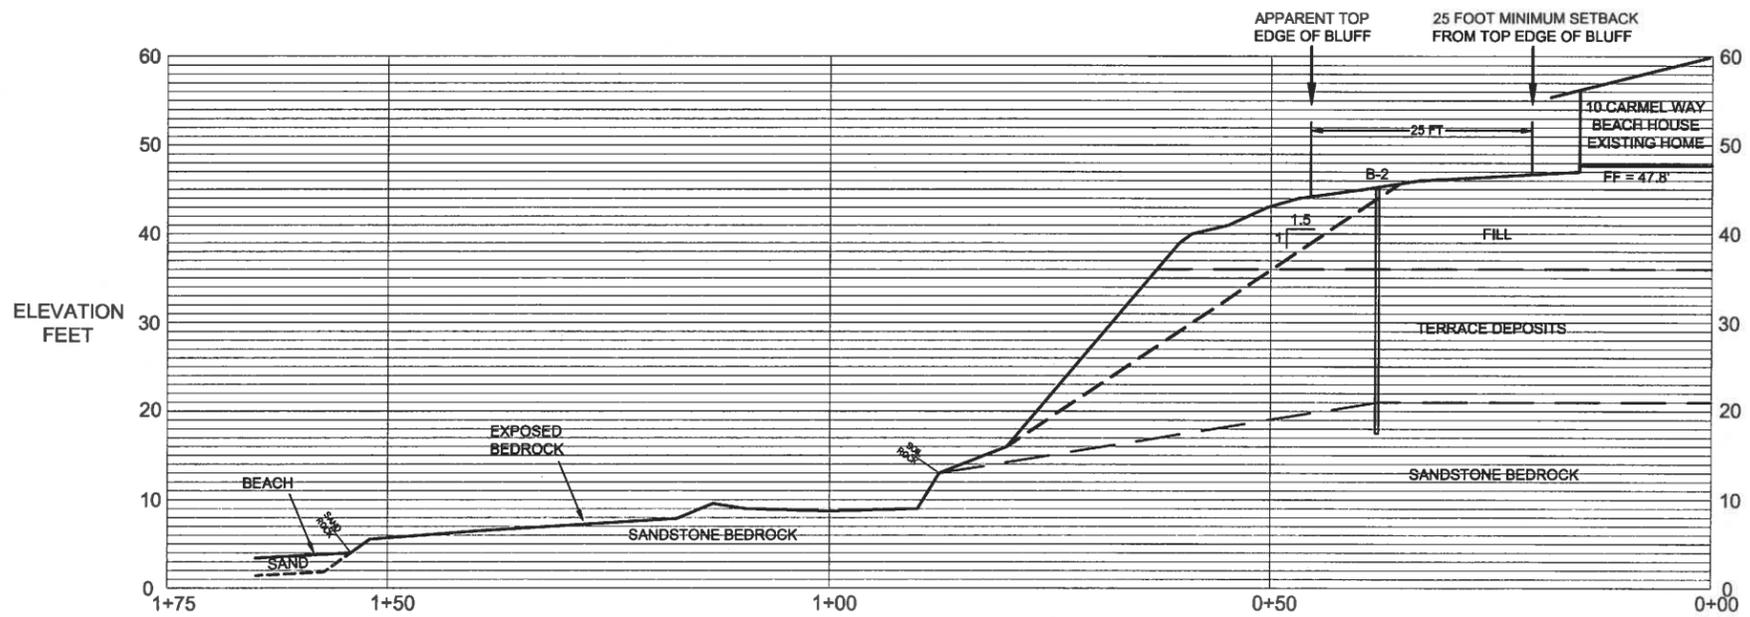
ESTIMATED 100 YEAR FUTURE COASTAL BLUFF RECESION SETBACK CROSS SECTIONS
BEACH HOUSE AT 10 CARMEL WAY, CARMEL-BY-THE-SEA, CA
APN 010-321-021

SECTION 1

SECTION 2

To insure the safety of the structures it is necessary to have a safety buffer. Therefore, CapRock recommends that all future construction be setback a minimum of 30 feet from the top of the cliff face, which corresponds to an average erosion rate of 0.3 feet per year (refer to the attached Caprock and Haro, Kasunich Associates reports). Based on the analysis and findings conducted by CapRock, it is entirely possible that the average erosion rate for the project site has been less than 0.3 feet per year over the last 75 years, but in the absence of hard numbers to support that contention and for the sake of providing a sufficient setback incorporating an adequate margin of safety, 0.3 feet per year is the appropriate rate of coastal bluff erosion for the subject property.
