CITY OF CARMEL-BY-THE-SEA CITY COUNCIL AGENDA

CITY COUNCIL SPECIAL MEETING Monday, August 2, 2021 4:30 PM

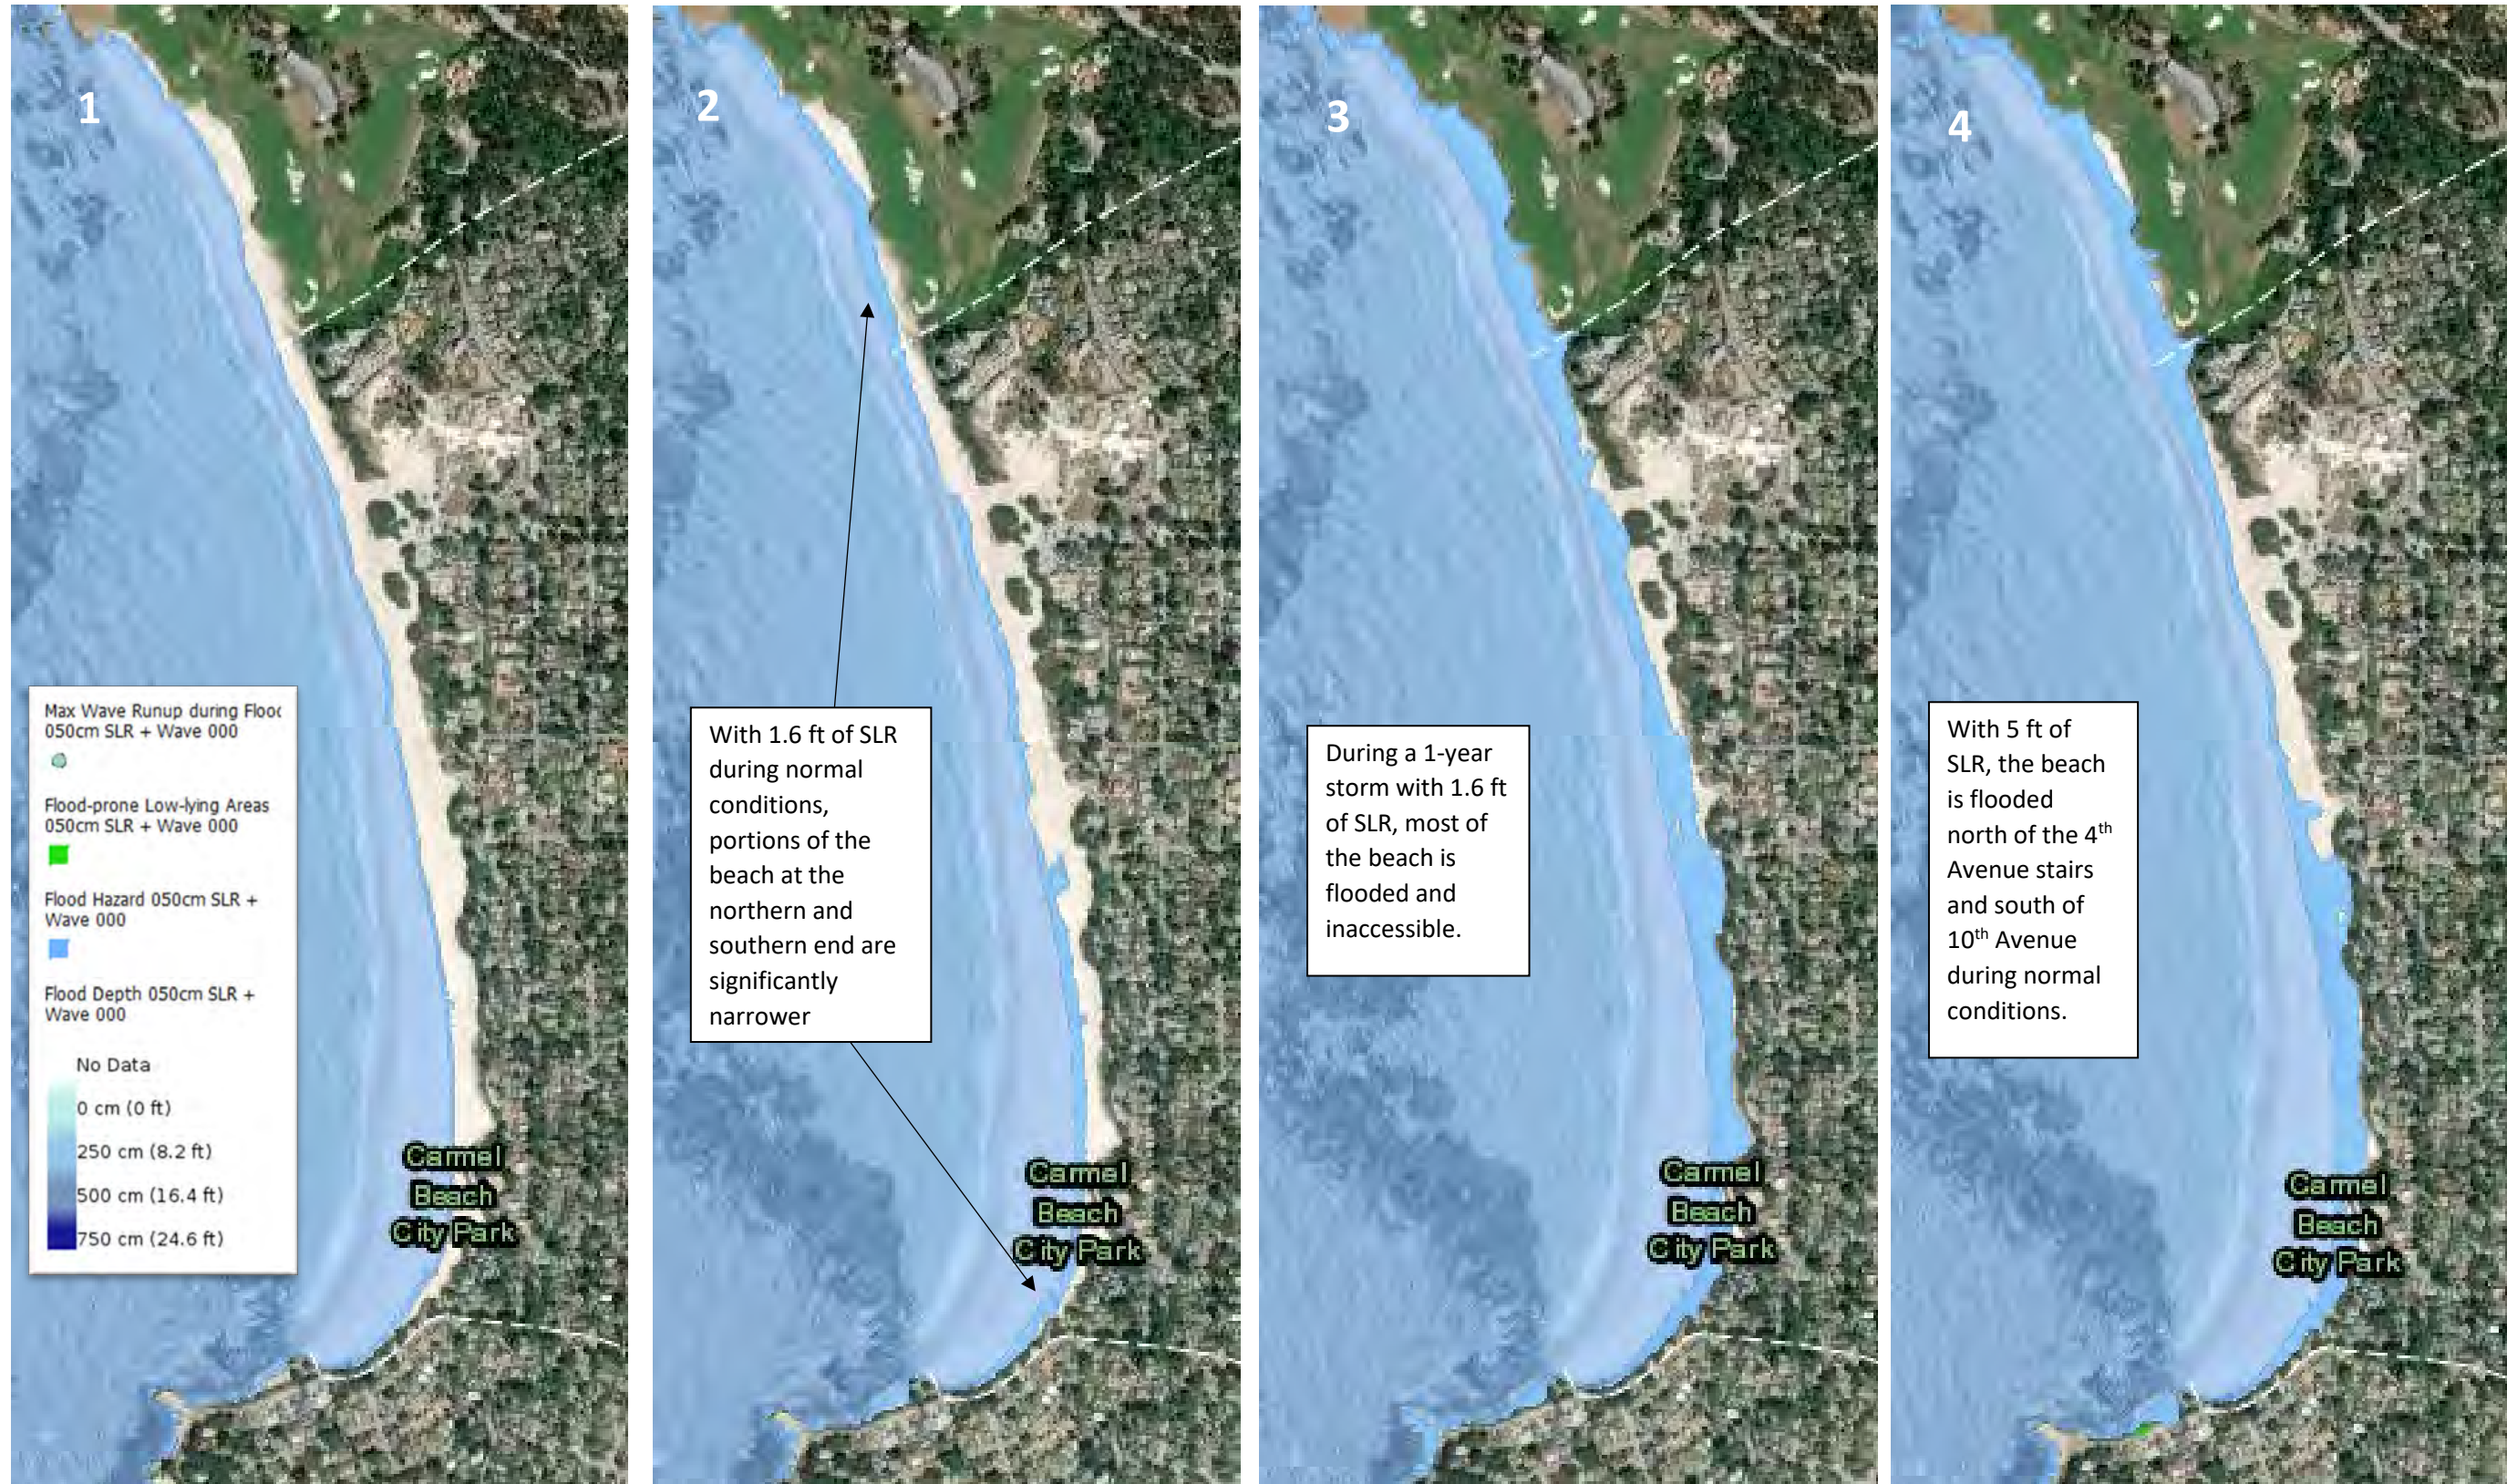
Figure 2: Comparison of Carmel Beach maximum wave run-up during: 1) current conditions, 2) with 1.6 ft of sea level rise (SLR) and no storm, 3) 1.6 ft of SLR and 1-year storm, and 4) 5 ft of SLR and no storm.

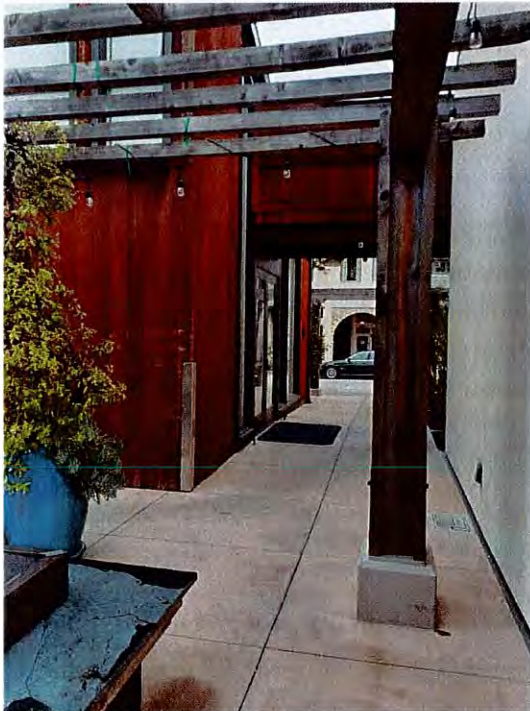
The community room will be demolished as part of this project. It is connected to the main bank building at the second-floor level by an elevated walkway. When the community room is demolished a gap will be created in the exterior wall of the bank building. The wall should be repaired by matching the original wall in design, color, texture, and if possible, materials. If this is clearly indicated on the construction plans, then the work will be consistent with Standard Five.

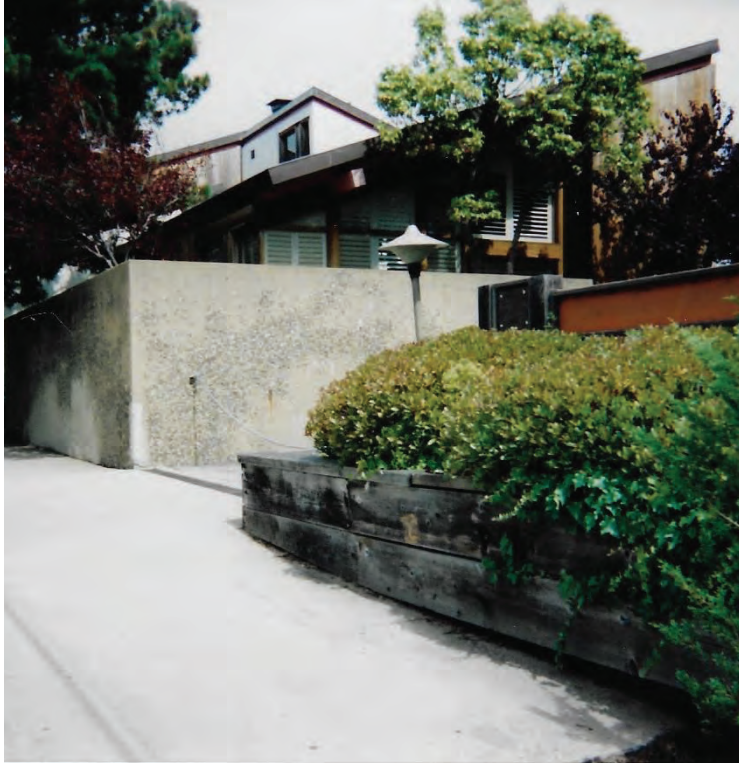
Views showing original window design, 1999.

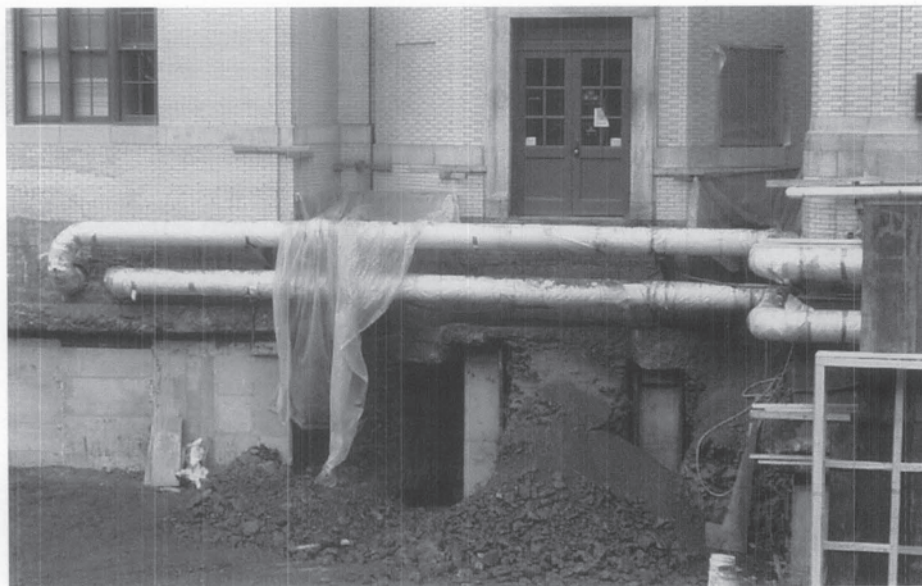
Figure 3. Concrete pier underpinning to an existing building may be necessary when adjacent construction occurs. In this example, pits are hand dug beneath the foundation of the historic building to provide space for wood forms. After concrete is poured into the forms, the space between the top of the pier and the bottom of the original foundation is packed with a quicksetting grout. The historic building owner should retain an independent engineer to ensure that the underpinning plan adequately protects the historic structure. Photo: Professor Arpad Horvath, Department of Civil and Environmental Engineering, University of California, Berkeley.

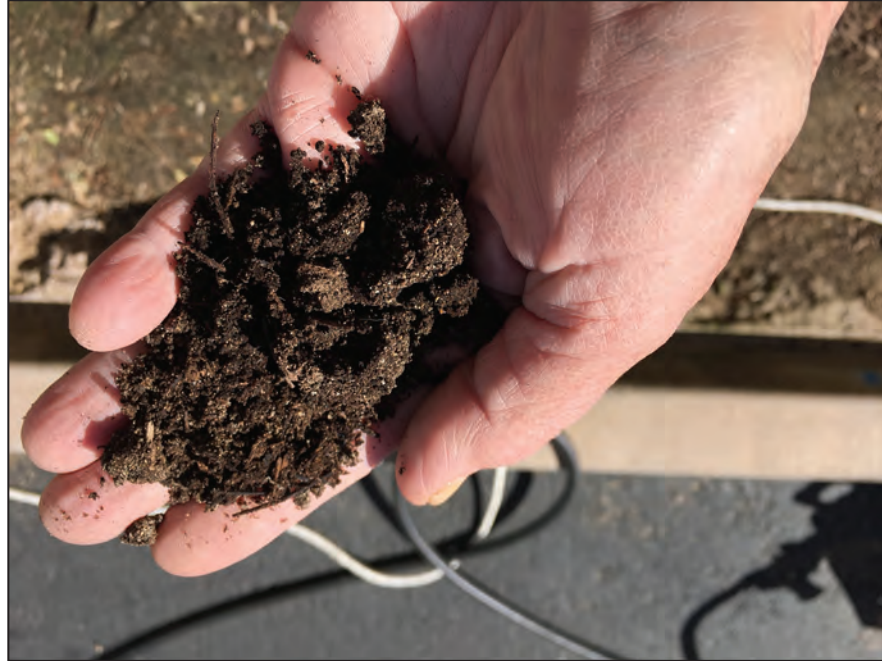
Figure 7: Soils along the eastern perimeter of the parking lot are sandy loam with no cultural materials observed.

The soils of the project parcel are exposed in numerous locations around the parcel. **Figure 7** is a close up of a handful of soils from the northern parcel, APN 010-145-023. The USDA Web Soil Survey classifies soils in this neighborhood as OaD--Oceano loamy sand, 2 to 15 percent slopes. Oceano loamy sands are stabilized eolian soils (<https://websoilsurvey.sc.egov.usda.gov>). These soils are found on marine terraces. The soil of the project parcel is dark brown to dark yellowish brown, 10YR 3/3 to 3/4, sandy loam, darkened by recent rains. There are no marine shell fragments, there are no cobbles or cobble fragments (burnt or unburnt), bone or flaked stone on the project parcel that would indicate a prehistoric site, nor are there traces of these materials. There are no fragments of old glass, or ceramics, or metal that would represent an historic site.

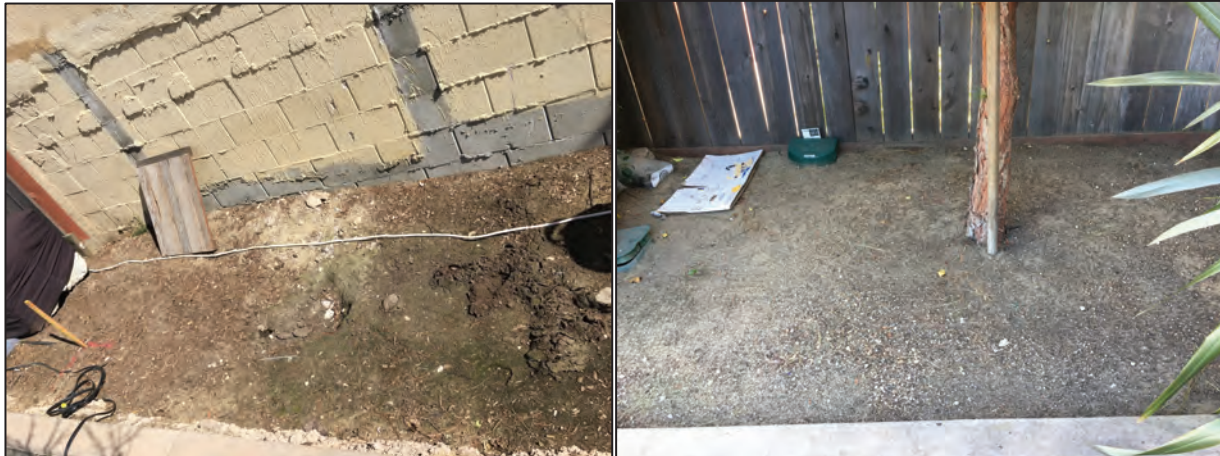
Figure 8: Soils near the eastern margins of the project parcels are exposed. The photo on the left is the northern parcel APN 010-145-023. The photo on the right is the southern of the two parcels, APN 010-145-023.

Figure 8 shows the eastern margin of the both parcels. On all three sides of these two parcels the soils are clearly exposed and more than adequate for determining the presence of cultural materials. **Figure 9** shows the soils exposed along the south margin of APN 010-145-024.

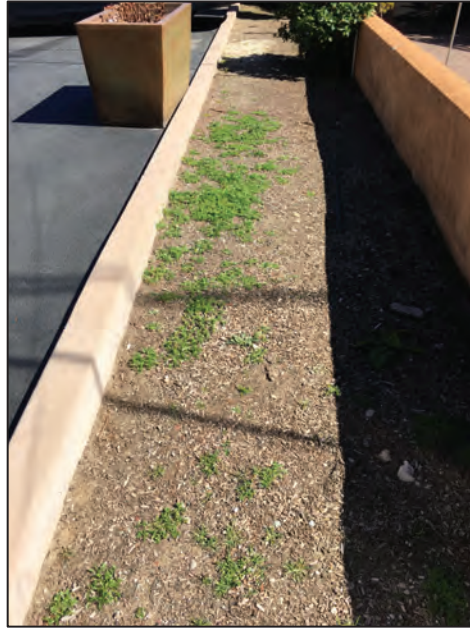
Figure 9: Soils exposed on the south side of the project parcel APN 010-145-024.

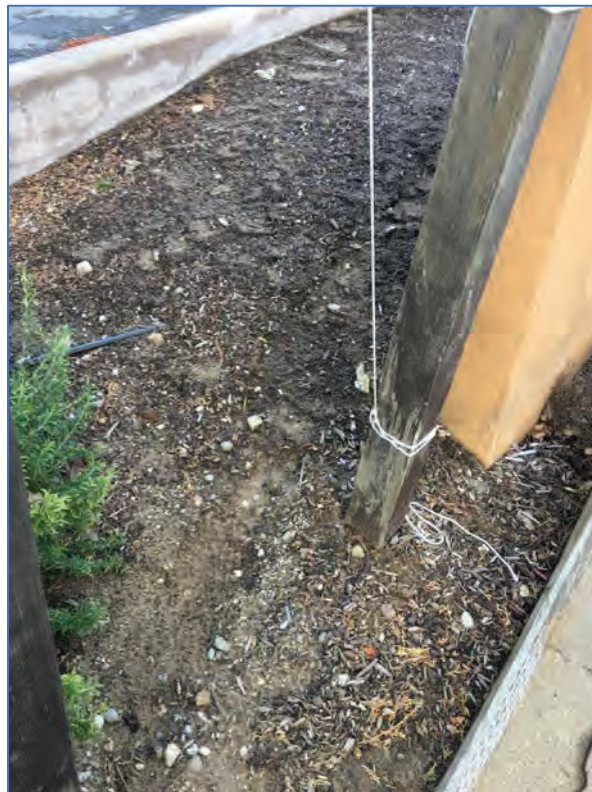
Figure 8: Soils exposed on the northwest corner of the project parcel.
