BRITTON RESIDENCE

DEMOLITION OF (E) RESIDENCE AND ACCESSORY STRUCTURE, AND CONSTRUCTION OF NEW ONE-STORY RESIDENCE WITH ATTACHED 2-CAR GARAGE
CONSTRUCTION OF NEW DETACHED ACCESSORY DWELLING UNIT.

COVER SHEET

BRITTON RESIDENCE
SANTA FE STREET , 2 SW OF MOUNTAIN VIEW AVE.
CARMEL-BY-THE-SEA, CA 93923
A.P.N. 010-082-002

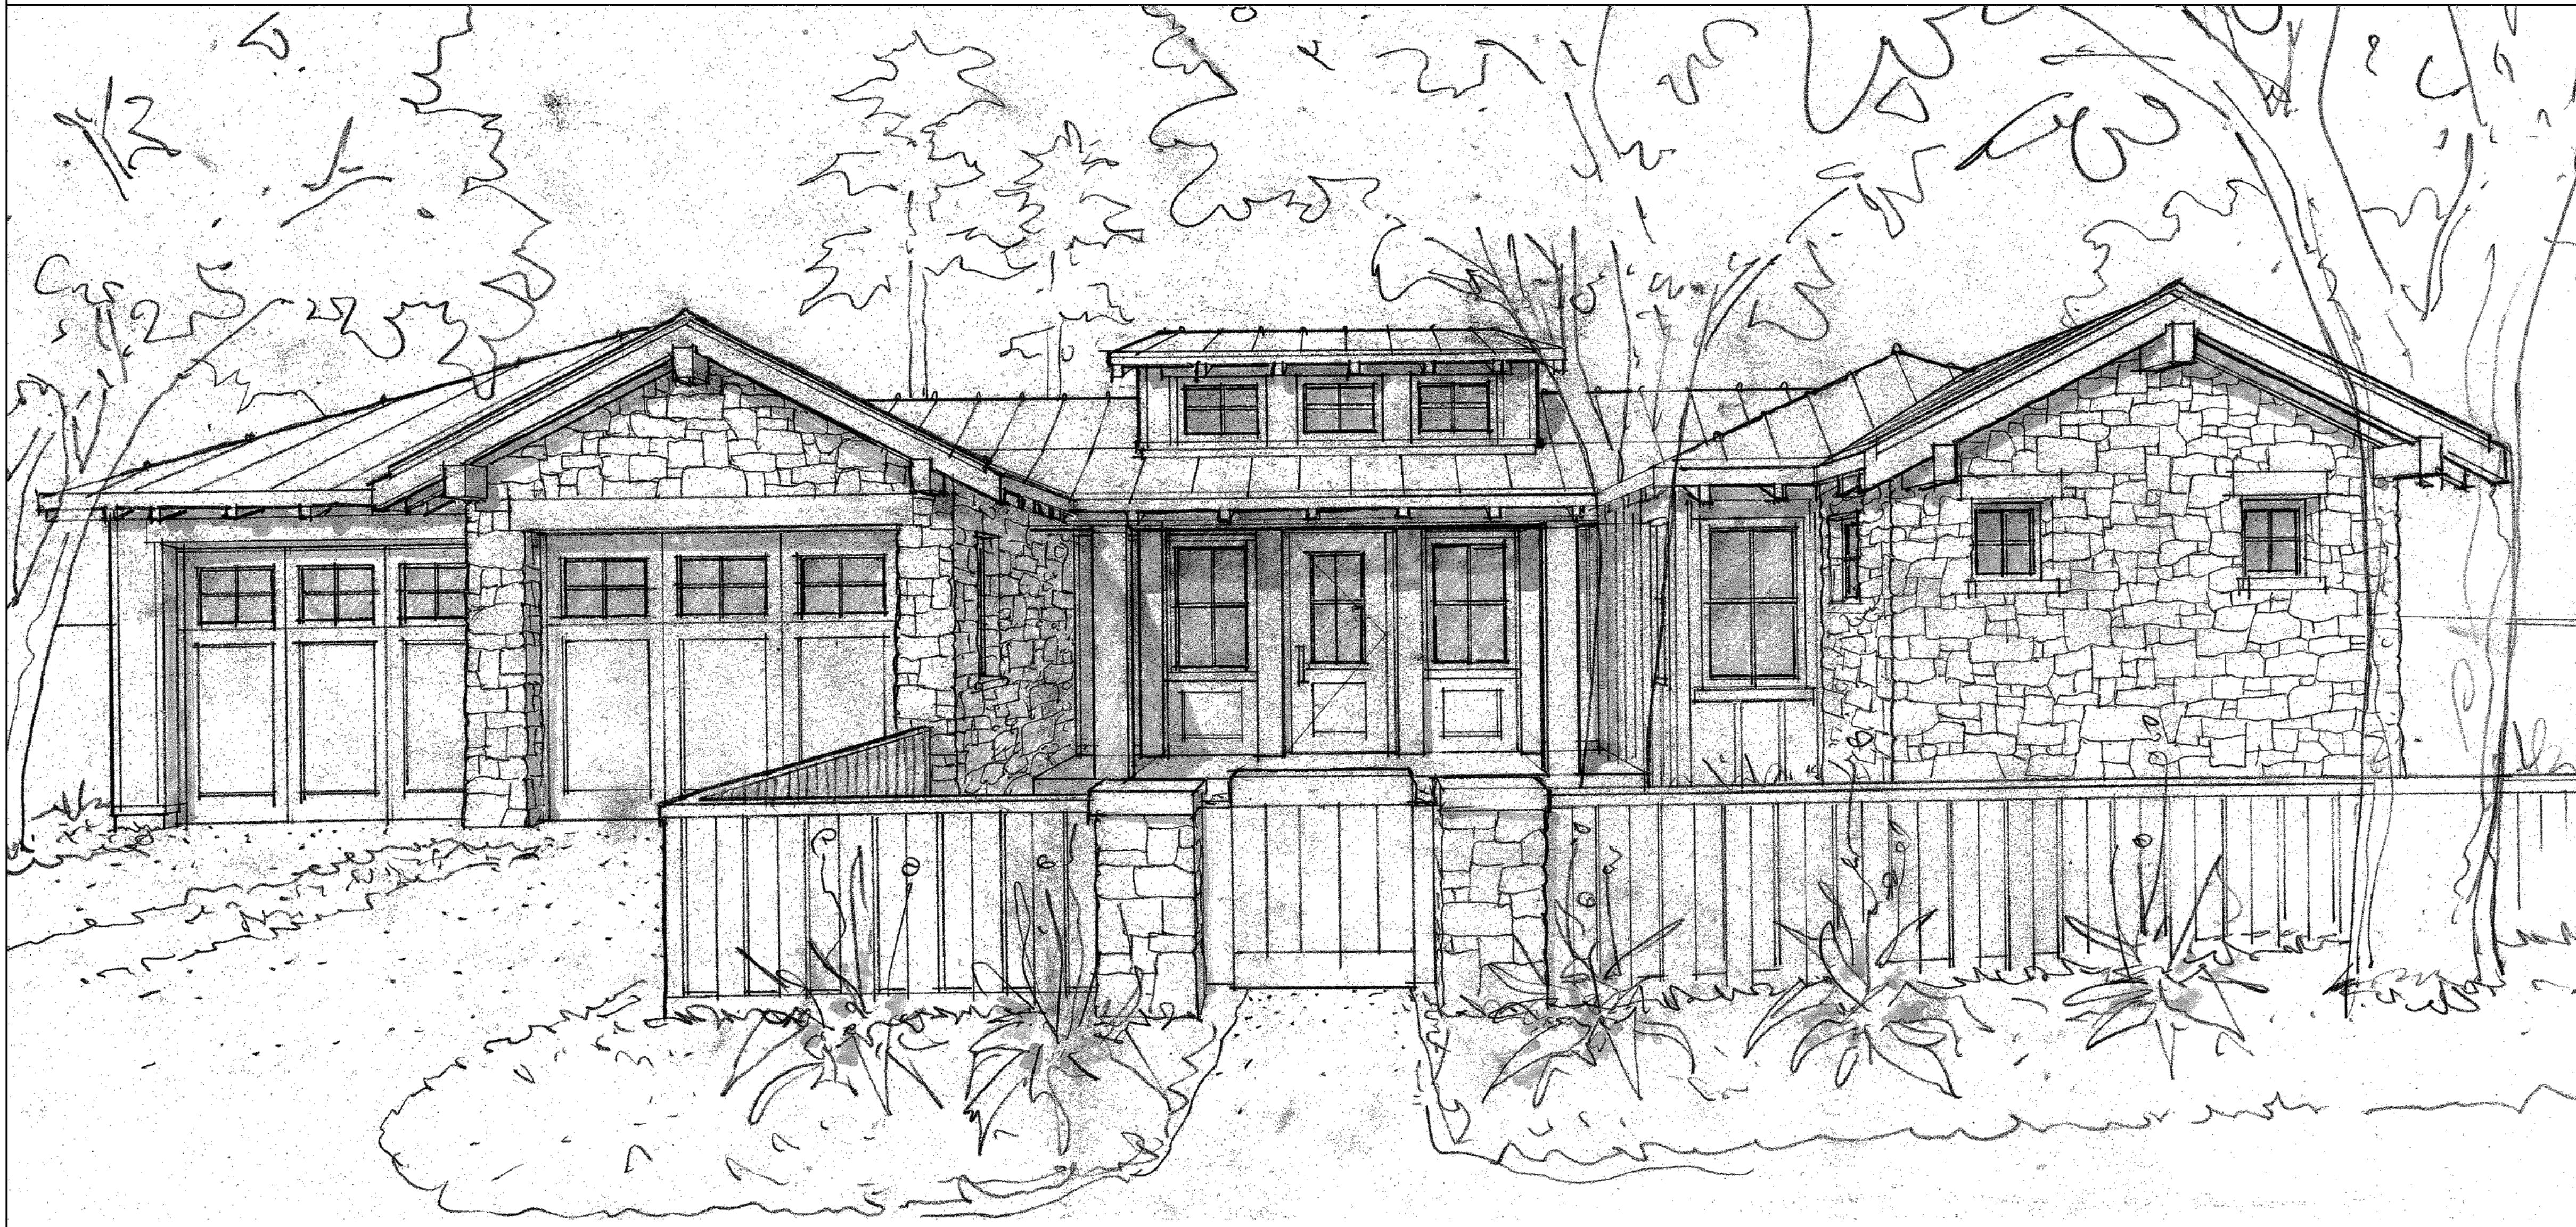
3D ELEVATION (FOR ILLUSTRATION PURPOSES ONLY)

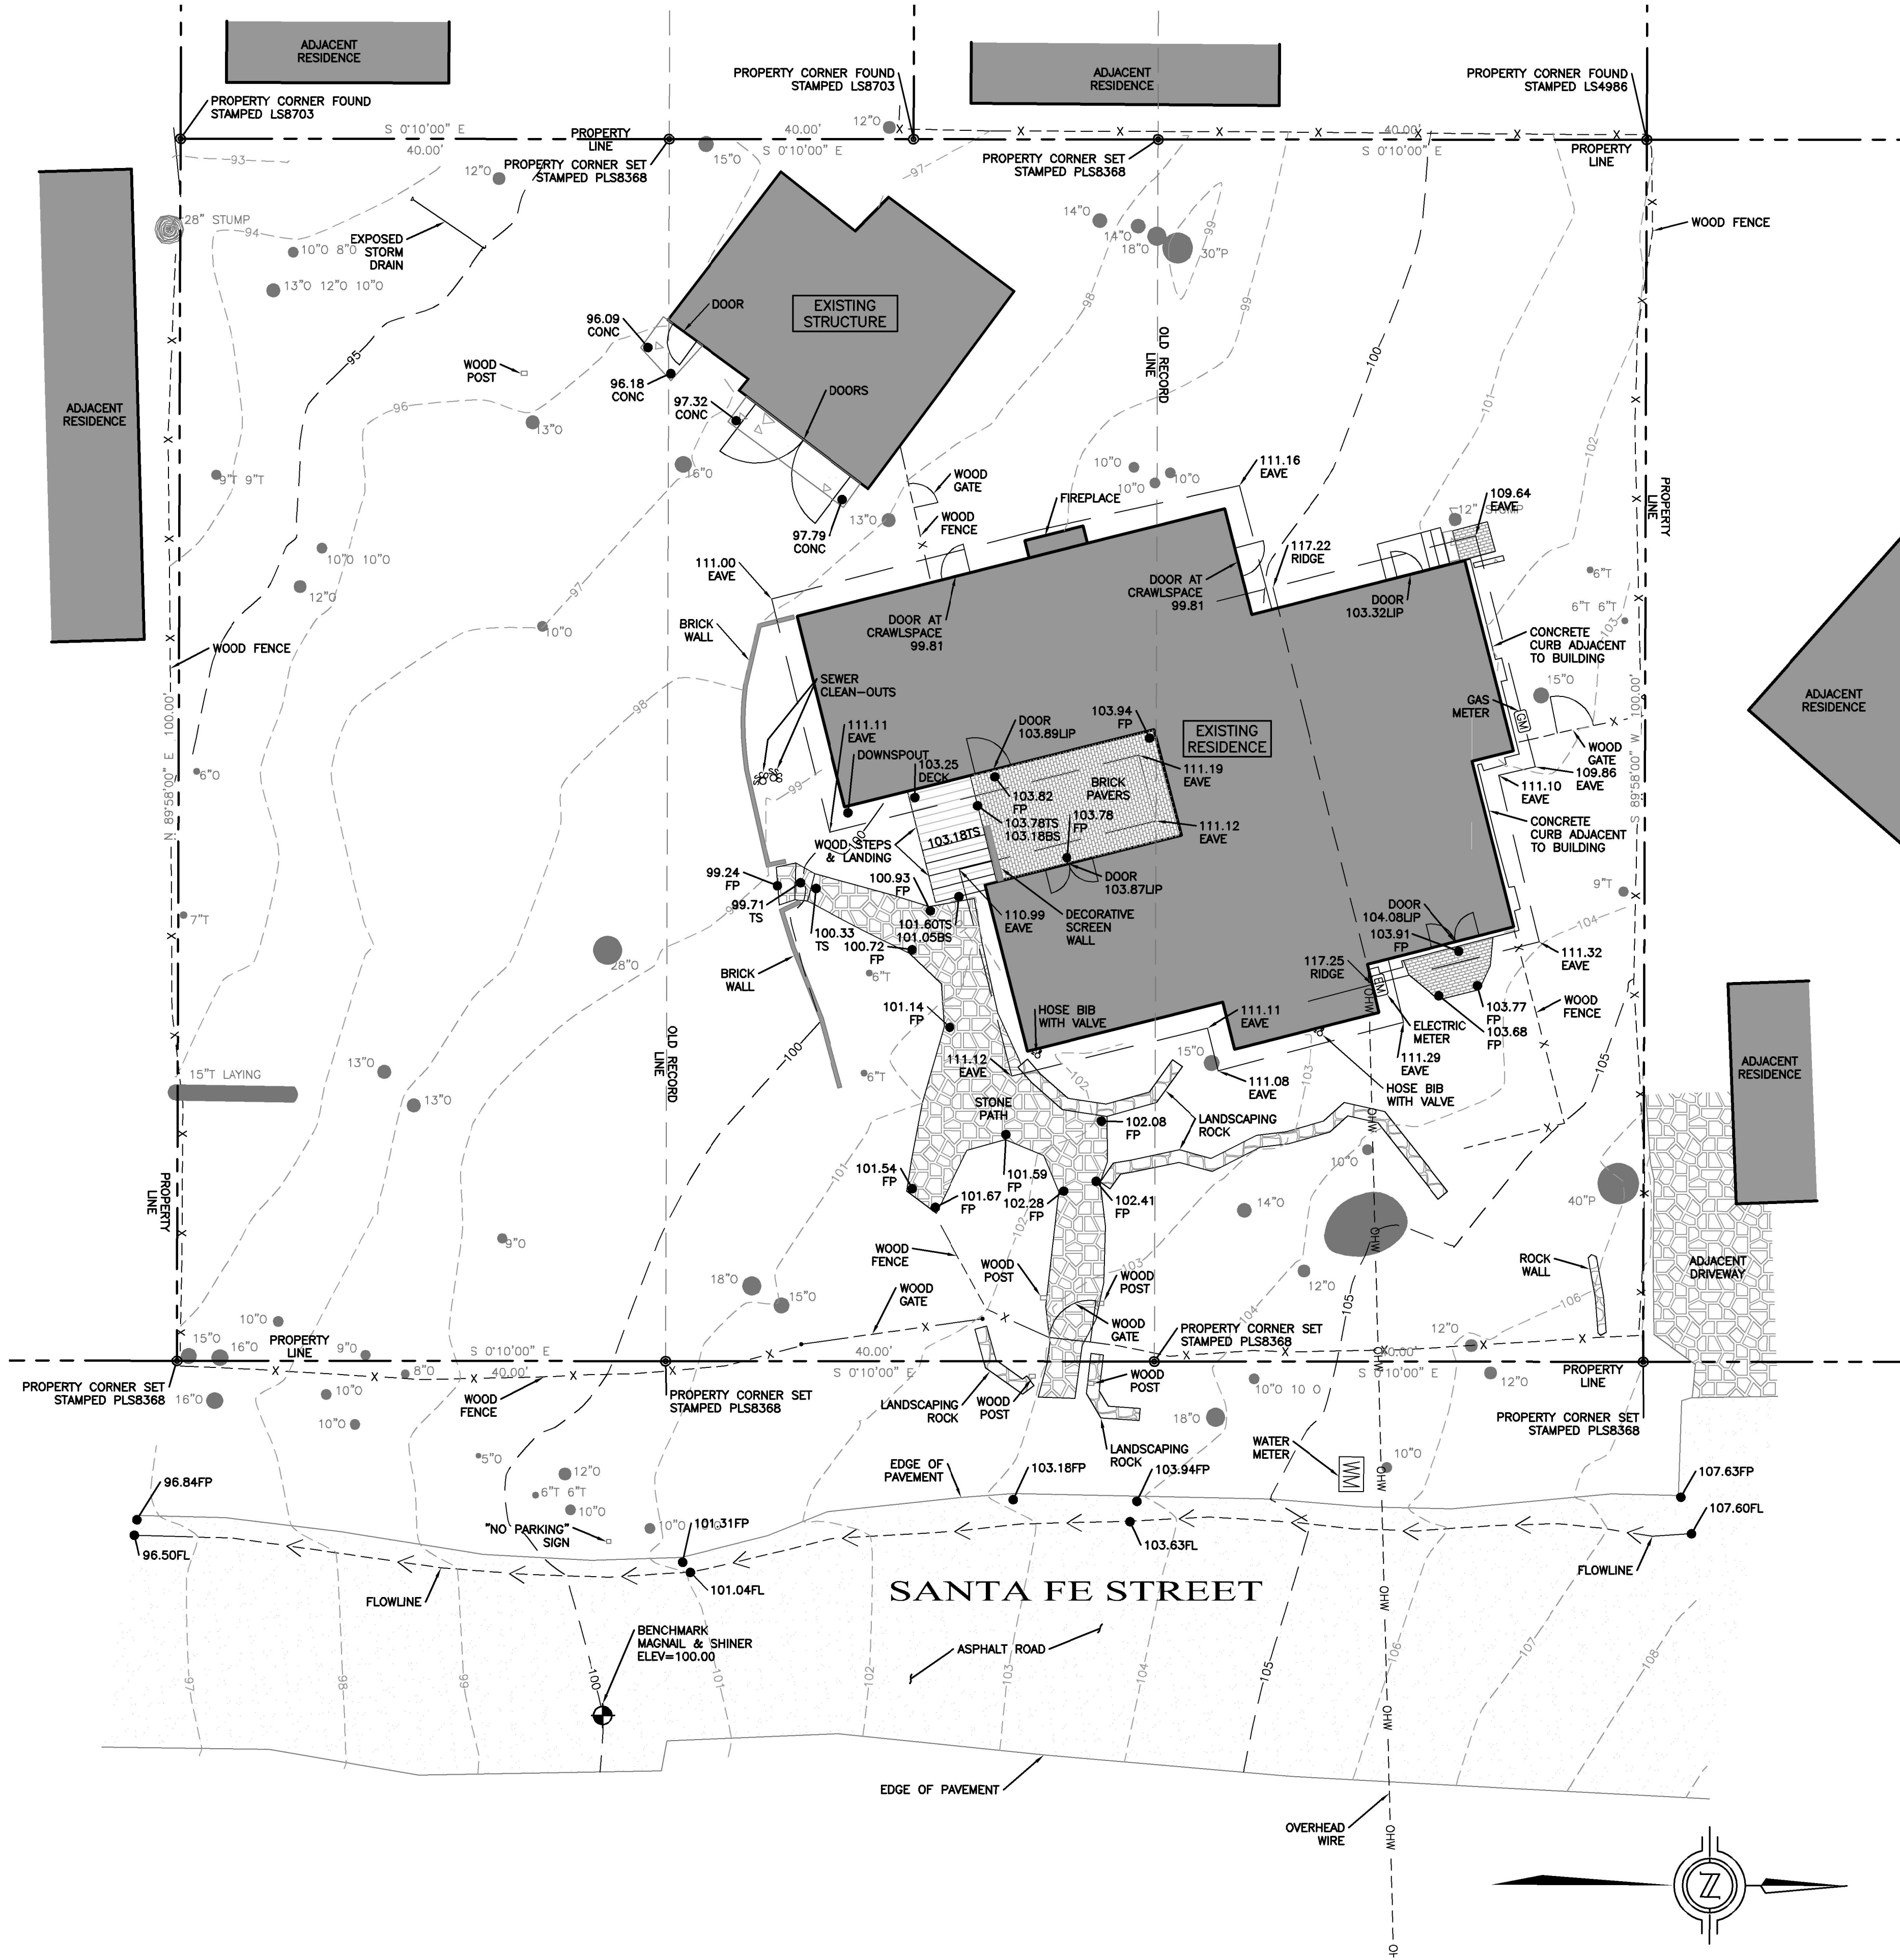
- NOTES:**
- BOUNDARY DATA SHOWN HEREON WERE DETERMINED WITH THE BENEFIT OF A FIELD SURVEY SUPPLEMENTED BY RECORD DOCUMENTS. ALL BOUNDARY DATA SHOWN HEREON ARE FROM THE RECORDS PER VOLUME 27 SURVEYS, AT PAGE 142, AND SHOWN APPROXIMATE ONLY.

- THIS TOPOGRAPHIC SURVEY IS PREPARED FOR DESIGN PURPOSES ONLY.
 - ENTITLEMENTS OR ENCUMBRANCES AFFECTING THIS PROPERTY MAY NOT NECESSARILY BE SHOWN.
 - DISTANCES SHOWN ARE EXPRESSED IN FEET AND DECIMALS THEREOF.

- CONTOUR INTERVAL = ONE FOOT.
 - TREE TYPES ARE INDICATED WHERE KNOWN. DIAMETERS OF TREES ARE SHOWN IN INCHES AND ARE APPROXIMATE ONLY, TO BE VERIFIED BY AN APPROVED ARBORIST. TREES SMALLER THAN 6" ARE NOT NECESSARILY SHOWN. DIRECTION OF GROWTH AND DRIP LINE SHAPE TO BE VERIFIED BY OTHERS.

- A LOCAL BENCHMARK FOR THIS PROJECT IS A SET MAG NAIL AND SHINER IN SANTA FE STREET AS SHOWN HEREON, HAVING AN ELEVATION OF 100.00 BASED ON AN ASSUMED DATUM.

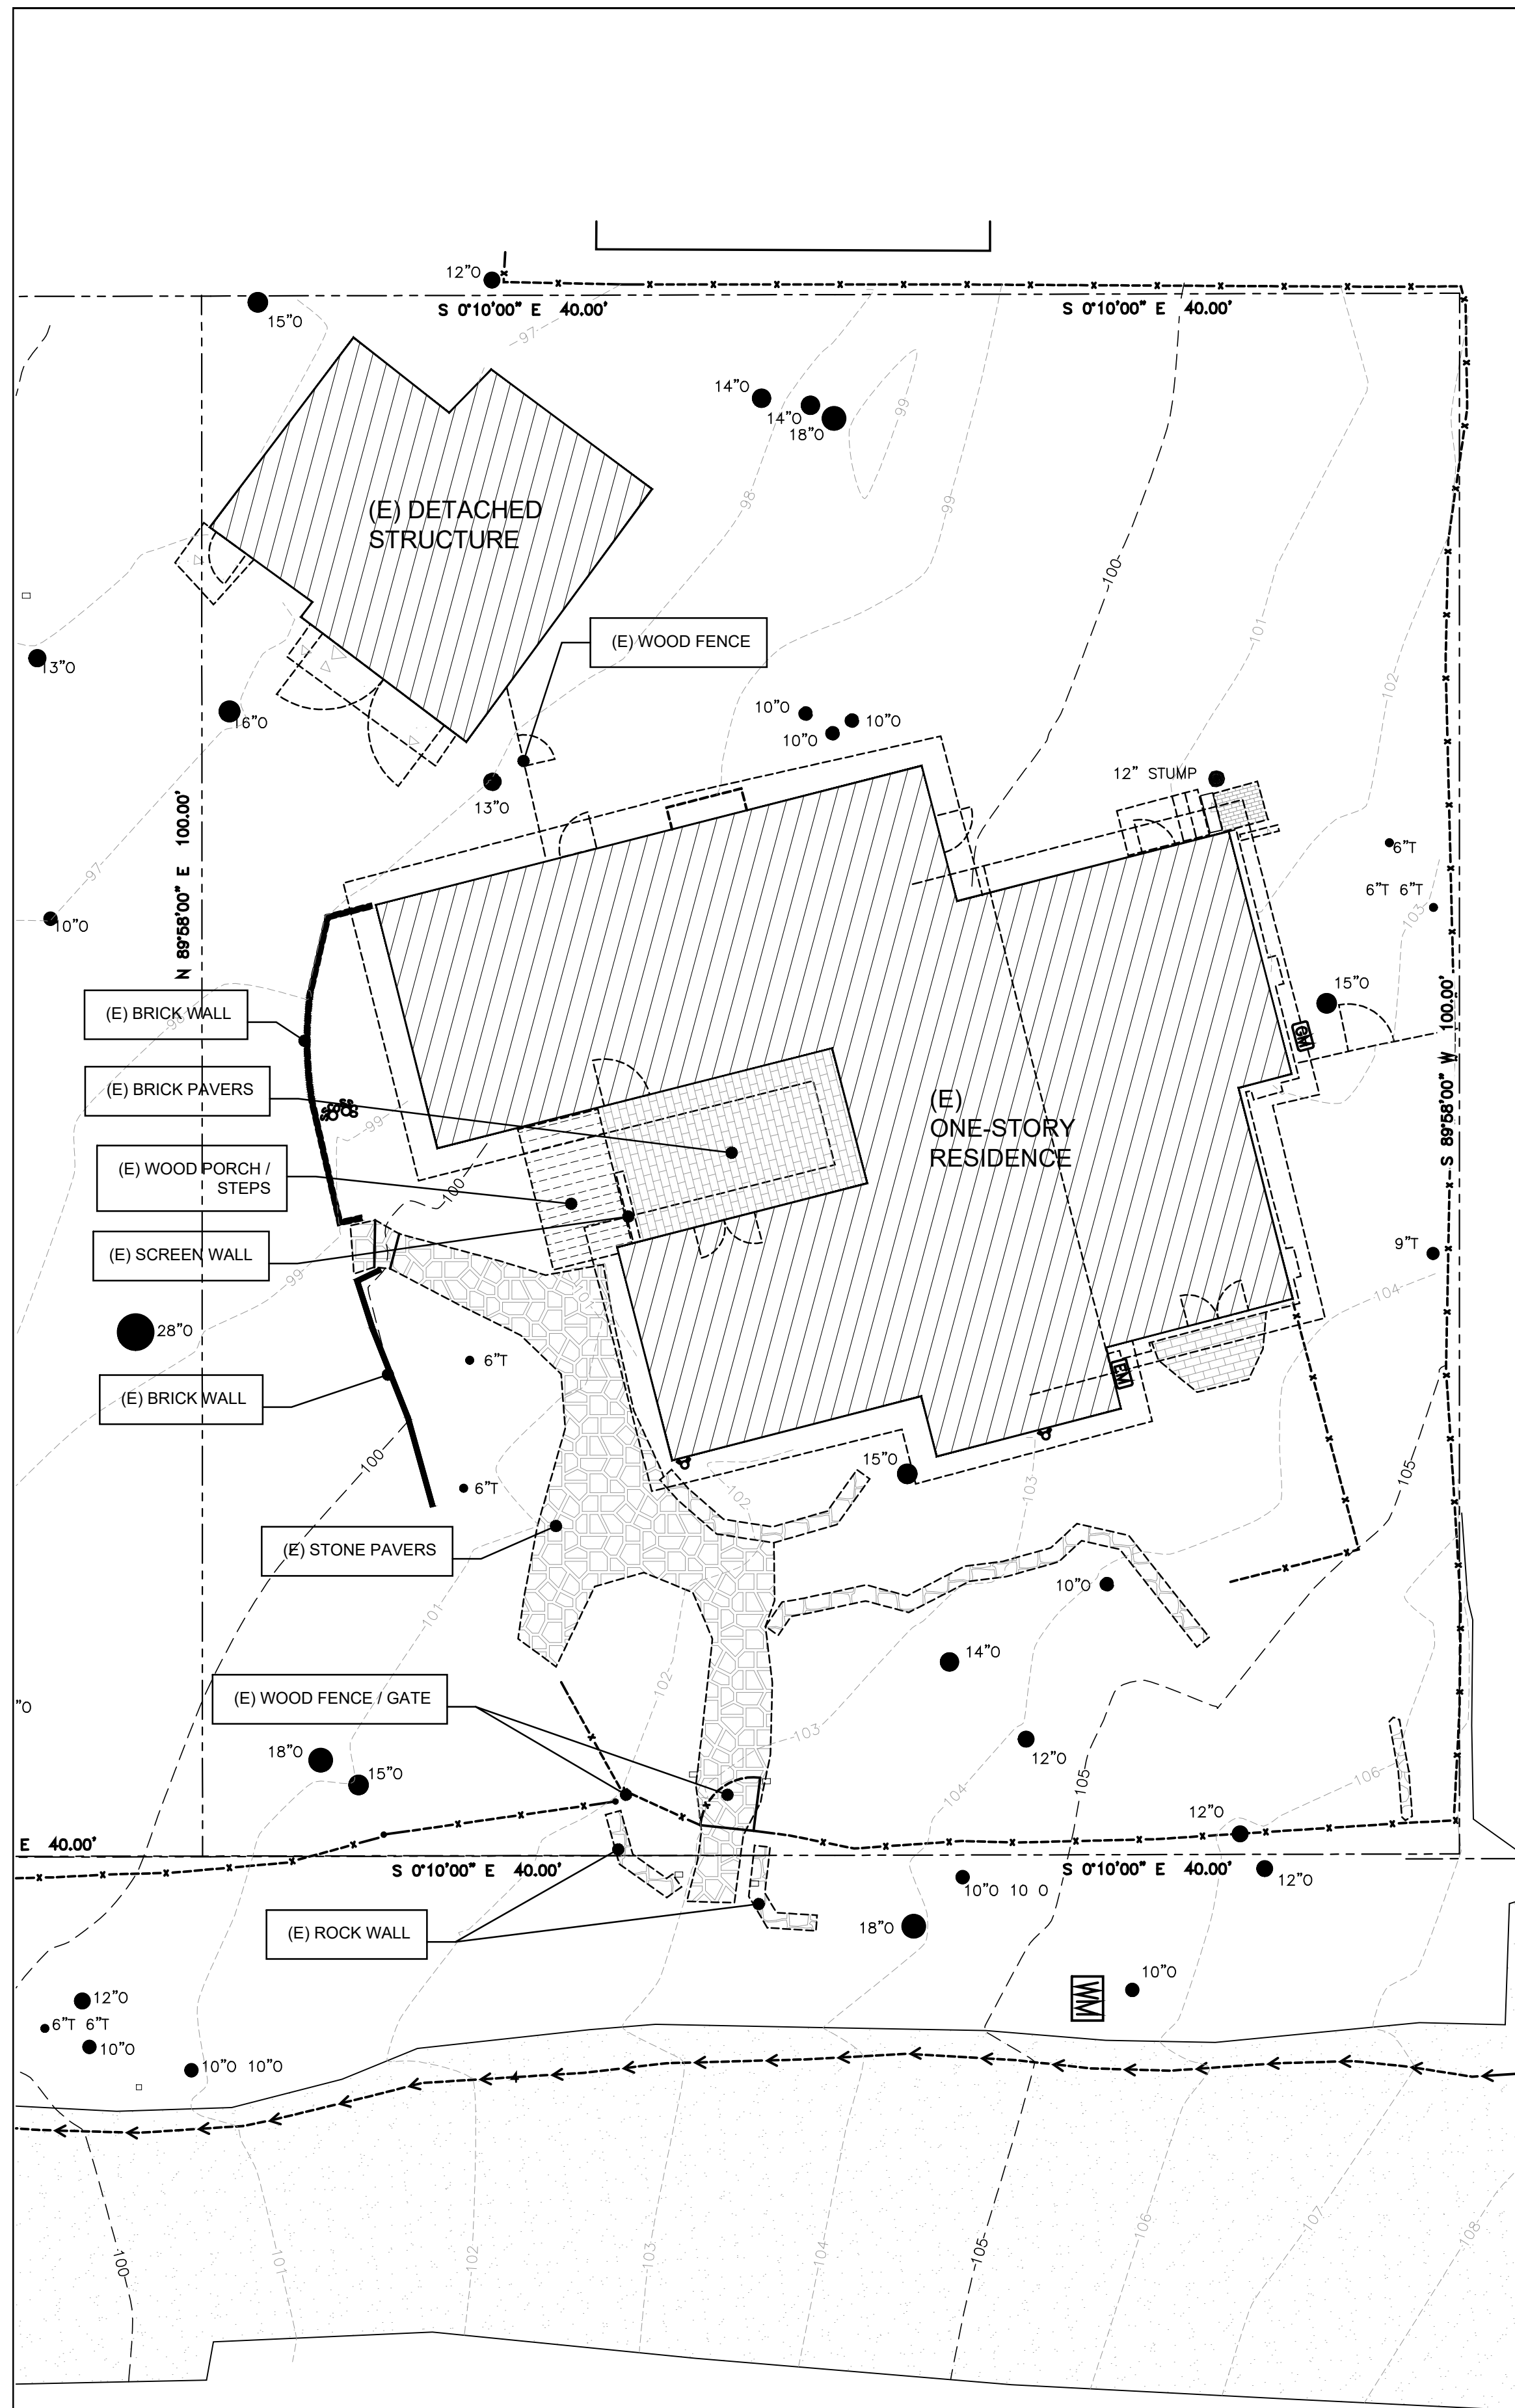
(E) SITE PLAN
SCALE: 1/8" = 1'-0"

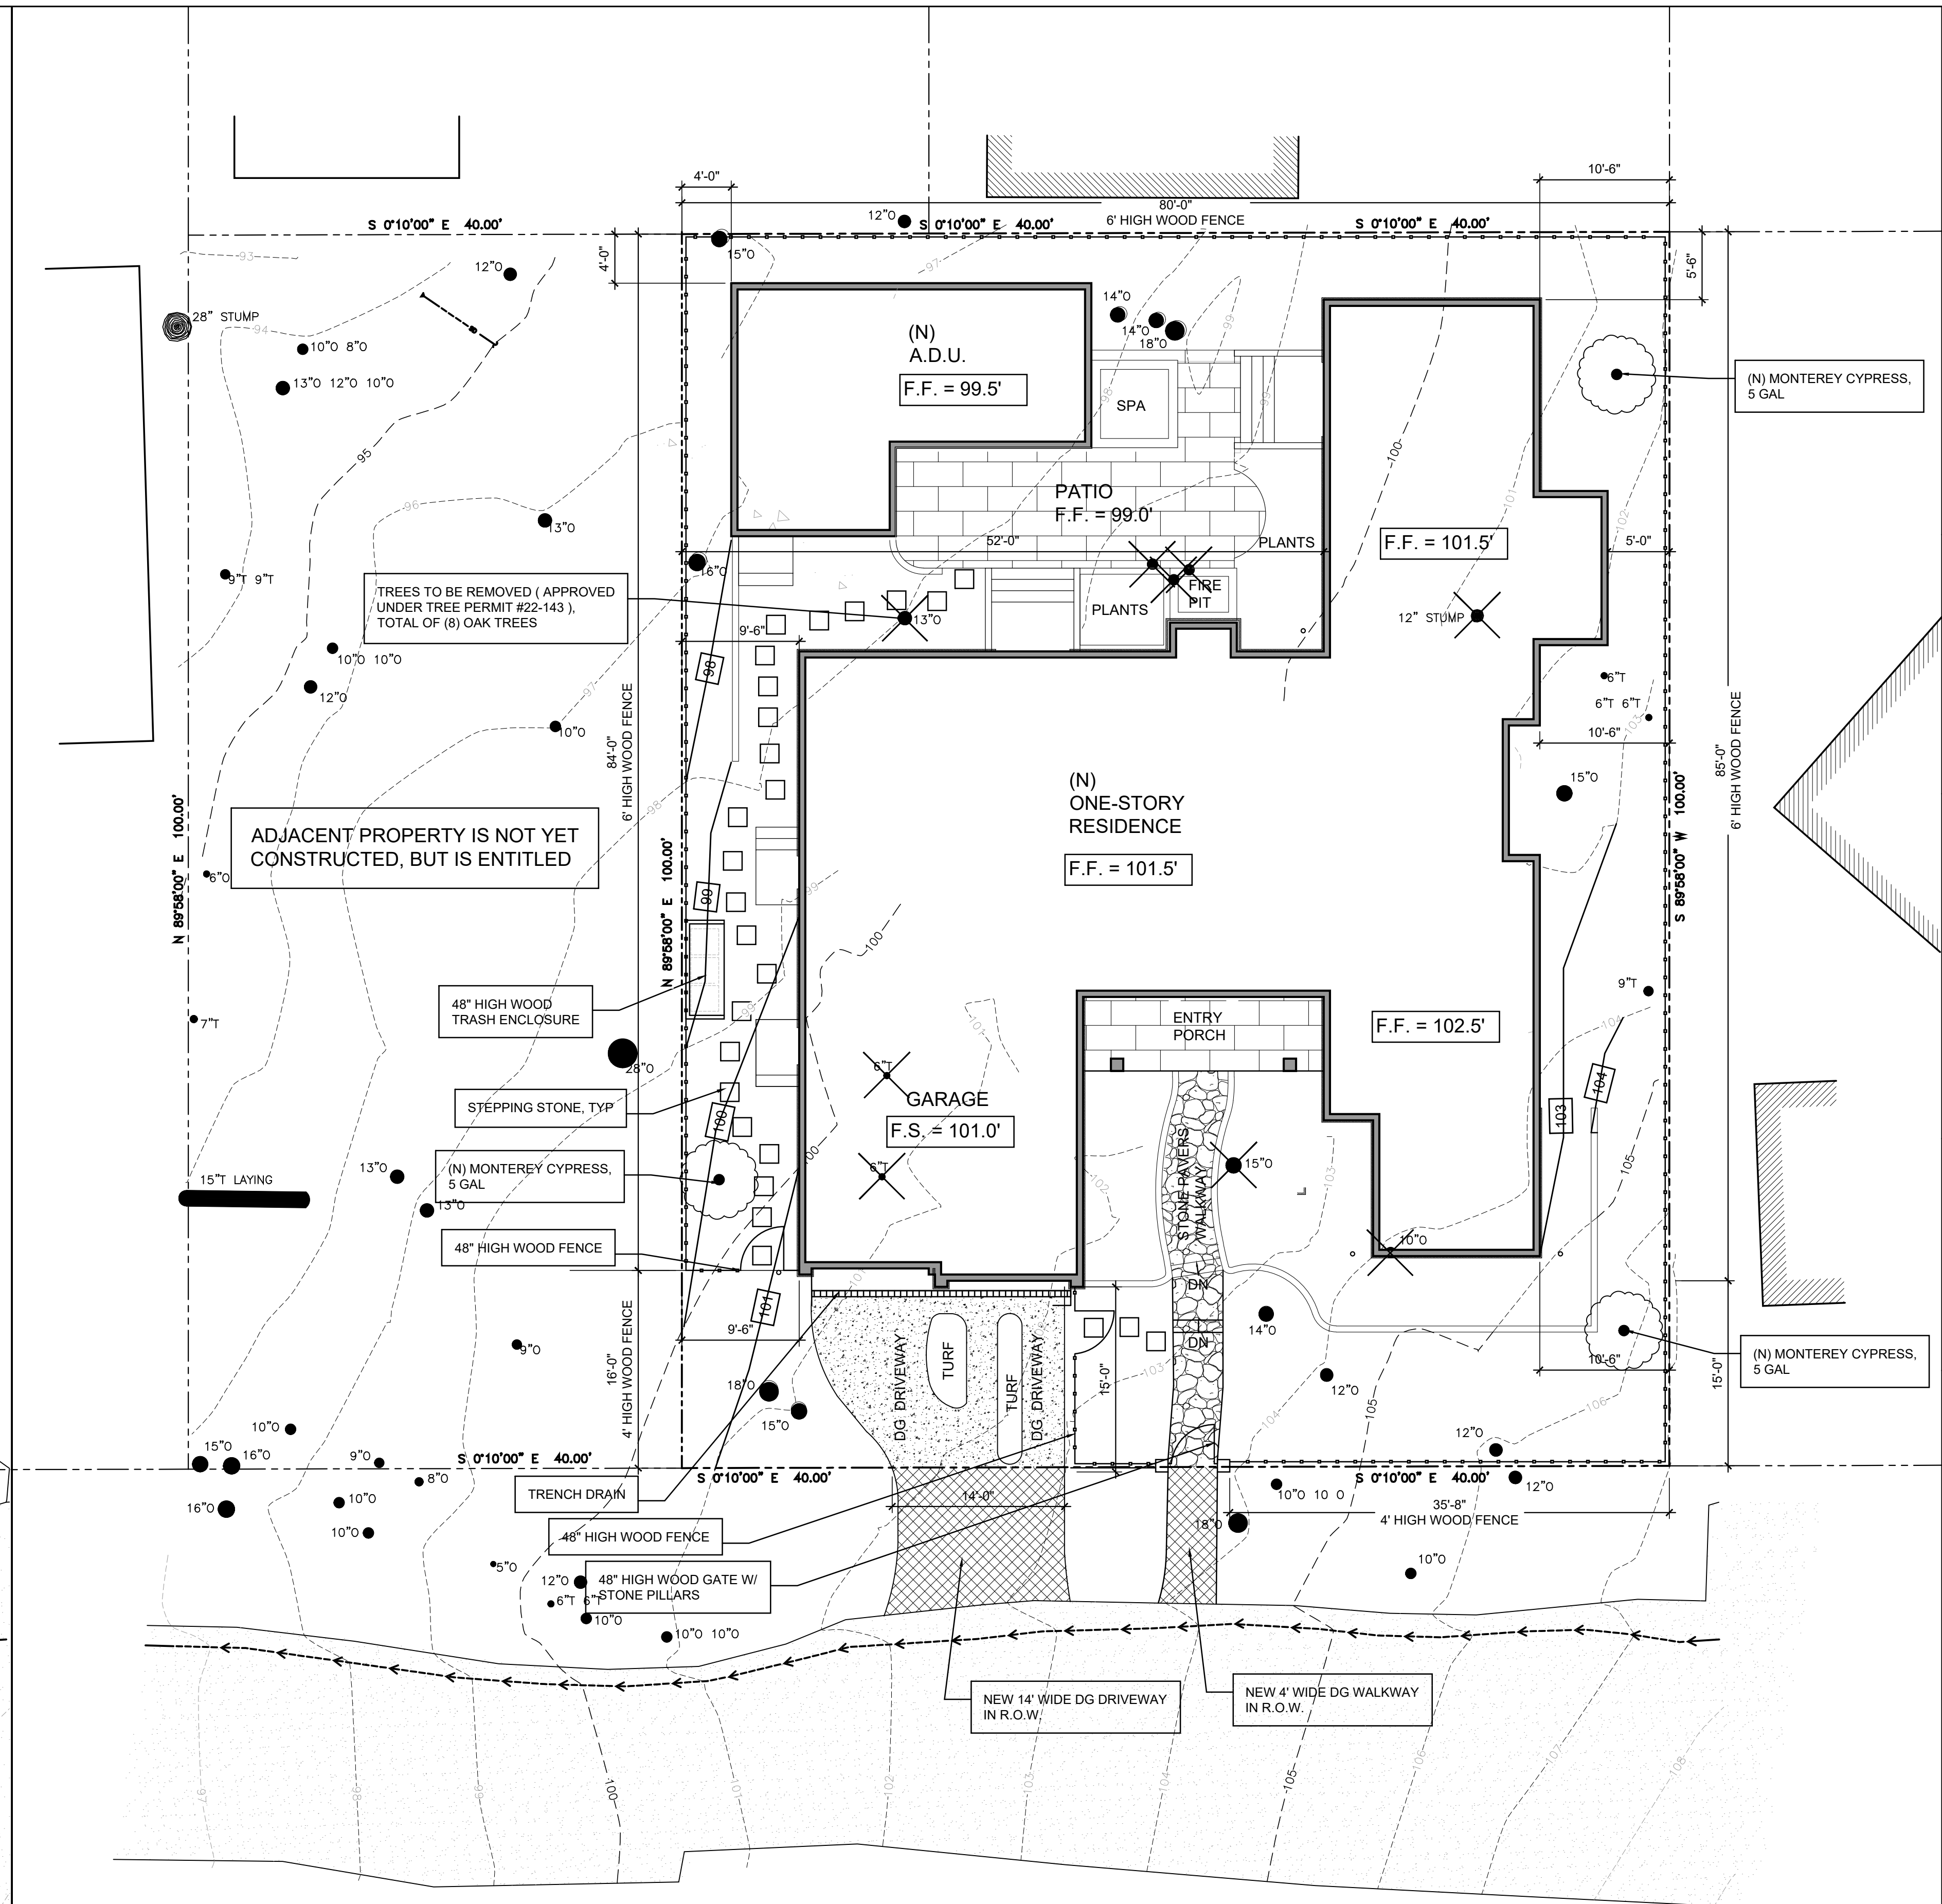
PROPOSED SITE PLAN
SCALE: 1/8" = 1'-0"

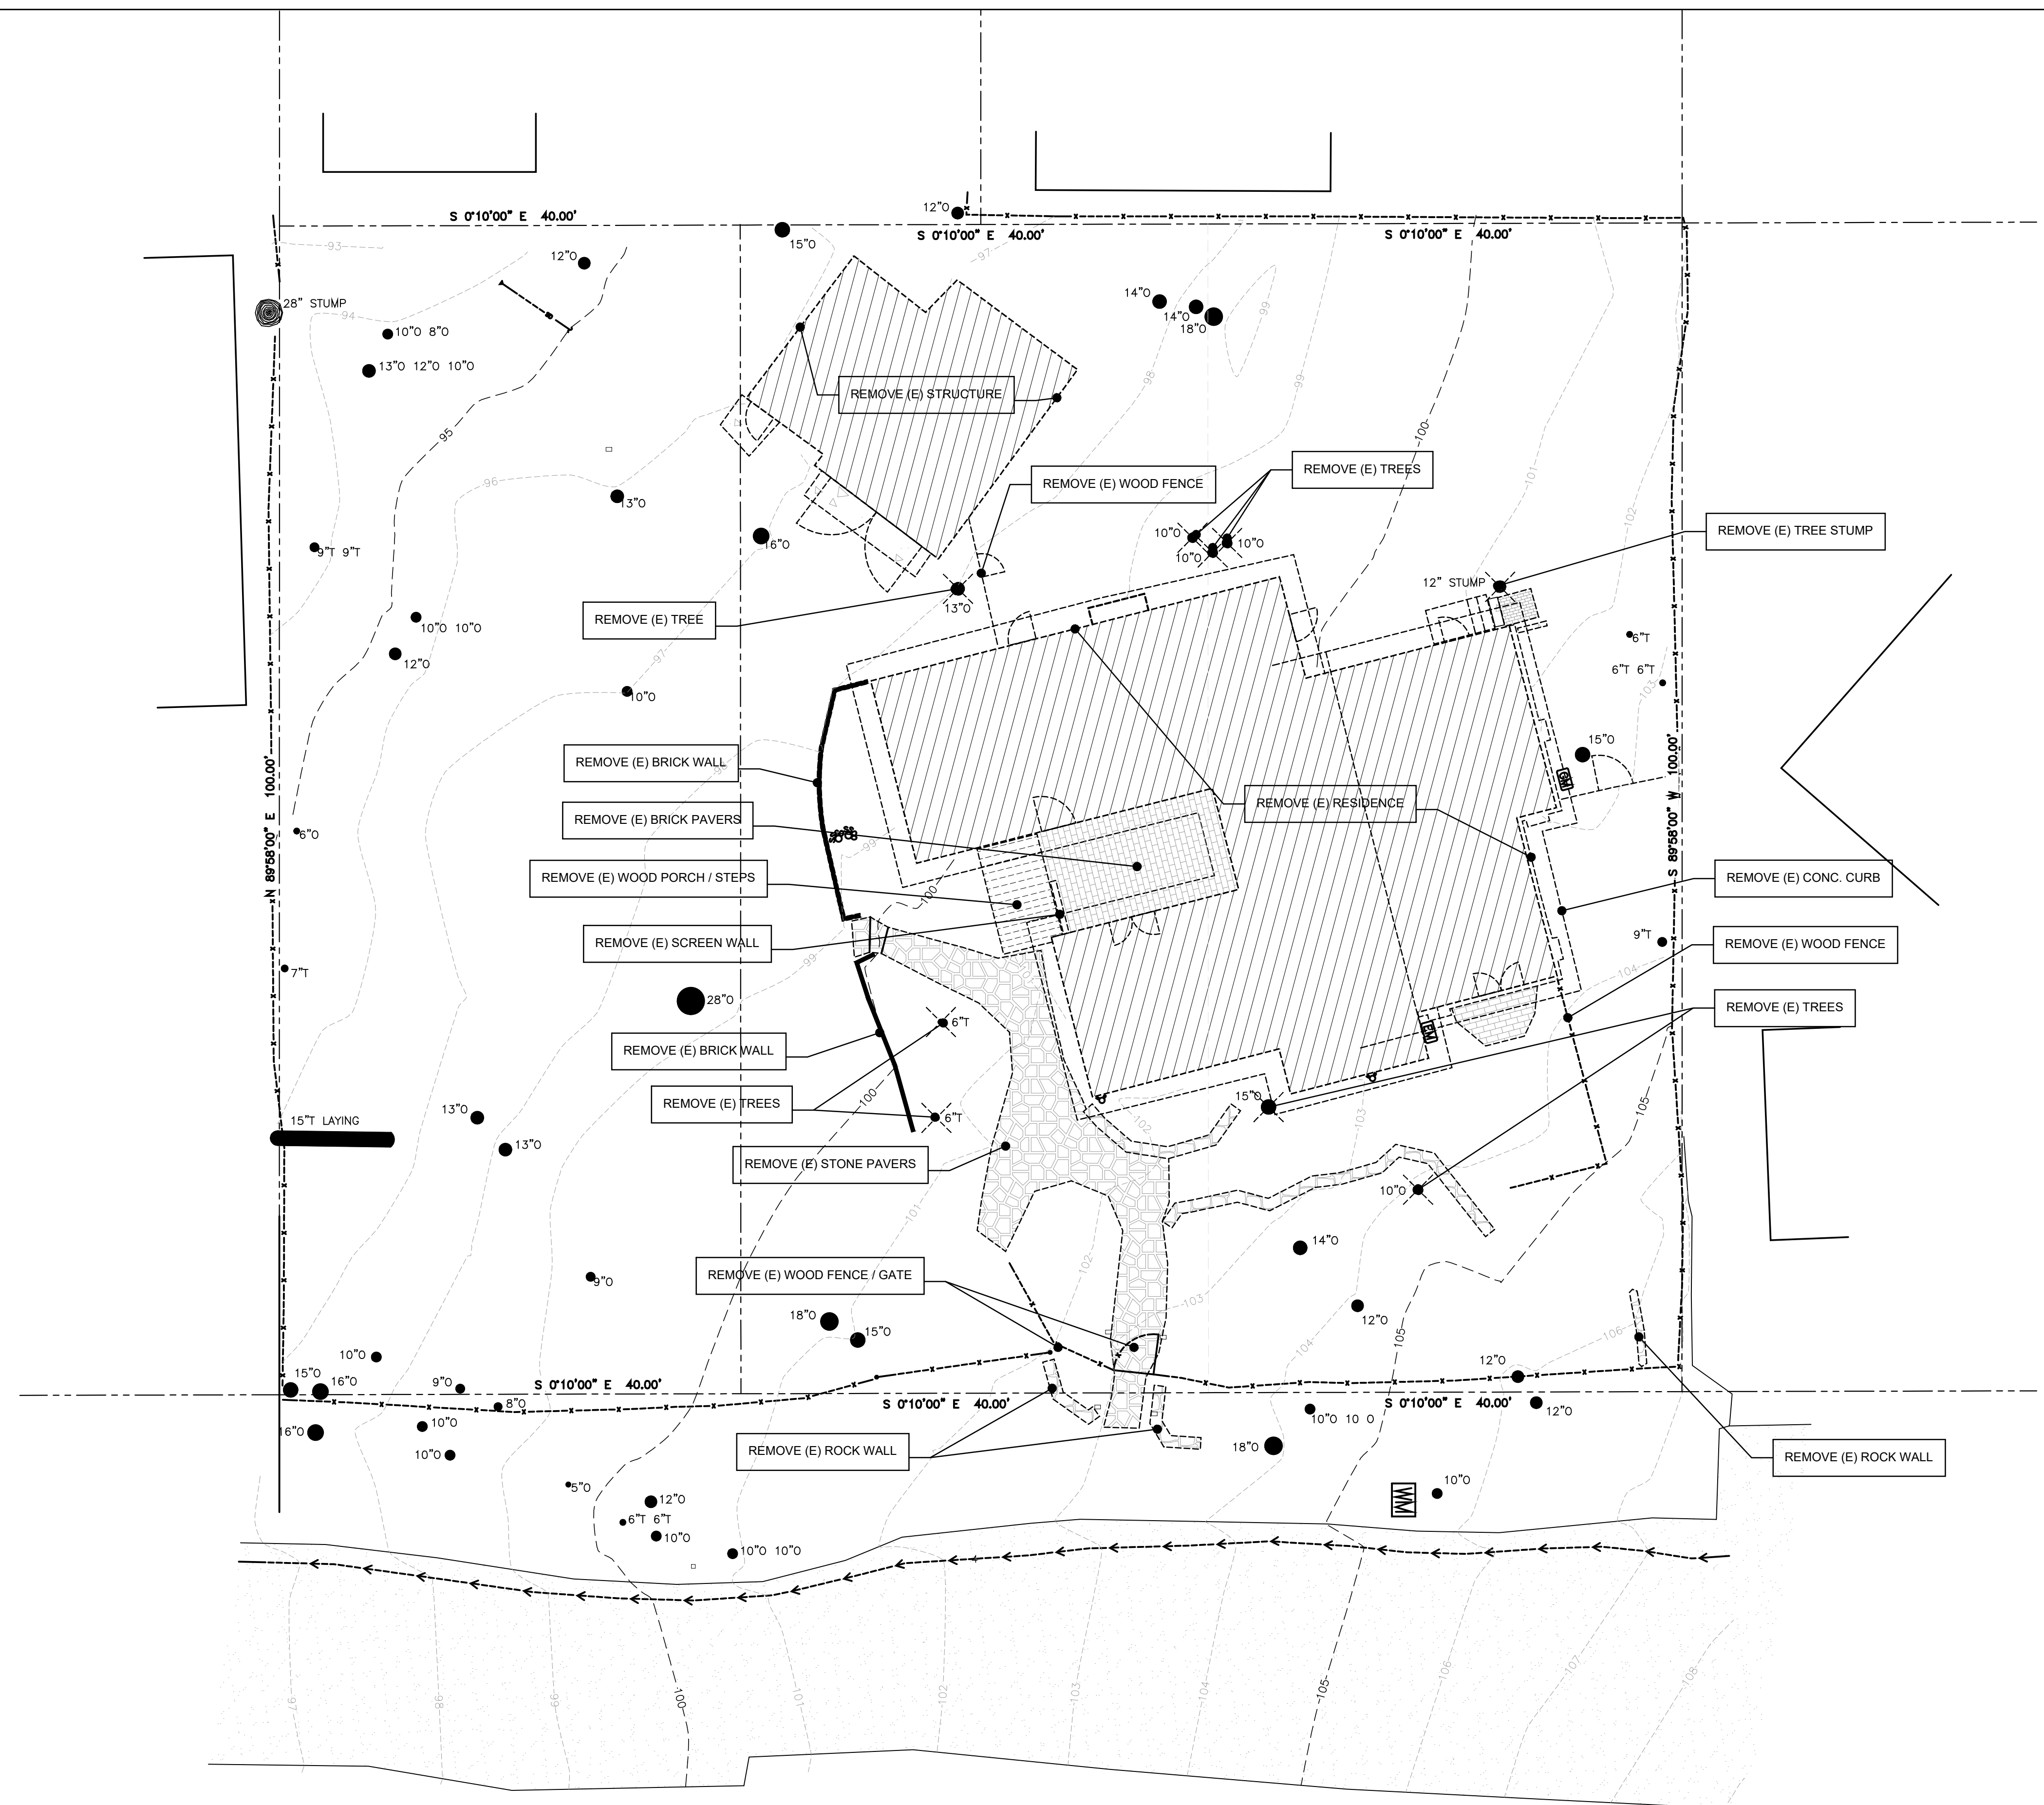
SITE DEMOLITION PLAN

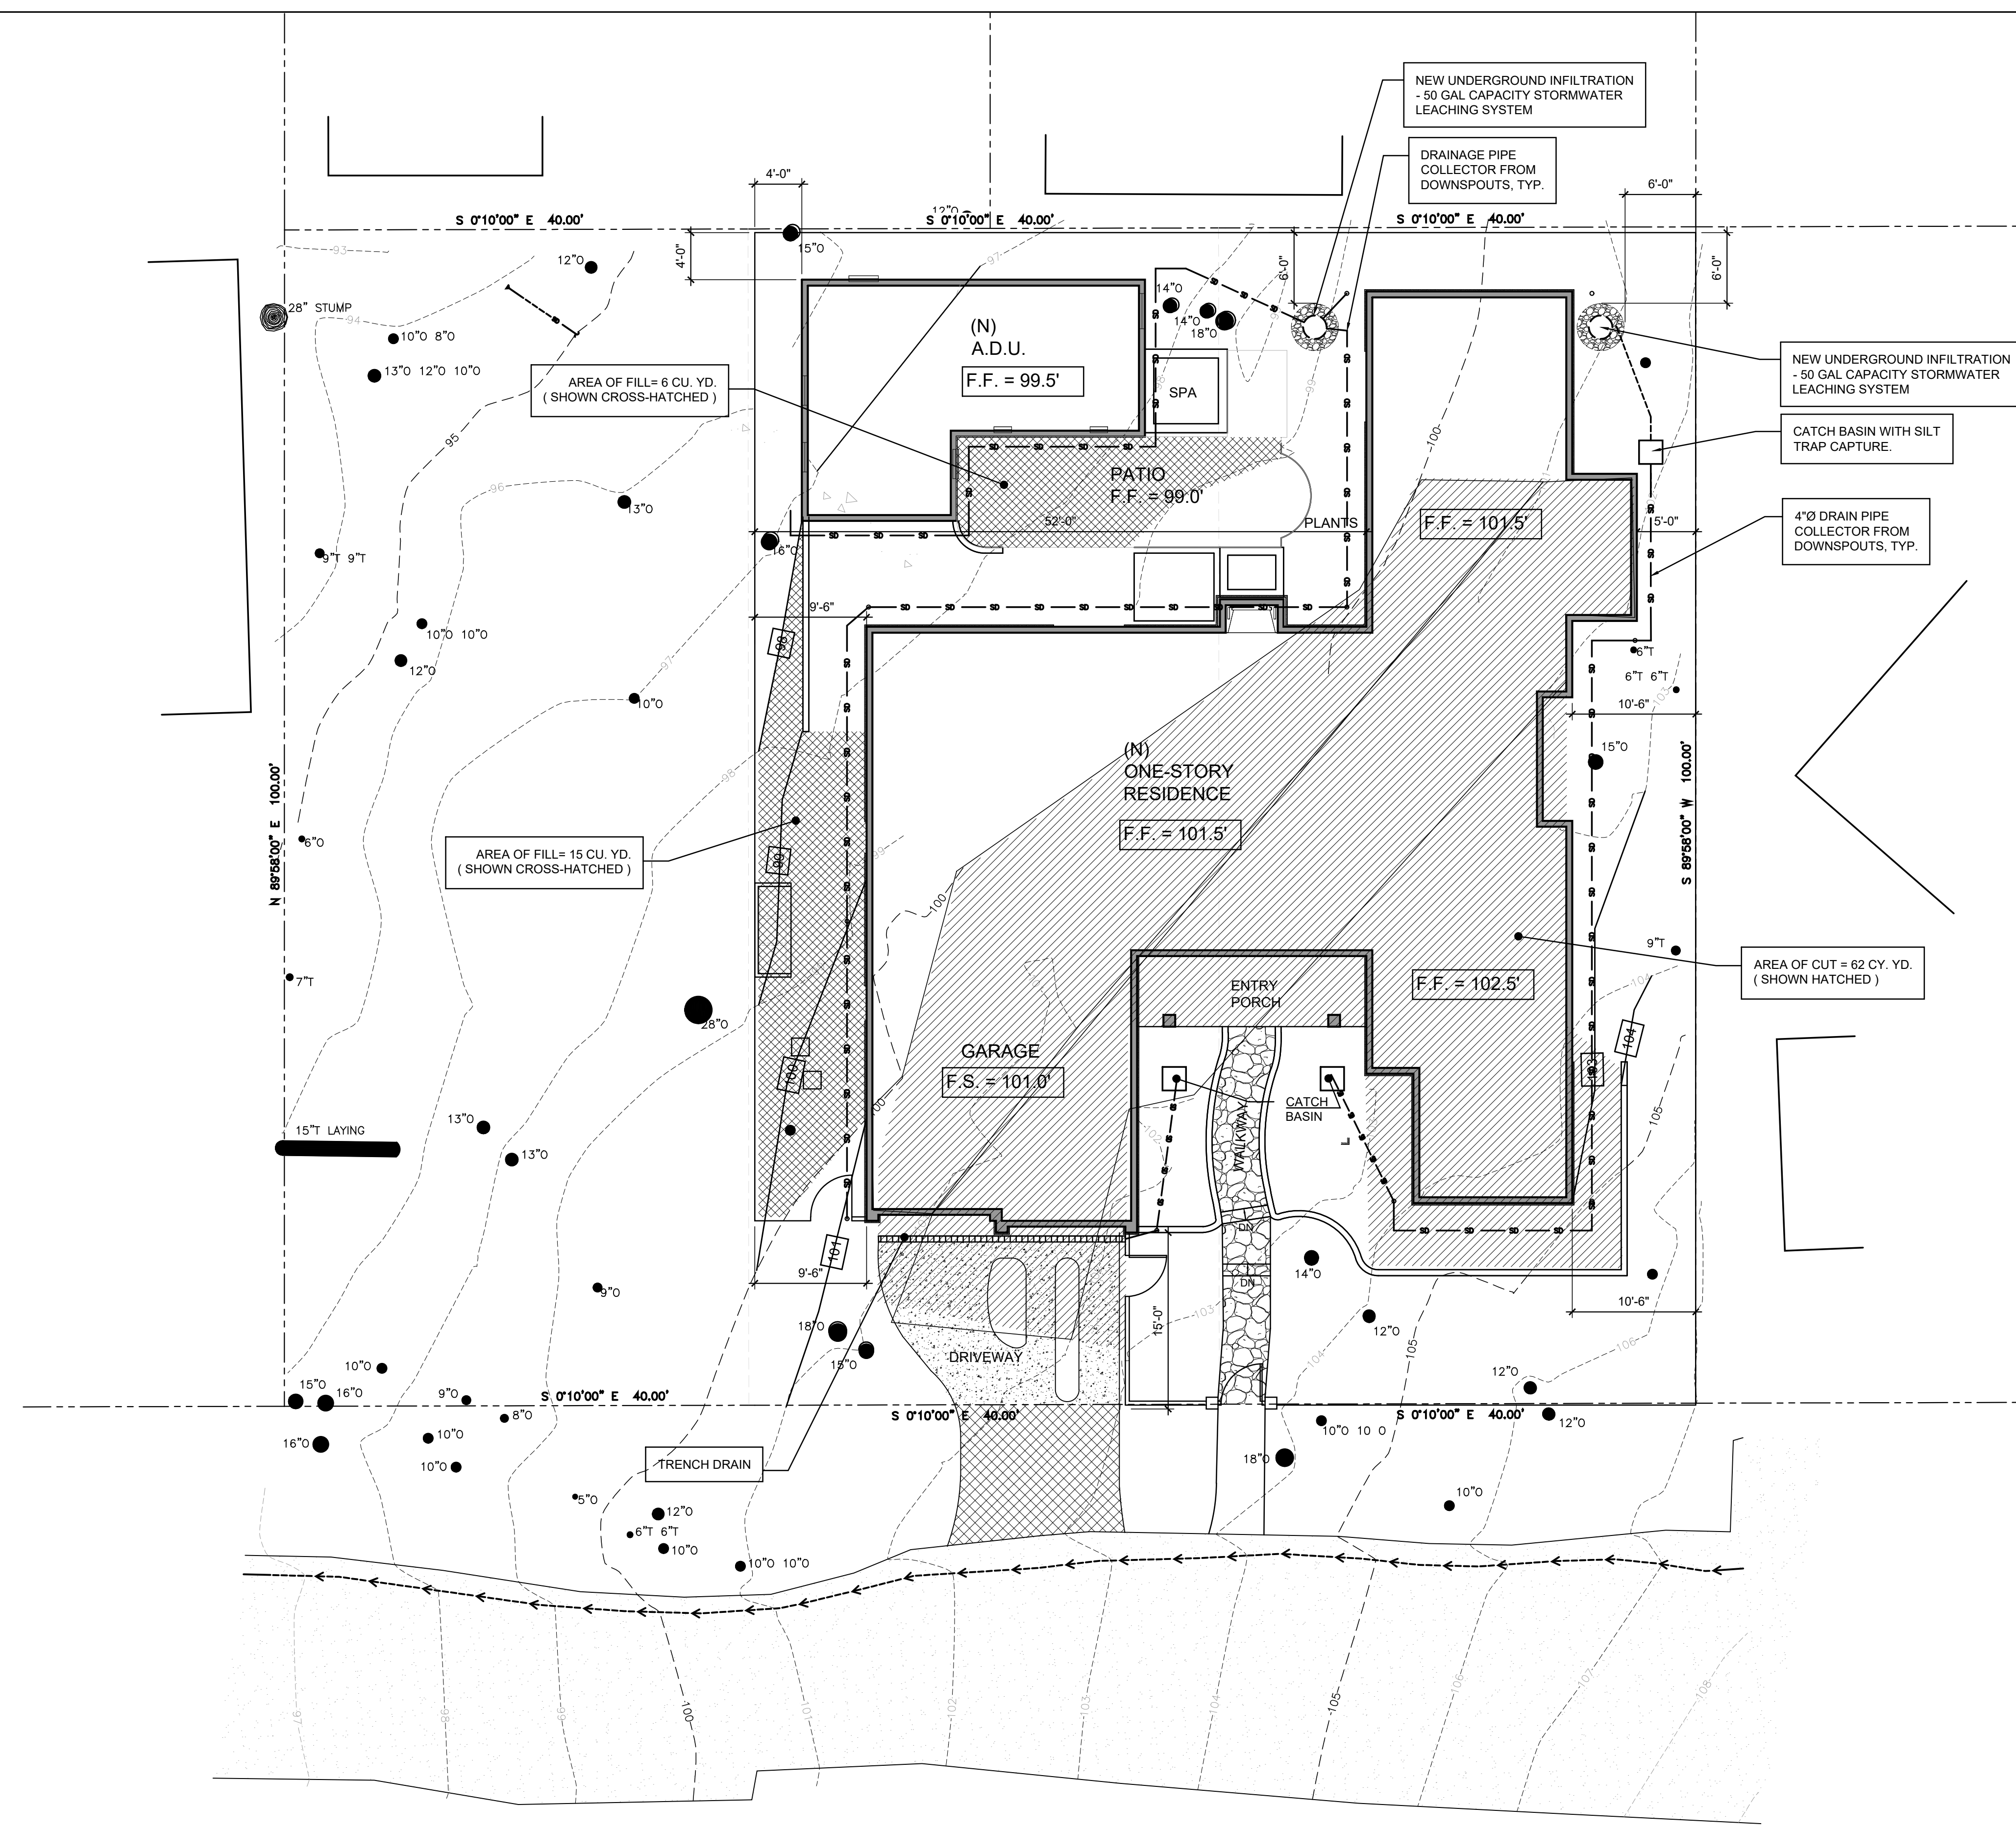
PRELIMINARY GRADING & EROSION CONTROL PLAN
