BRITTON RESIDENCE

DEMOLITION OF (E) RESIDENCE AND ACCESSORY STRUCTURE, AND CONSTRUCTION OF NEW ONE-STORY RESIDENCE WITH ATTACHED 2-CAR GARAGE
CONSTRUCTION OF NEW DETACHED ACCESSORY DWELLING UNIT.

COVER SHEET

BRITTON RESIDENCE
SANTA FE STREET , 2 SW OF MOUNTAIN VIEW AVE.
CARMEL-BY-THE-SEA, CA 93923
A.P.N. 010-082-002

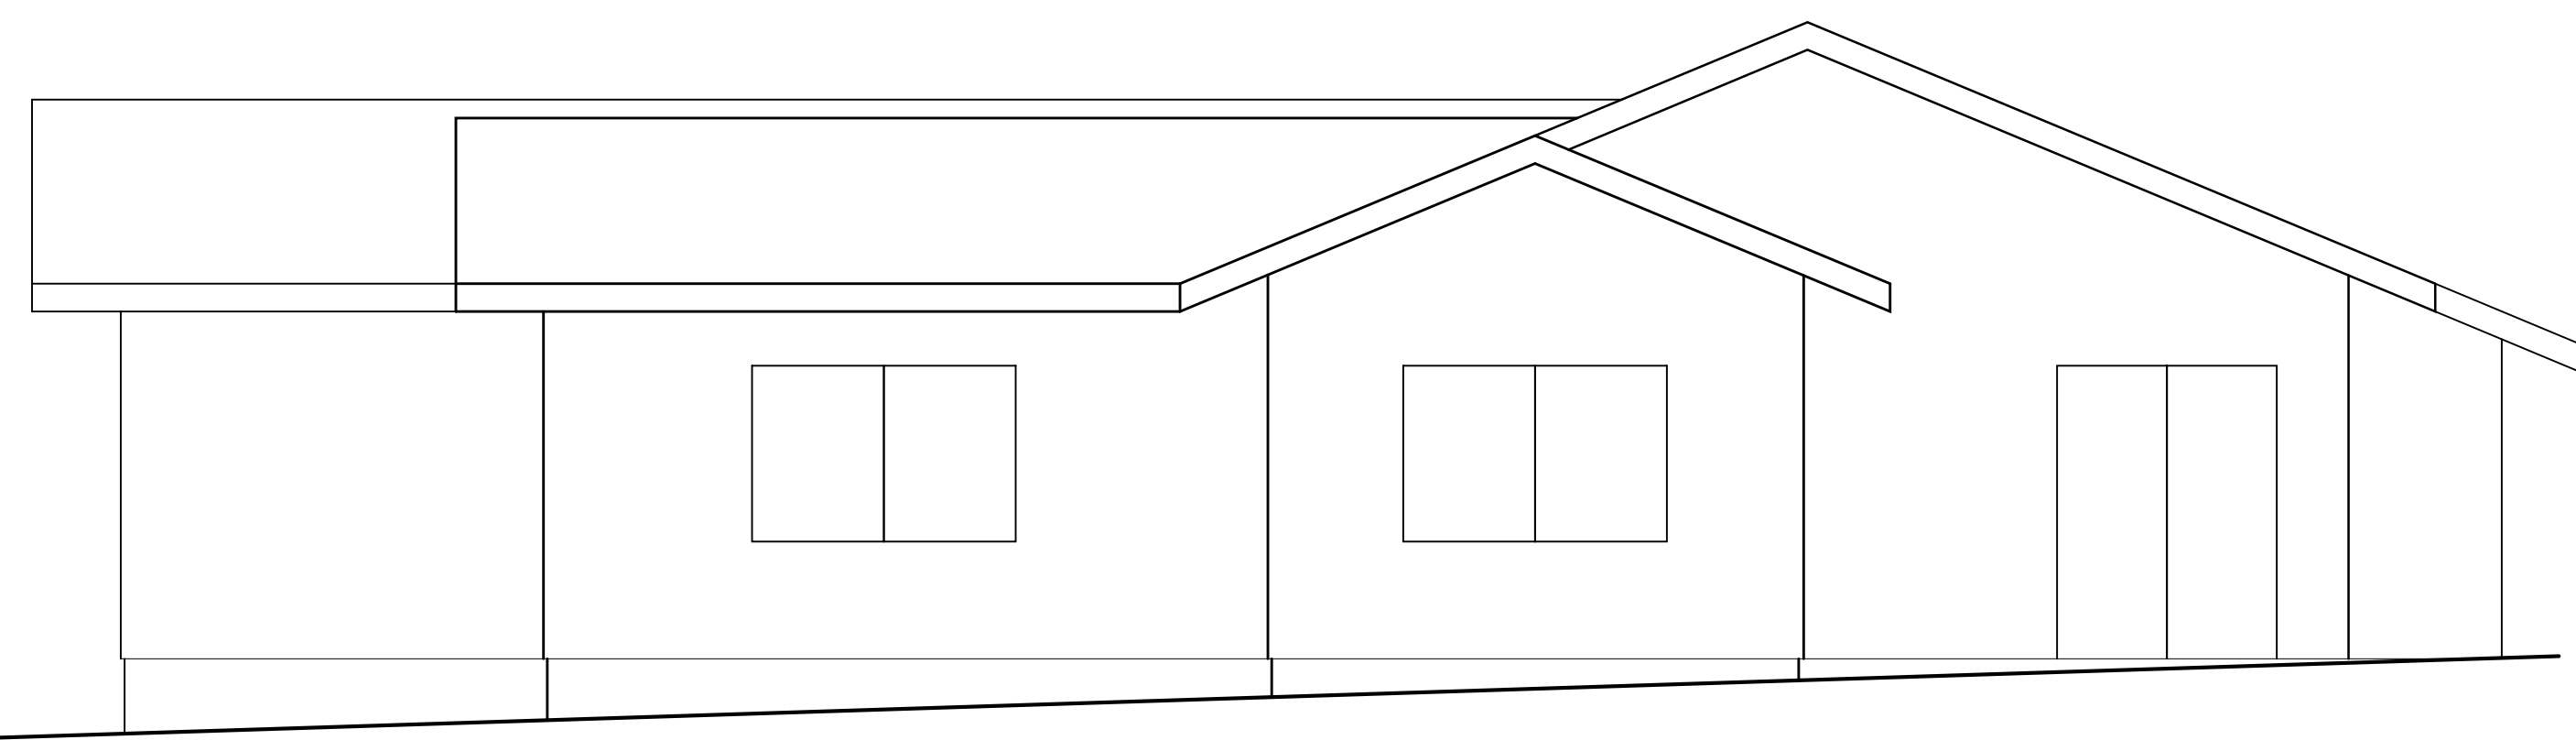
EXISTING EAST (FRONT) ELEVATION (TO BE DEMOLISHED)

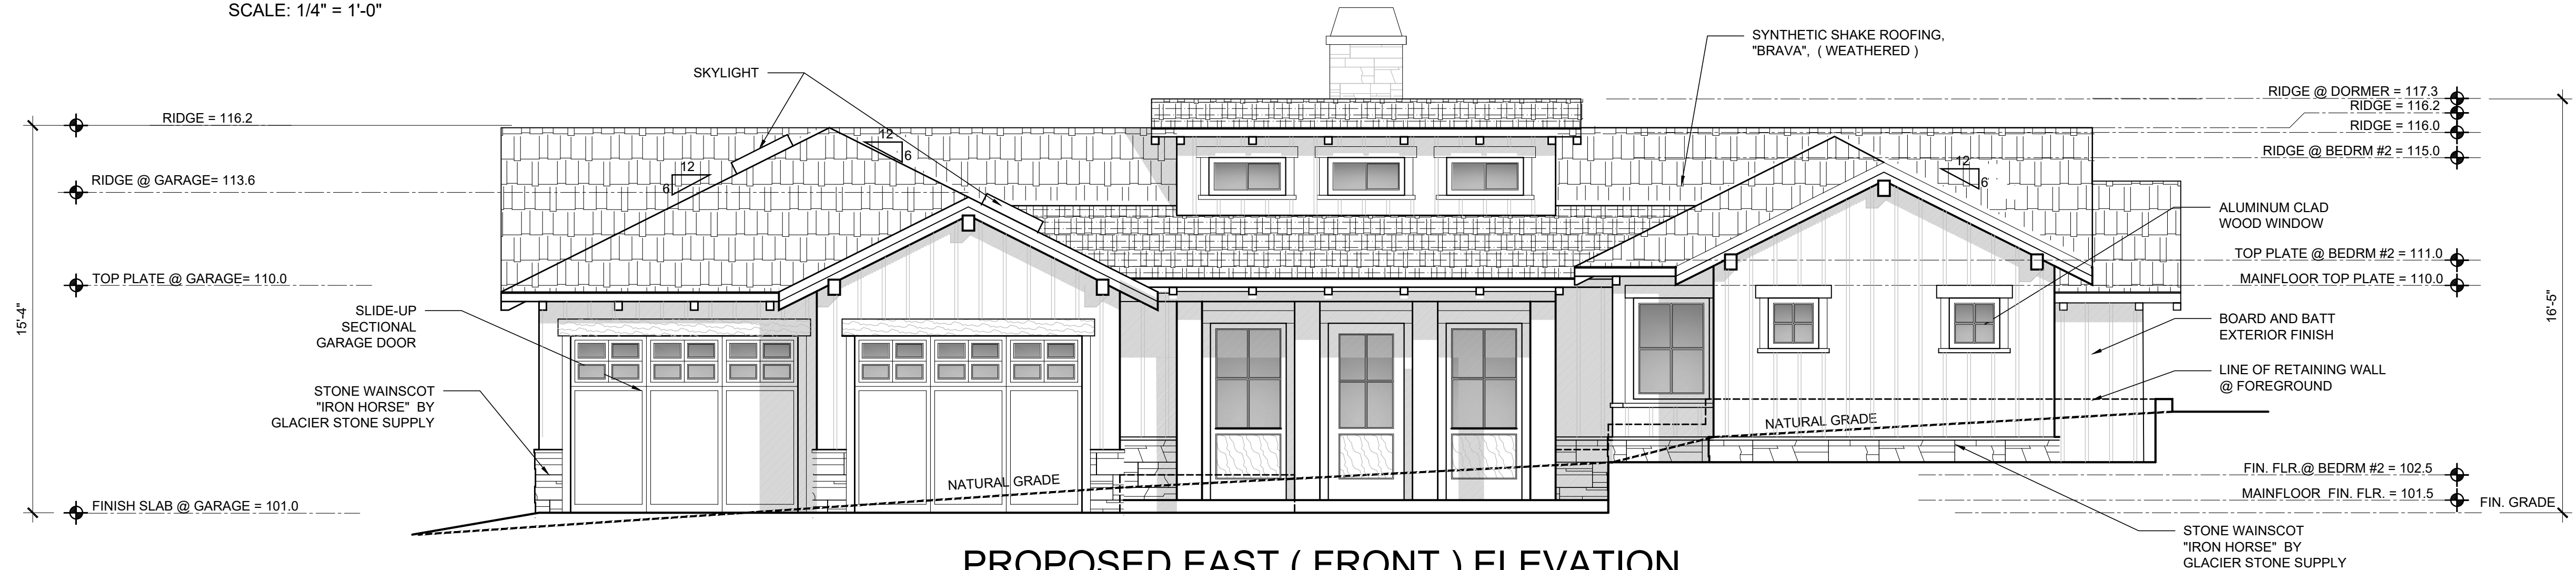
PROPOSED EAST (FRONT) ELEVATION

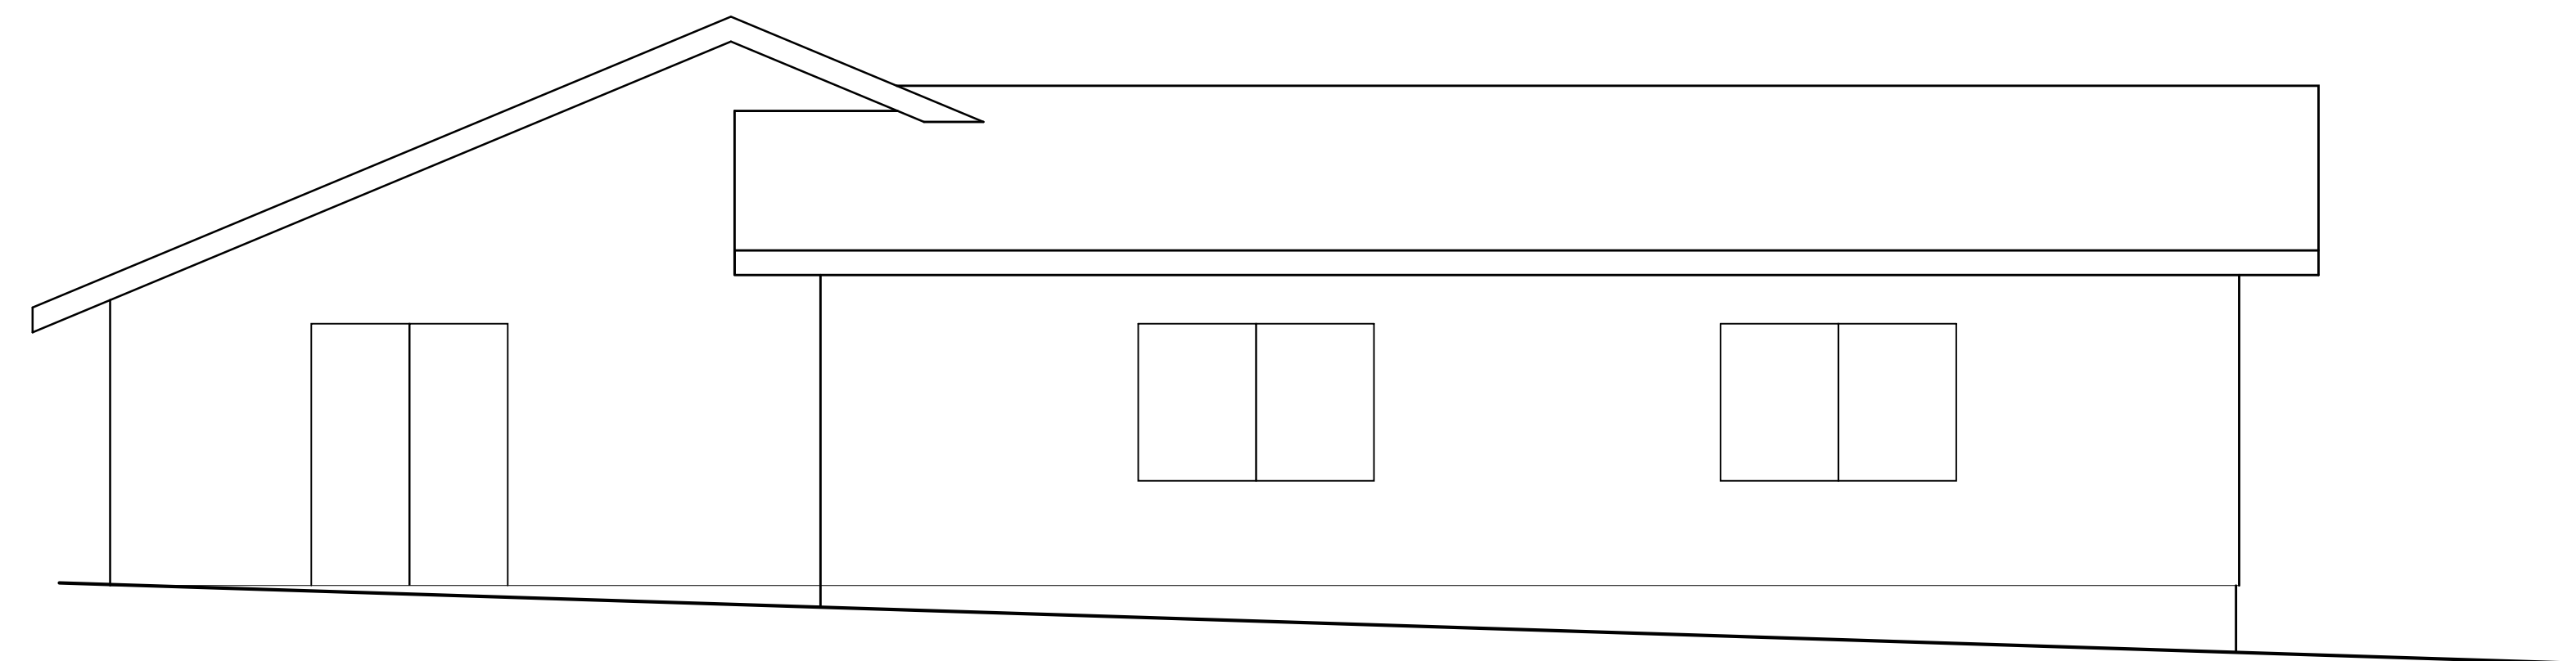
EXISTING WEST (REAR) ELEVATION (TO BE DEMOLISHED)

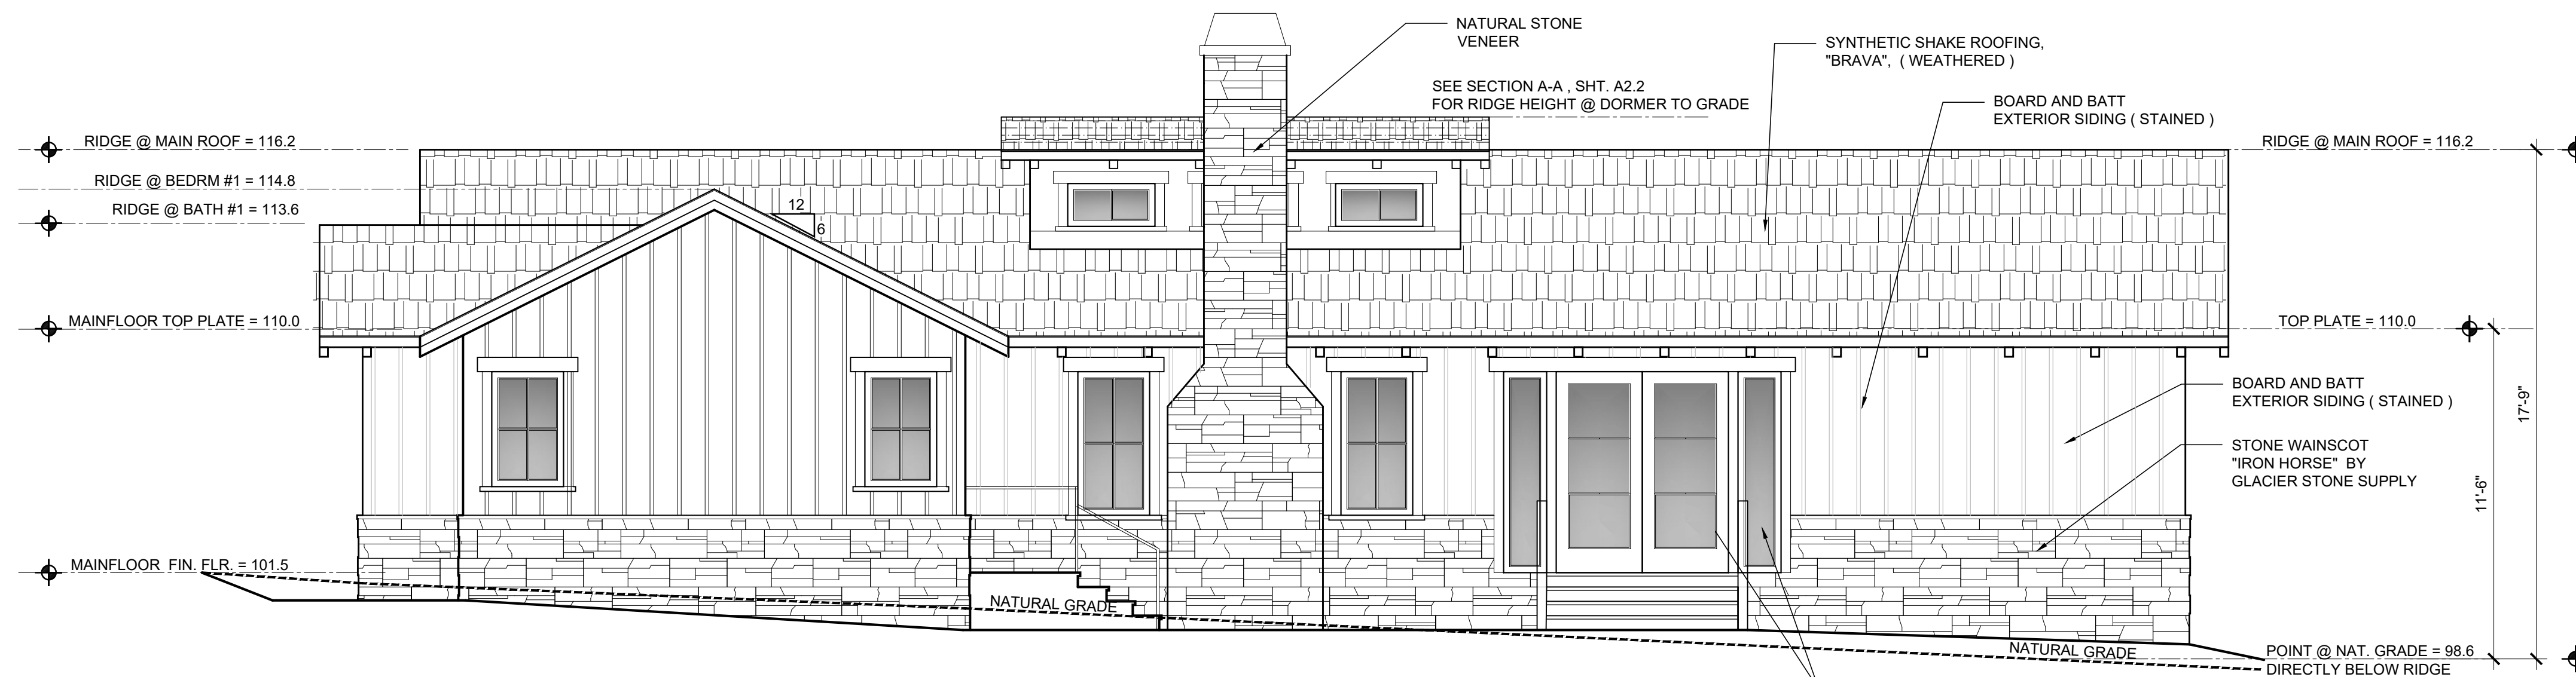
PROPOSED WEST (REAR) ELEVATION

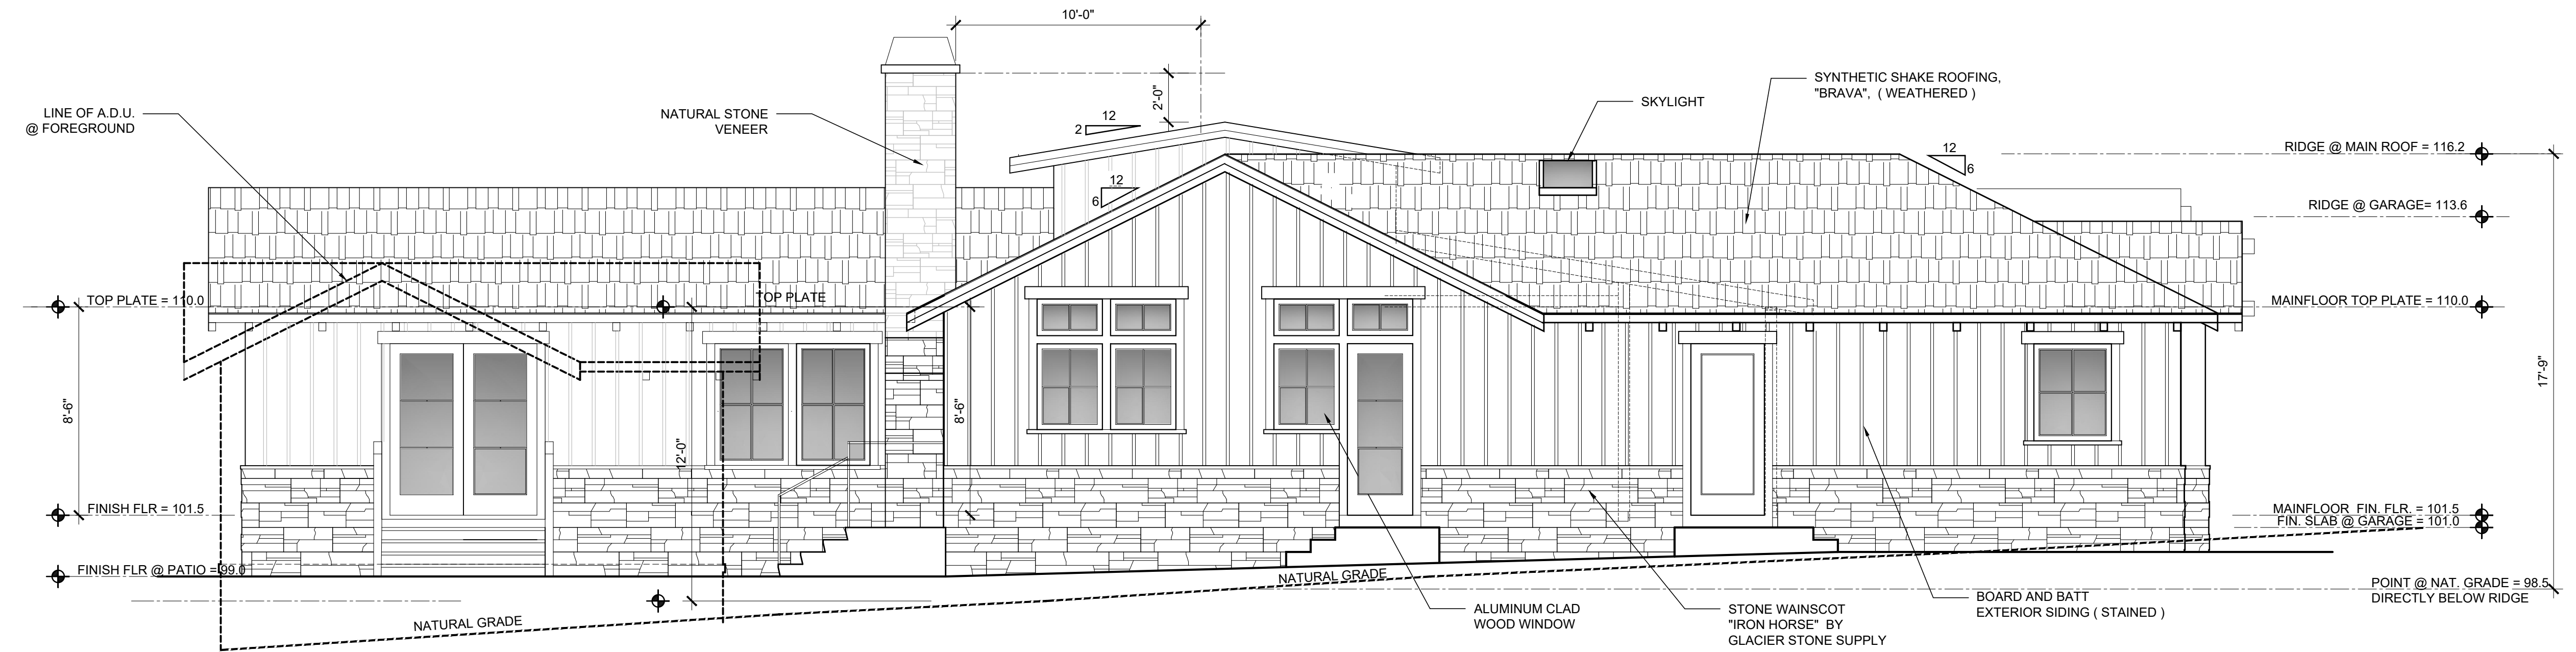
PROPOSED SOUTH ELEVATION

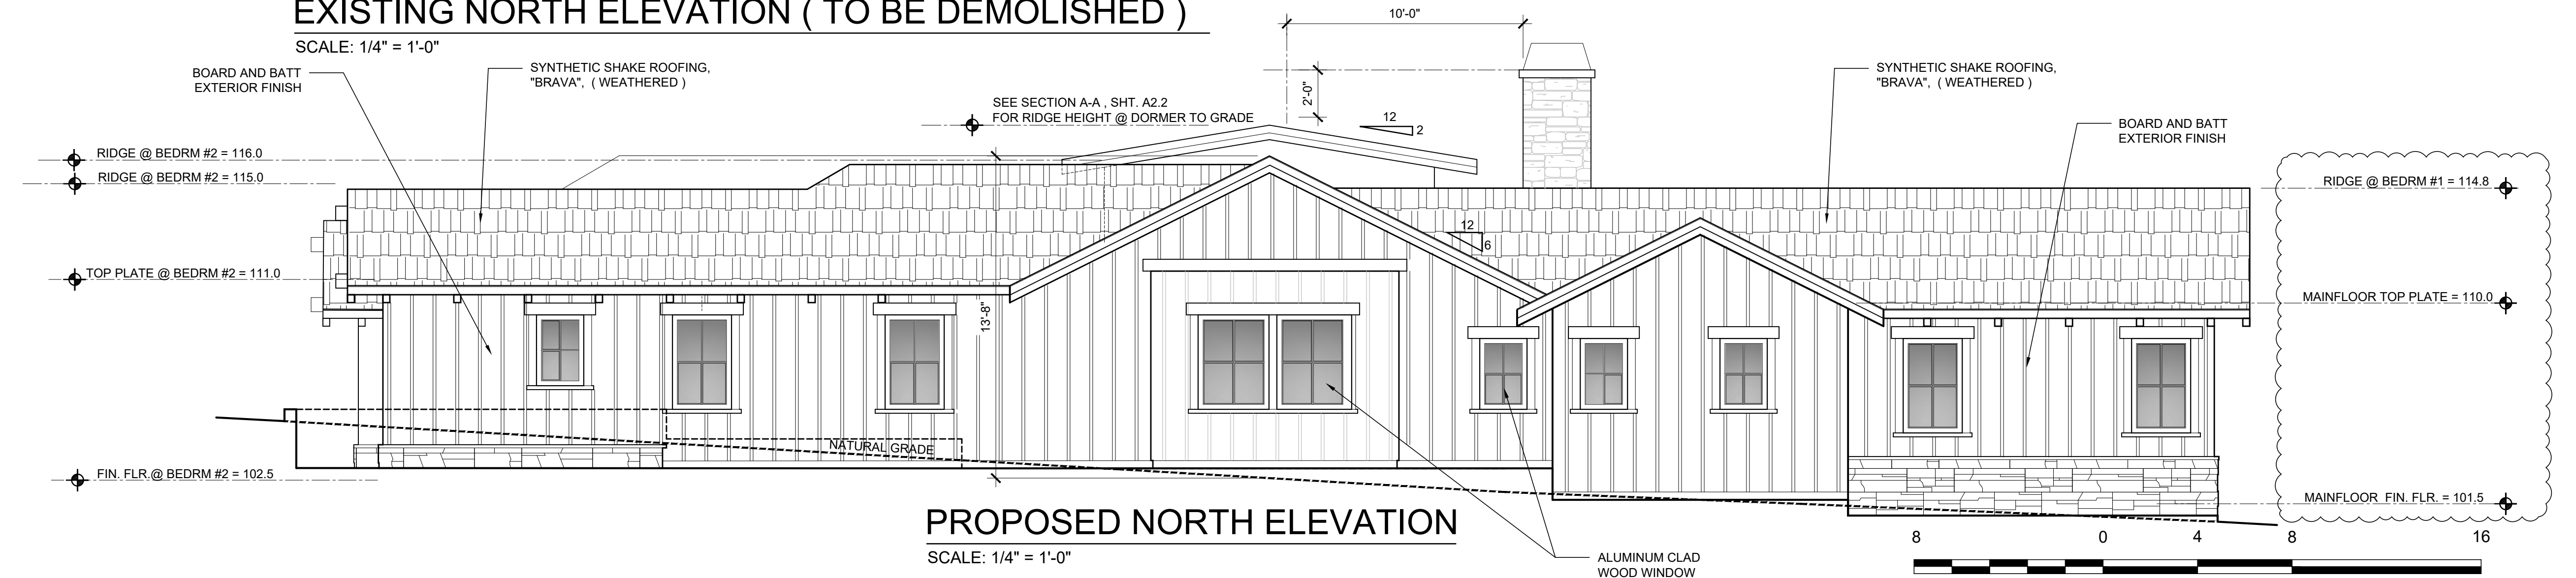
PROPOSED NORTH ELEVATION

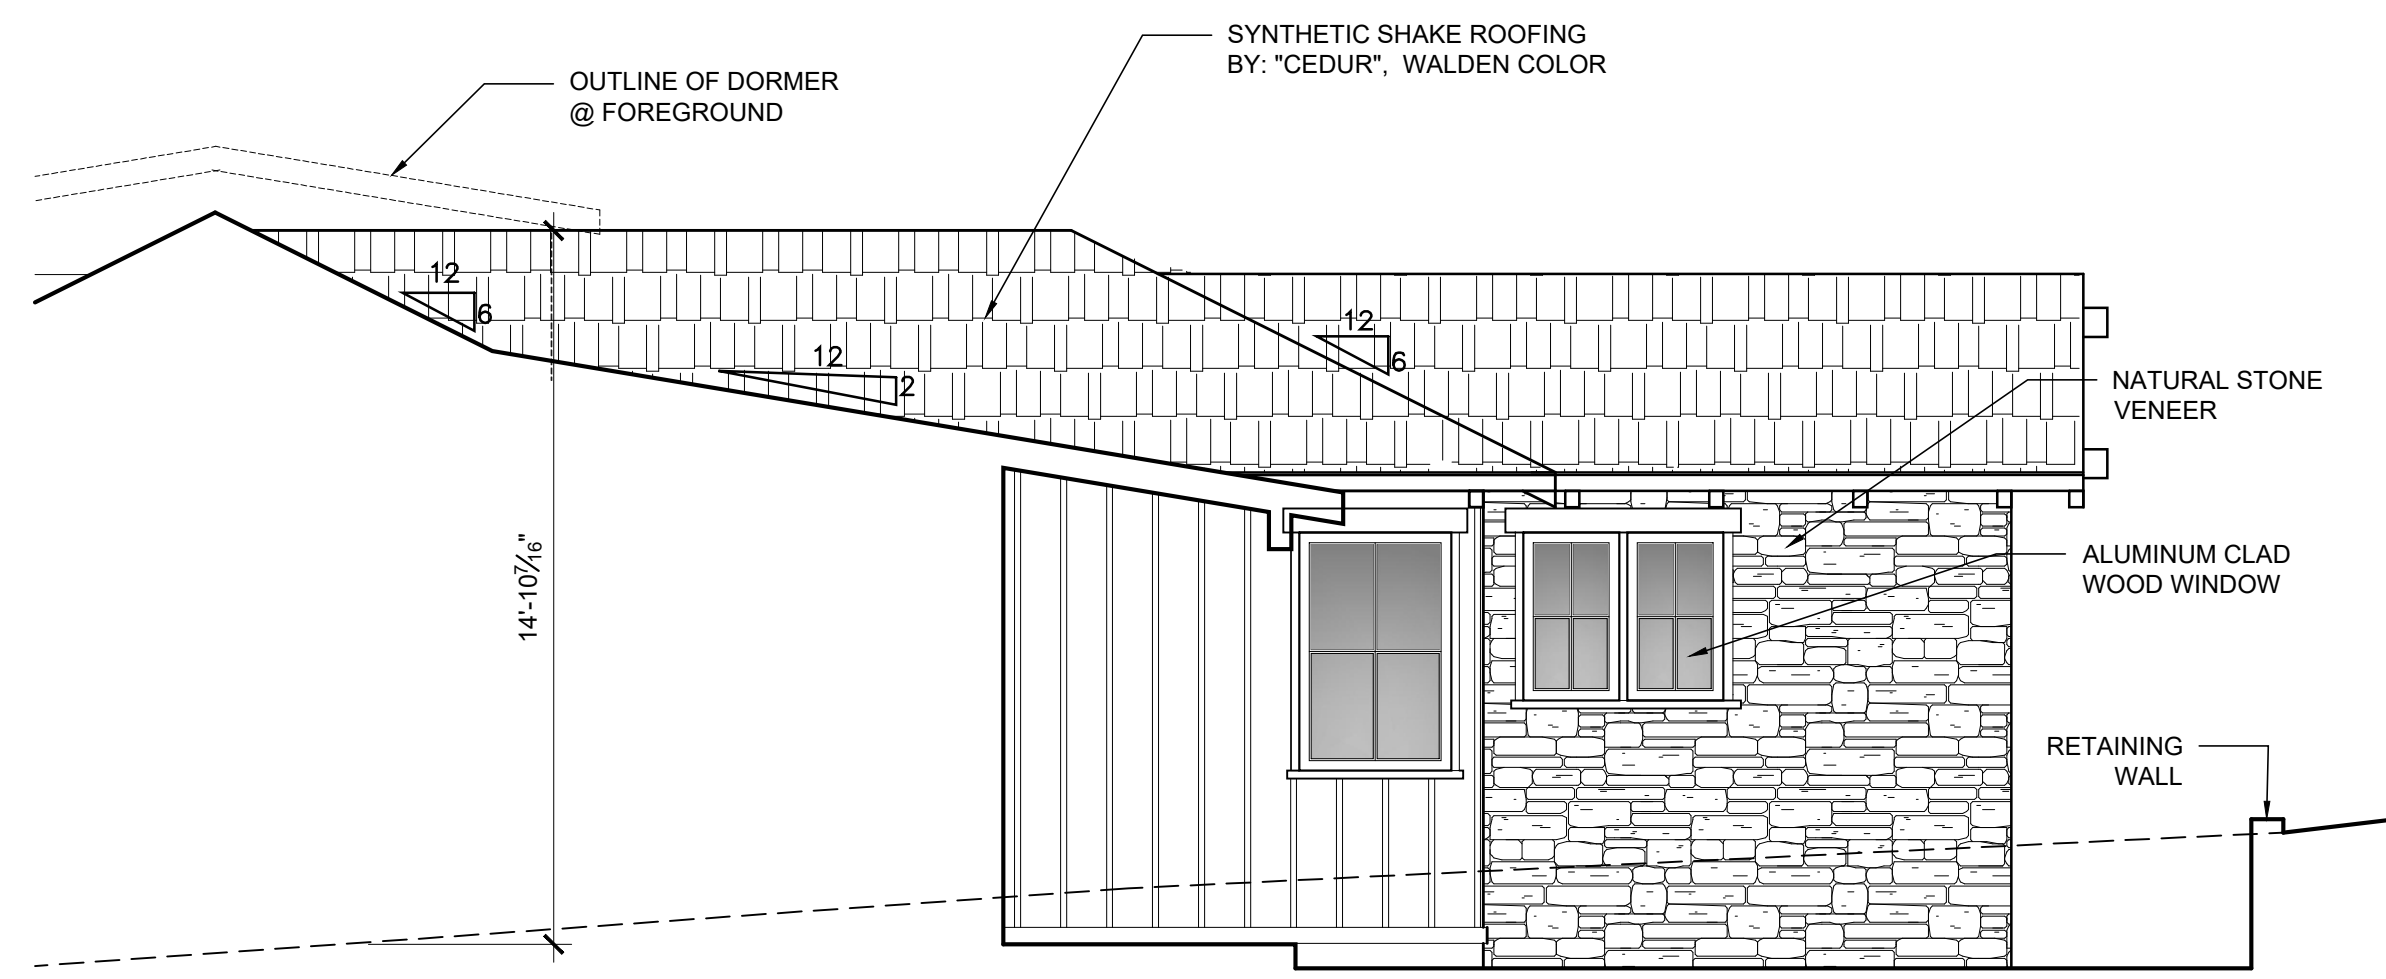
SOUTH COURTYARD ELEVATION

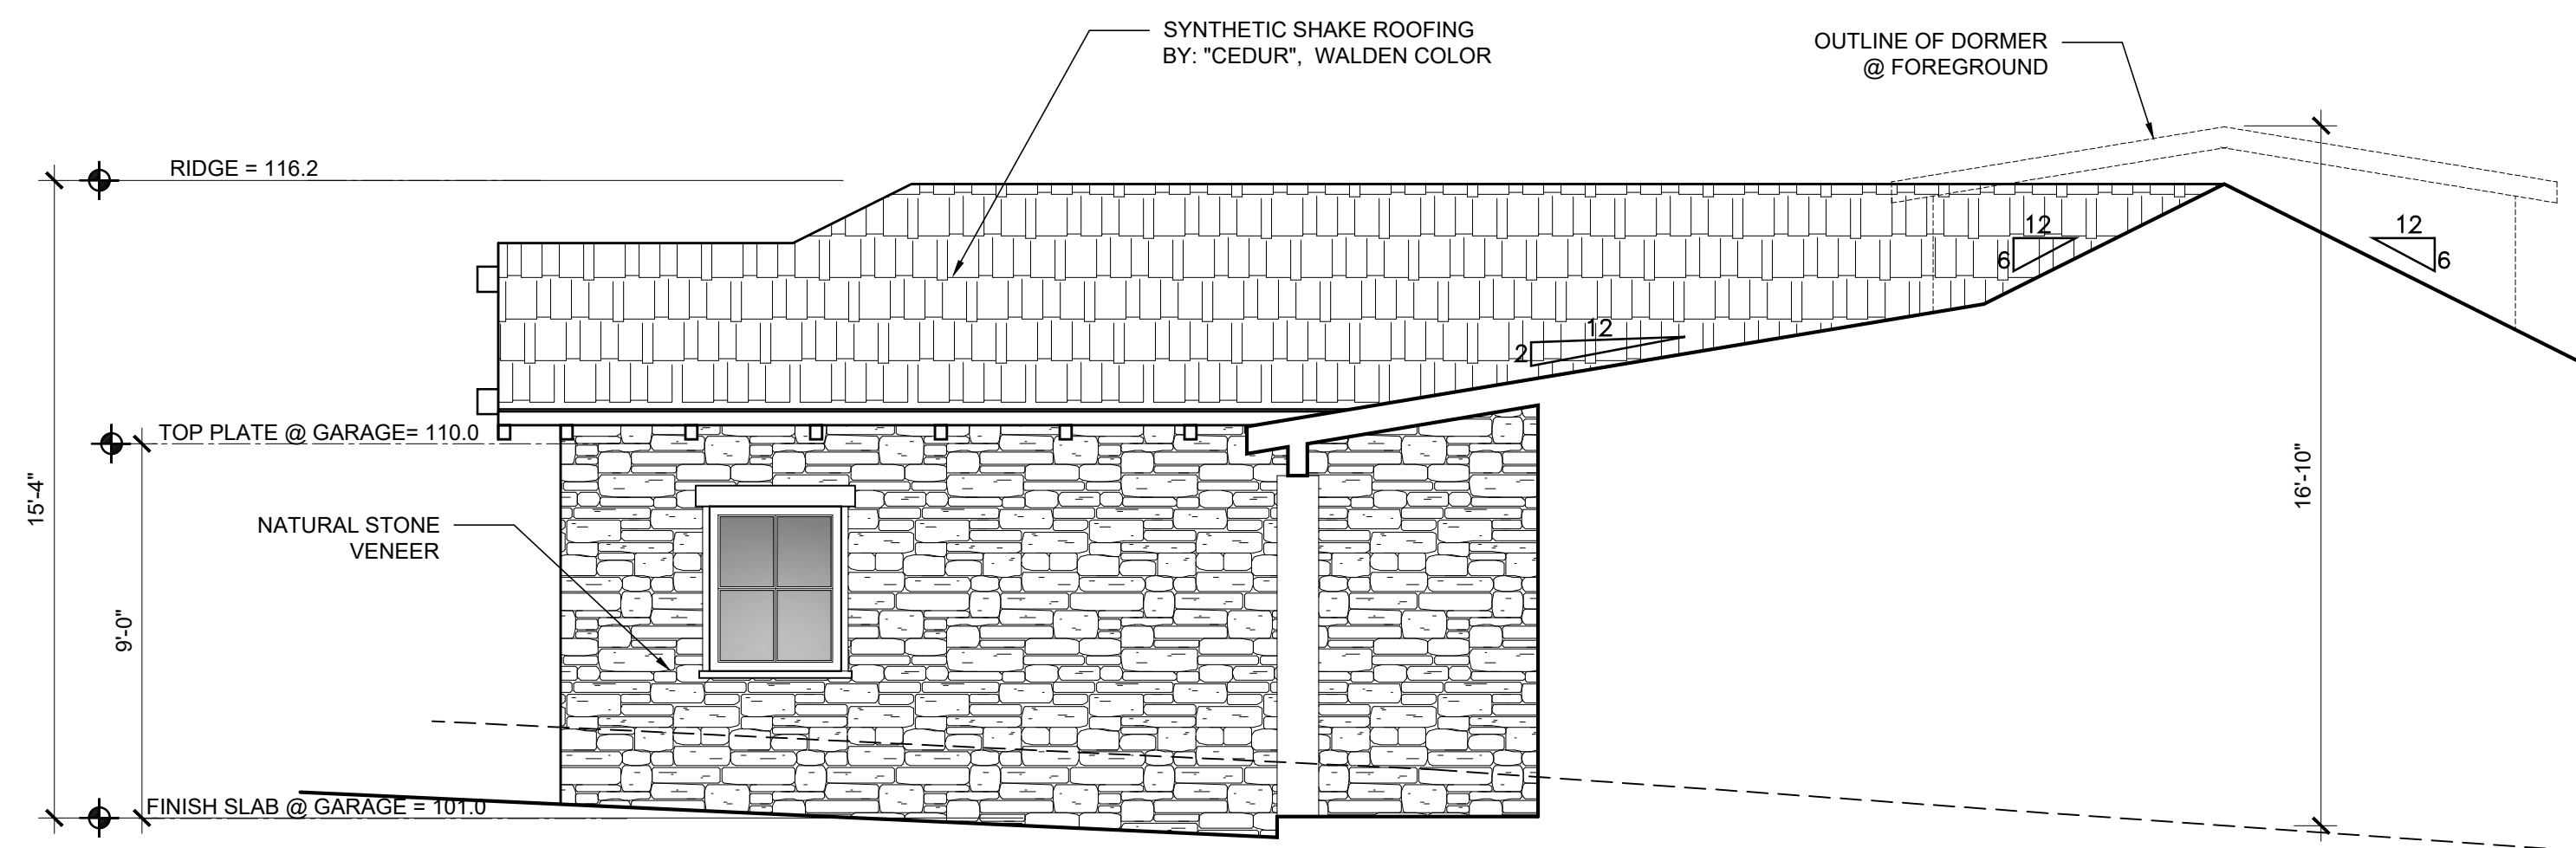
NORTH COURTYARD ELEVATION

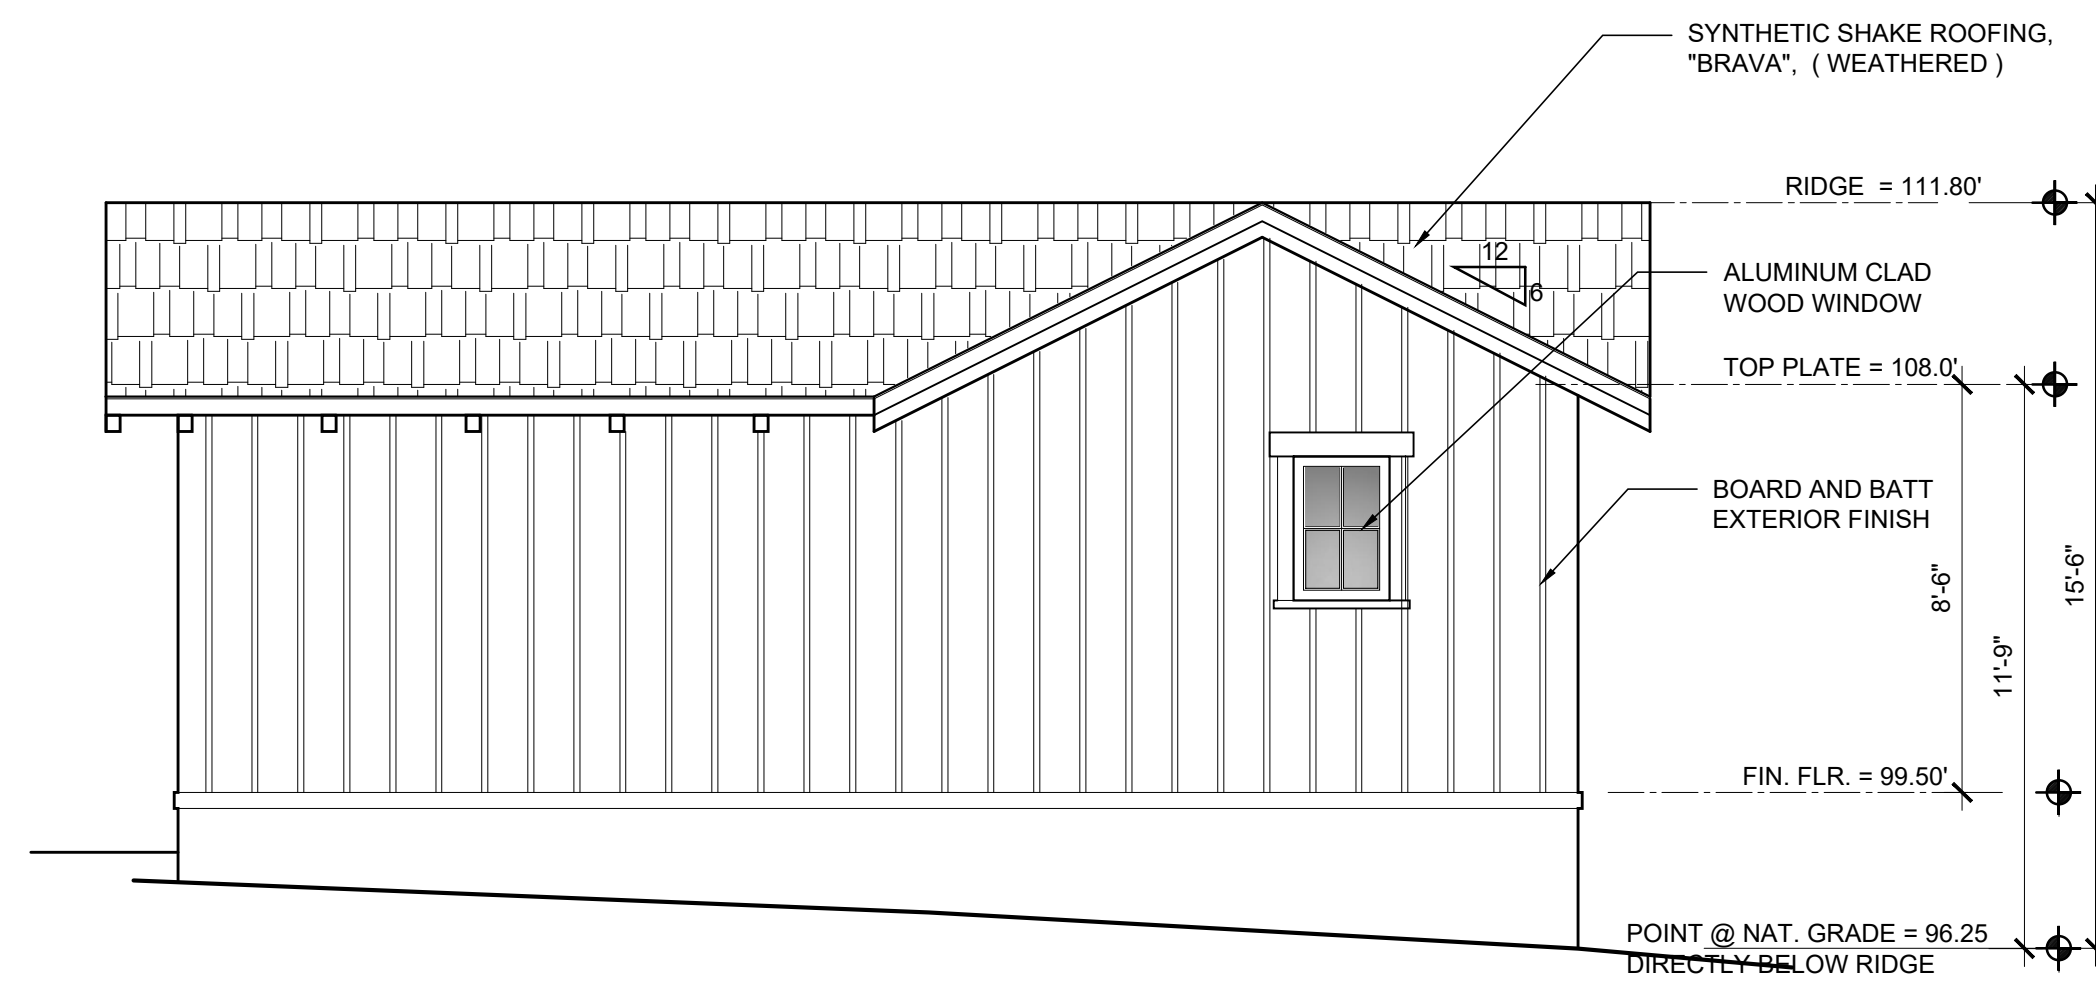
A.D.U. WEST ELEVATION

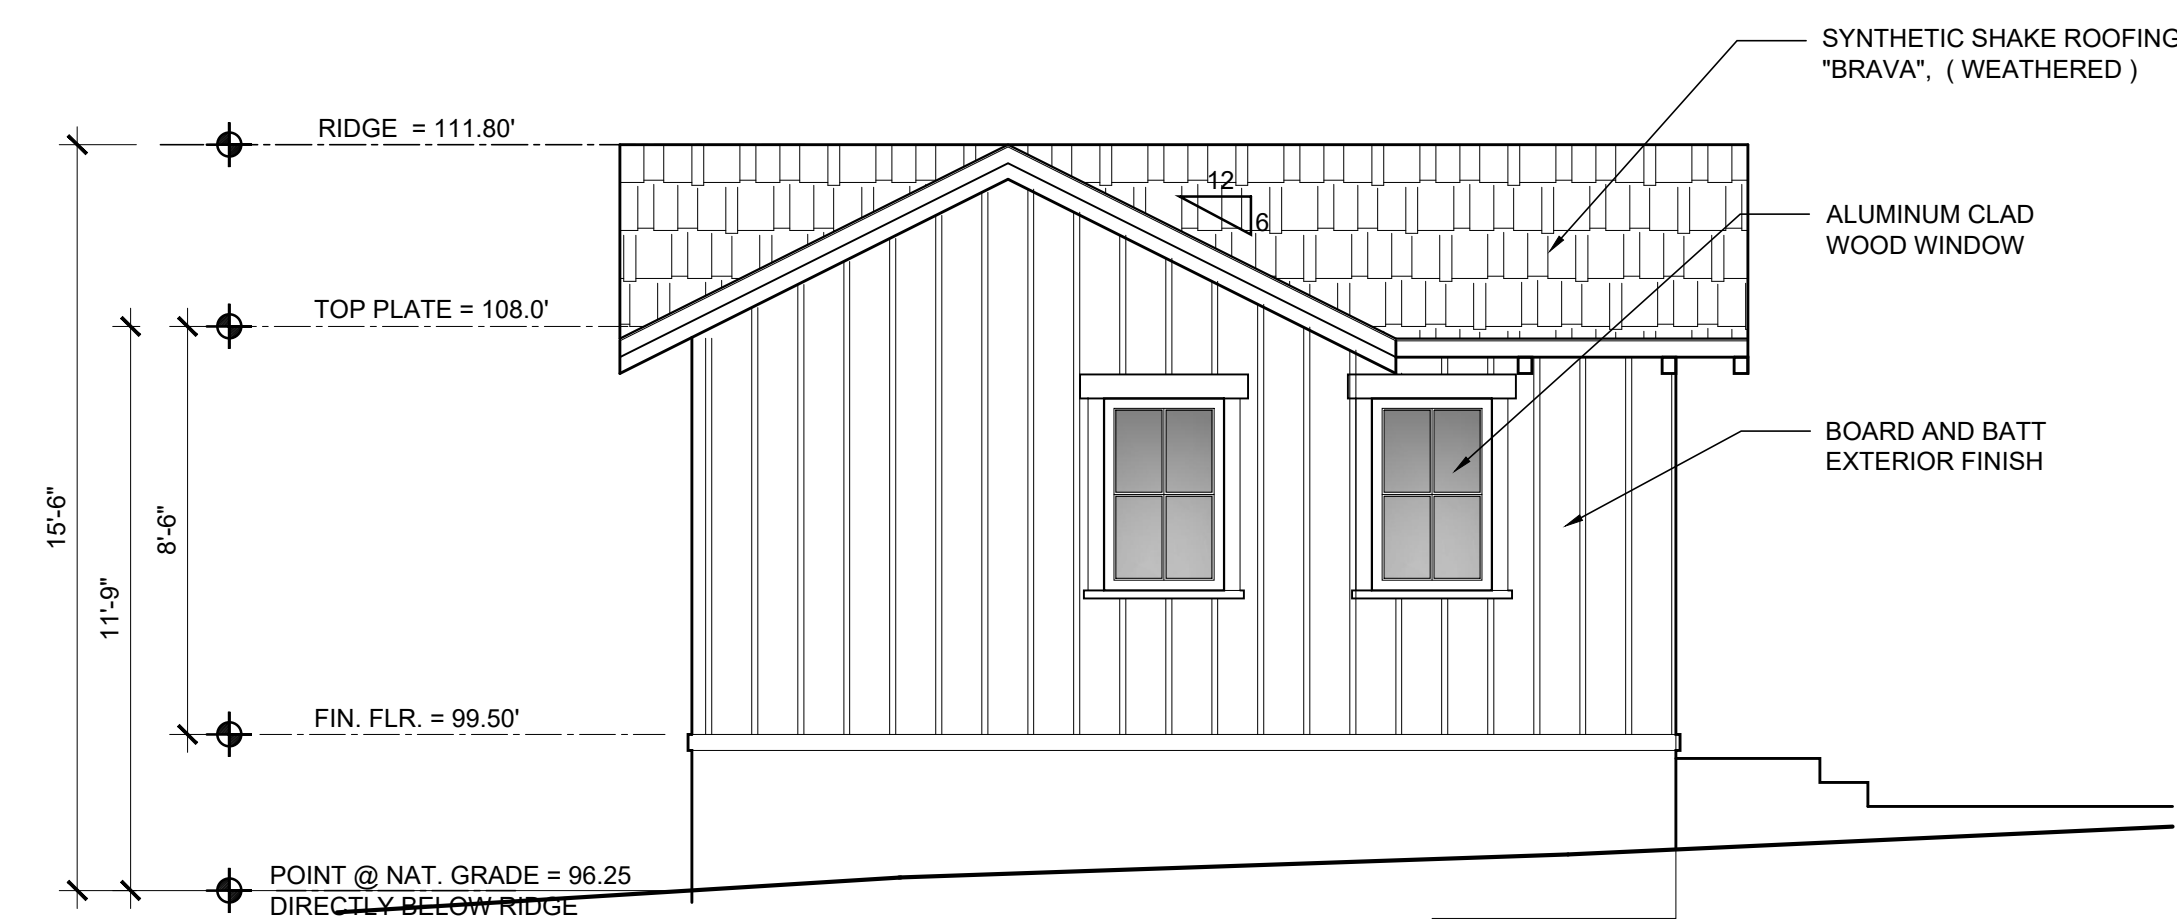
A.D.U. SOUTH ELEVATION

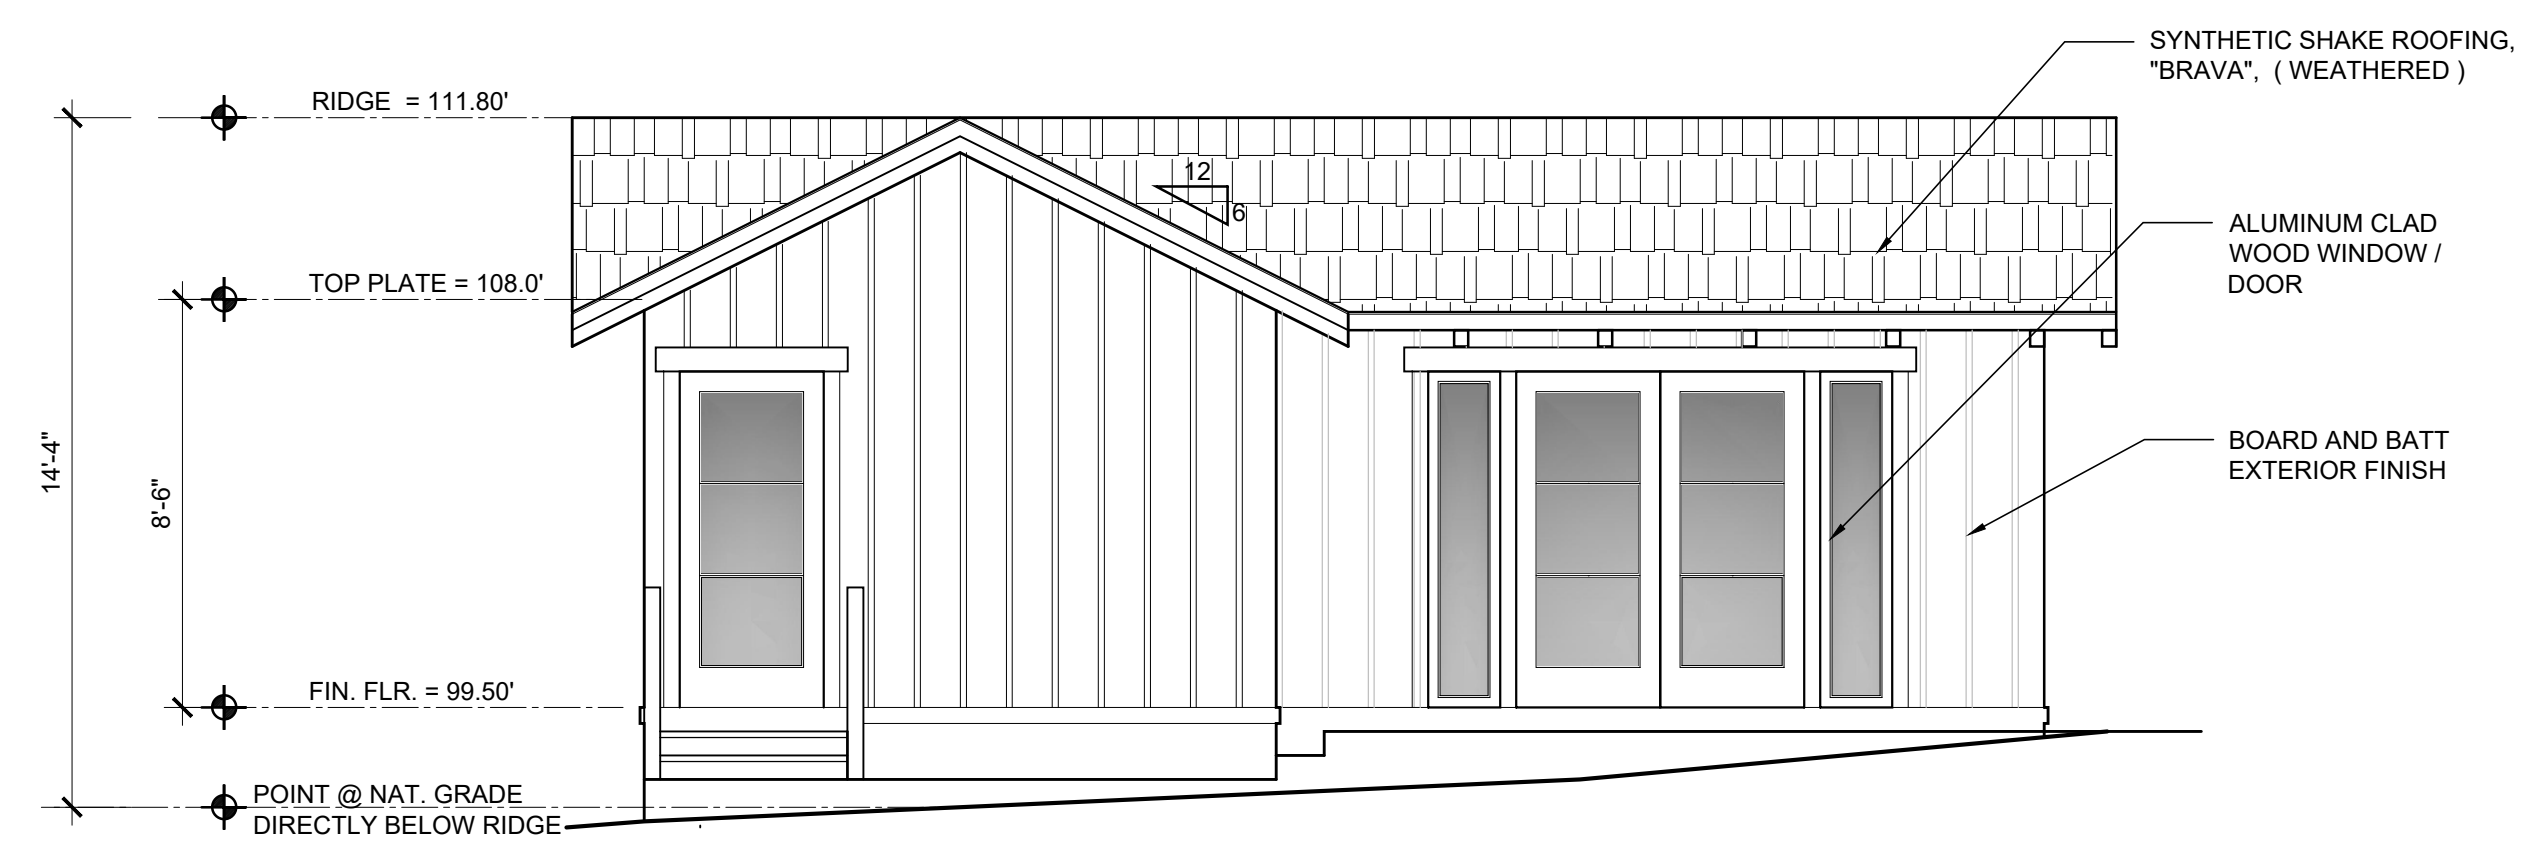
A.D.U. EAST ELEVATION

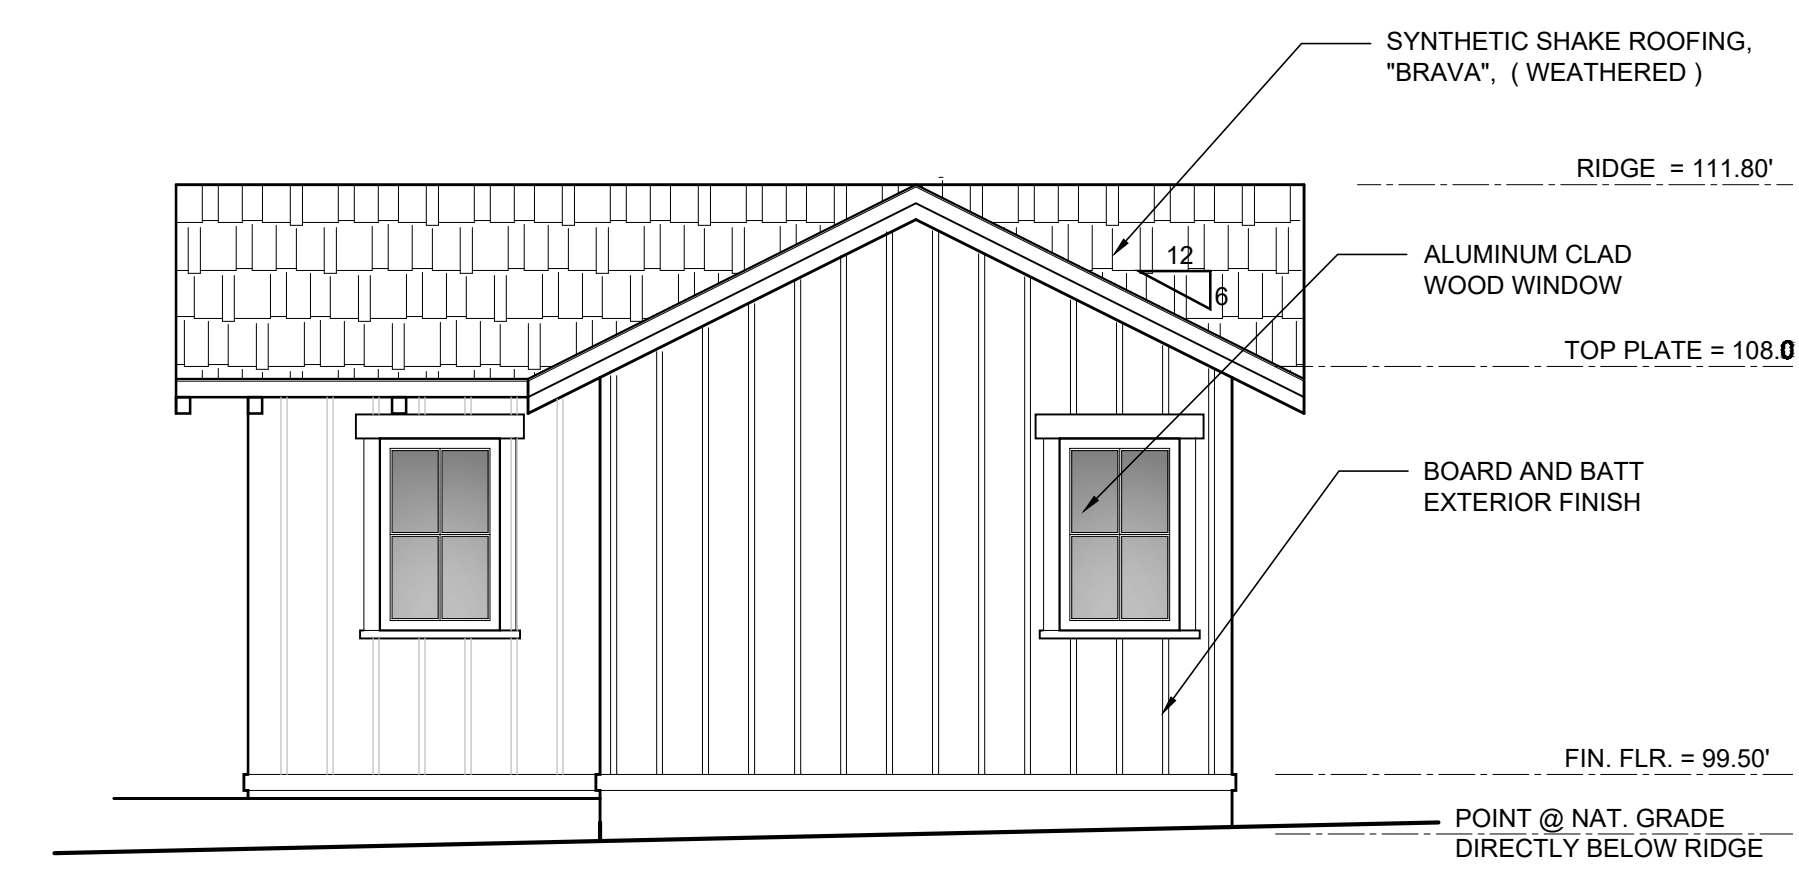
A.D.U. NORTH ELEVATION
