BRITTON RESIDENCE

DEMOLITION OF (E) RESIDENCE AND ACCESSORY STRUCTURE, AND CONSTRUCTION OF NEW ONE-STORY RESIDENCE WITH ATTACHED 2-CAR GARAGE
CONSTRUCTION OF NEW DETACHED ACCESSORY DWELLING UNIT.

COVER SHEET

BRITTON RESIDENCE
SANTA FE STREET , 2 SW OF MOUNTAIN VIEW AVE.
CARMEL-BY-THE-SEA, CA 93923
A.P.N. 010-082-002

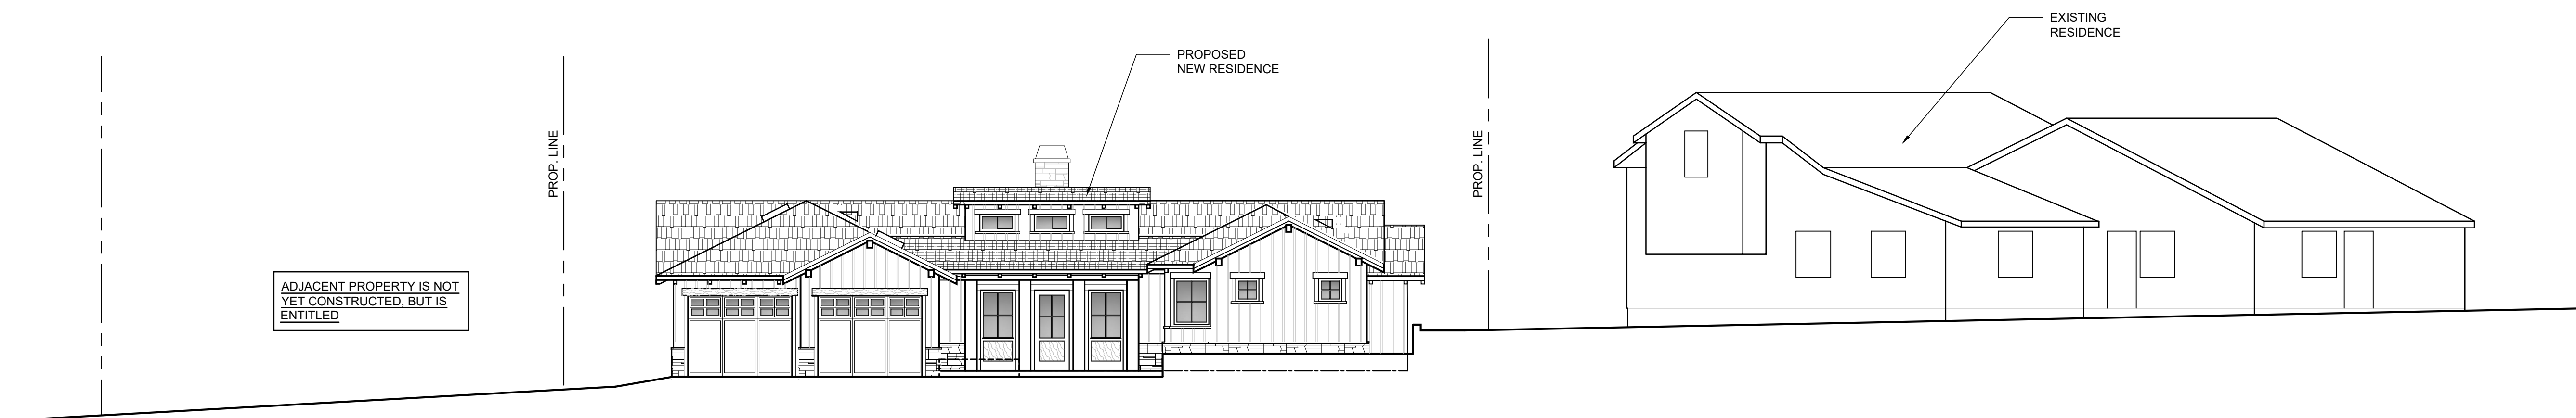
PROPOSED STREET PROFILE

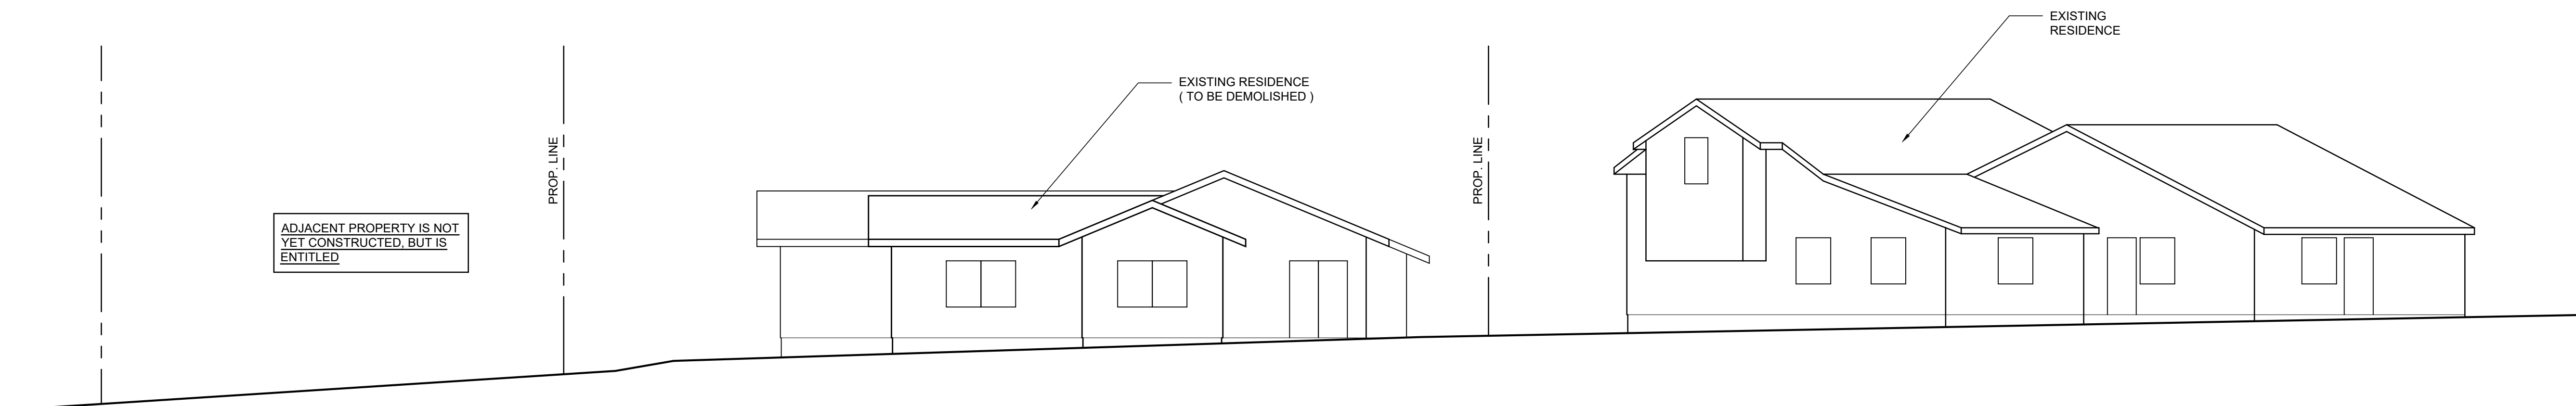
EXISTING STREET PROFILE

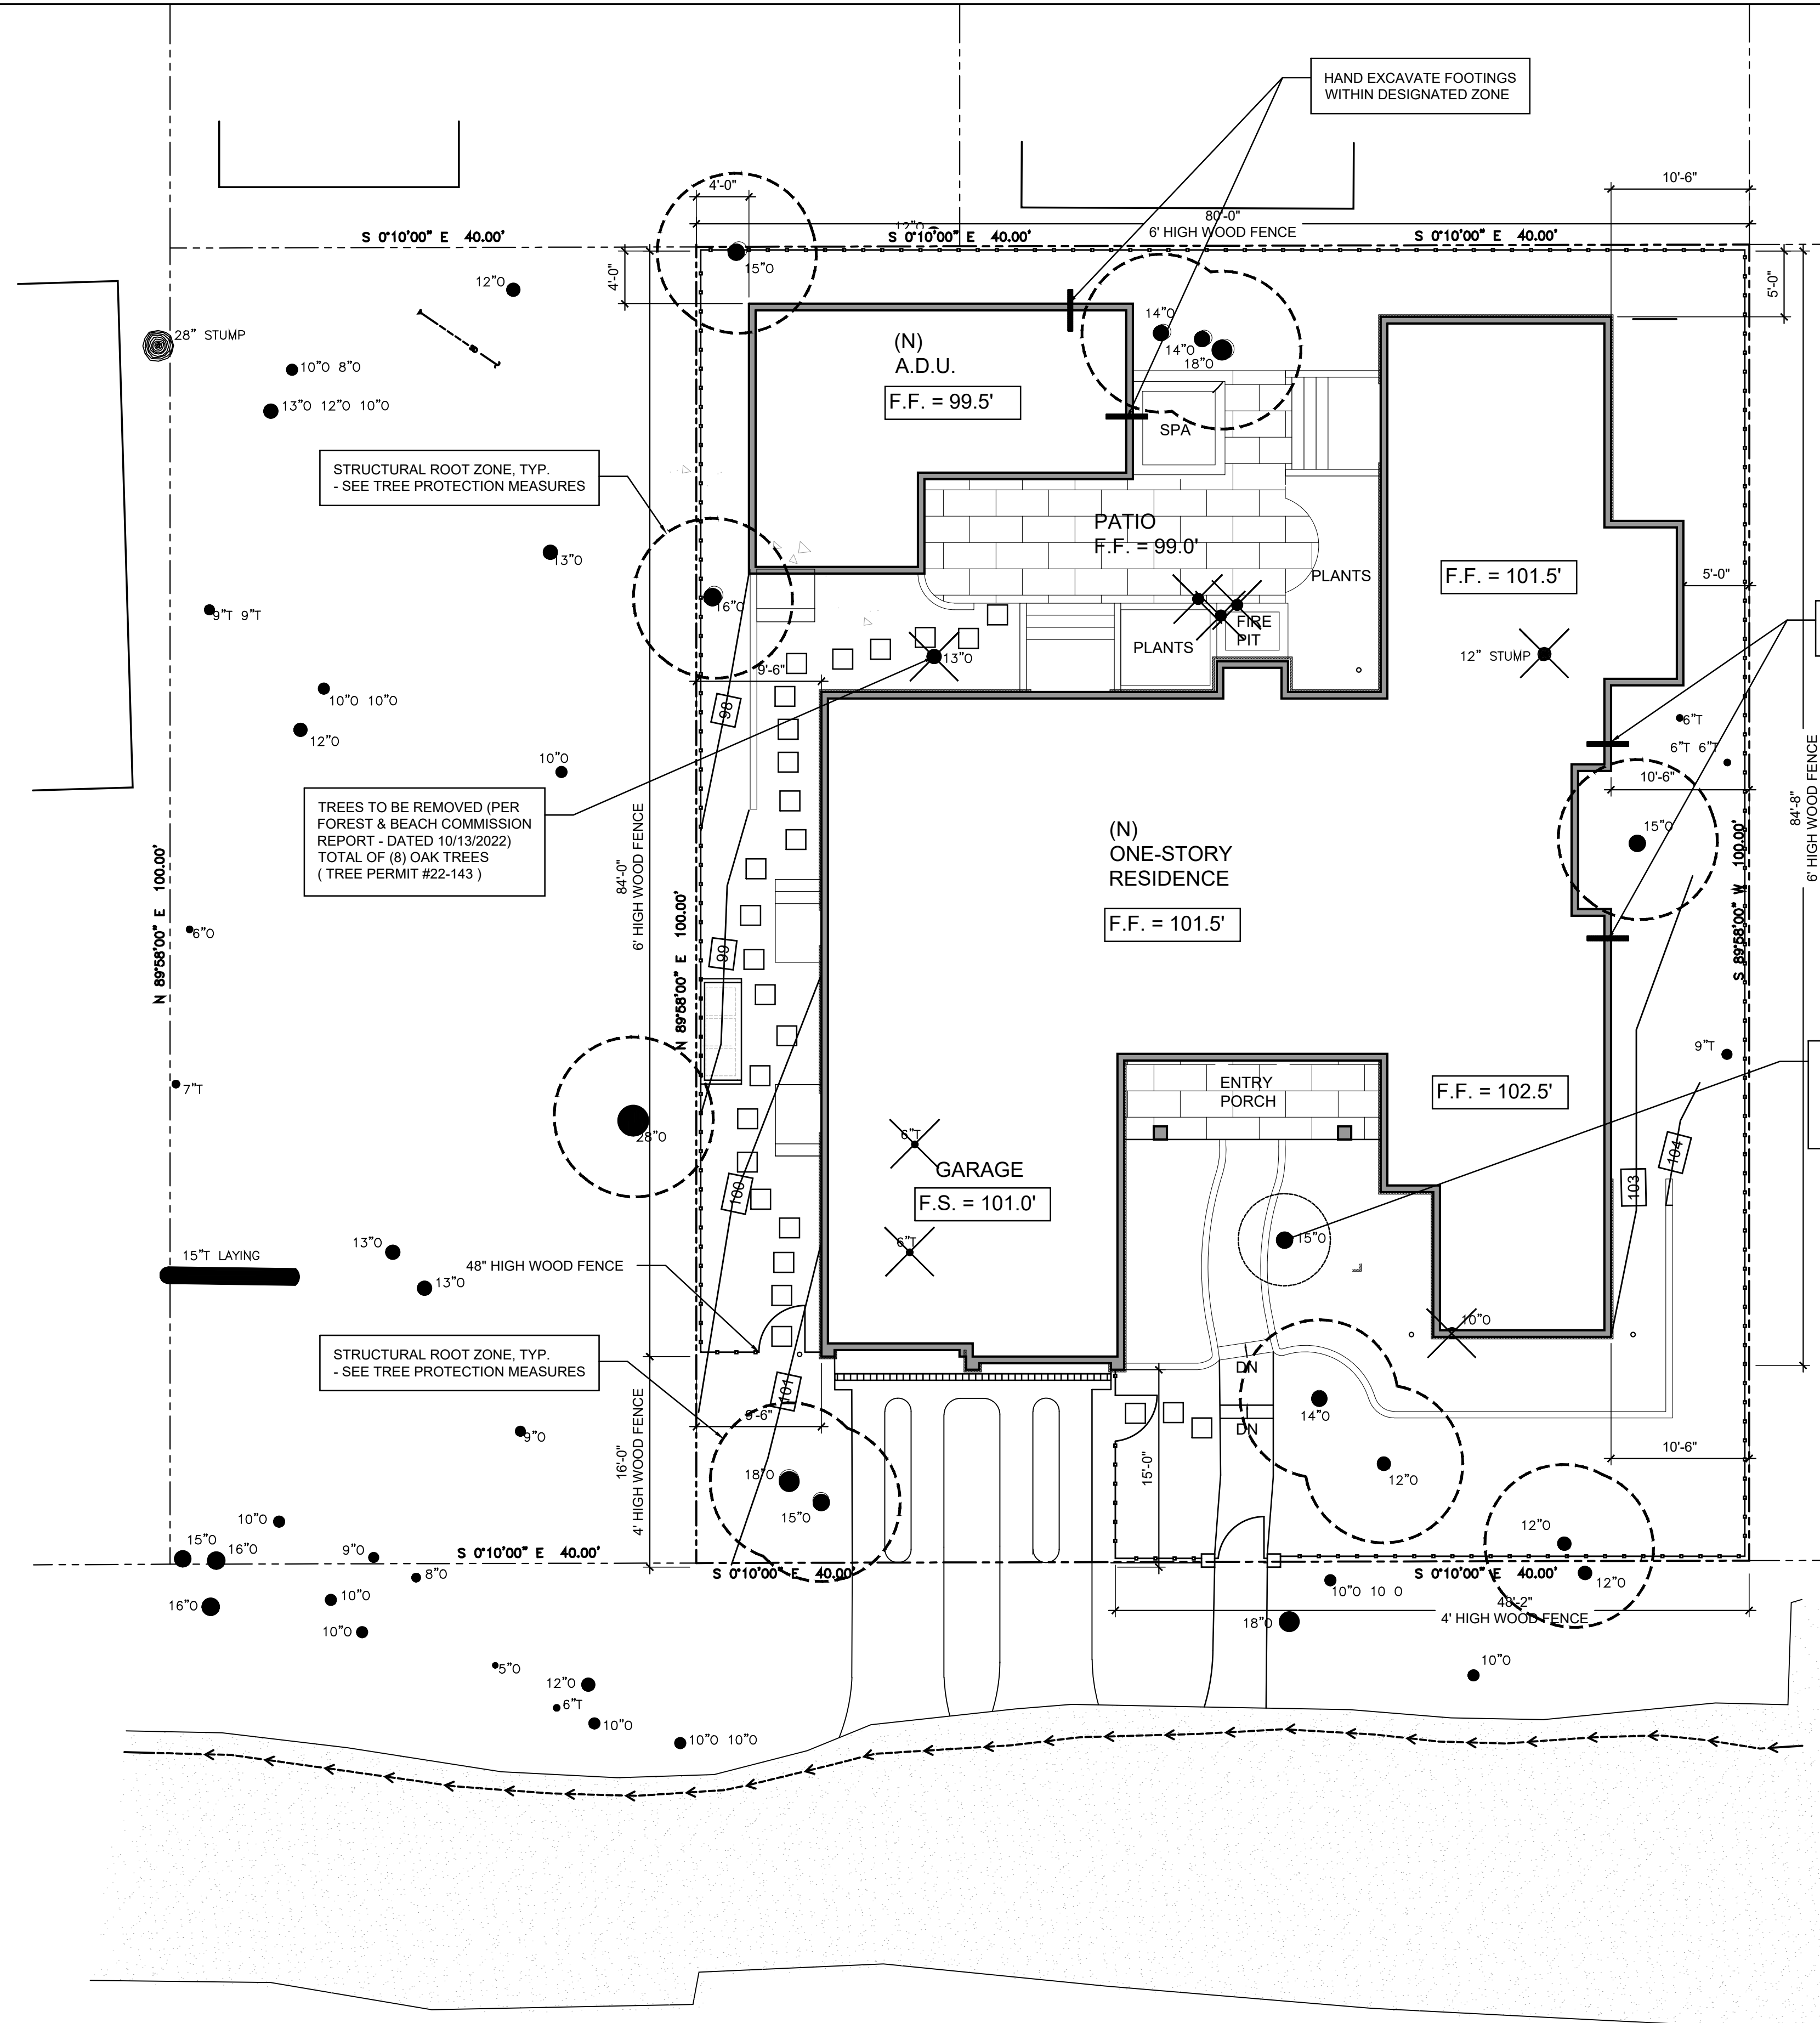
TREE PROTECTION PLAN
BRITTON RESIDENCE
SANTA FE STREET, 2 SW OF MOUNTAIN VIEW AVE.
CARMEL-BY-THE-SEA, CA 93923
A.P.N. 010-082-002

- Requirements for tree preservation shall adhere to the following tree protection measures on construction site.
- Prior to grading, excavation, or construction, the developer shall clearly tag or mark all trees to be preserved.

- Excavation within 6 feet of a tree trunk is not permitted.
 - No attachments or wires of any kind, other than those of a protective nature shall be attached to any tree.

- If roots greater than 2 inches in diameter or larger are encountered within the approved Structural Root Zone the City Forester shall be contacted for approval to make any root cuts or alterations to structures to prevent roots from being damaged.

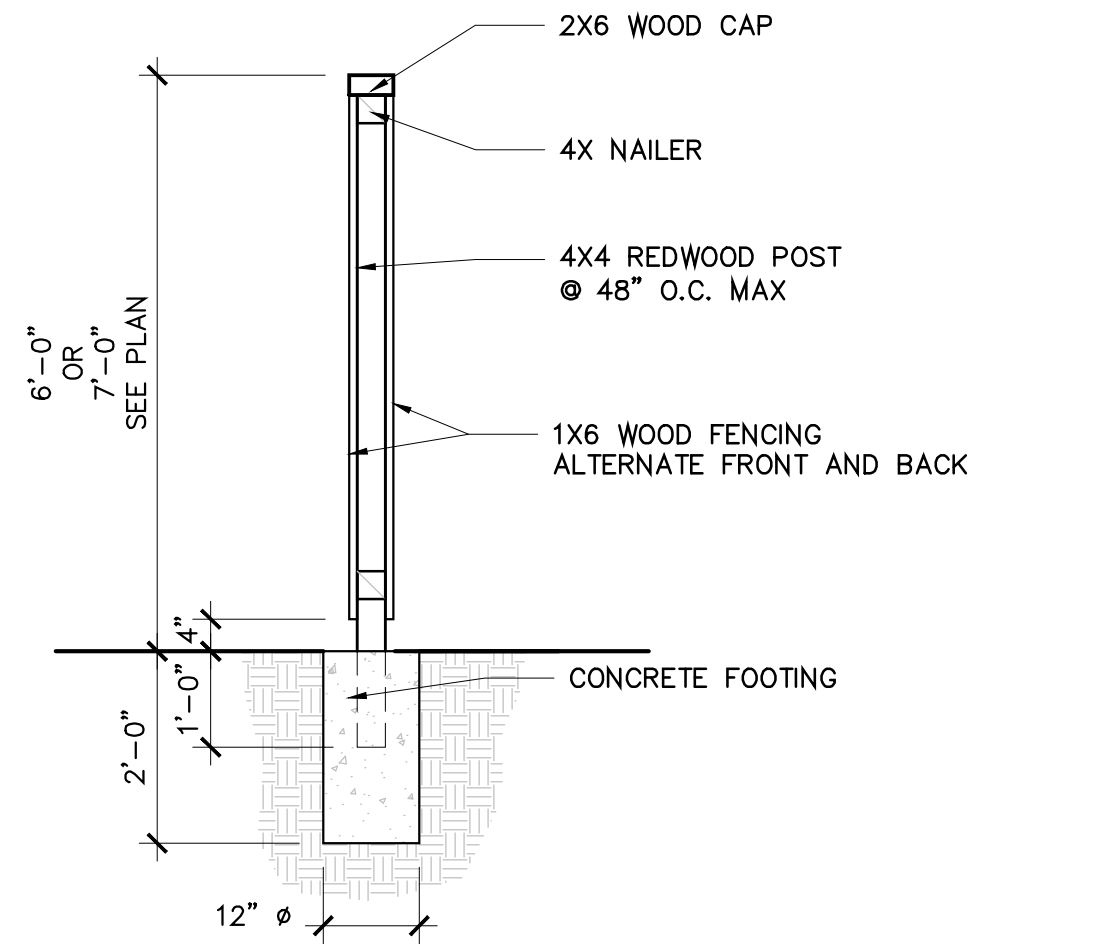
② 6' 7/8" HIGH WOOD FENCE
SCALE: 1/2" = 1'-0"

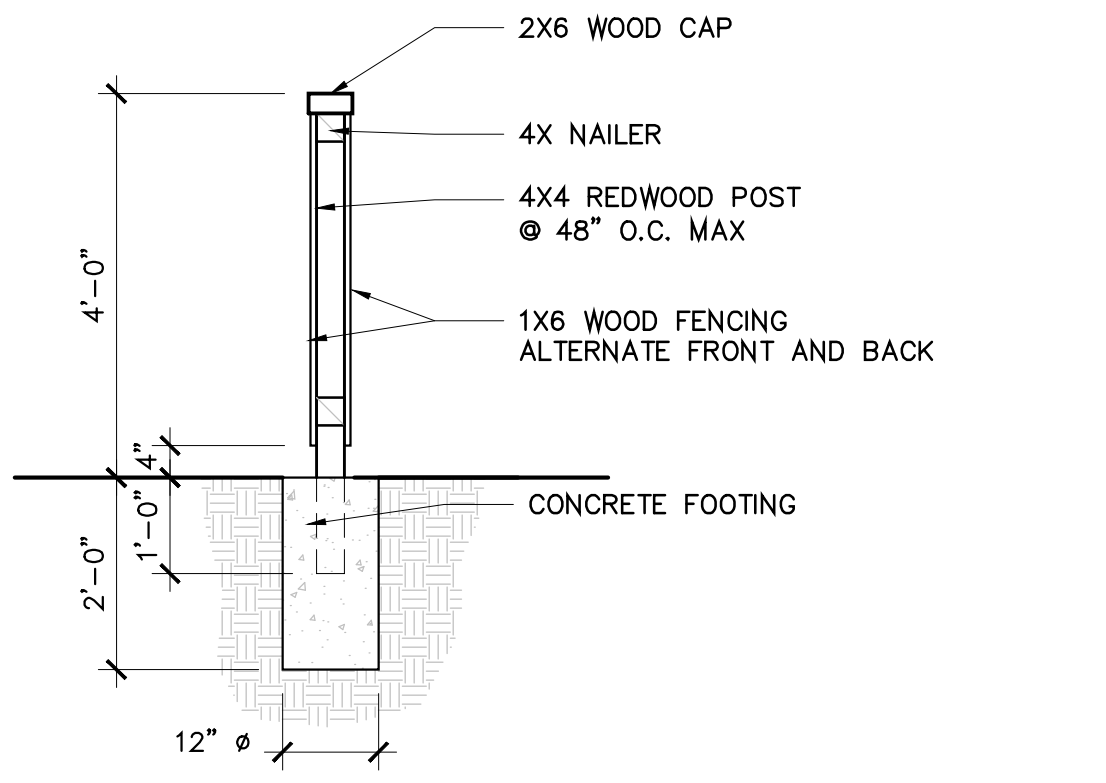
① 4' HIGH WOOD FENCE
SCALE: 1/2" = 1'-0"
