## MEMORANDUM

**Subject:** Carmel Climate Change Vulnerability Assessment, Shoreline and Beach Change Analysis: Seasonal and Long Term

**Project No.:** C3016

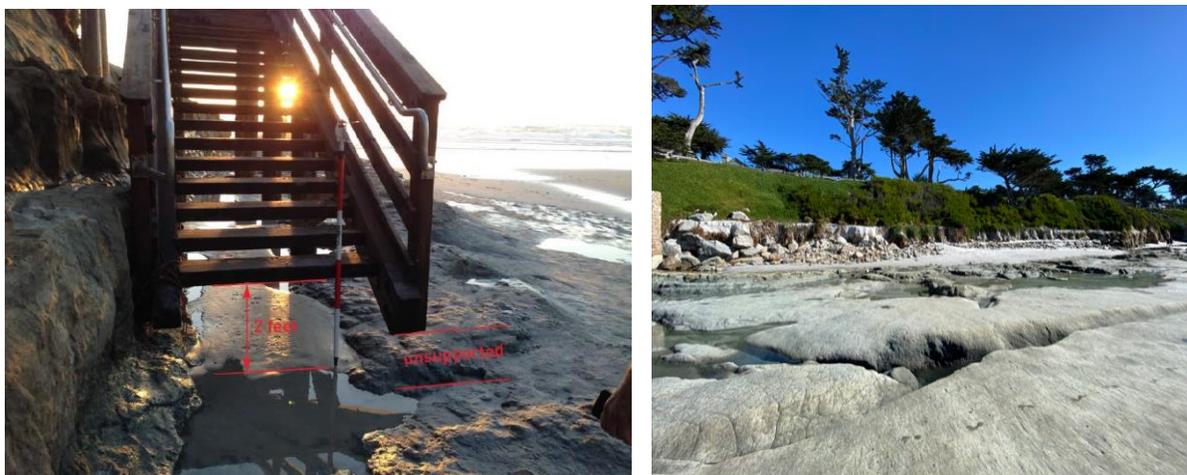
Figure 1. Left, undermined 12th Avenue stairway following the El Niño Winter of 2015–16 (January 24, 2016). Source: Easton Geology (2016)  
Right, the beach scoured down to bedrock near 10th and 11th avenues following strong winter storms of 2022–23 (January 30, 2023). Source: HKA (2023).

During this task in the project, large ocean swells associated with the energetic winter storms of 2022–23 caused substantial beach scouring. Examples of these hazardous conditions can be seen in Figure 1 below, where scouring made beach access difficult (see Figure 1, left) and portions of the beach became difficult to navigate (see Figure 22, right).

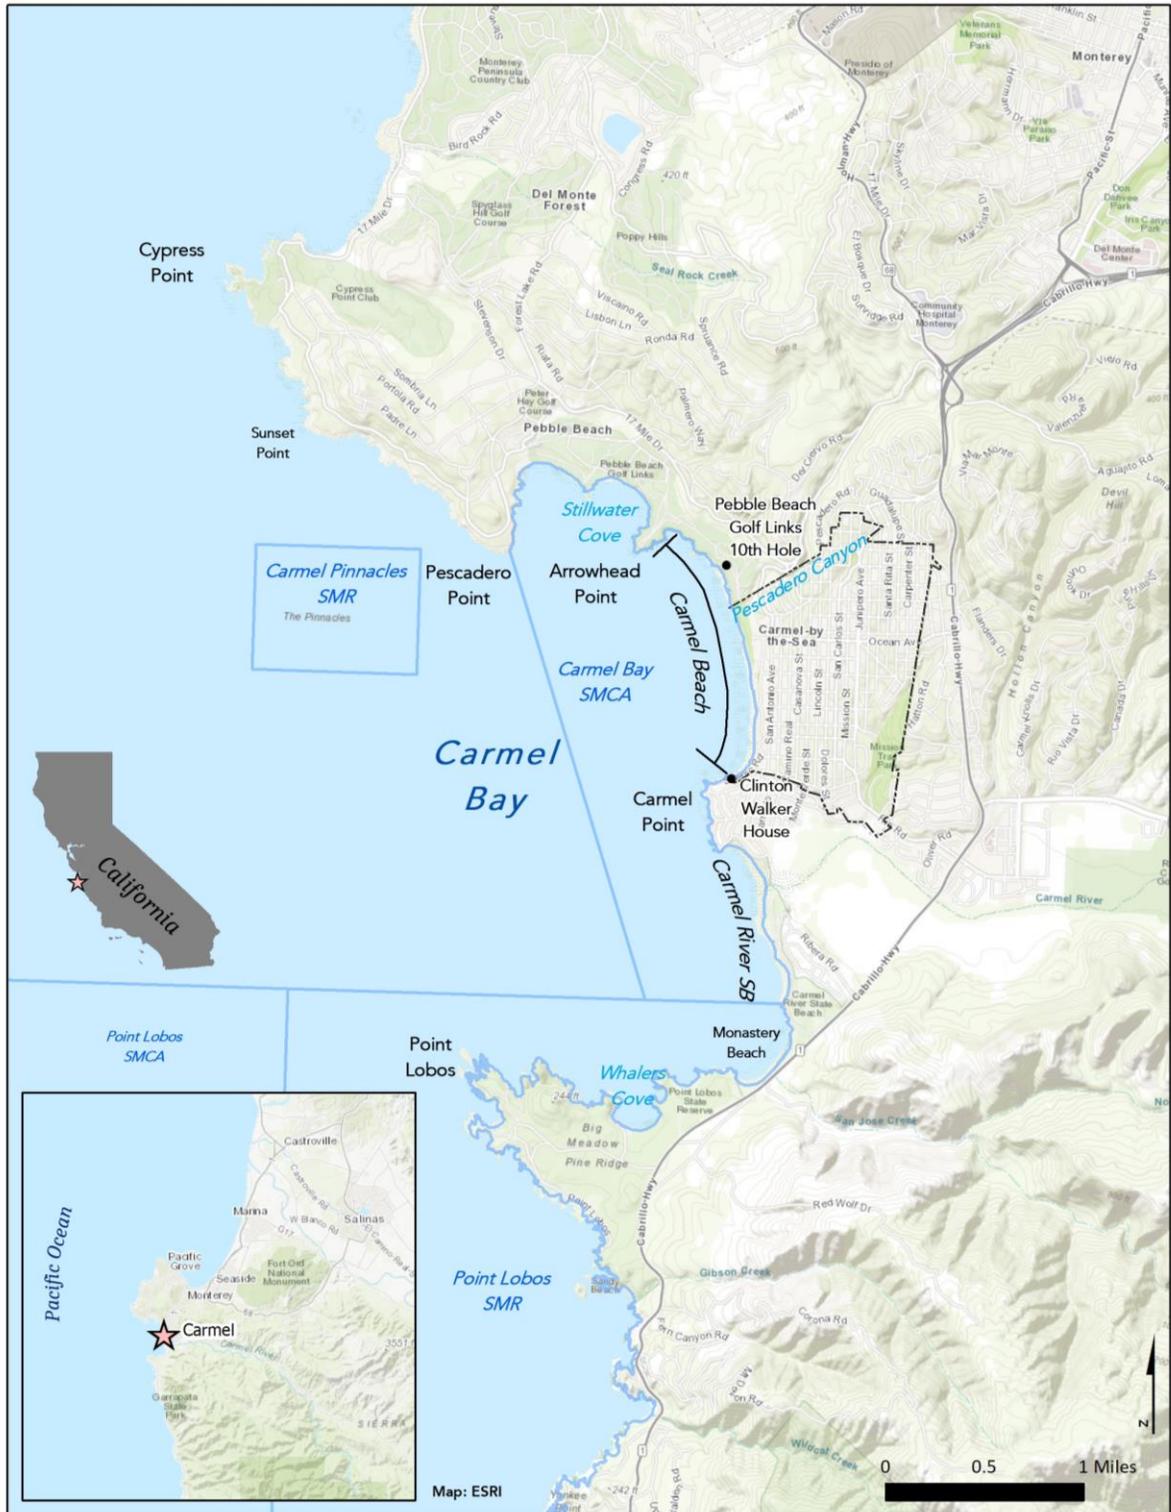
This study focuses on Carmel Beach within Carmel Bay, illustrated by the brackets in Figure 2. Carmel Beach is a pocket beach extending between Arrowhead to Carmel Points, the city portion of Carmel Beach encompasses the lower three-fourths of this northern pocket beach (from Pescadero Canyon to Carmel Point), with the Pebble Beach section extending north towards Arrowhead Point<sup>1</sup> (see Figure 2). As the city and non-city portions of Carmel Beach form a connected system, the analysis is focused on both portions.

Over the course of human timescales (i.e., decades to centuries), the sediments in Carmel Bay mostly remain between Arrowhead and Carmel points. Unlike most other California beaches that are located on exposed, open coastlines, Carmel Beach is a pocket beach situated between two headlands. On an open, exposed coastline, a beach can receive sediment from adjacent beaches. At Carmel, however, the headlands impede the delivery of sediment into and out of the beach. Therefore, Carmel receives very little sediment via alongshore littoral transport from the beaches north (Monterey Bay) and south (Carmel River State Beach) (see Figure 2. Project Study Area. Figure 2), and the sediment mostly moves in the cross-shore direction seasonally, as explained below.

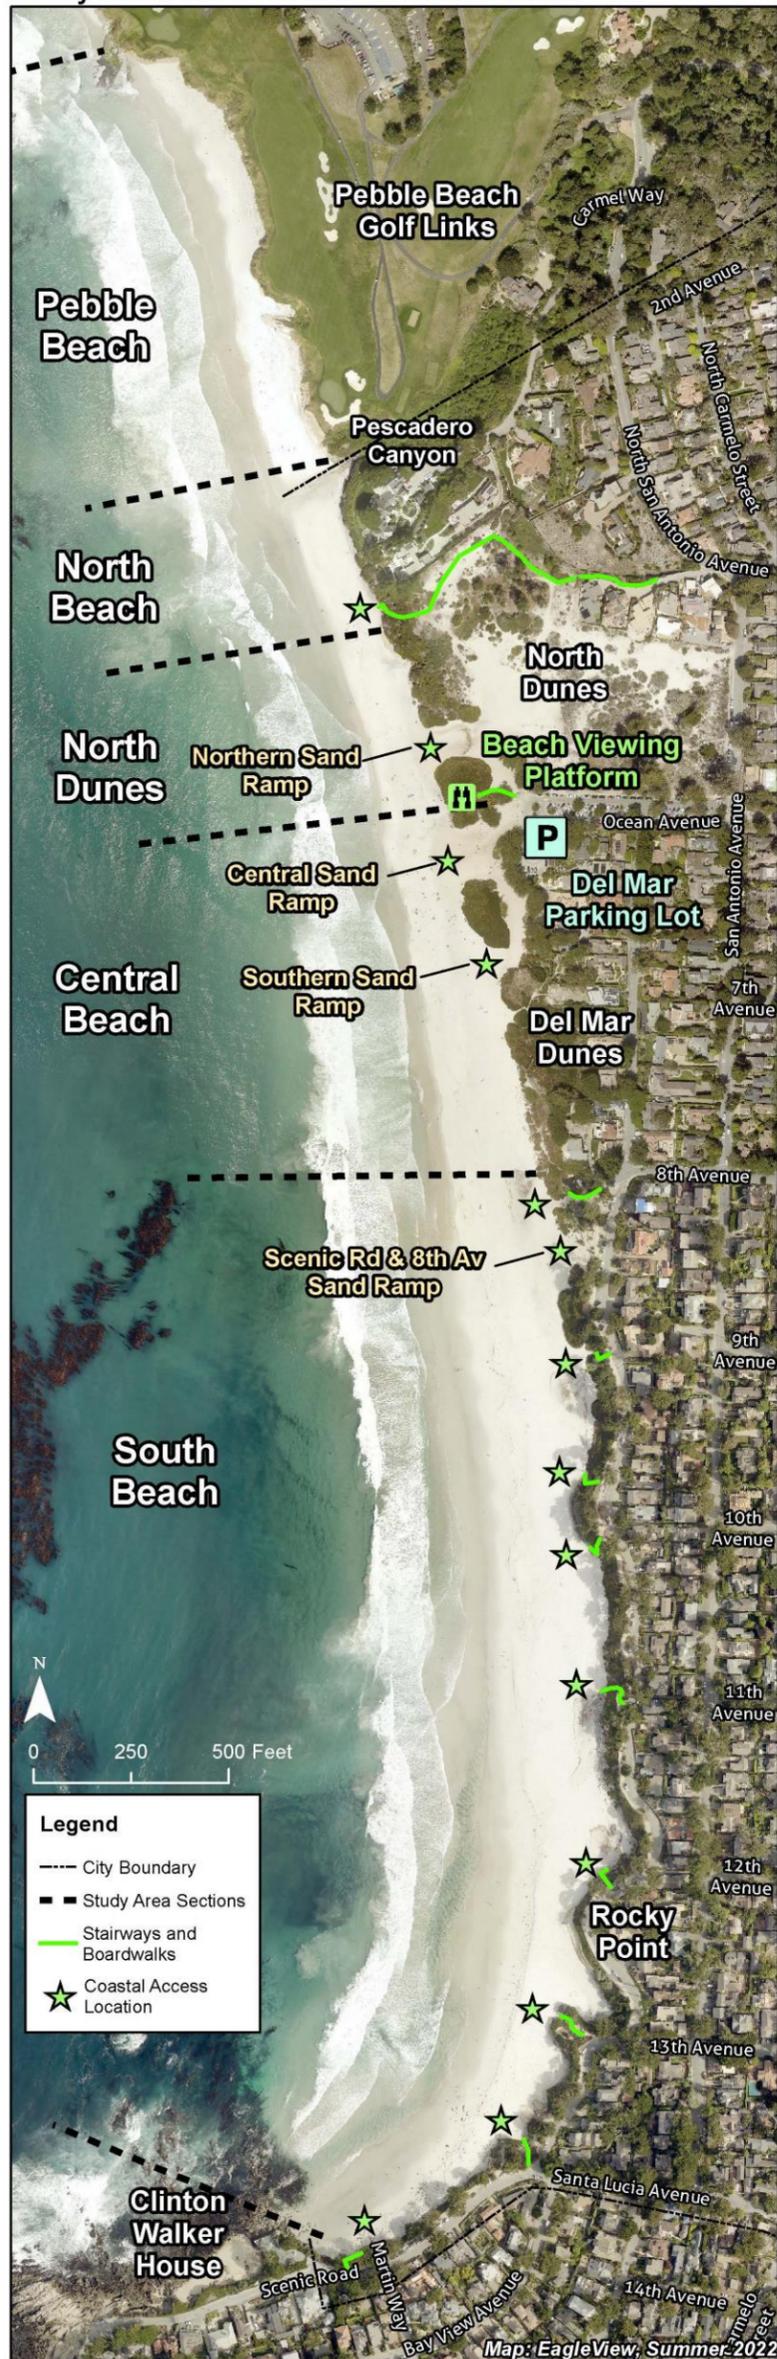
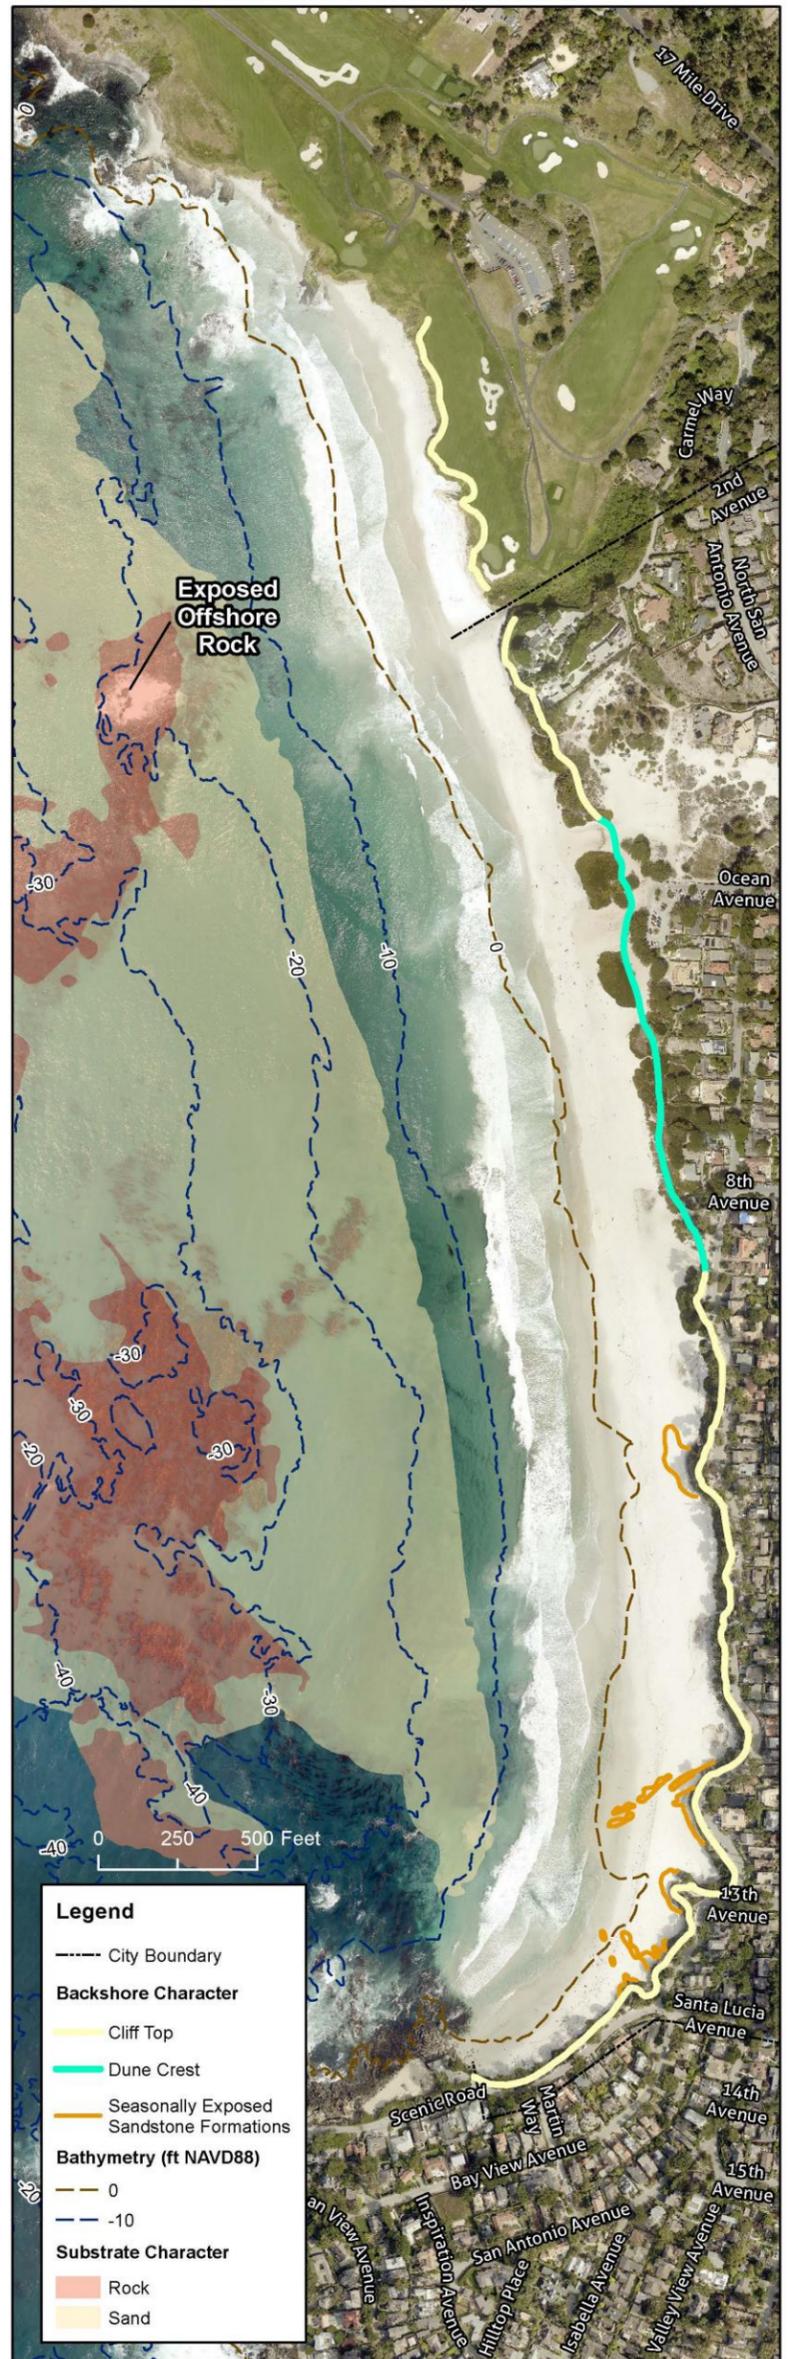
Figure 3. Carmel Beach Sections and Coastal Access (left), and Offshore and Nearshore Characteristics (right)

The city beach is a 22.5-acre public park accessed by locals and visitors alike. It is served by an extensive public access system that includes 10 beach access stairways and four sand ramps. Beach access parking is available at the Del Mar Parking Lot (122 spaces), as well as along Scenic Road (127 spaces) and North San Antonio Avenue in the north (10 spaces) (Shonman and D'Ambrosio 2003) (see Figure 3).

In nearshore waters, sediment pockets overlay and fill areas of sandstone bedrock, which are punctuated by areas of Salinan Block granodiorite (see Figure 3, right). This rock serves as a holdfast for kelp, which is visible in many aerial photos offshore of the South and North Beach areas. Approximately 1,000 ft seaward of the North Beach section near Pescadero Canyon an offshore rock outcrop emerges from the bay, and these rocks can affect wave refraction and breaking wave patterns.

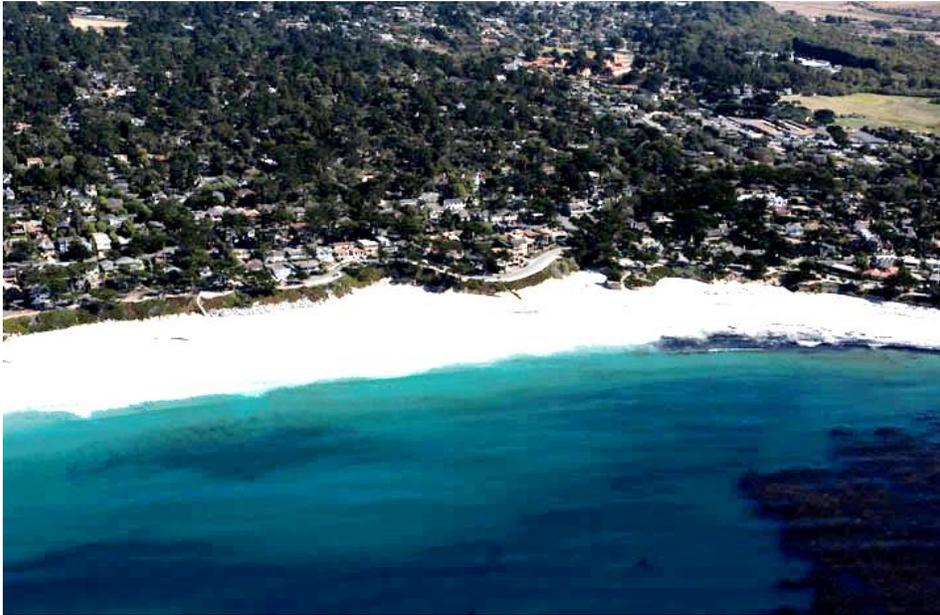
Figure 4. Section 1, South Beach. Source: California Coastal Records Project (2018)

- Mostly armored cliffs and bluffs along Scenic Road south of 8th Avenue. Henceforth referred to as **Section 1, South Beach** (Figure 4).
- Unarmored dunes along private property between 8th Avenue and Del Mar Parking Lot. Henceforth referred to as **Section 2, Central Beach** (Figure 5).
- Mostly natural, unarmored North Dunes area. Henceforth referred to as **Section 3, North Dunes** (Figure 6).
- Armored private properties on the cliffs at the north end of the City. Henceforth referred to as **Section 4, North Beach** (Figure 7).

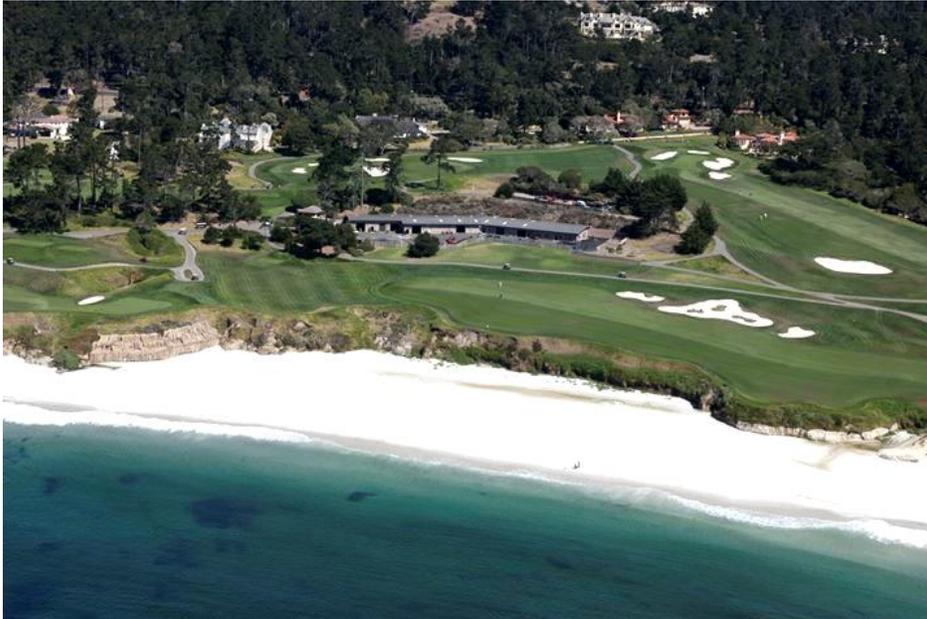
Figure 8. Section 5, Pebble Beach. Source: California Coastal Records Project (2018)

For the sake of brevity, each beach section in this memo will be referred to by section number and/or its short name, South Beach, Central Beach, North Dunes, or North Beach. Also included is the beach section north of the City limits, referred to in this study as **Section 5, Pebble Beach** (Figure 8).

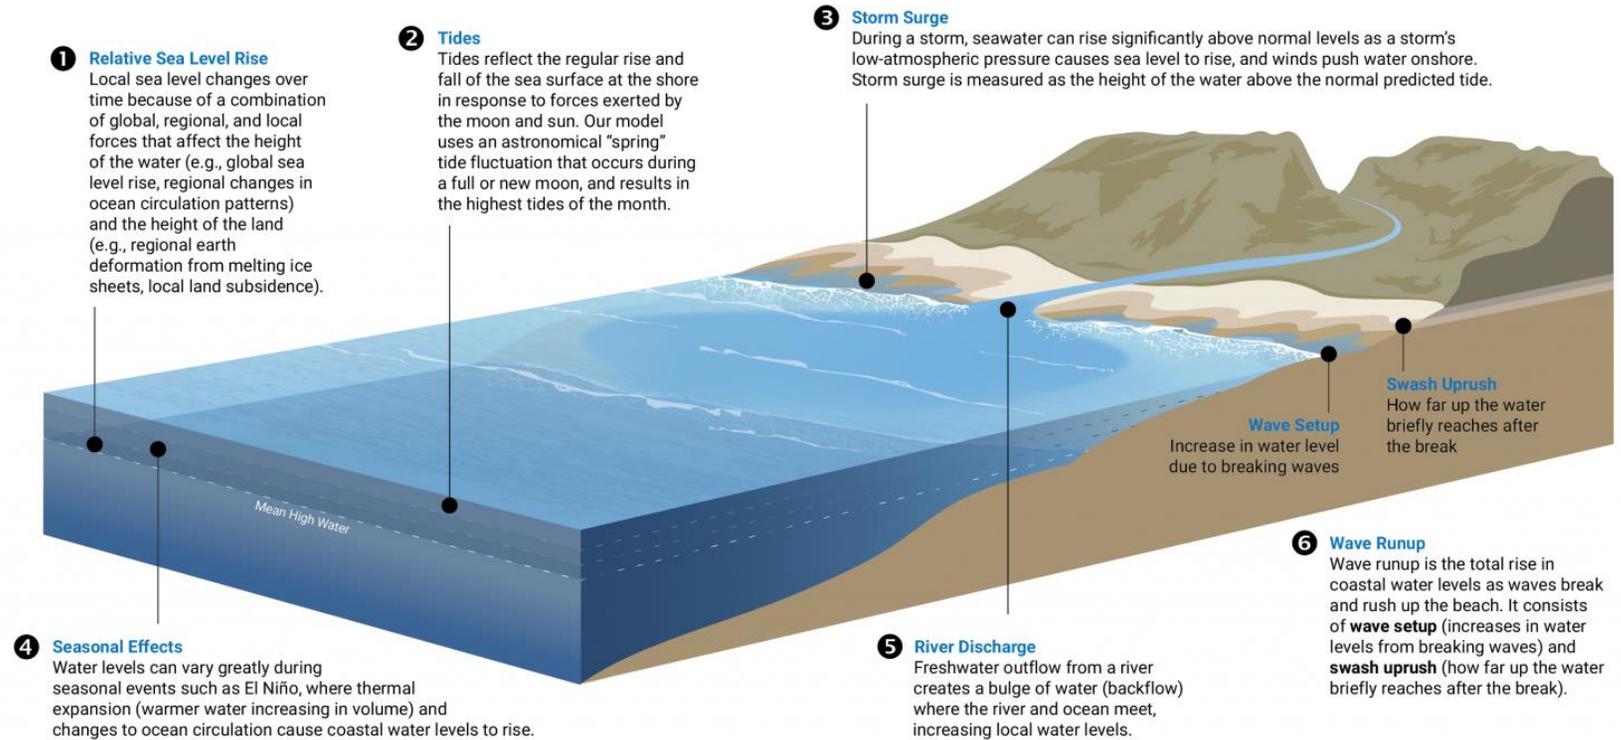
Figure 9. Conceptual diagram of the components of total water level.

$$\text{Total Water Level} = \text{1 Relative Sea Level} + \text{2 Tides} + \text{3 Storm Surge} + \text{4 Seasonal Effects} + \text{5 River Discharge} + \text{6 Wave Runup}$$

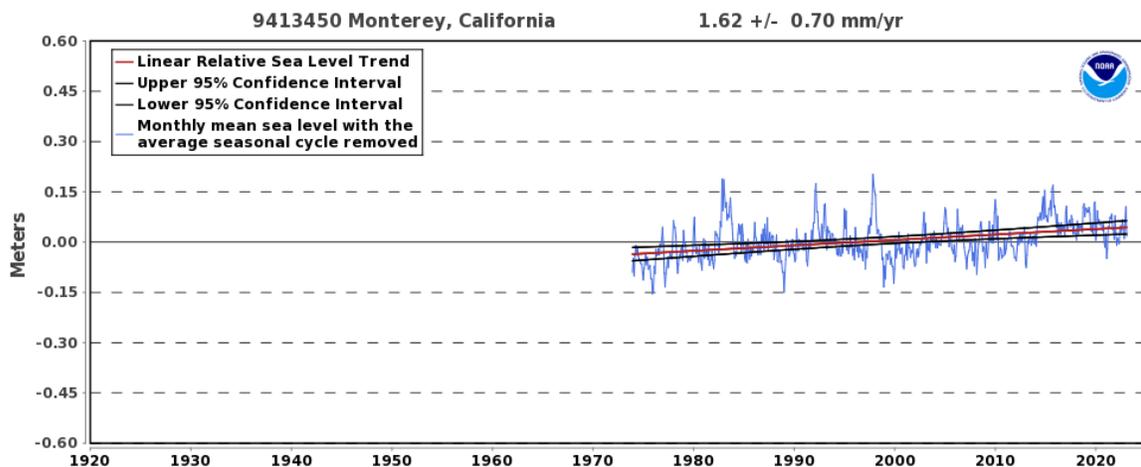
Figure 10. Relative Sea Level Trend for the NOAA Monterey Tide Gauge (NOAA Station 9413450)

Maximum water levels occur due to astronomical tides, wind surges, wave setup, density anomalies, long waves (including tsunamis), and cyclic El Niño and Pacific Decadal Oscillations. On longer time scales, the tides will reach higher elevations as sea levels rise. The National Oceanic and Atmospheric Administration (NOAA) Monterey tide gauge (Station 9413450) is the closest tide gauge to Carmel with readings extending only to the 1970s, whereas some gauges date back much further. For instance, the San Francisco tide gauges dates back to the mid-1800s. The relative rise in sea level, based on the Monterey gauge, is 1.62 millimeters per year (mm/yr.), based on monthly mean sea level data from 1973–2022, with a 95% confidence interval of 0.70 mm/yr. (Figure 10). This indicates that sea levels have risen 0.3 ft since the early 1970s. These measured local relative sea-level rise trends when compared to the global average provide estimates of land motion. In this case, the land is rising but just not as fast as sea levels.

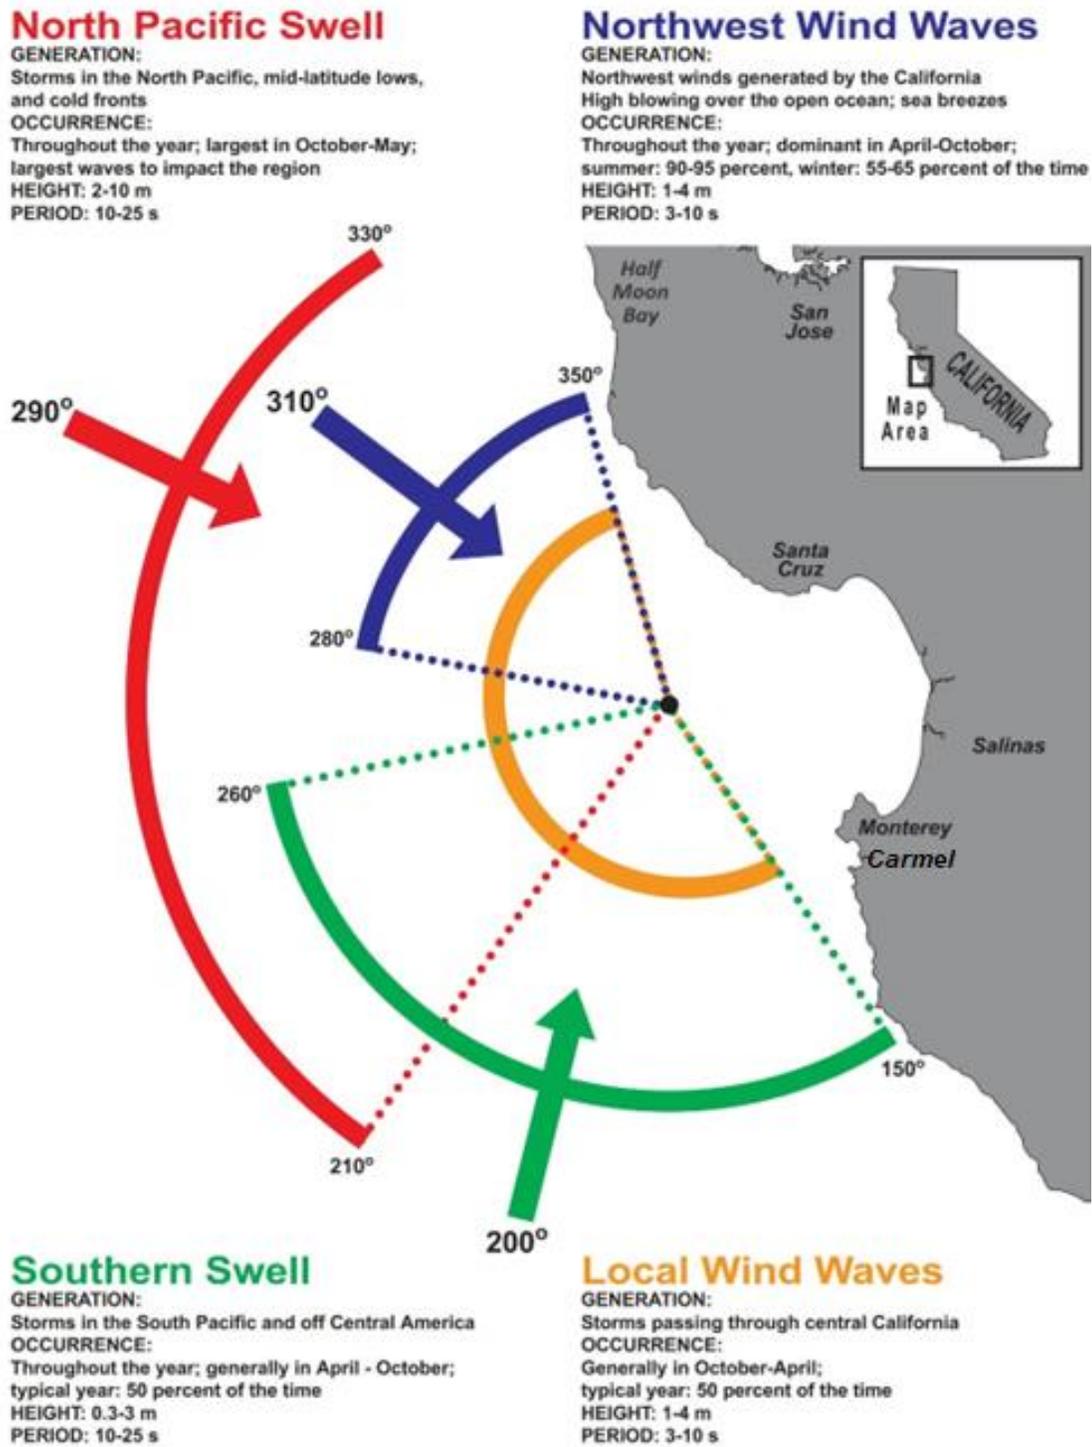
Figure 11. Diagram depicting dominant wave types, directions, and seasons for Carmel Beach and Monterey Bay.  
 Source: Storlazzi and Wingfield (2005)

The waves that approach Carmel Beach are characterized by three dominant types depending on their wave source and direction (see **Error! Reference source not found.**) **Error! Reference source not found.** Most wave energy approaches the study site from the northwest and west (Storlazzi and Wingfield 2005) by waves generated by

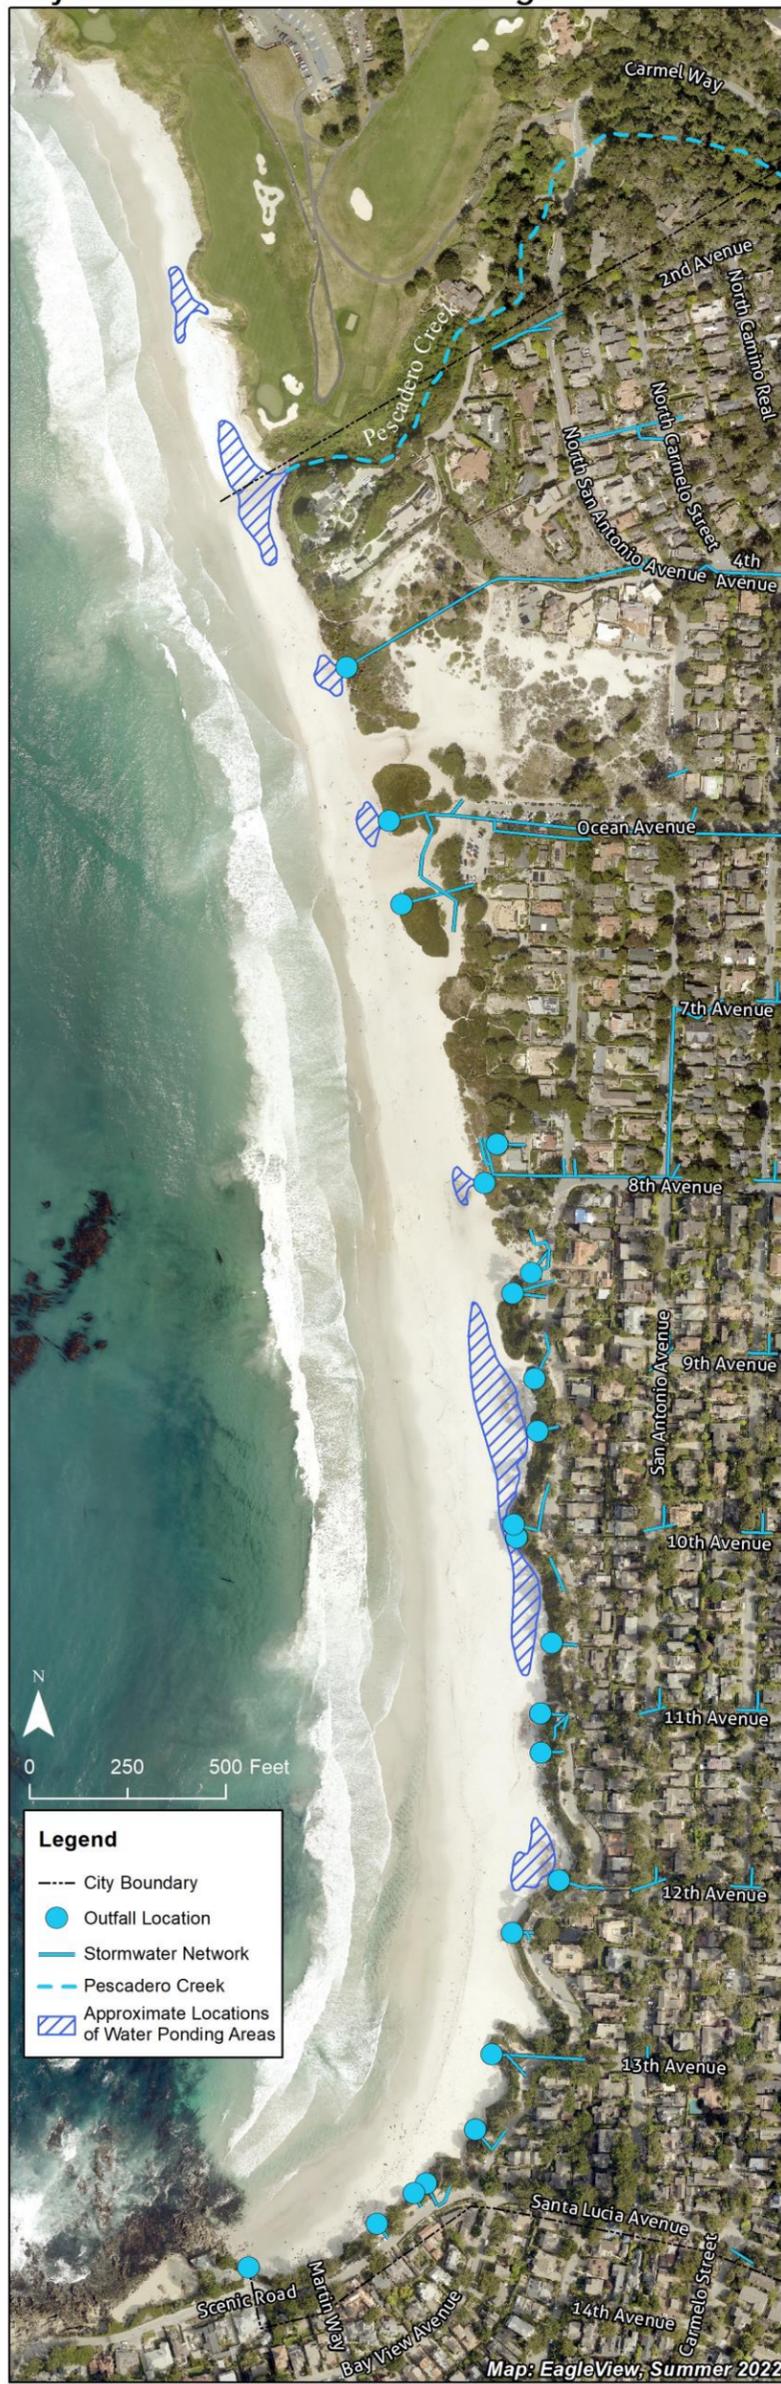
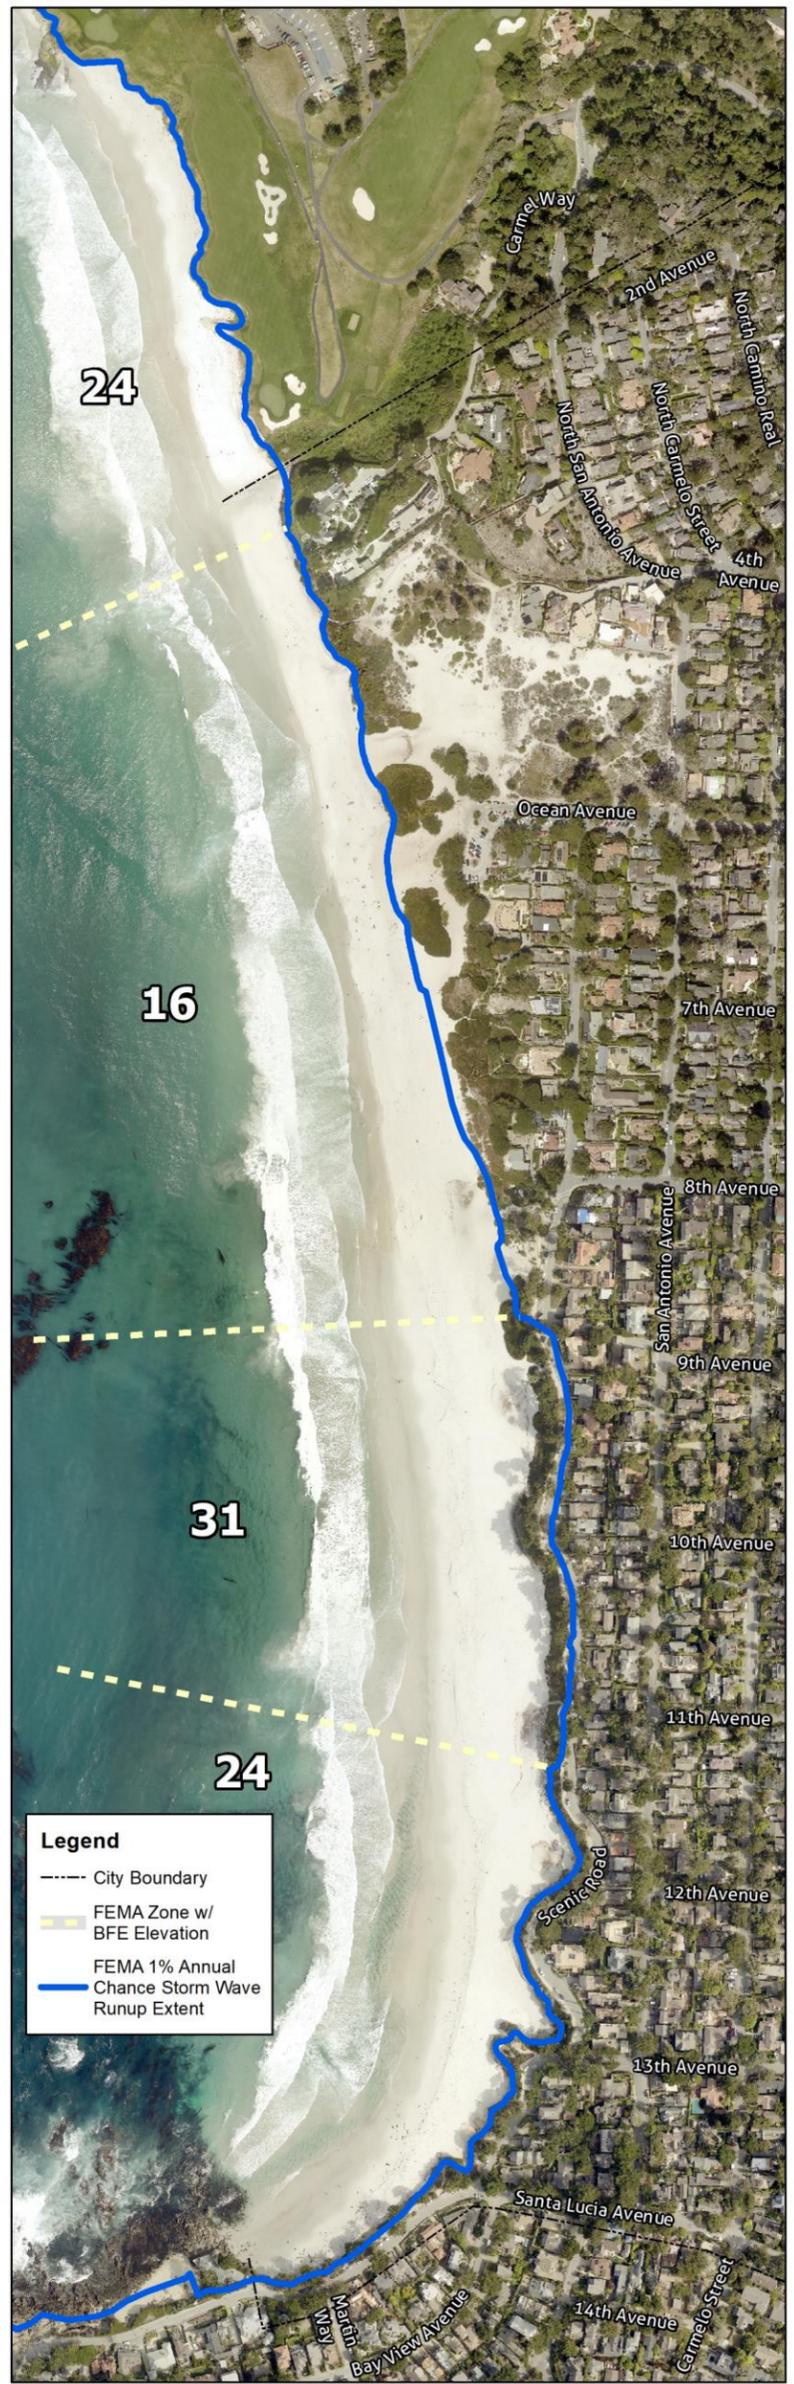
Figure 12. City stormwater and water ponding areas (left), and FEMA 1%-annual-chance storm wave flood extent (right). Water ponding locations represent general areas, and were sourced from differences between winter 2009 and summer 2010 digital elevation models, as well as aerial images from 2003–2022.

The National Flood Insurance Program, administered by the Federal Emergency Management Agency (FEMA), is intended to reduce future flood damage by encouraging local governments to adopt floodplain management regulatory programs. The regulatory Flood Insurance Rate Maps identify base flood elevations according to a 1%-annual-chance TWL elevation at the coast. The base flood elevations are depicted in **Error! Reference source not found.** (right) and vary from 16 to 31 ft. FEMA has determined that the highest wave runup extents between 9th and 11th avenues, and this is the one location where FEMA projects that the current 1%-annual-chance wave runup hazards to overtop the crest of the bluff.

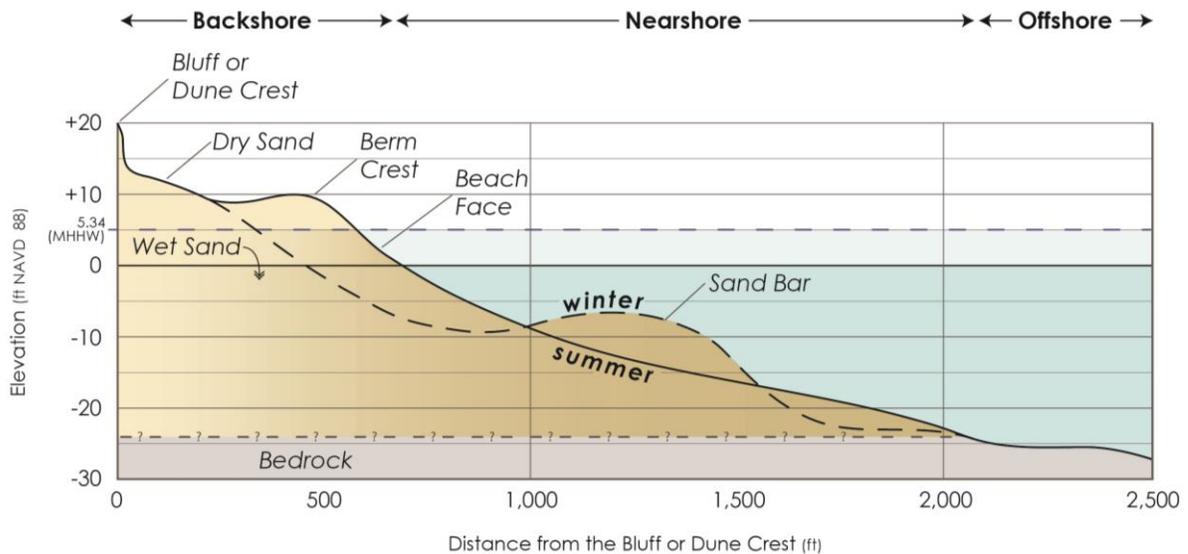
Figure 13. Example of a cross-shore profile showing seasonal change for Carmel Beach. The beach profile changes seasonally with a widening of the beach typically occurring between April and September, and a narrowing of the beach occurring in conjunction with winter storms and large waves, typically occurring in the winter months. The solid black line represents a typical summer profile, with a beach berm forming in spring and summer and a widening of the dry sand beach by as much as 200 ft. The hatched line represents a typical winter profile, with the beach face retreating and a longshore bar developing in the nearshore. Image adapted from *Waves and Beaches* by Willard Bascom, 1964 (updated in 2020 by Kim McCoy).

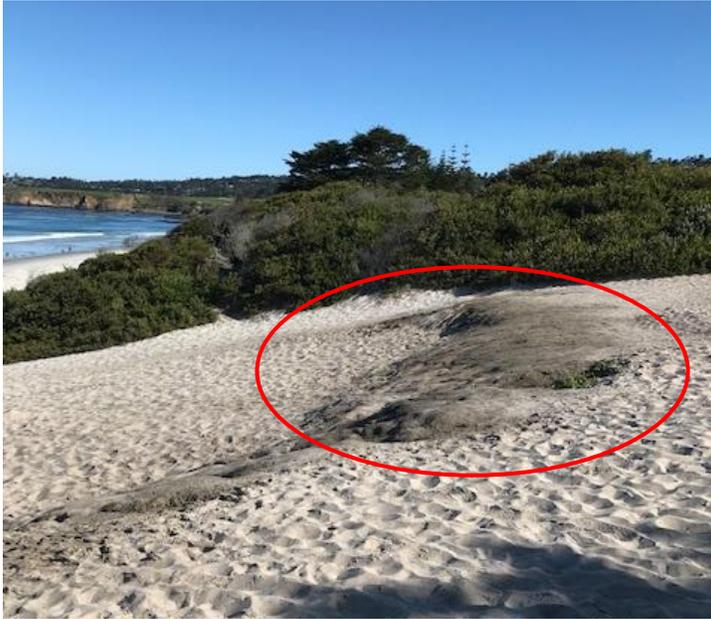
Figure 14. The exposed sandstone formation, indicated in red, located at the central sand ramp near the Del Mar Parking Lot.

Carmel Beach is backed by sandstone cliffs and sand dunes. The cliff-backed portions make up 64% of the city's backshore and are comprised of sandstone overlaid by loose terrace deposits (see Figure 3, right). The dune-backed portions of the shore comprise 36% of the city's backshore and are comprised of sandstone at an unknown depth and location, overlaid by windblown dune sands and dune vegetation (see **Error! Reference source not found.**, which shows the underlying sandstone exposed).

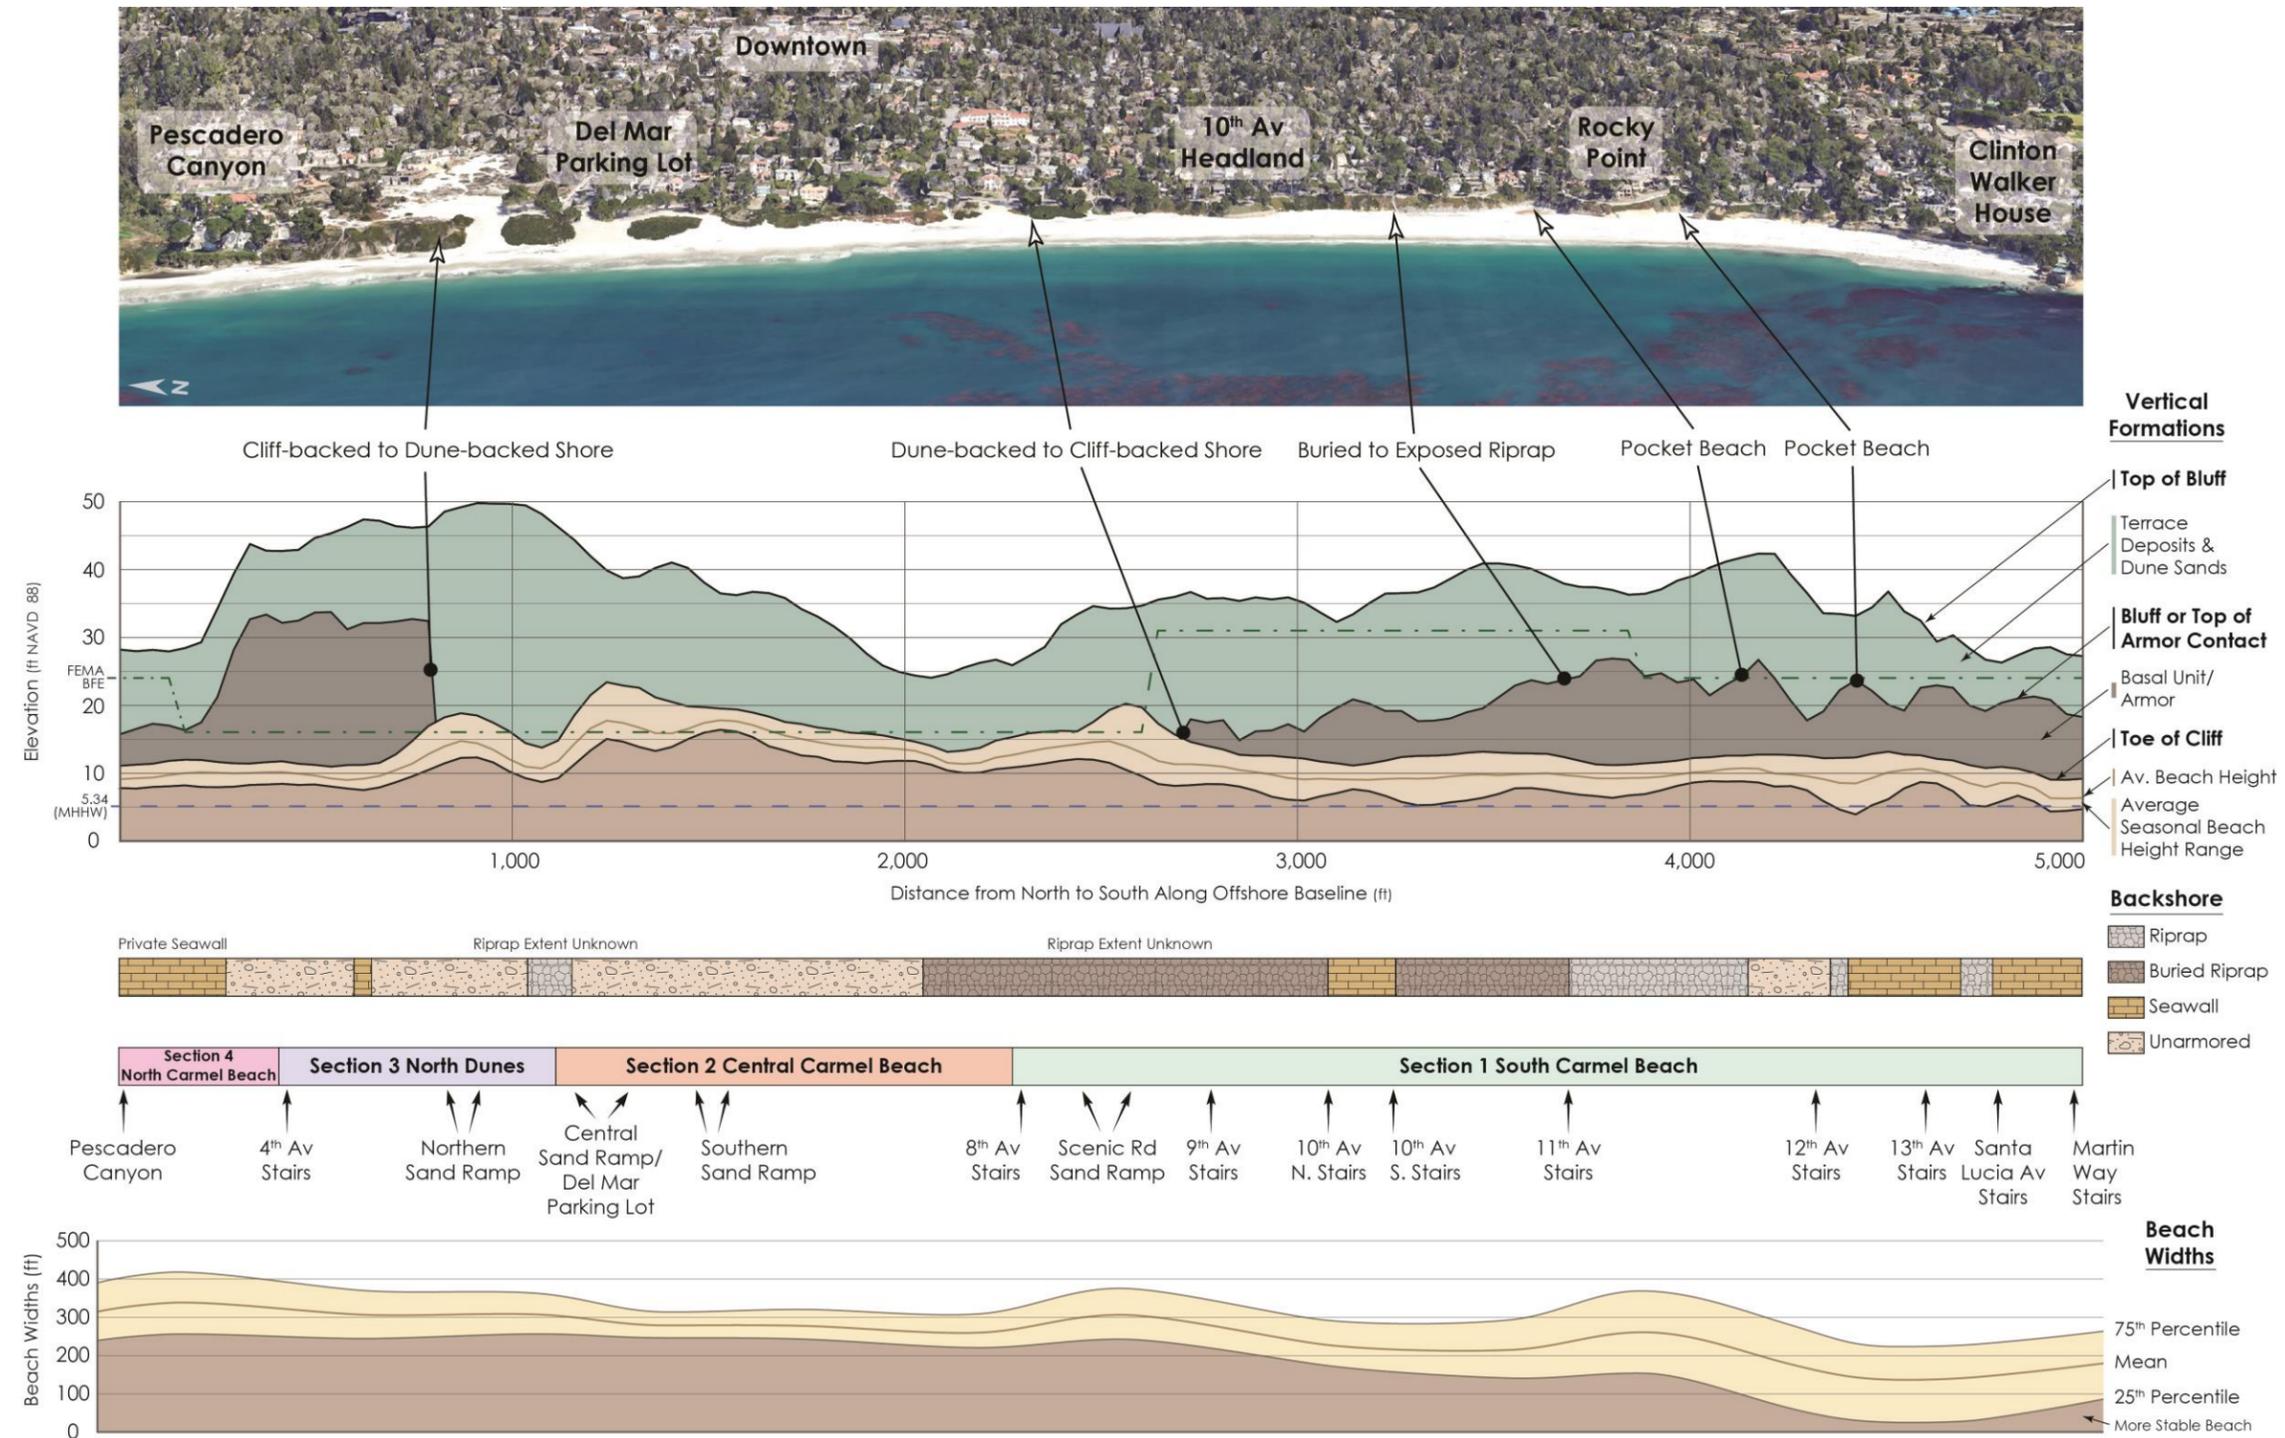
Figure 15. Beach locations (first/top panel), a cross section of the geology (second panel), a depiction of backshore protection (third panel), beach sections (fourth panel), and beach width measurements from CoastSat (fifth/bottom panel). Note that the mean 25th and 75th percentile beach widths are from the entire satellite-derived beach width dataset (years 1984–2021). Approximately half of the linear distance of the city’s shoreline protection structures are seawalls; however, as they have been built on many crenulated portions of the backshore, this distribution is not reflected in the figure, which follows a linear path along the foreshore.

Figure 15 provides a shore-parallel cross section of the varying vertical cliff and dune formations, as well as a diagram of coastal armoring locations and seasonal beach widths. Along the beach, the contact between the less consolidated softer marine terrace deposits and the dense sandstone basal unit varies but tends to be lower in the Central Beach section between 11th and 8th avenues, and highest in the North Beach and South Beach. Sandstone underlies the terrace for the entirety of the beach, however in the central portion of the beach, remnant windblown Pleistocene sand dunes and dune vegetation overlay the basal sandstone geologic unit (James C. Reynolds and Associates 1986, Shonman and D'Ambrosio 2003).

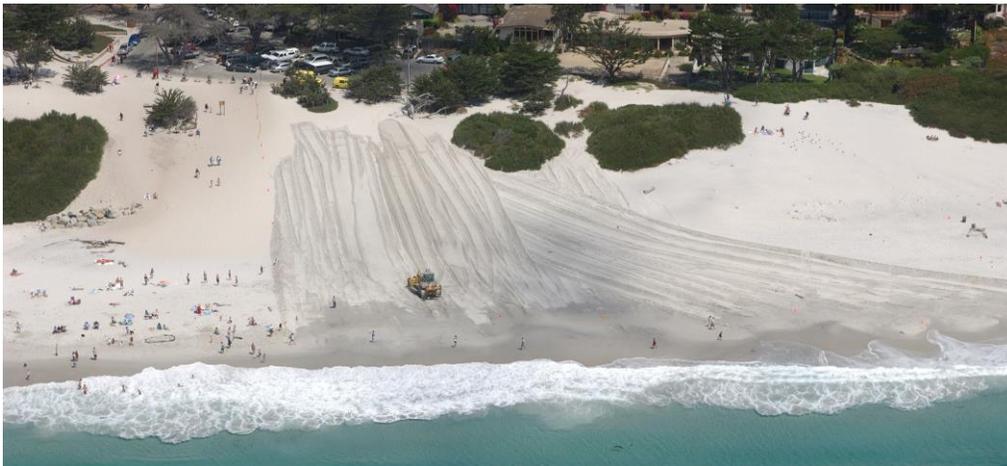
Figure 16. Active Beach Management near the Del Mar Parking Lot  
Source: Coastal Records Project (August 2003)

The city’s sand redistribution program has involved bulldozing sand from the lower beach (located above high tide line) to the upper beach and is intended to improve public safety and compensate for sand that is naturally pushed downslope by visitors (see Figure 16). This program has been in place since the 1960s and originally operated below the Del Mar parking lot in late spring/early summer. Starting in 1984, the sand redistribution plan expanded, and sand was also bulldozed to cover the riprap revetments (see Figure 17 as a reference from 2003). The total sand redistribution volume varies between 50–100,000 cubic yards depending on conditions (mild winter requires less sand movement than severe winters) (Shonman and D’Ambrosio 2003).

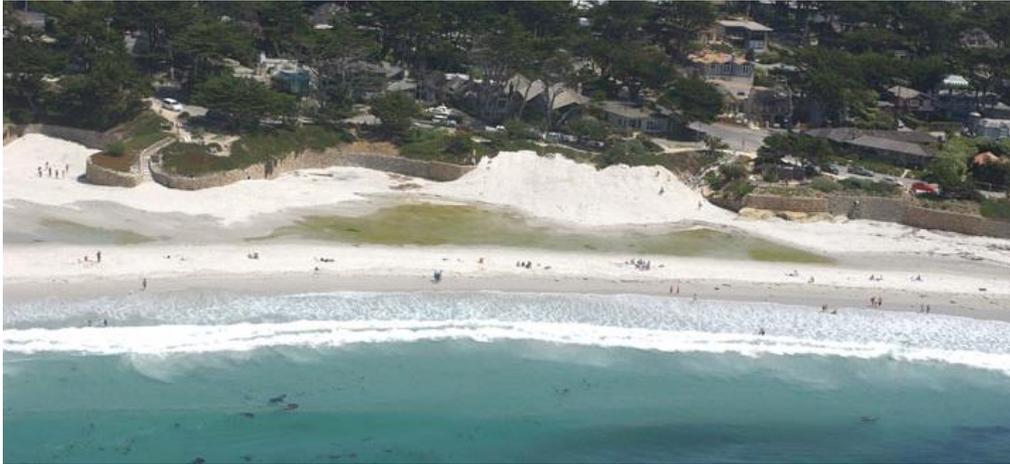
Figure 17. Beach management with sand bulldozed over the riprap revetments near 13th Avenue  
Source: Coastal Records Project (August 2003).
