## MEMORANDUM

**Subject:** Carmel Climate Change Vulnerability Assessment, Shoreline and Beach Change Analysis: Seasonal and Long Term

**Project No.:** C3016

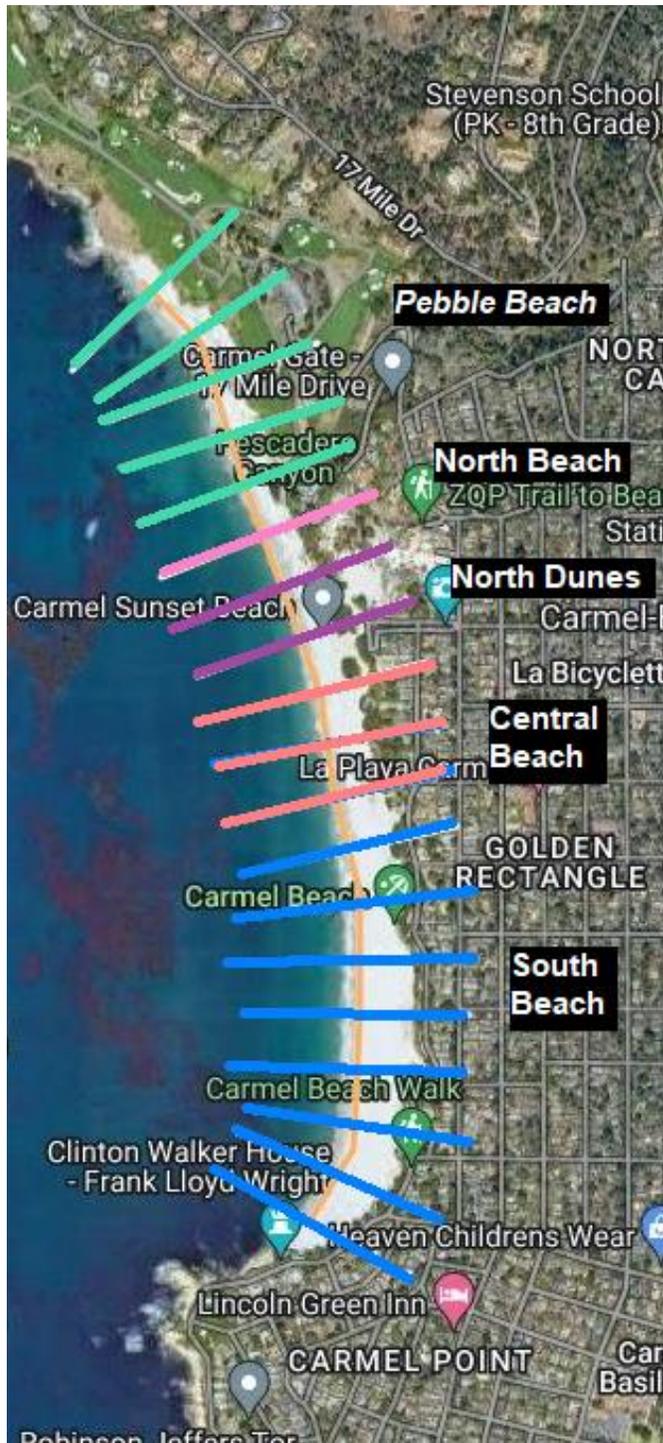
Figure 18. CoastSat transects and groupings based on beach section. Interactive map and data available at:

For this study, 18 cross-shore transects were grouped by section: South Beach, Central Beach, North Dunes, North Beach, and Pebble Beach. At each transect, a backshore toe location was determined for the most landward side of the transect, and this toe location was subtracted from the shore position to determine a dry sand beach width for each time step. These dry sand beach widths were then analyzed for overall, seasonal, and interannual trends, and the findings are presented below.

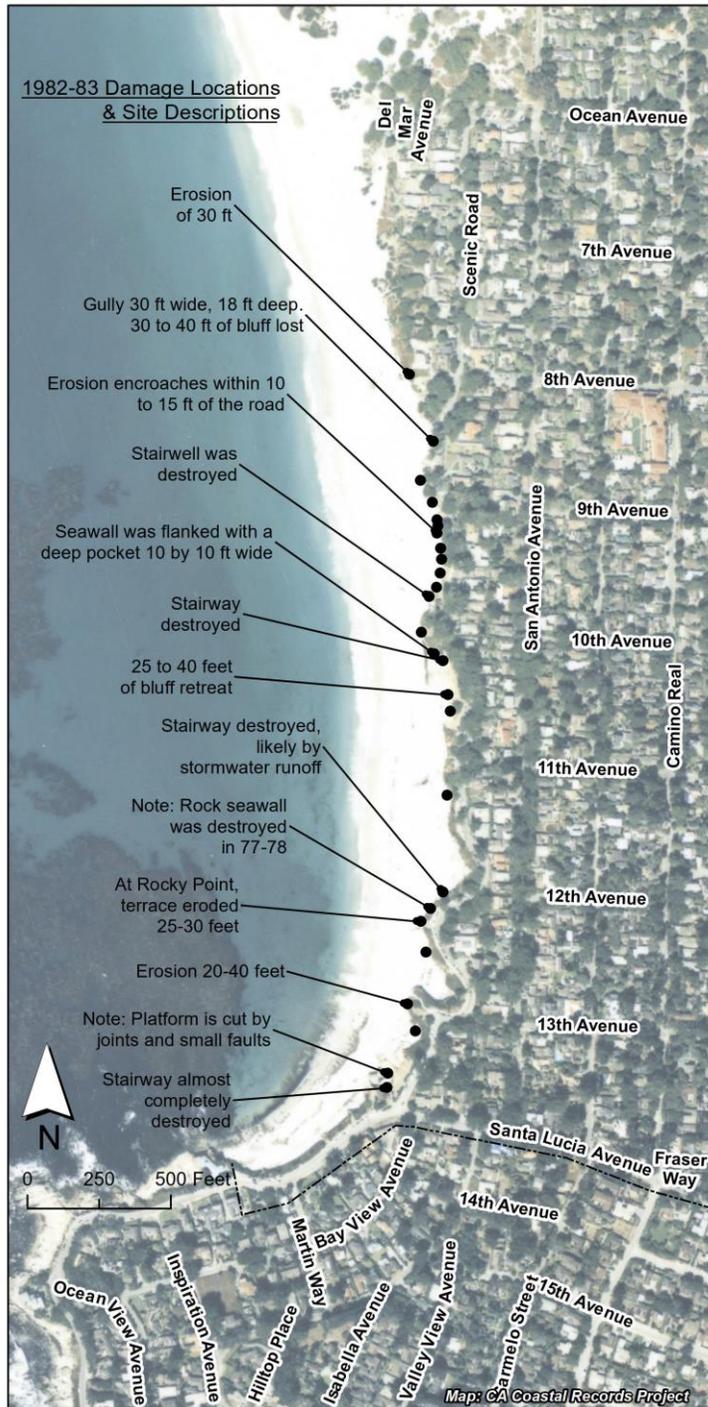
Figure 19. Winter of 1982–83 shoreline damages. Observations compiled from Rogers E. Johnson and Associates

The cliffs and bluffs along the City's shoreline have endured numerous erosion events, with perhaps the most notable in recent memory being the 1982-83 El Niño winter. As recounted in local media and post-storm surveys, the beach was heavily scoured following a series of storms. This left the bluffs less protected from wave attack and exposed them to considerable amounts of subaerial erosion processes. The City contracted Rogers E. Johnson and Associates to perform a post-storm assessment, and a map of observed damage locations from the assessment can be found in

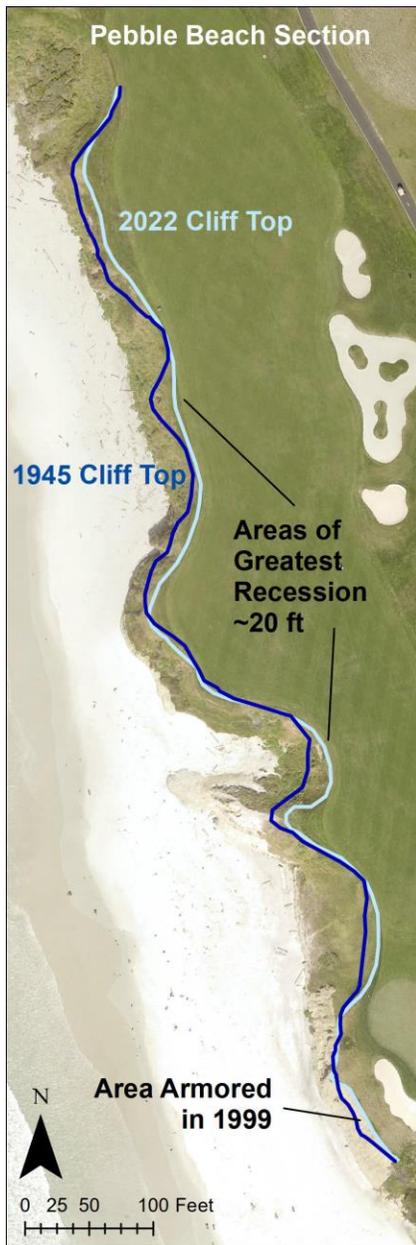
Figure 20. Bluff-top position for the Pebble Beach section along Carmel Beach.

The Integral team used the DSAS tool to determine both an endpoint erosion rate and a linear regression erosion rate for the Pebble Beach section of cliffs. The average bluff top recession from 1945 to 2022 was found to be just over 1 in./yr (as an averaged linear rate), with the greatest erosion occurring at two locations where erosion averaged ~3 in. a year or ~20 ft total (see the areas noted in ).

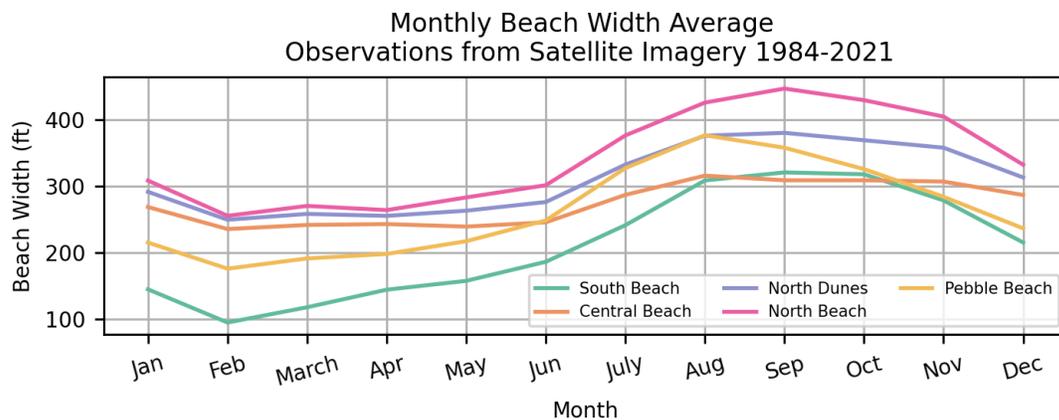
Figure 21. Beach widths were averaged by month for the entire dataset and grouped by beach section. The beach widths show a seasonal oscillation.

Widening and narrowing along the beach happened at different times for different sections of the beach. Both the extreme north (Pebble Beach) and south were more likely to recover earlier in the year, with beach widths widening beginning in late winter (i.e., March), whereas the central areas of Carmel Beach often recovered later in the year, with beach widths widening in the late spring or summer (i.e., June). The first section of the beach that eroded was Pebble Beach; Pebble Beach began to narrow in the late summer.

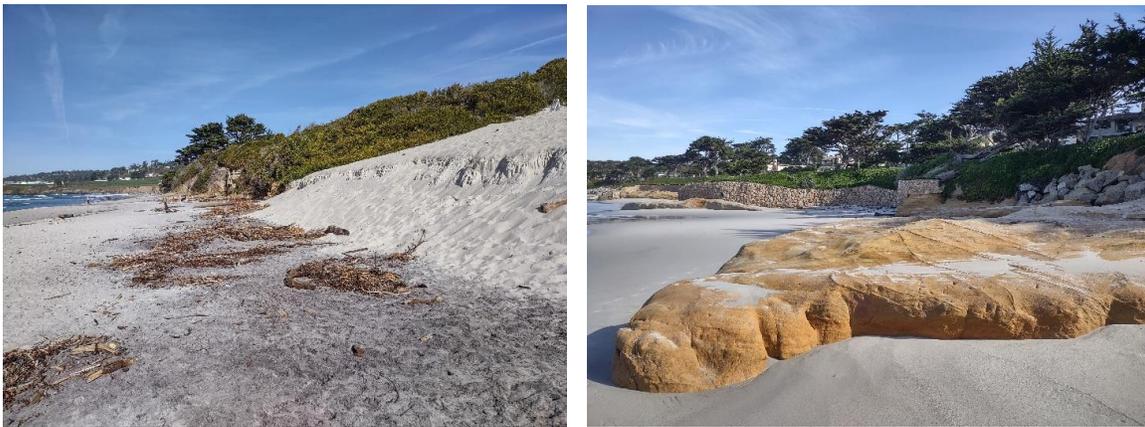
Figure 22. In response to winter storms (seen here in 2023), it is common for the steep sand dunes around Del Mar Avenue to scarp on the seaward edge (left), and for scouring to expose the underlying base of sandstone outcroppings (right) and footings of the coastal armoring in the southern areas of the beach.

During this task in the project, large ocean swells associated with the energetic winter storms of 2022–23 caused substantial beach scouring. Examples of these hazardous conditions can be seen in Figure 1 below, where scouring made beach access difficult (see Figure 1, left) and portions of the beach became difficult to navigate (see Figure 22, right).

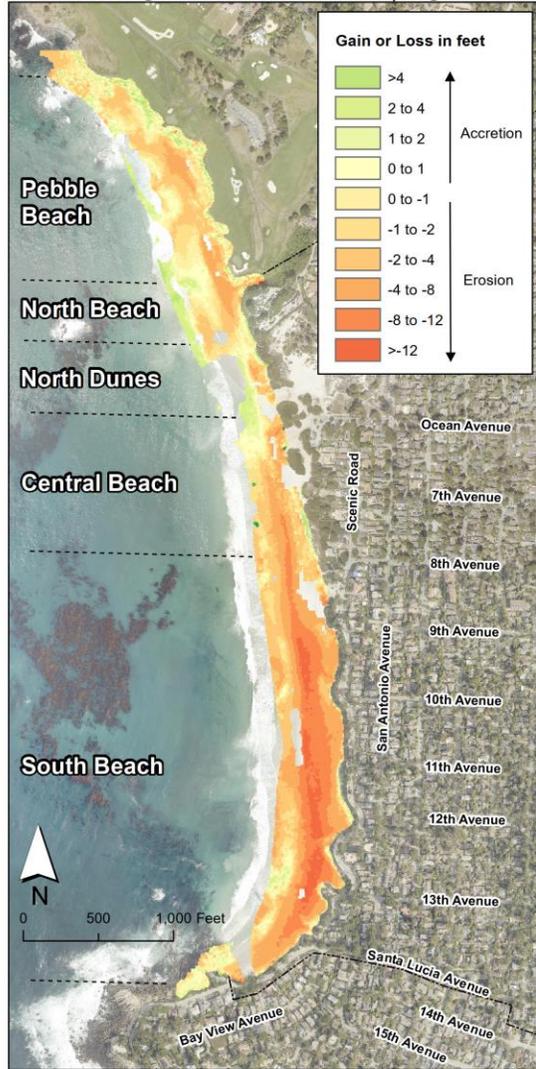
Figure 23. Beach elevation change following the El Niño winter of 1997–98

The beach scouring that occurred in the winter of 1997–98 corresponds with observations and documentation of other El Niño years that have occurred.

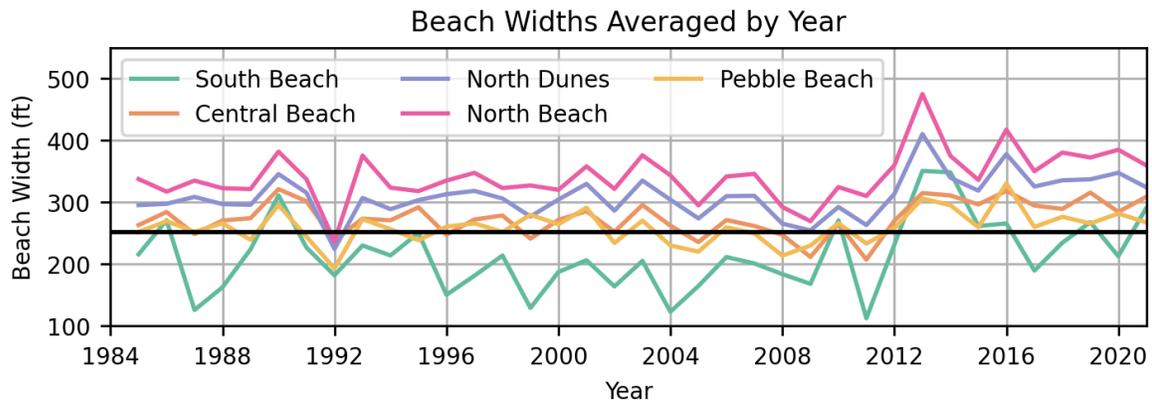
Figure 24. Beach widths were averaged by year for the entire dataset and grouped by beach section. The beach widths are generally stable and deviate about a mean.

Overall, while the shoreline was variable both seasonally and in response to large storm events, it showed a mostly stable long-term trend between 1984 to 2021 across all beach sections. To examine any long-term trends in dry sand beach widths, the beach widths were averaged by year, and the results are plotted in Figure 24.

The beach widths average about 250 ft without any significant trend (no obvious accretion or erosion) in the 40-year dataset. This provides good evidence that over the last 40 years, the sand volume in the Carmel Bay pocket beach has stayed relatively constant.

Interannual recovery for each beach section can also be seen in Figure 24 when beach widths increase. After the 1992 El Niño, beach widths for all beach sections dropped and then recovered the following year (1993), except for the southern portion of the beach. Beach widths for the southern portion of the beach remained narrow until about 2013 when it recovered again. The years 2011–2013 also saw high recovery rates, when beach widths widened until the 2014 El Niño when they narrowed again.

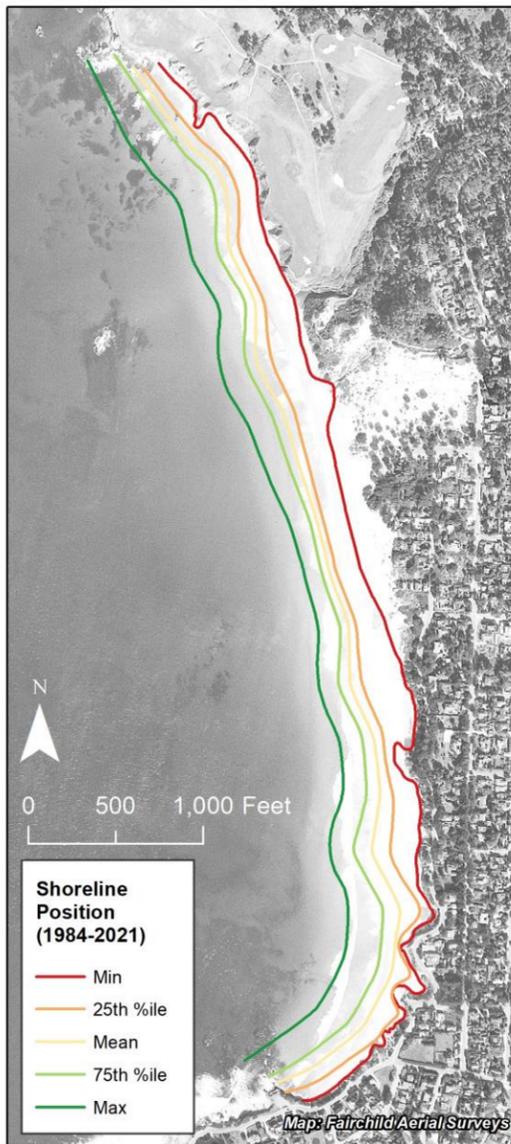
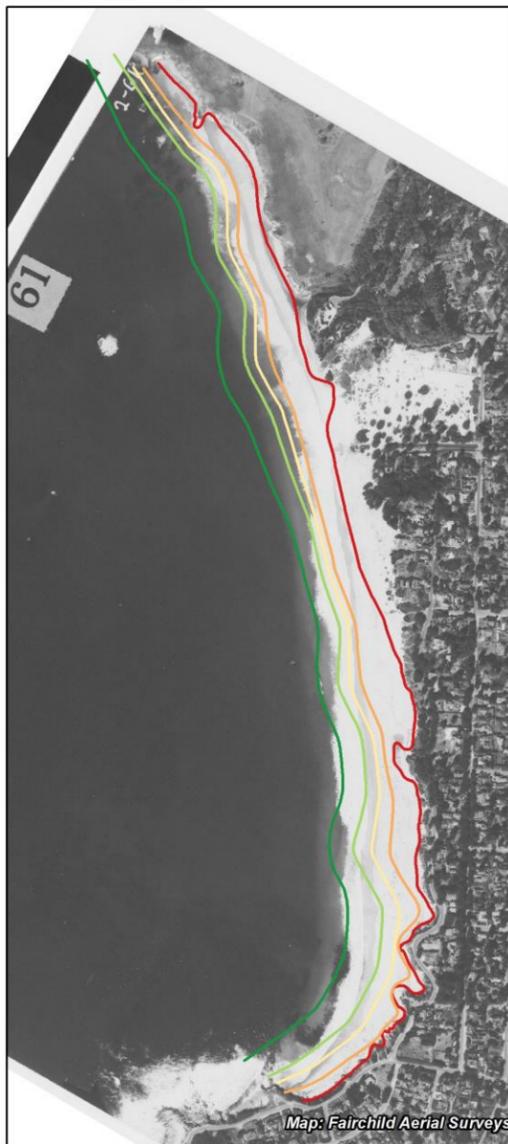
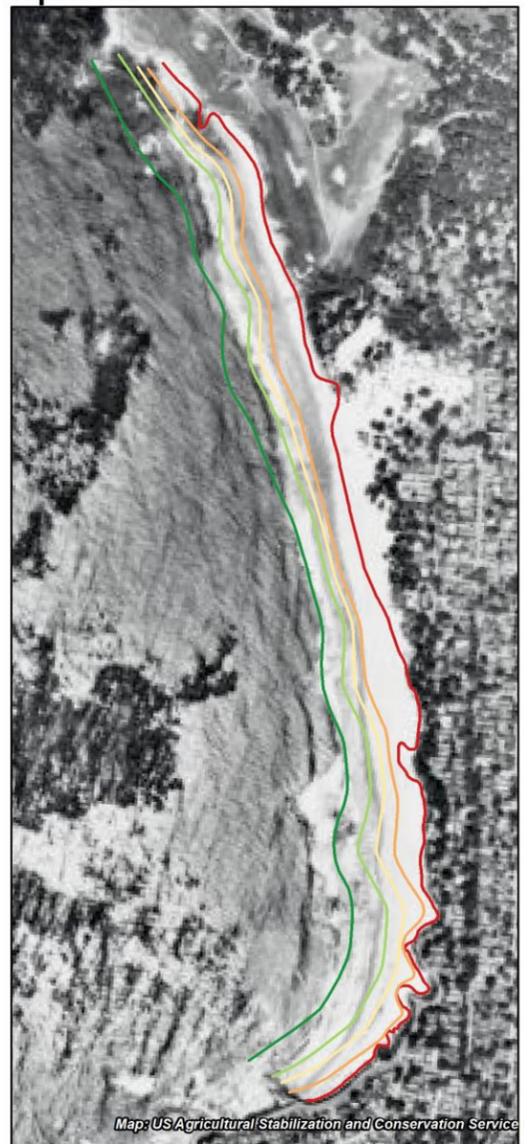
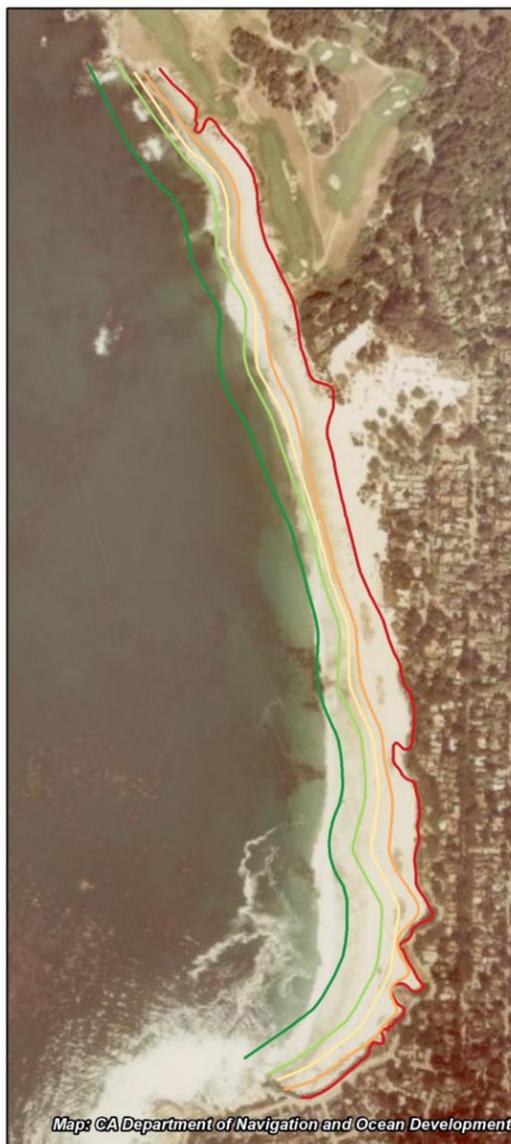
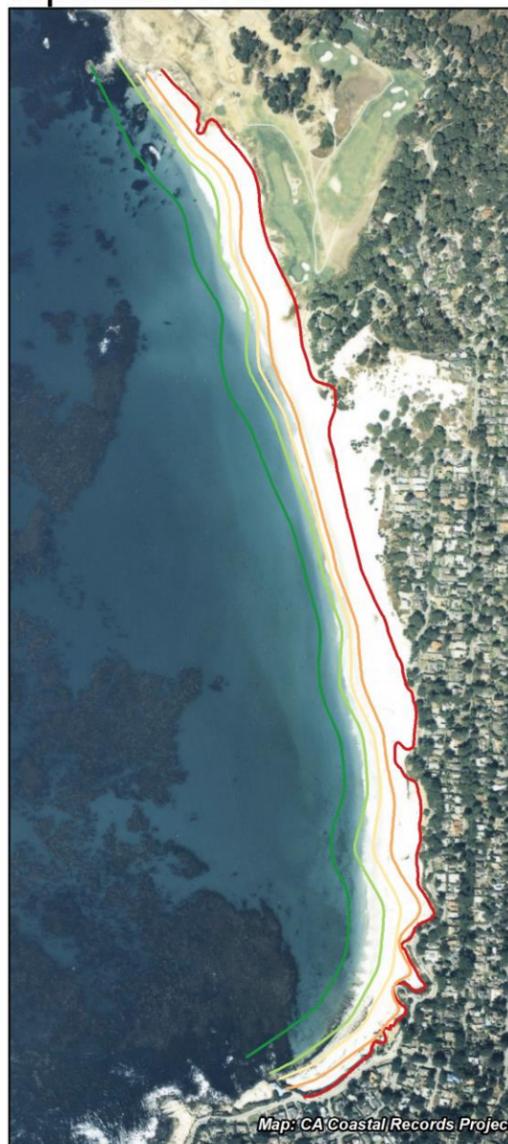
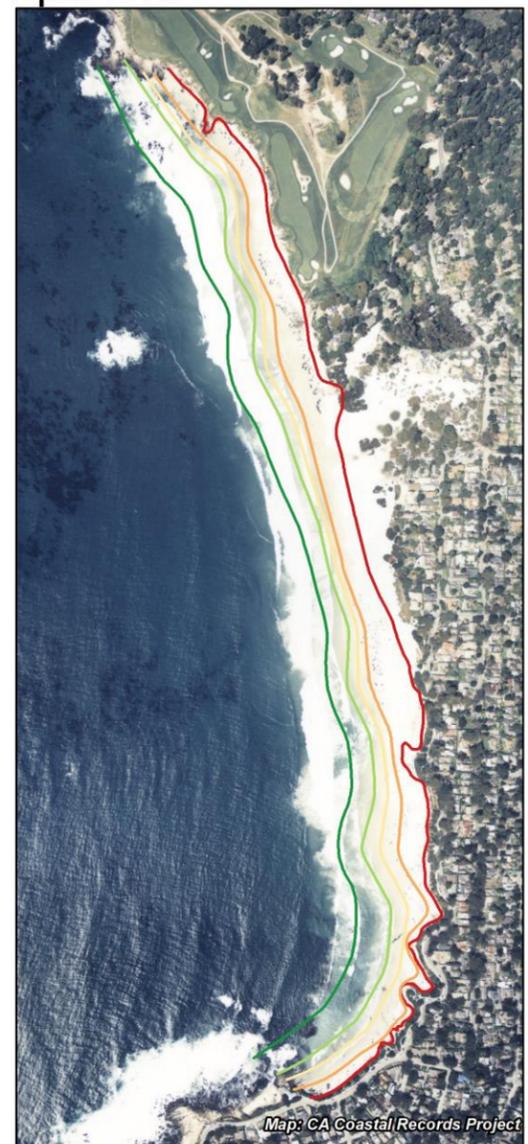
Figure 25. Aerial time series for select years from 1941–1993 with shoreline beach positions from 1984–2021.

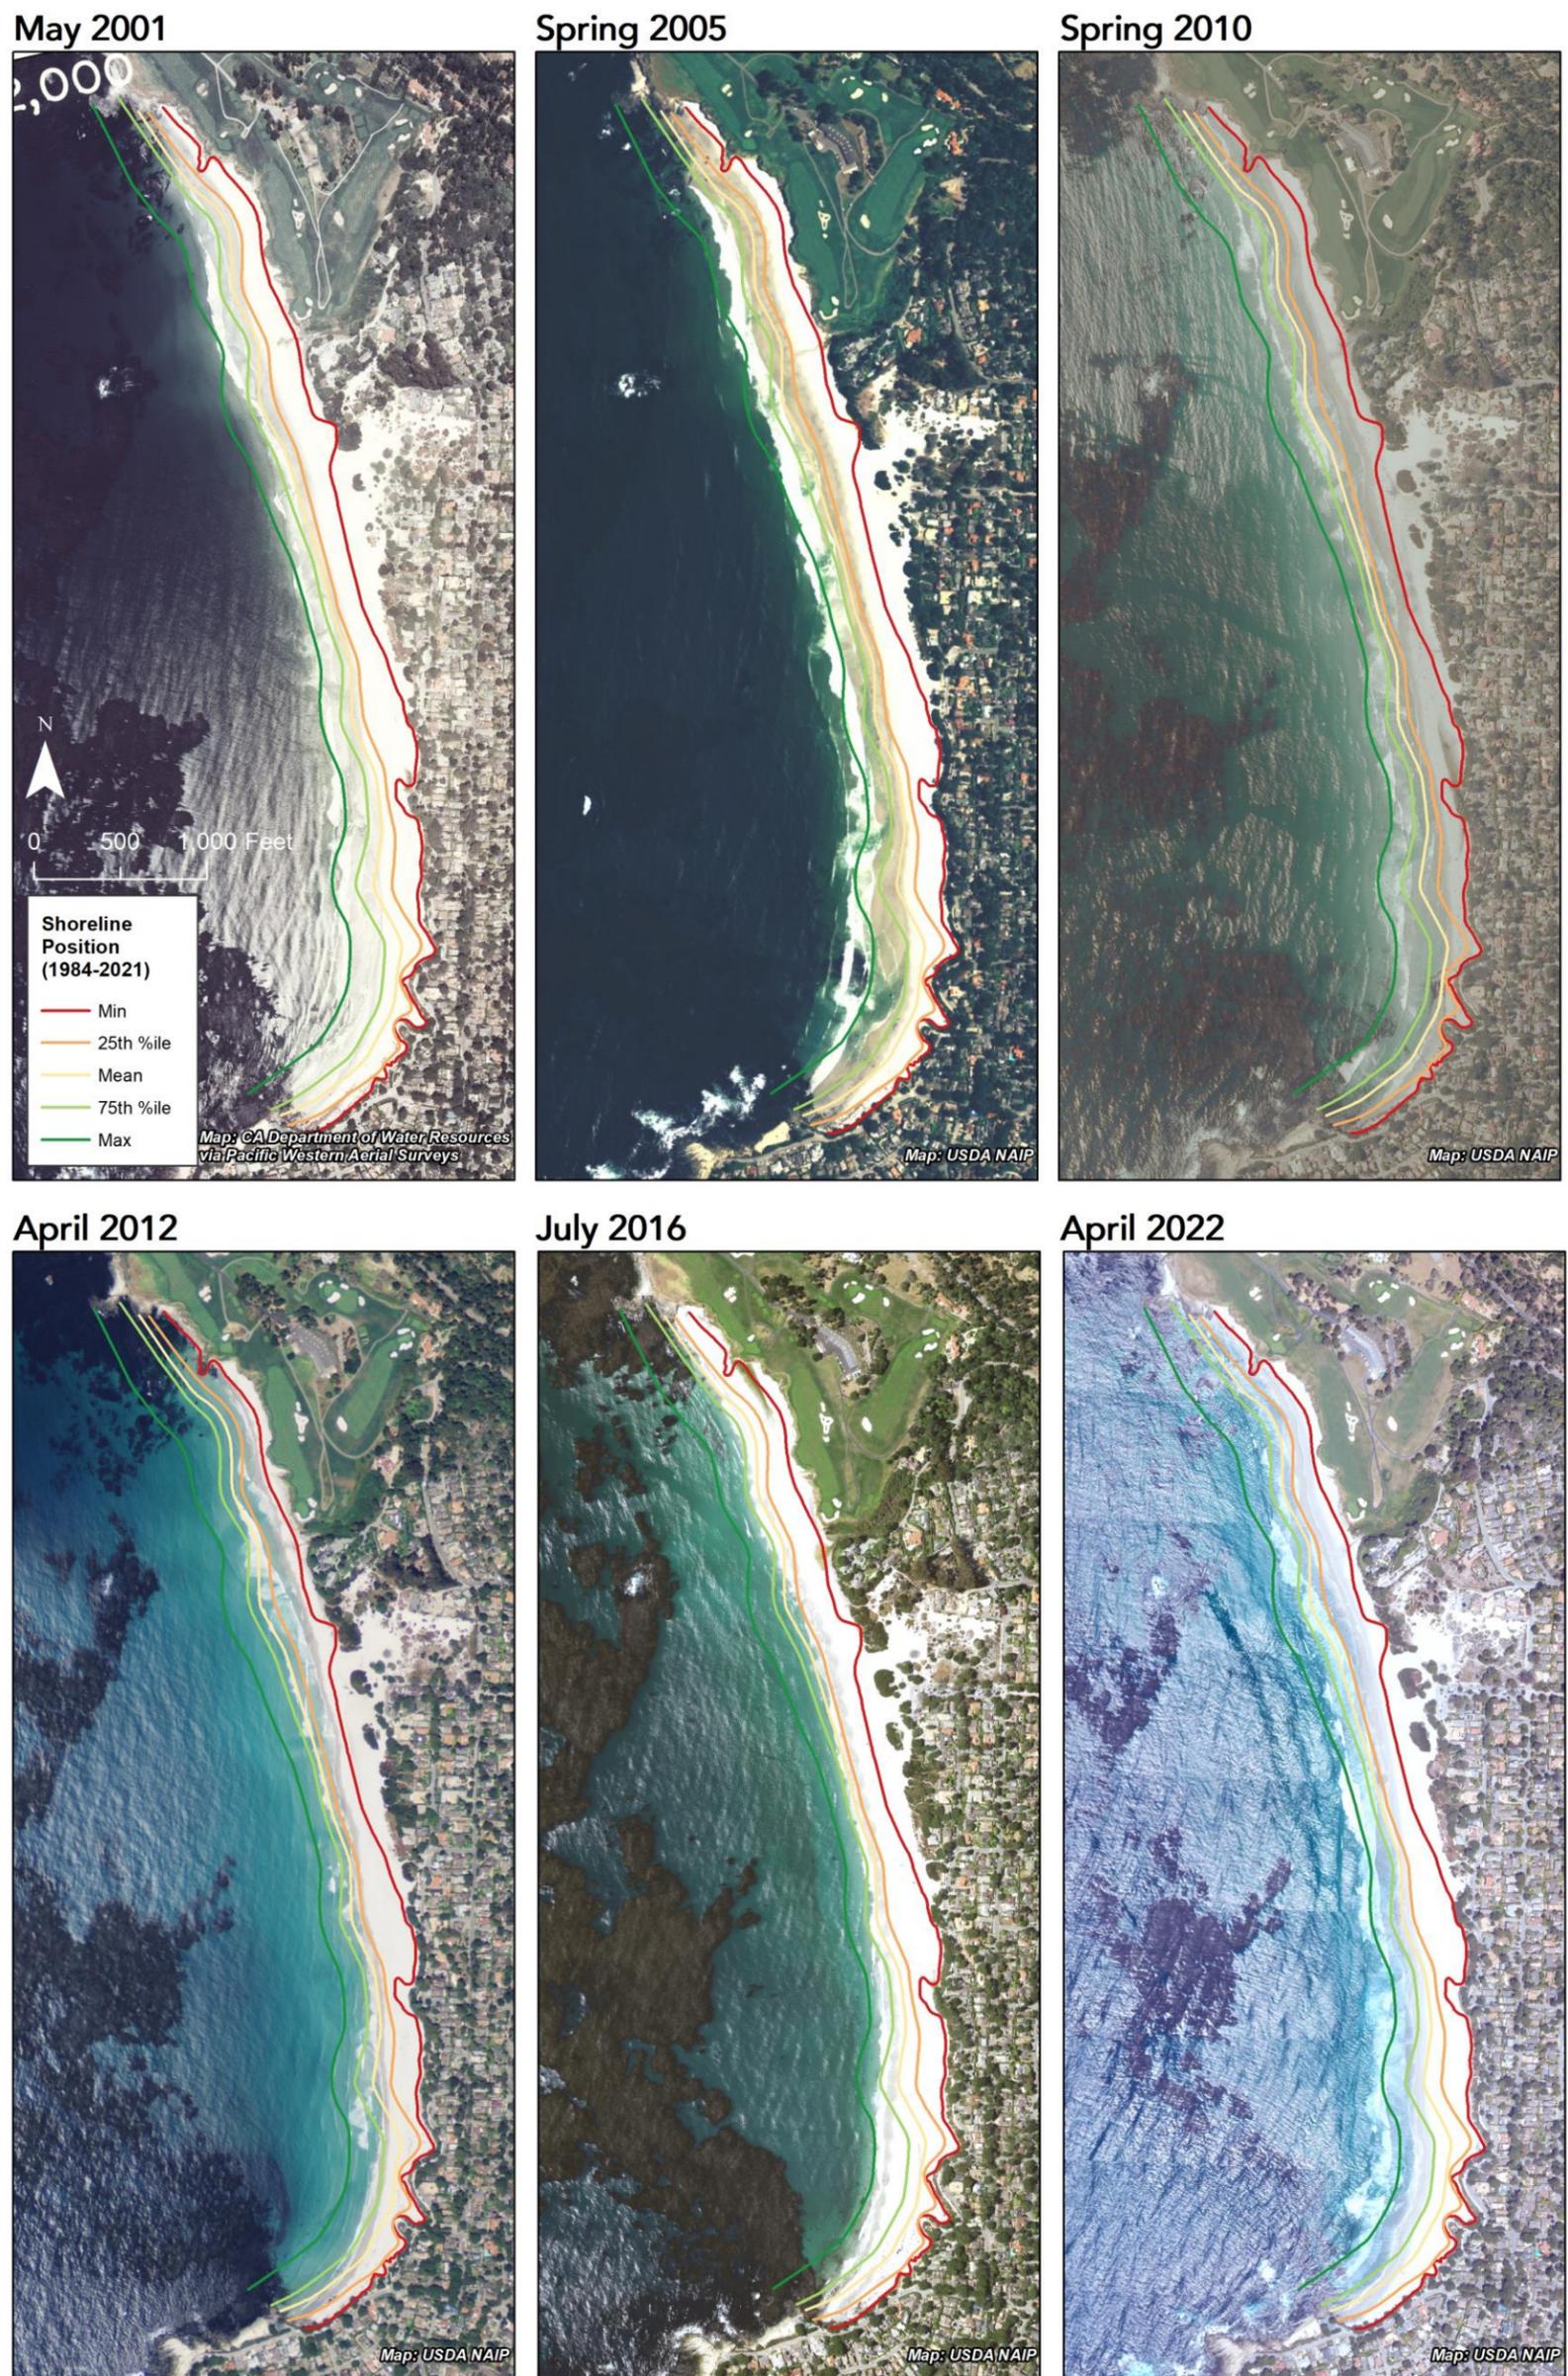
Figure 26. Aerial time series for select years from 2001–22 with shoreline beach positions from 1984–2021.

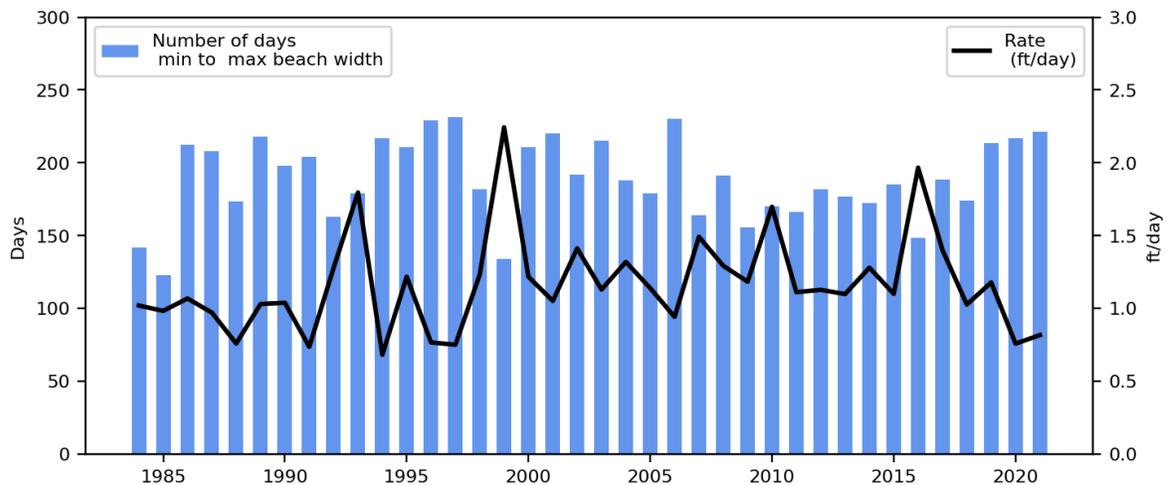
Figure 27. Recovery time scales. Note the sharp peaks in recovery rates around the stronger El Niño years of 1997–98 and 2014–16.
