**CITY OF CARMEL-BY-THE-SEA  
FOREST AND BEACH COMMISSION  
MEETING AGENDA  
Thursday, November 12, 2015  
Regular Meeting – 3:30 p.m.**

Map 1 – Carmel Shoreline Assessment (CSA) – Area of Study

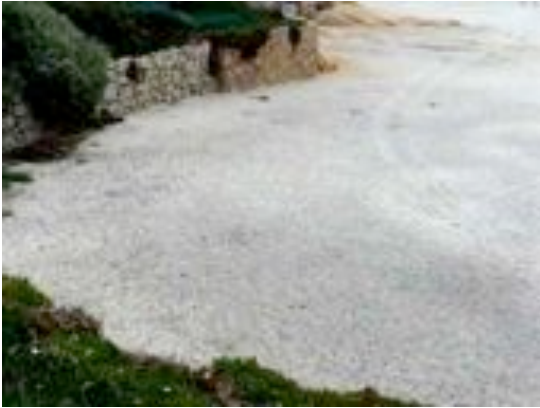
Fig 1#1

- CITY PLANS TO LIMIT BEACH FIRES TO 26 BEACH FIRE CONTAINERS INSTALLED SOUTH OF 10<sup>TH</sup> AVE. FOR A ONE-YEAR PILOT PROGRAM TO HELP DECREASE AMOUNT OF FIRE-DEBRIS ON THE BEACH.
- CITY SHOULD CONTINUE & STRENGTHEN ON-GOING BEACH FIRE-RELATED PROGRAMS
  - ENSURE THAT THE CONTRACT FOR WASTE HAULING SERVICES INCLUDES DETAILED SPECIFICATIONS FOR CLEANING FIRE-DEBRIS FROM BEACH;
  - INCREASE PUBLIC EDUCATION & CODE ENFORCEMENT ACTIVITIES (WILL REQUIRE CARMEL POLICE DEPT. INPUT ON WORDING OF SIGNS);
- CITY SHOULD CONSIDER PLACING TRASH CANS ON BEACH IN FIRE ZONE.

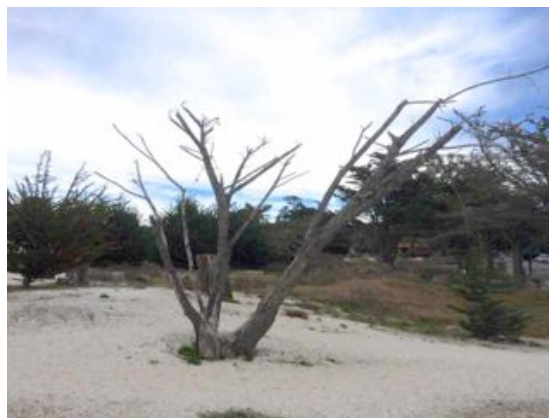
Fig 2#1

- **Condition:** Several dead Monterey Cypress trees have been left standing in the North Dunes area. The City is in the process of deciding what should be done.

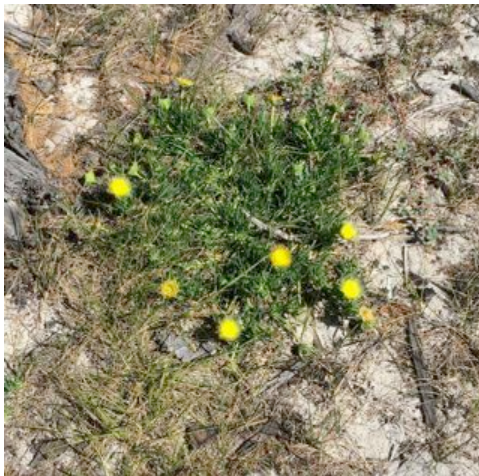
Fig 2#2

- **Condition:** Many stands of the “narrow-leaf ice plant” (*Conicosia pugioniformis*), an invasive plant introduced from South Africa, are growing in the North Dunes. While not as aggressive as the more common South African ice plant (*Carpobrotus edulis*) also growing along the Carmel shoreline, both should be removed as part of any restoration program in the North Dunes.

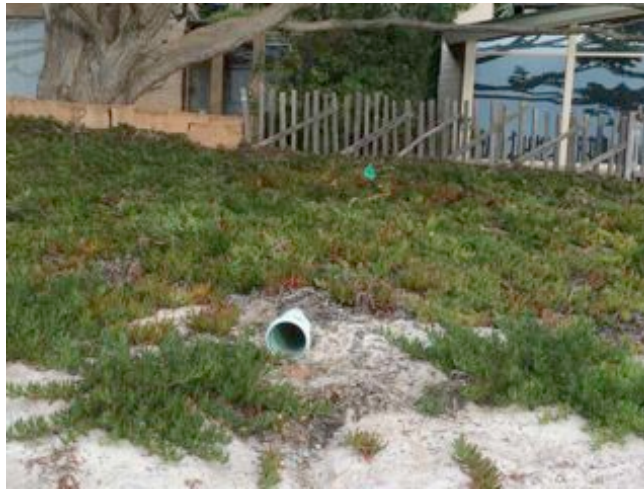
Fig 2#3

- **Condition:** A few of the houses in the Del Mar Dunes have pipes that drain onto the City's dunes. It is likely that these transport drain storm water away from their houses.
- ⇒ **Recommended Action:** CITY SHOULD VERIFY THAT PRIVATE DRAIN PIPES, WHICH DISCHARGE ONTO CARMEL'S DEL MAR DUNES, DO NOT CAUSE EROSION OR OTHER NEGATIVE IMPACTS.

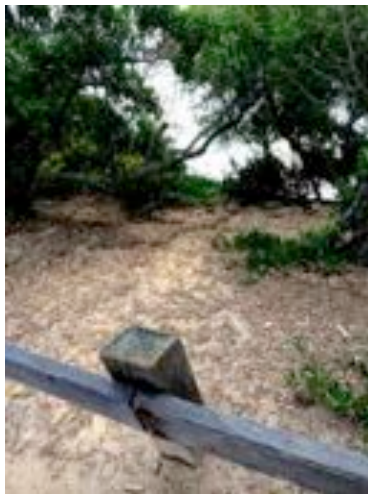
Fig 3#2

**3.1.1b Bluff between 10<sup>th</sup> Ave. Stairway (south) and 11<sup>th</sup> Ave. Stairway**

- WHEN PATHWAY IS RESURFACED, DIP ABOVE BLUFF DAMAGE SHOULD BE RAISED TO MATCH ADJACENT GRADE;
- REPAIR BLUFF EROSION AS PER GENERAL RECOMMENDATIONS LISTED ABOVE.

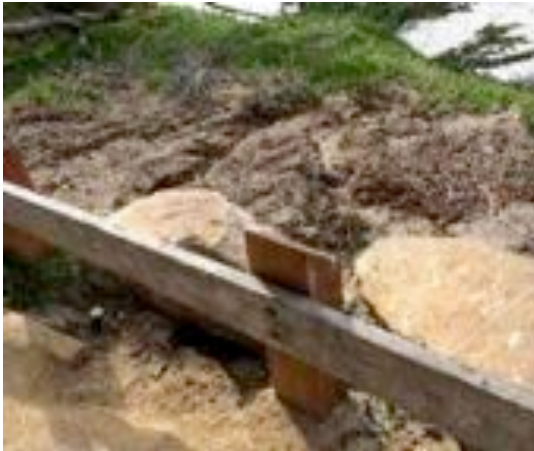
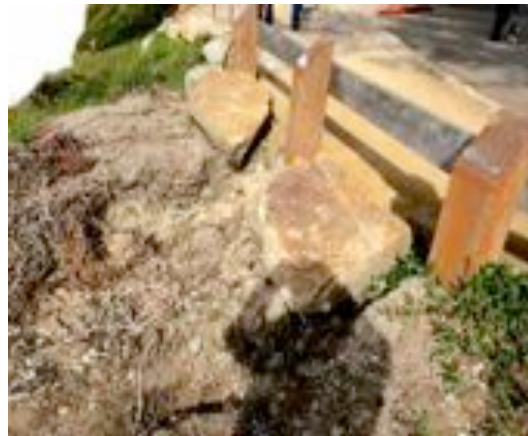
Fig 3#8

3.1.1e **Bluff south of 11<sup>th</sup> Ave. Stairway**

⇒ **Recommended Action:** REPAIR BLUFF EROSION AS PER THE GENERAL RECOMMENDATIONS LISTED ABOVE.

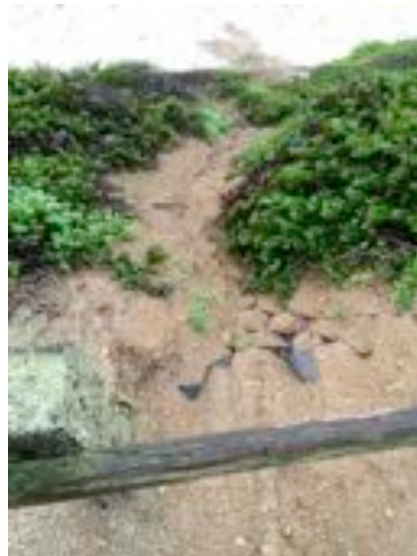
Fig 3#10

**3.1.1f Bluff between 11<sup>th</sup> and 12<sup>th</sup> Ave.s**

- REPAIR BLUFF EROSION AS PER THE GENERAL RECOMMENDATIONS LISTED ABOVE.
- WHEN REPORTED IN PREVIOUS ASSESSMENTS, STAFF COMMENTS INDICATED LACK OF SOIL HINDERED REPLANTING
  - EFFECTIVE RESPONSE SHOULD INCLUDE STEPS TO CREATE BEDS OF AMPLE SOIL.

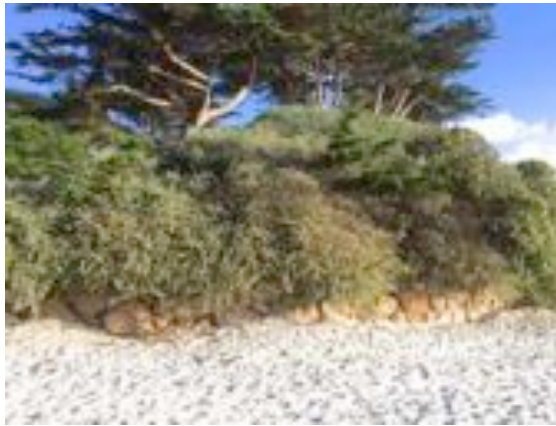
Fig 5#5

- **Condition:** Portions of the seawalls (shown below) were covered by salt bush (*Atriplex* sp.), ice plant (*Carpobrotus* sp.) and other overhanging vegetation. This vegetation helps “soften” appearance of massive hard walls, but also obscures mortar and weep holes from inspection.
- Seawall at 10<sup>th</sup> Ave.

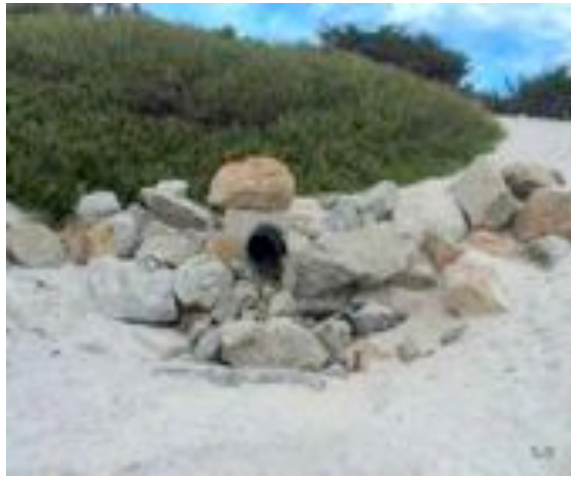
Fig 5#8

- **Condition:** Loose, perched, and/or migrating boulders were observed at the sites listed below. Due to moderate winter conditions, other shoreline revetments could not be assessed because sand levels were unseasonably high.
- Storm Water Outfall #2 (@ Foot of Ocean Ave.)

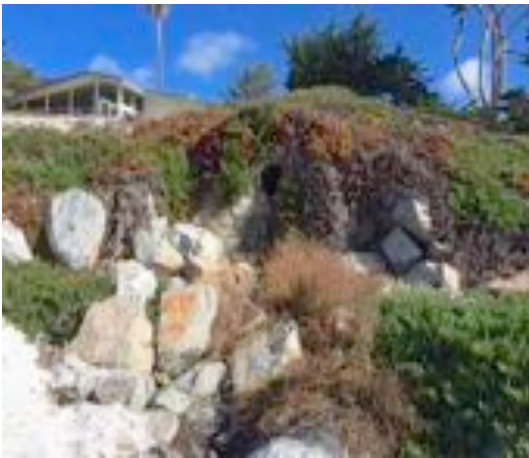
Fig 5#9

- Revetment/Storm Water Outfall #4 (@ North of 8<sup>th</sup> Ave.)

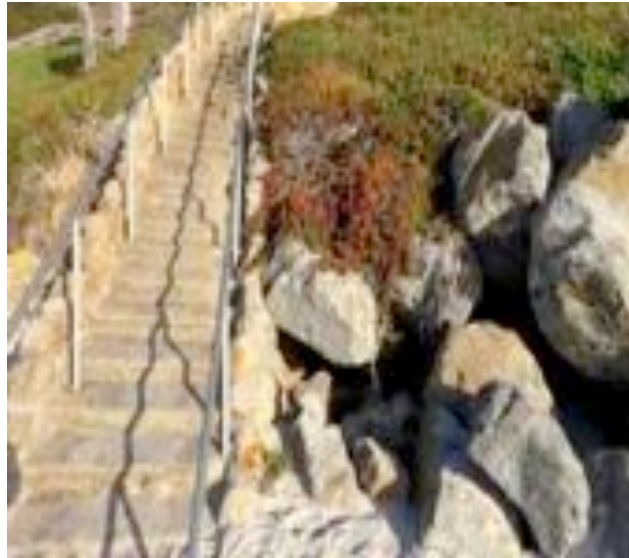
Fig 5#11

- Revetment @ Base of 11<sup>th</sup> Ave. Stairway

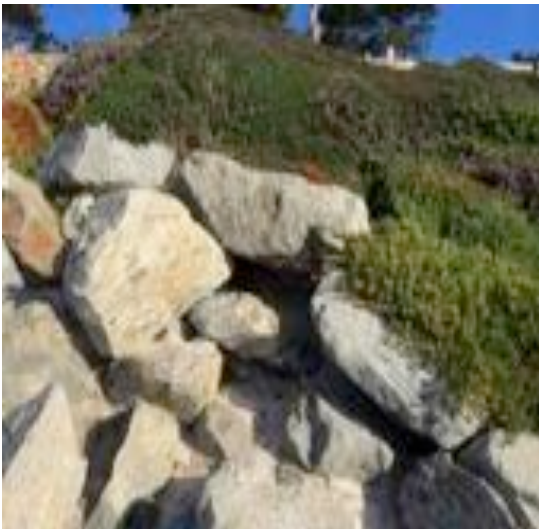
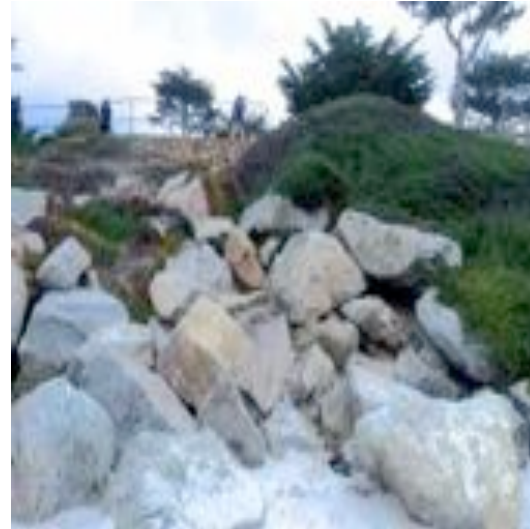
Fig 5#12

- Revetment @ South of 11<sup>th</sup> Ave.

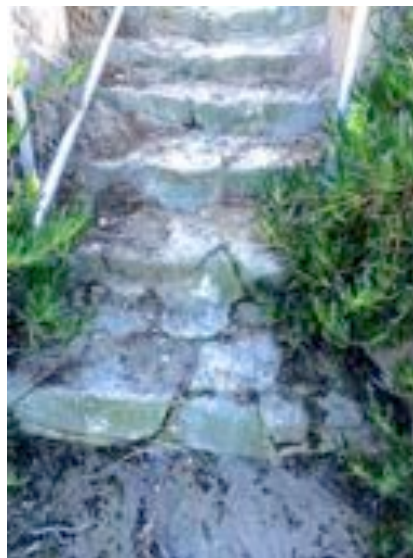
Fig 6#3

STEPS WERE RE-POINTED BY PUBLIC WORKS BEFORE NEW RESTROOM WAS OPENED TO PUBLIC

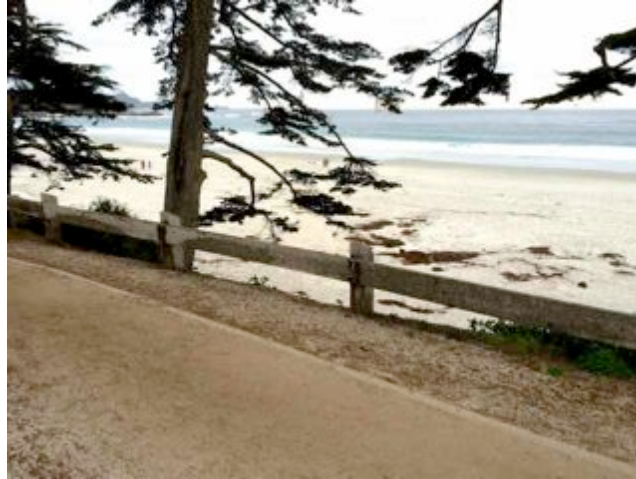
Fig 9#8

- **Condition:** Guardrail posts are wobbly.

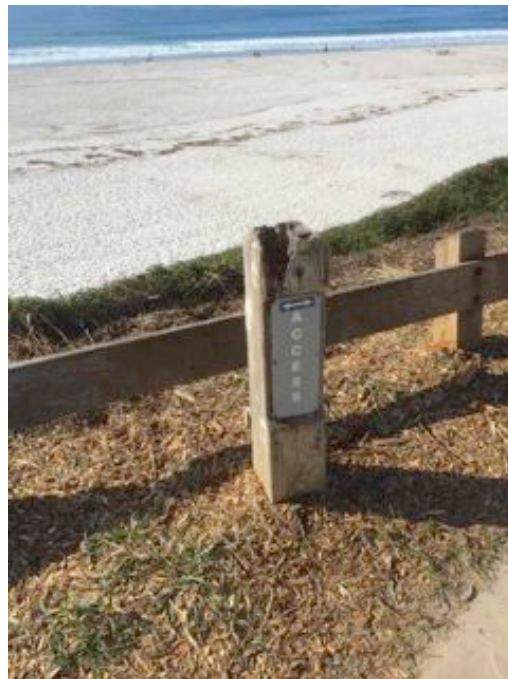
Fig 9#9

- **Condition:** Access-sign post badly decayed.

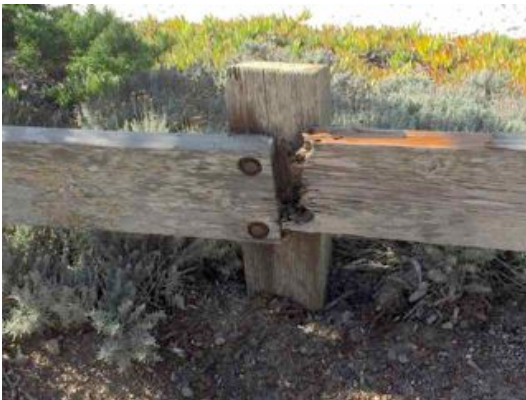
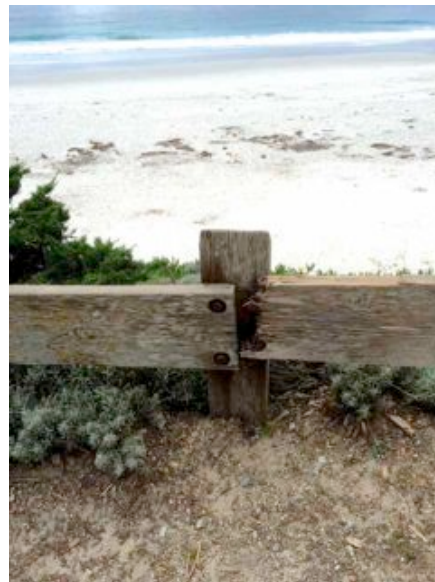
Fig 9#11

- **Condition:** Guardrails badly decayed and not securely fastened.

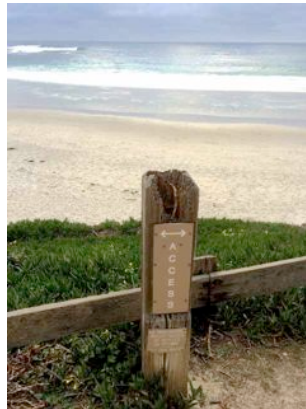
Fig 9#13

- **Condition:** Access-sign post badly decayed.

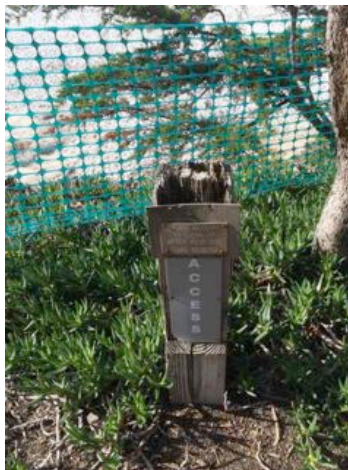
Fig 9#14

- **Condition:** Access-sign post badly decayed.

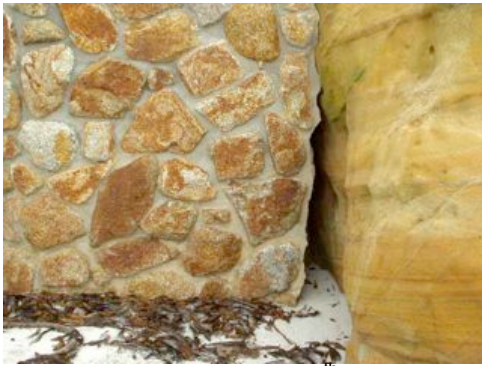
Several years ago, along the beach between 13<sup>th</sup> Ave. and Santa Lucia, the City repaired a gap between a seawall and the adjacent sandstone; its subsequent patch seems to be holding, but will eventually widen as the sandstone continues to erode.

Gap in seawall between 13<sup>th</sup> & Santa Lucia  
(2004)
