Carmel Gas Incident

April 2014

At the request of PG&E, Exponent has conducted an investigation of the gas leak and subsequent explosion on March 3, 2014 in Carmel-by-the-Sea (Carmel), California.

Inadequate verification of system status and configuration when performing work on a live line.

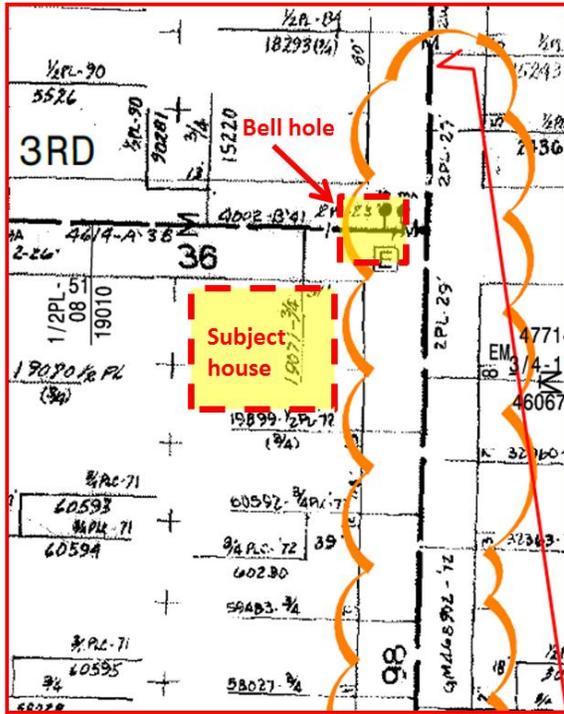
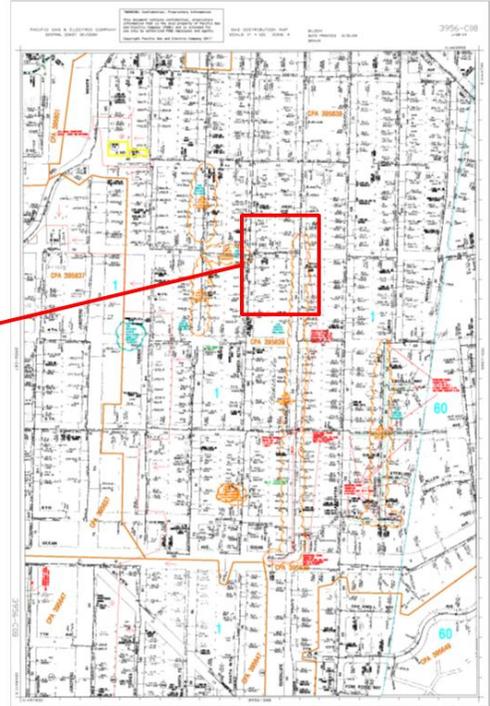
The work being conducted on the day of the incident was part of PG&E job 30921135. The work included a tie-in to connect a new plastic gas distribution line on Guadalupe Street to an existing line on 3rd Avenue. The new line being installed was intended to replace a section of Aldyl-A pipe on Guadalupe Street that was installed in 1972. The distribution plat sheet for the area in question is shown in Figure 1.

Figure 1. Annotated distribution plat sheet for the subject area. Subject house and bell hole labels and outline added by Exponent.

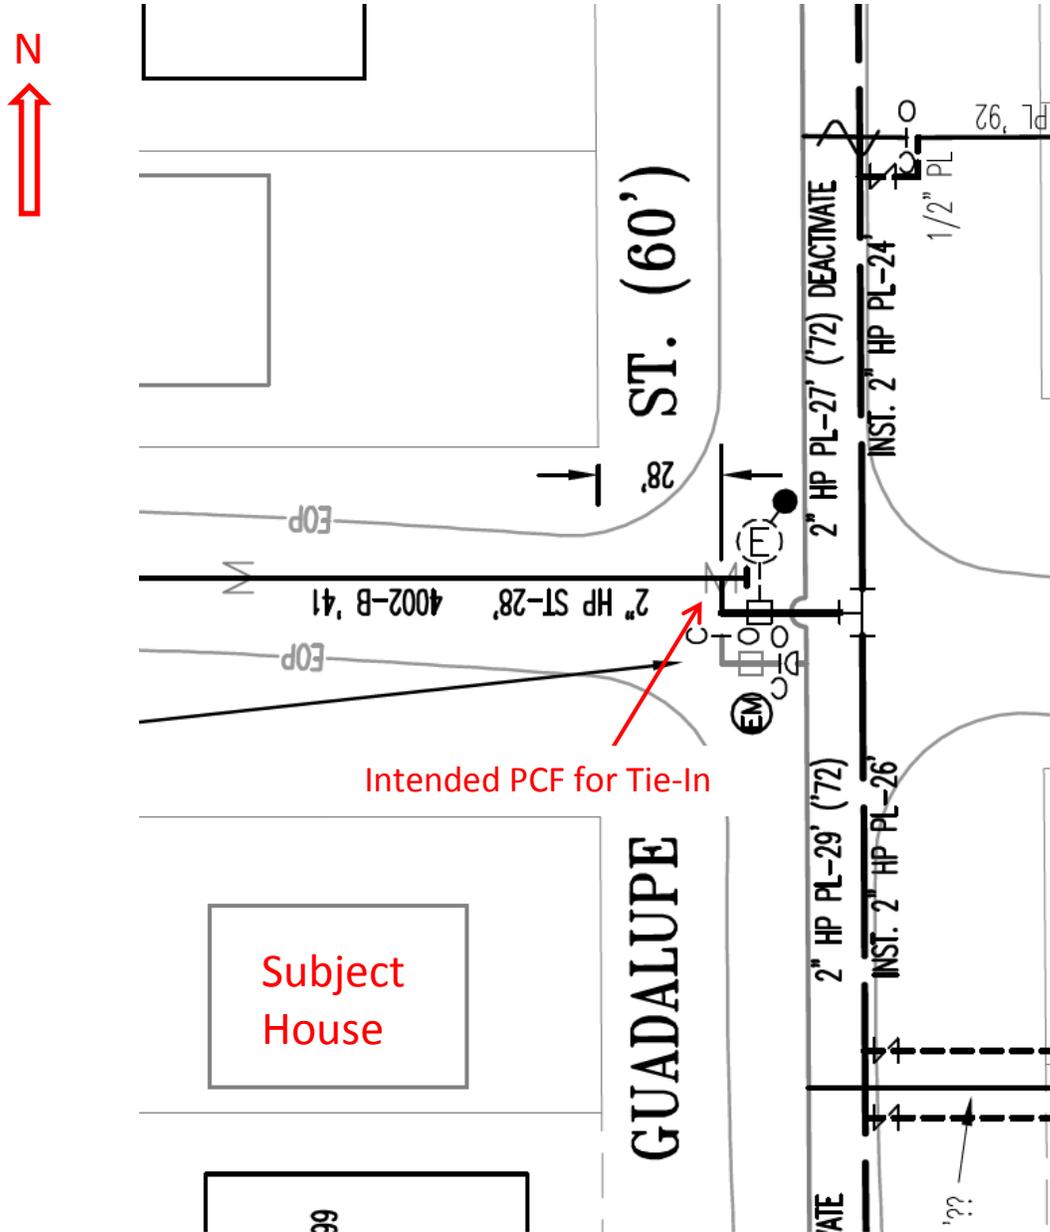
Figure 2. Annotated portion of construction drawing showing subject area. Red annotations added by Exponent. Source: Construction drawing for job 30921135.

The construction drawing shows that the job intended to tie into an existing pressure control fitting located on the steel distribution line on 3rd Avenue. The job also intended to install a transition fitting where the pipe material transitioned from steel to plastic.

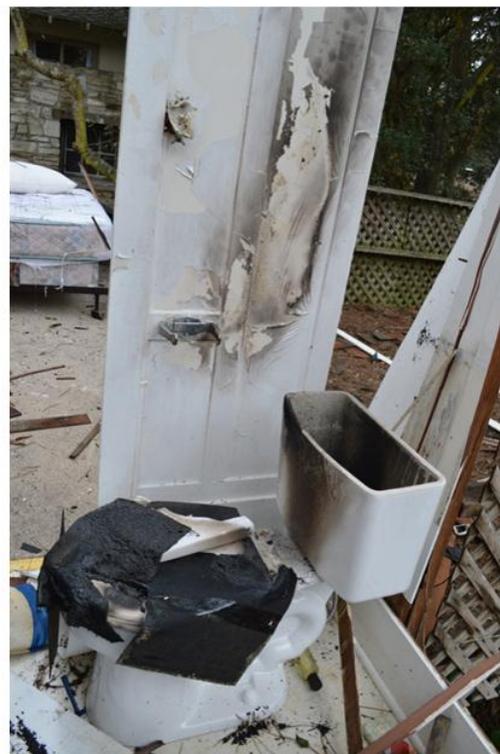
³ The water valve for the bathroom toilet was also found in the closed position.

Figure 14. Bathroom toilet. Photograph by Exponent on March 6, 2014.

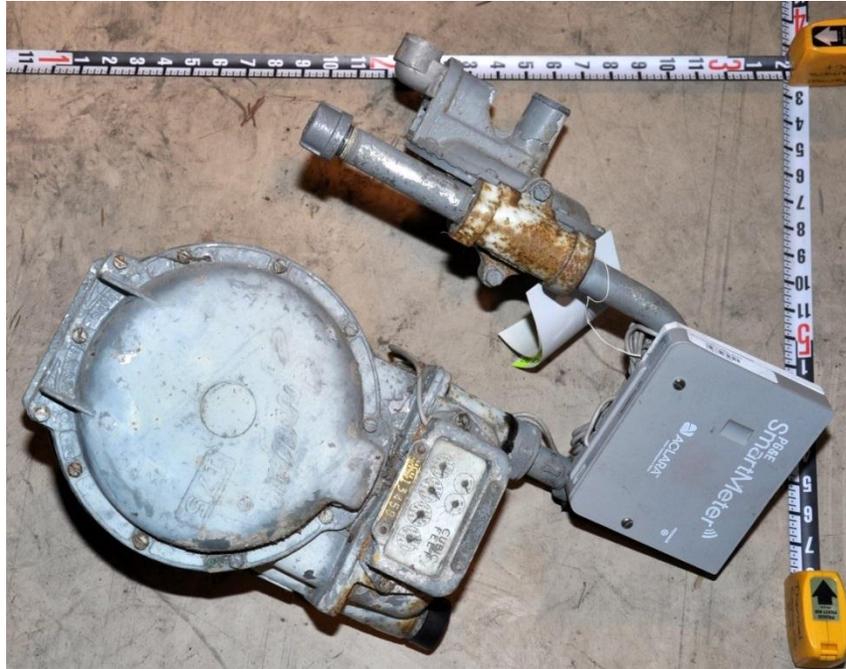
The regulator and meter set (Figure 22) had been removed just downstream of the service riser shut-off valve. The meter was equipped with a SmartMeter module. No functional tests were performed during the inspection.

Figure 22. Regulator meter set removed from incident house. Photograph by Exponent on March 10, 2014.

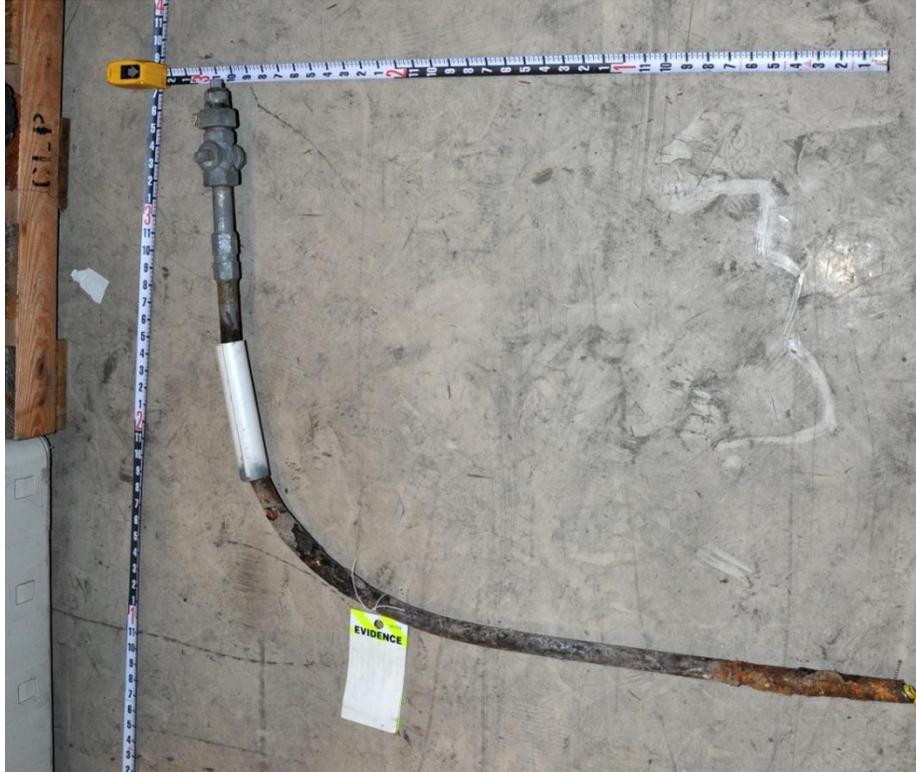
The steel $\frac{3}{4}$ -inch gas service line and riser are shown in Figure 23. The steel line is approximately five feet in length and inserted with a $\frac{1}{2}$ -inch plastic line (Figure 24). The line segment terminates in a service head adapter kit and service riser shut-off valve. According to the PG&E leak repair report, the service riser shut-off valve was turned to the closed position during the incident response operations.

Figure 23. Portion of the gas service line to incident house. Photograph by Exponent on March 10, 2014.

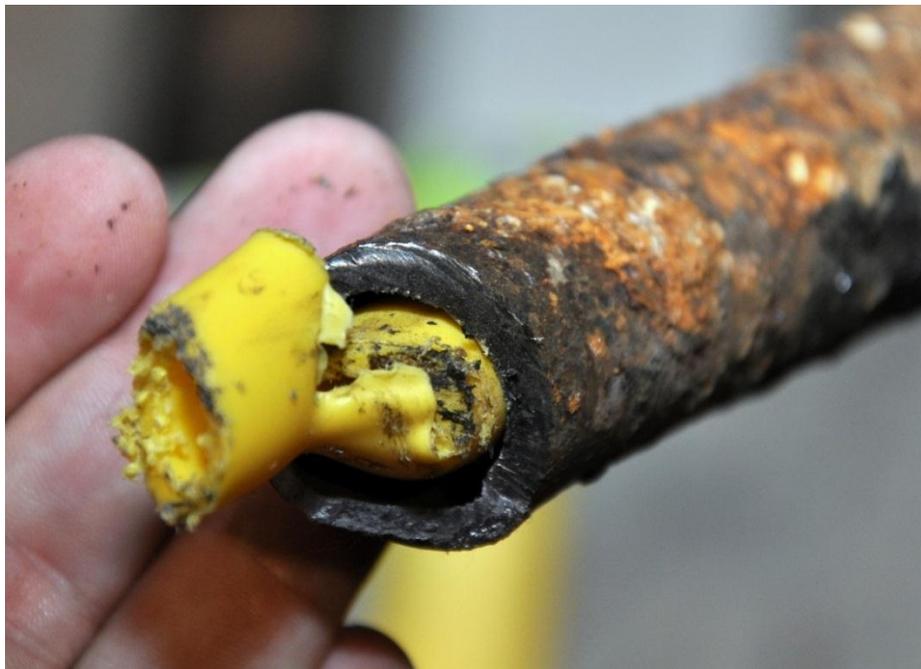
Figure 24. Close-up of the cut end of the gas service line. Photograph by Exponent on March 10, 2014.

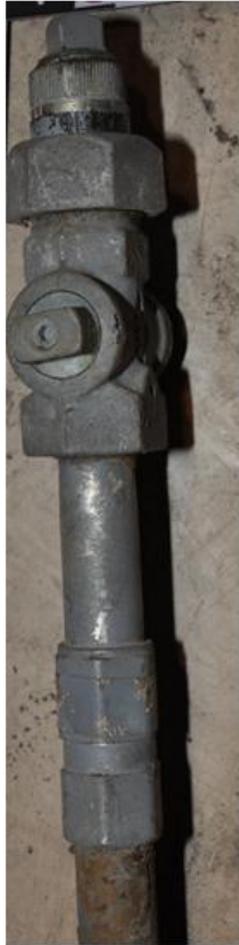
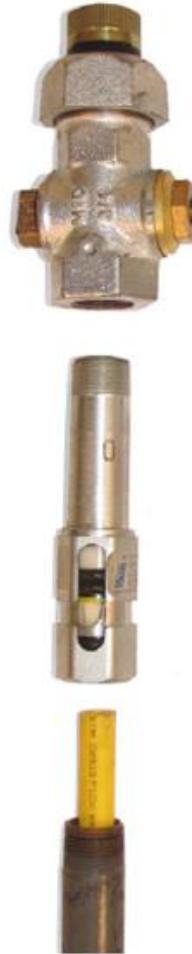
The service head adapter seals the annular space between the 3/4-inch steel pipe and the 1/2-inch plastic pipe. The service head adapter was lacking identifying markings, but appears to be similar to a Perfection 3/4" x (1/2" PE) x 3/4" Extended Service-Head Adapter. The two service head adapters are shown in Figure 25.

Figure 25. Service head adapter. Sources: Photograph by Exponent on March 10, 2014, service head adapter image from PG&E Gas Methods and Procedures document Service-Head Adapter Photo Identification.

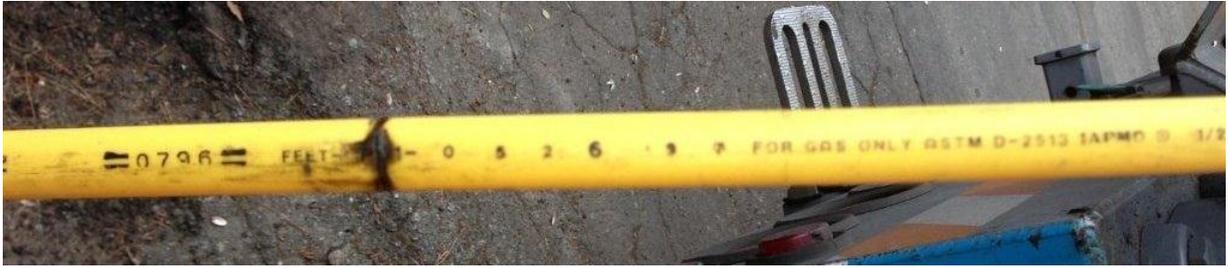
The inserted plastic pipe from the service line had a date code that read "052697," indicating a date of manufacture of May 26, 1997. The inserted plastic service line is shown in Figure 26.

Figure 26. Inserted plastic service line. Photograph source: PG&E.

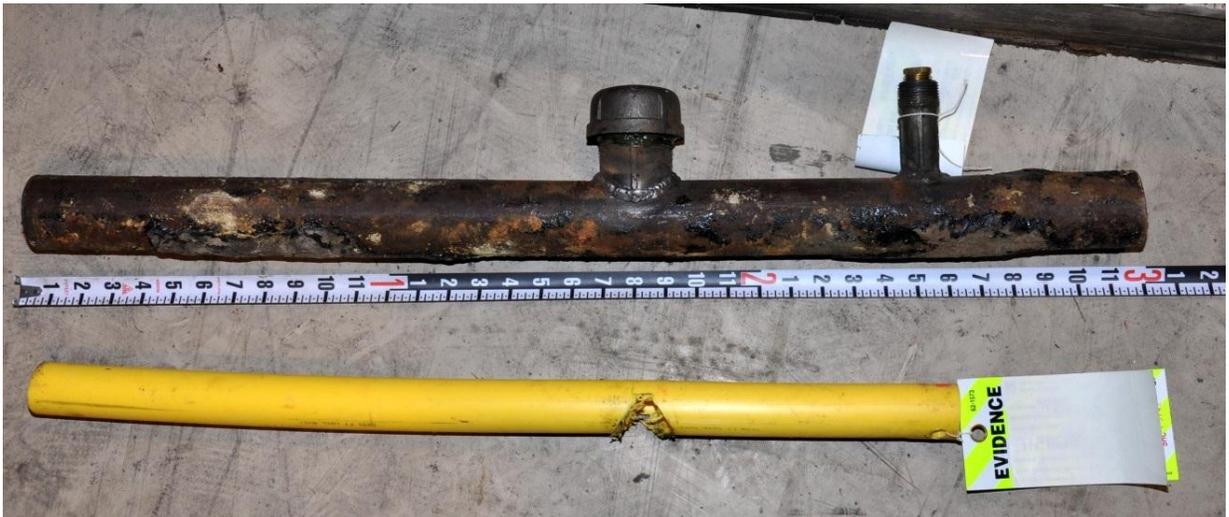
A three-foot long section of the 2-inch steel main running along 3rd Avenue was removed from the bell hole at the intersection of Guadalupe Street and 3rd Avenue (Figure 27). The steel pipe segment has two welded fittings that were installed on March 3, 2014; one is a 1-inch Save-a-valve fitting and the other is a 2-inch M/2 line stopper fitting. There were no obstructions either in the main pipe or the two fittings.

Figure 27. Portion of the gas main along 3rd Avenue. Steel pipe (top) with welded fittings and plastic pipe insert. Photograph by Exponent on March 10, 2014.

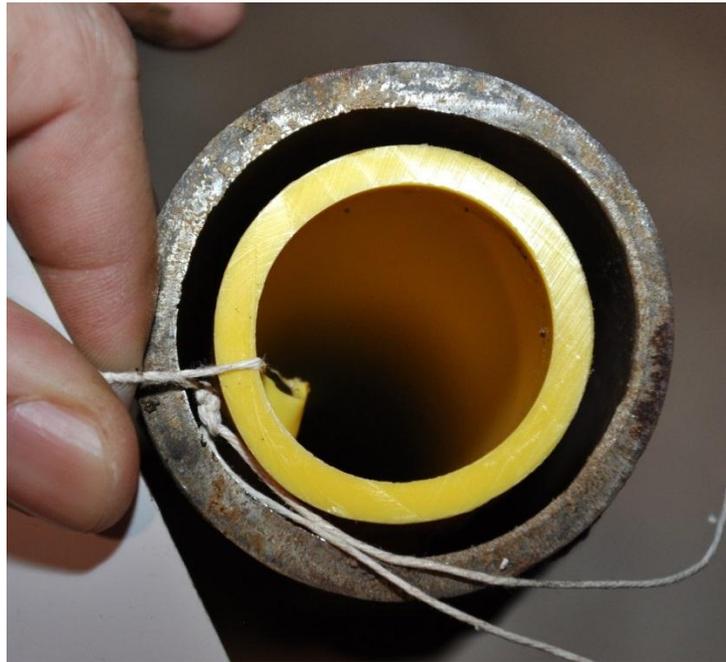
pipes (Figure 28). The plastic line segment has two perforations that correspond to the Save-a-Valve and M/2 fittings (Figure 29). There are some markings printed along the exterior of the pipe. A portion of the writing is associated with the fabrication date; in this particular piece only the year is visible, 1997 (Figure 30).

Figure 28. Plastic gas line inserted into steel line. Photograph by Exponent on March 10, 2014.

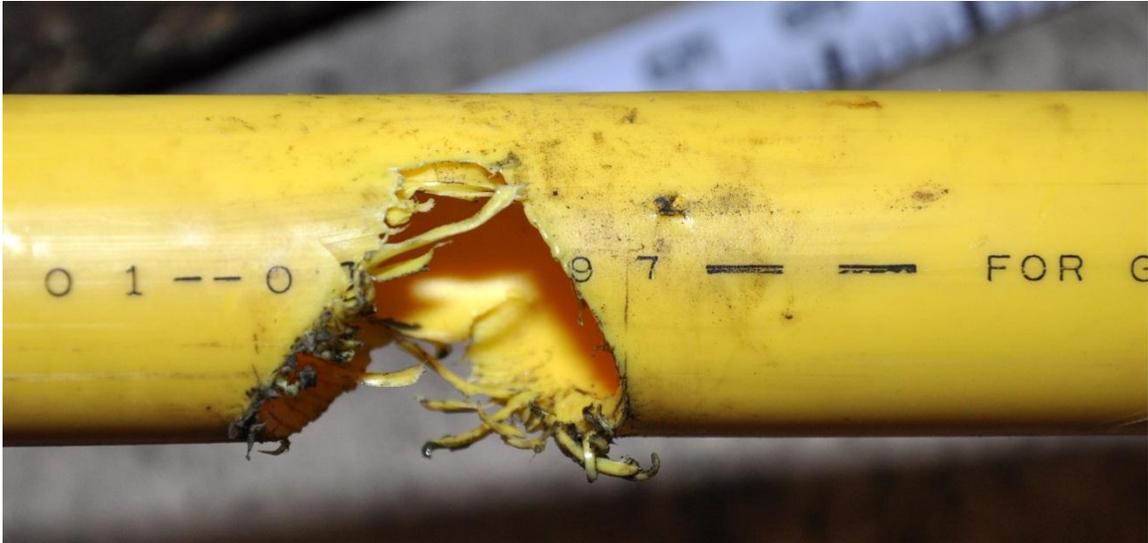
Figure 30. Close-up of the visible portion of the date code on the plastic pipe. Photograph by Exponent on March 10, 2014.

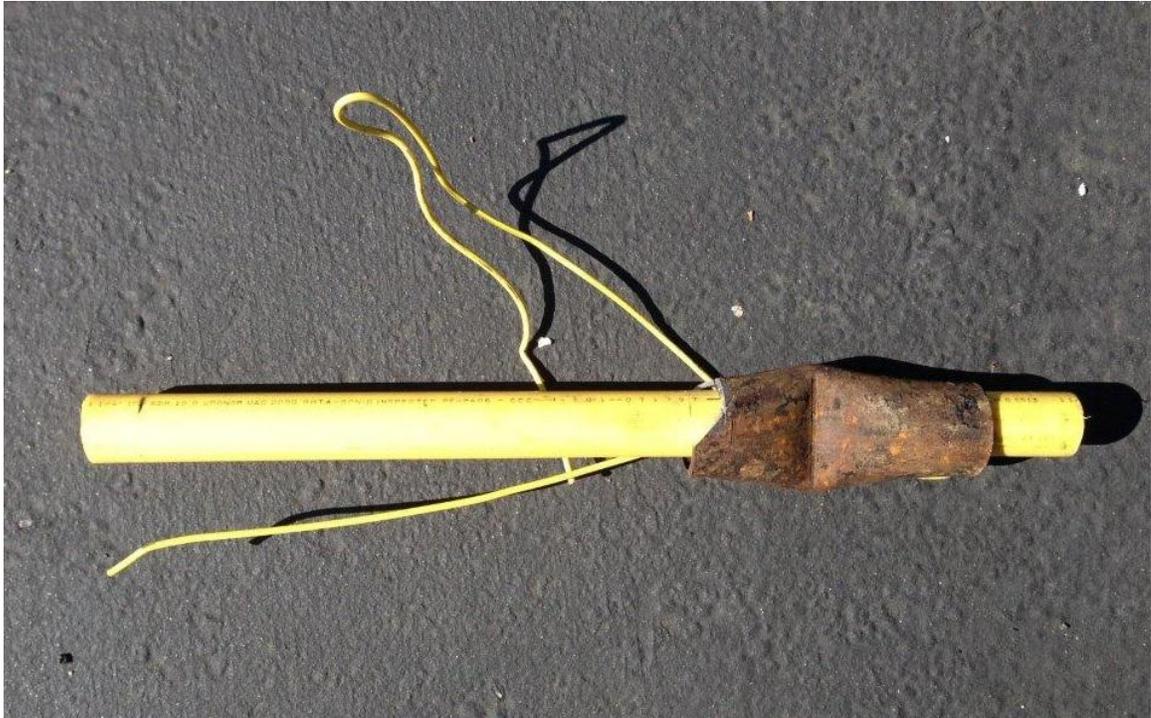
An additional portion of the gas main along 3rd Avenue was taken into evidence by PG&E. Exponent did not inspect this item, but PG&E provided multiple pictures to Exponent. The additional item corresponds to the west side gas main portion where the line had been squeezed after the incident (Figure 31). The writing on the photographs shown to Exponent indicates that the plastic pipe had a complete manufacturing date code of July 17, 1997 (Figure 32).

Figure 31. West-side squeeze point of the gas main along 3rd Avenue. Yellow tracer wire is visible. Photograph provided by PG&E.

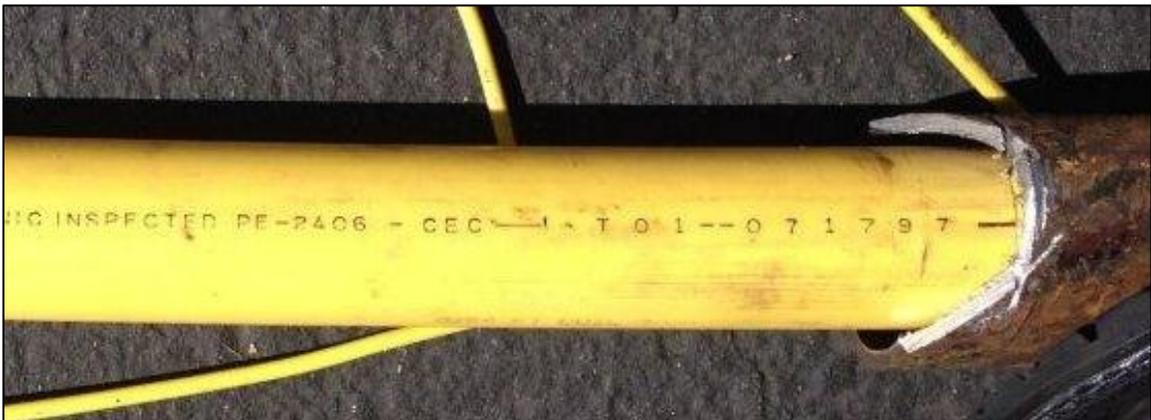
Figure 32. Close-up of the complete manufacturing date code of the plastic gas main. Photograph provided by PG&E.

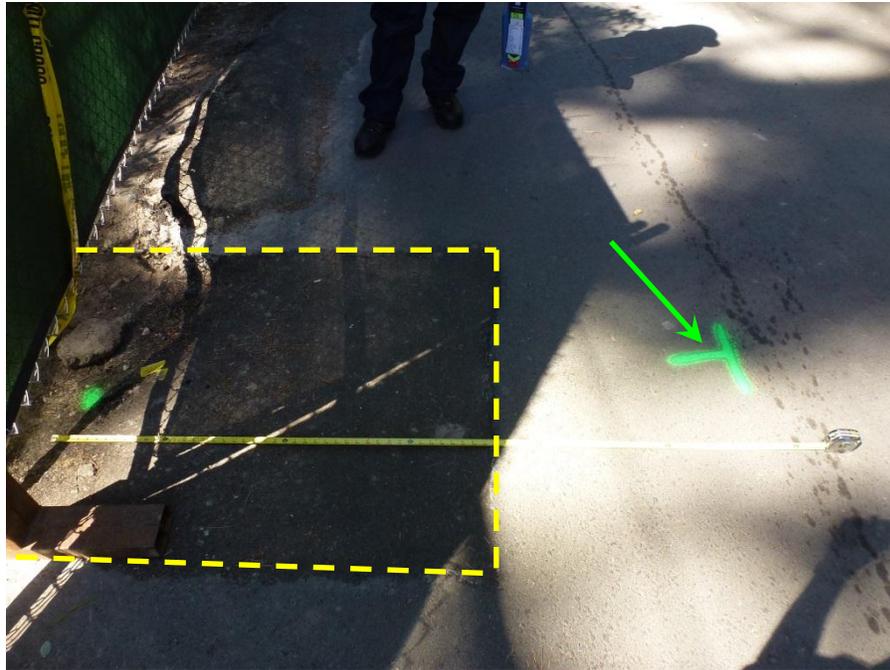
Along 3rd Avenue, approximately 50 feet west of the manhole at Guadalupe Street, a break tap was observed. This was the first lateral entry point from the aforementioned manhole. Figure 35 shows the street marking for the location of the sewer lateral and the asphalt patch performed

by PG&E for the gas service line. As shown in this figure, the sewer line is in close proximity to the gas service tee.

Figure 35. Relative location of cold asphalt patch for gas service tee (dashed yellow lines) and sewer lateral tap connection to sewer main (green arrow) for subject residence. Residence is to the left in photograph. Photograph by Exponent on March 11, 2014.

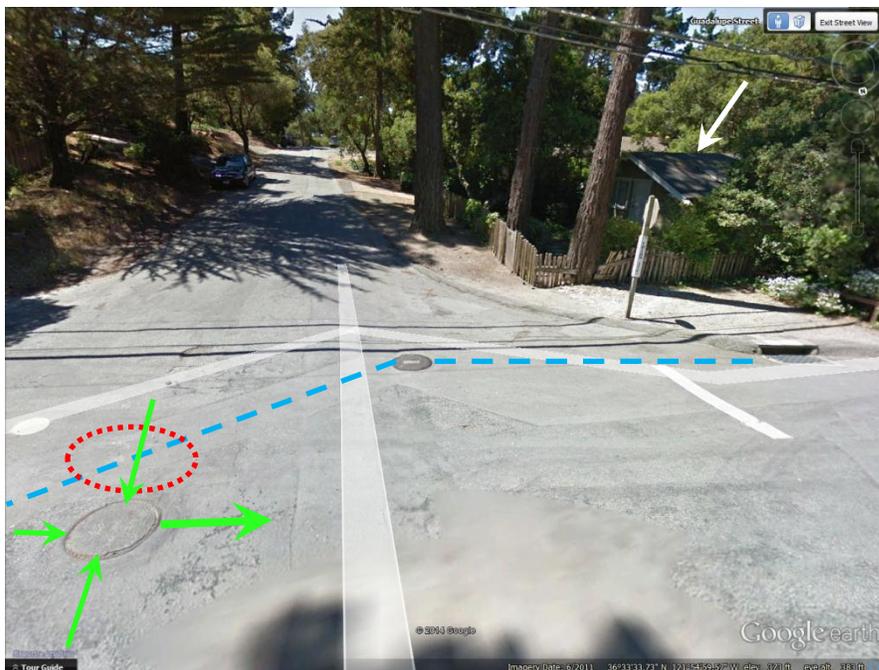
Figure 38. Underground utilities in the vicinity of subject residence (indicated by white arrow). Green arrows indicate sewer line flow directions into manhole (only one line discharging towards 3rd Avenue in the western direction). Blue dashed lines indicate likely alignment of storm drain pipes inside pavement trench marks. Red oval indicates approximate location of collapsed sewer pipe.

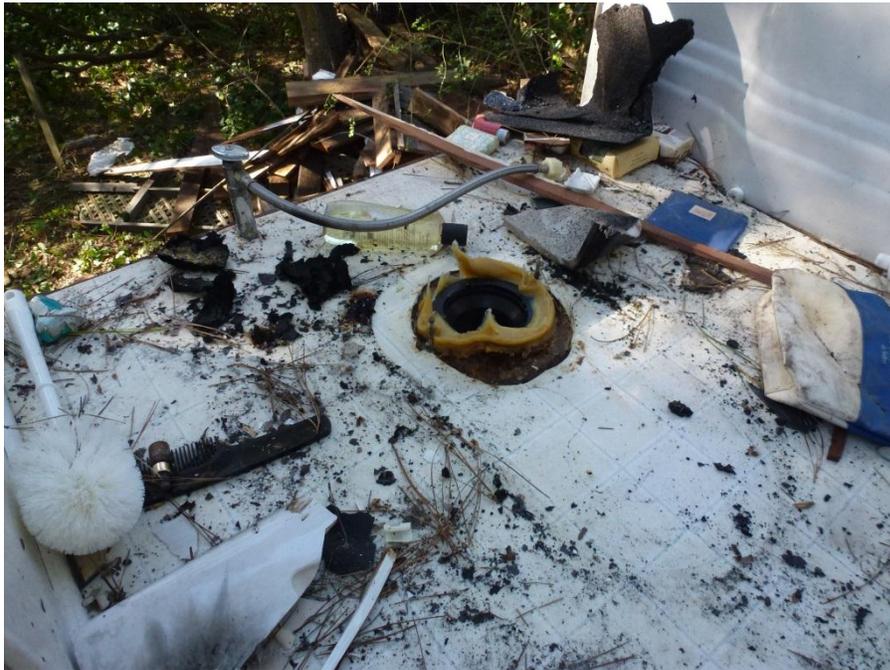
At the subject residence, because of the sewer lateral joint offset near the sewer main, video of the sewer lateral was attempted from the interior of the residence. The selected entry point for the video was a toilet, which was removed to allow the push camera to enter the sewer pipe (Figure 39).

Figure 39. Toilet removed to allow for insertion of sewer push camera. Photograph by Exponent on March 11, 2014.

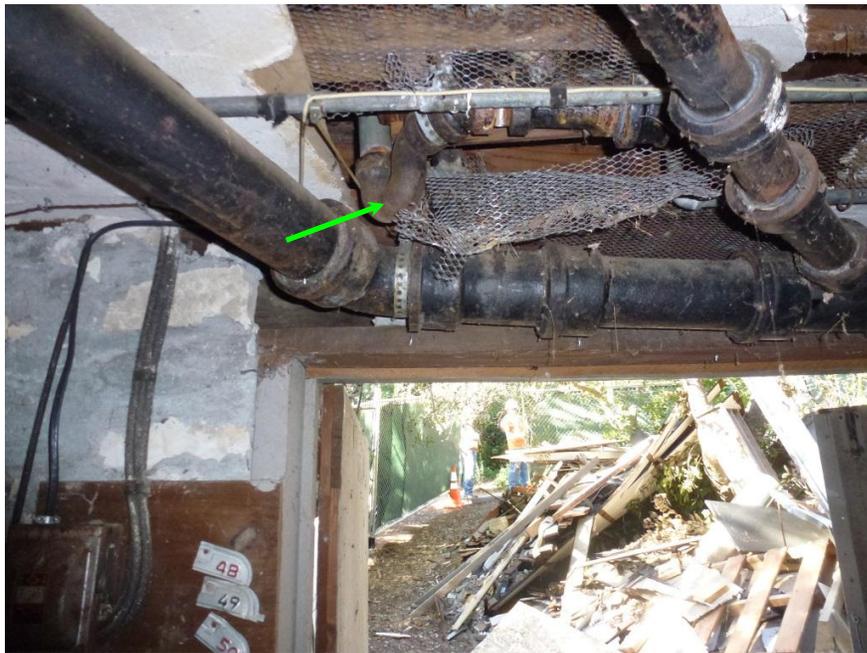
- Sewer line below toilet was an approximately 4-inch cast iron pipe (Figure 40).
- Various pipe connections occurred inside the house. The connections were for other sewer pipes and vents (Figure 41).
- Sewer pipe exited the residence approximately 23 feet from the toilet (distance measured along the sewer pipe). The sewer pipe at the wall’s residence exterior was approximately 1¼ feet below ground.

Figure 41. Multiple connections to building sewer system inside residence. Arrow indicates tub plumbing trap. Photograph from inside residence's basement. Photograph by Exponent on March 11, 2014.

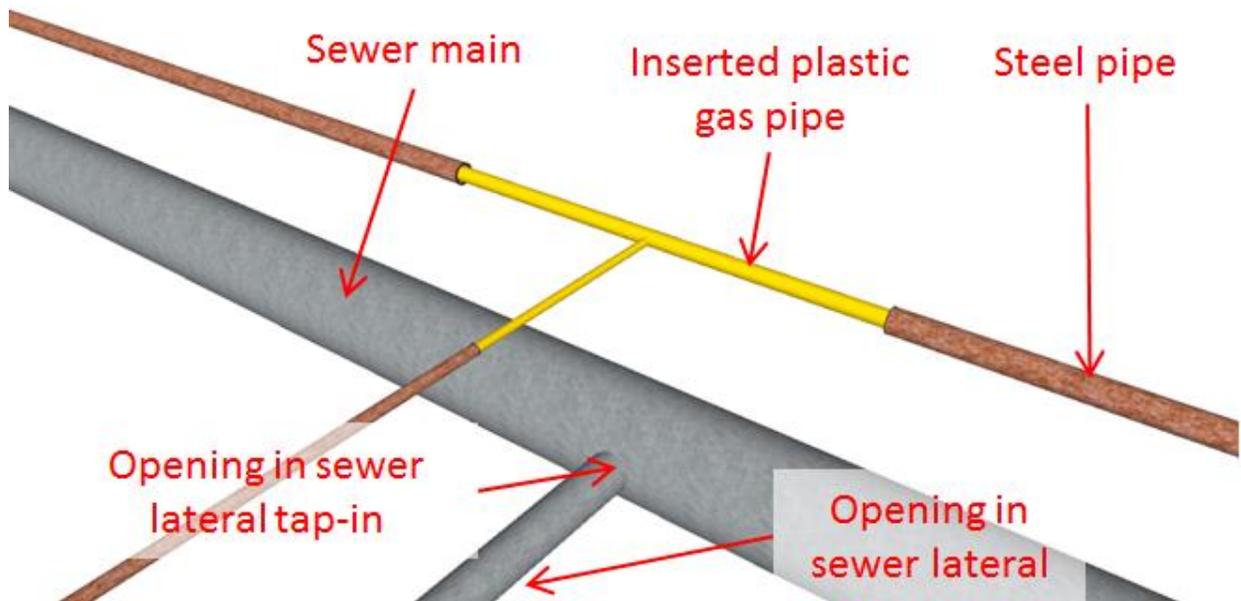
Figure 44 shows a schematic configuration of the sewer and gas systems in the vicinity of the excavation.

Figure 44. Schematic configuration of the sewer and gas systems in the vicinity of the excavation. Figure not to scale.

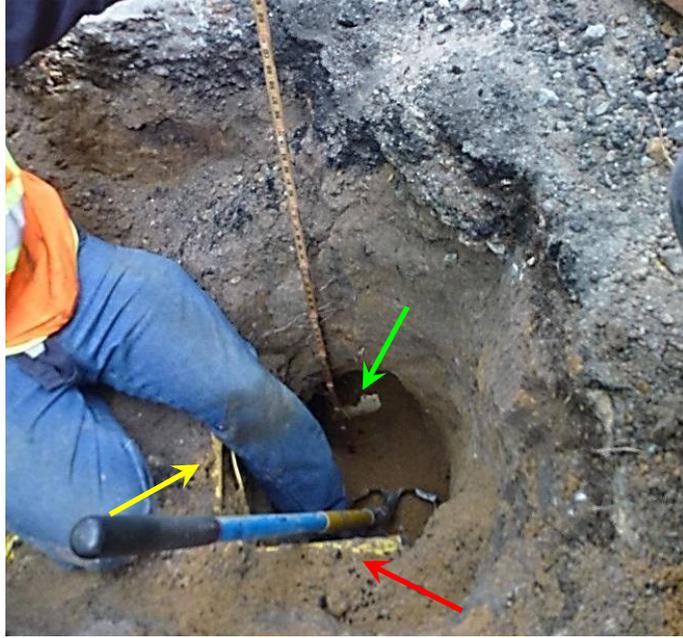
The approximate area previously excavated by PG&E on the day of the explosion (Figure 35) was re-excavated. The depth of excavation continued until a portion of the sewer lateral was exposed (Figure 45). As shown in Figure 46, the presence of a white plastic segment of sewer lateral, and an offset of the pipe, was confirmed by the excavation. The date of installation of the plastic segment in the sewer lateral is unknown. According to statements by John White of Fire Cause Analysis, the homeowners stated that they have not performed sewer replacement/repair work since they purchased the property in 1999.

Figure 45. Excavation to expose sewer lateral at subject residence in the vicinity of gas service tee. Yellow arrow indicates gas main along 3rd Avenue. Red arrow indicates gas service line. Green arrow indicates sewer lateral. Photograph by Exponent on March 21, 2014.

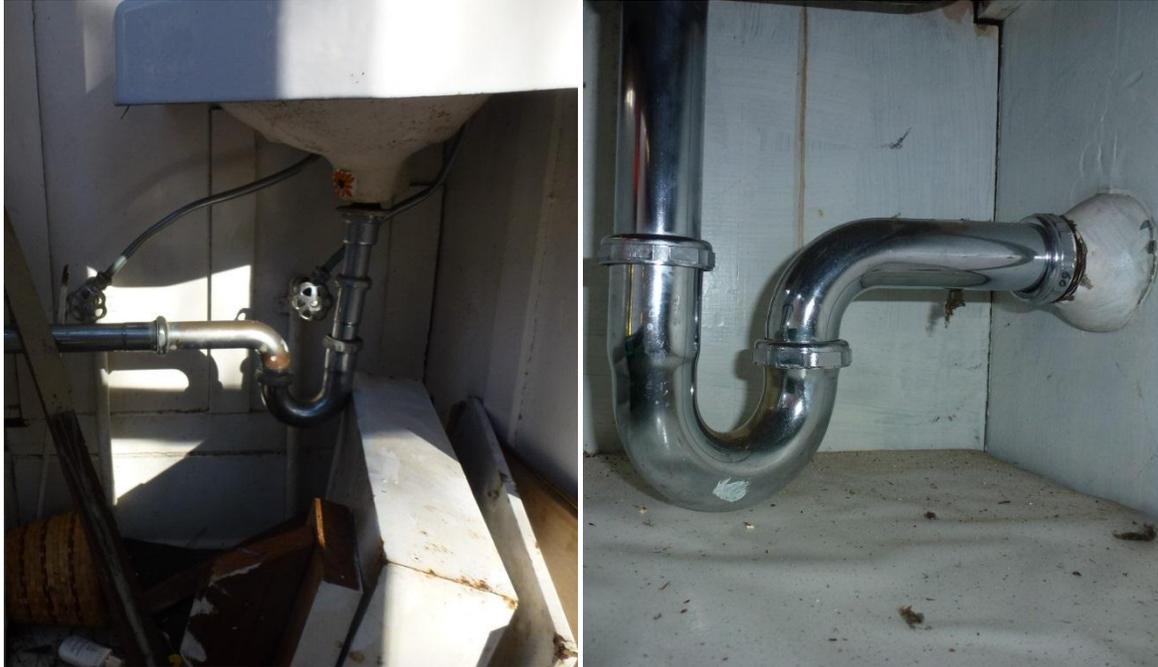
Plumbing traps are curved sections of pipe installed to contain water and provide a barrier to sewer gases entering living space. The water seal trap on any plumbing fixture or plumbing drain line must be filled with water to be effective. At the subject residence, traps were observed in all lines leading to, or in, all plumbing fixtures present.²⁴ Some of these plumbing fixture traps are shown in Figure 48 and some of the plumbing line traps are shown in Figure 41.

Figure 48. Plumbing traps at bathroom sink (left) and kitchen sink (right). Photographs by Exponent on March 11, 2014.

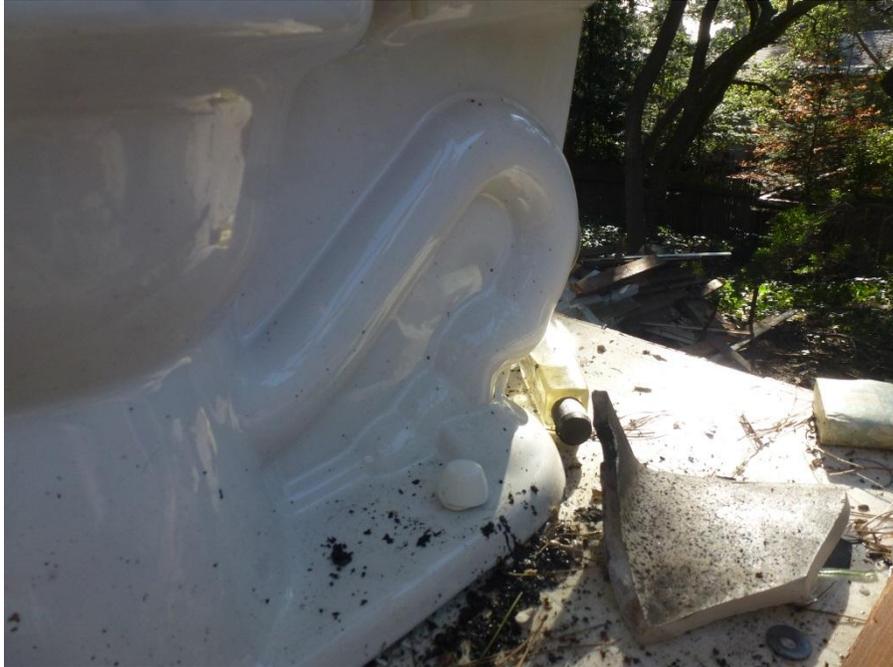
As previously noted, there was no plumbing trap in the sewer drain line section video recorded from the toilet towards the sewer main on 3rd Avenue. The only trap along this sewer line path was the integral trap in the toilet fixture. Figure 49 documents this trap.

Figure 49. Toilet drain trap. Photograph by Exponent on March 11, 2014.

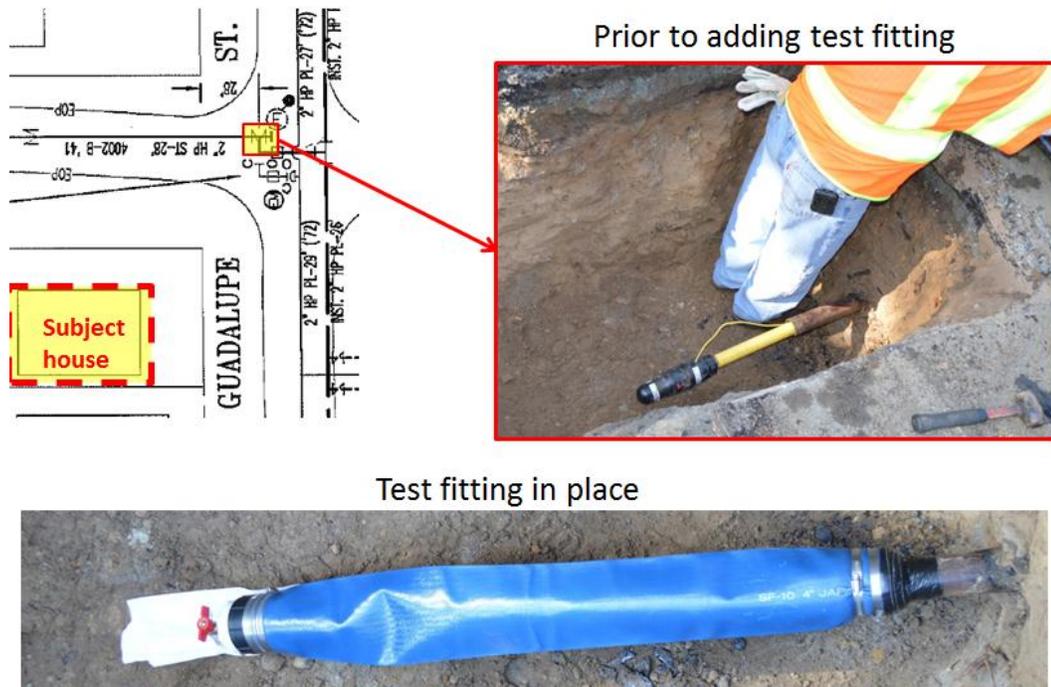
The gas migration test consisted of injecting helium gas through the annular space between the plastic gas main and the 2-inch steel pipe partially encasing it on 3rd Avenue. Helium injected through the annular space was allowed to travel through the area while helium concentrations were monitored at selected site locations during the test. The helium injection point near the location of the plastic pipe was punctured on the day of the explosion (Figure 51). The nineteen helium monitoring points are listed in Table 1 and shown graphically in Figure 52 for the area outside the subject residence, in Figure 53 at the residence's basement and in Figure 54 for the residence's first floor. Figure 55 through Figure 57 show example monitoring points for the tests.

Figure 51. Annotated D-Plat 3956-C08 showing helium injection point and test fitting. Photographs by Exponent on March 21, 2014.

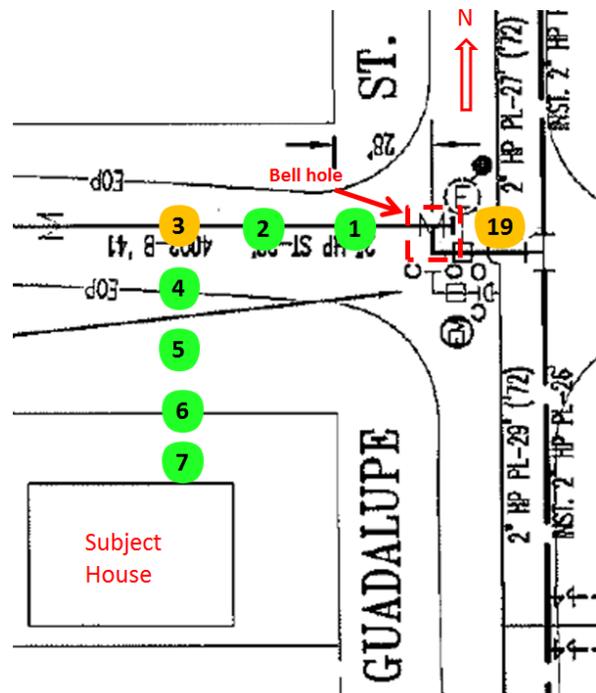
Figure 52. Helium test monitoring points and results outside of residence.

As summarized in Table 1 and Figure 52 through Figure 54, the results of the helium gas migration test conclusively show that, when helium gas is released near the location where the puncturing of the plastic pipe occurred on March 3, 2014, the gas can enter the sewer system in the vicinity of the subject residence. Once inside the sewer system, helium gas can travel through the sewer system and be released into the living space of the subject residence.

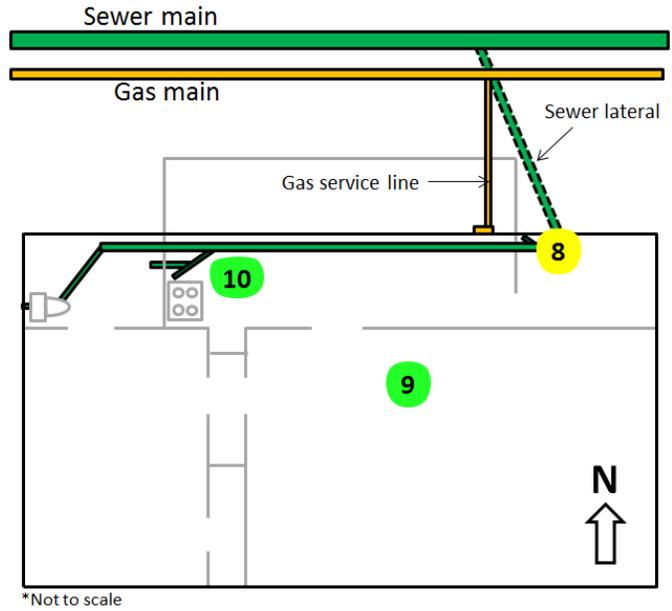
Figure 53. Helium test monitoring points and results at the residence's basement.

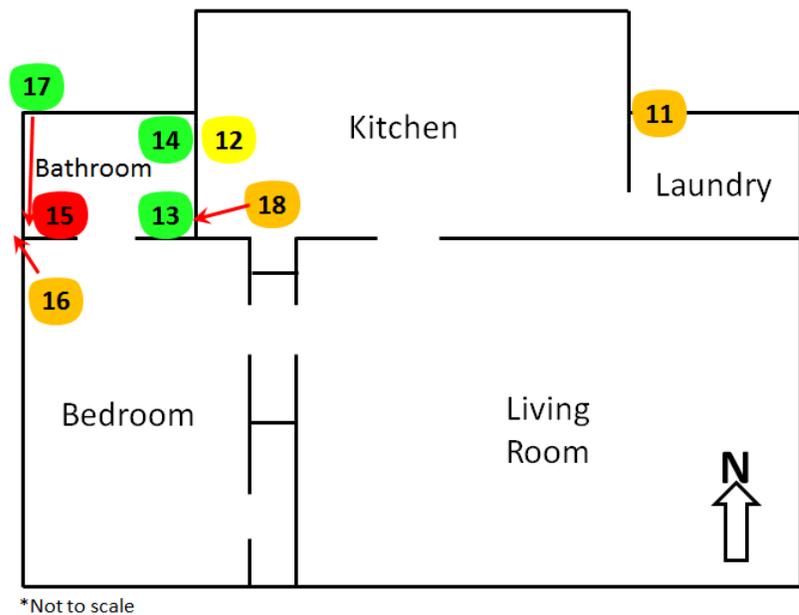
Figure 54. Helium test monitoring points and results at the residence's first floor.

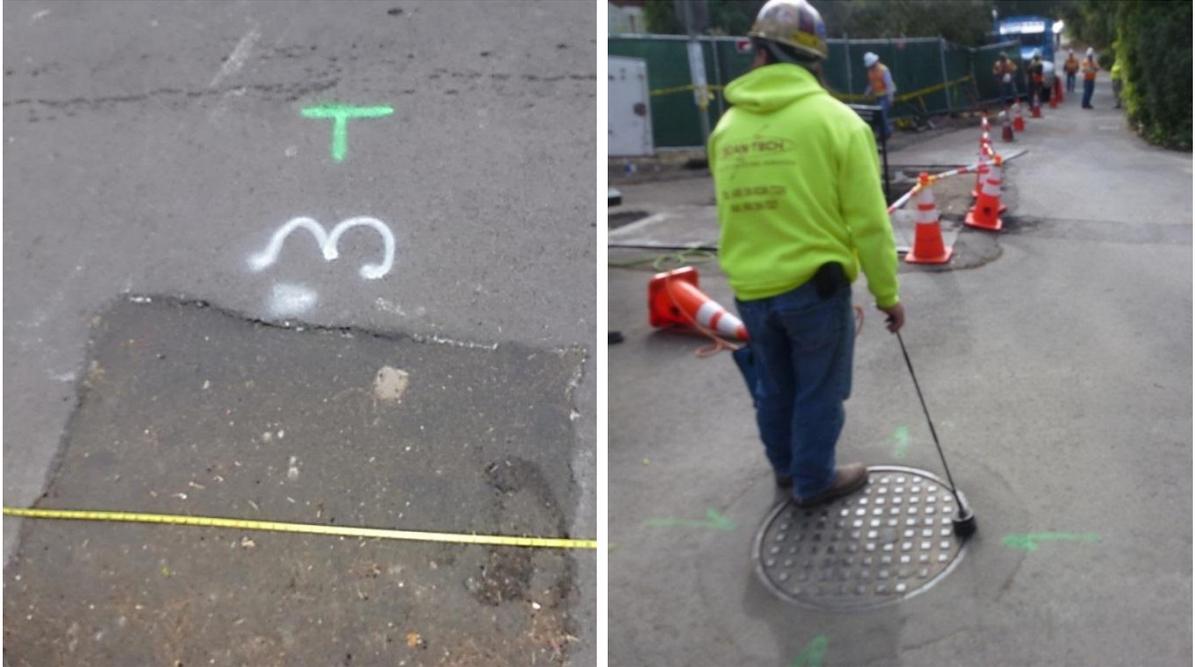
Figure 55. Example monitoring points outside of residence. Monitoring point #3 (left) near excavation performed by PG&E at gas service tee for residence. Monitoring point #19 (right) at sewer manhole near the intersection of 3rd Avenue and Guadalupe Street. Photographs by Exponent on March 21, 2014.

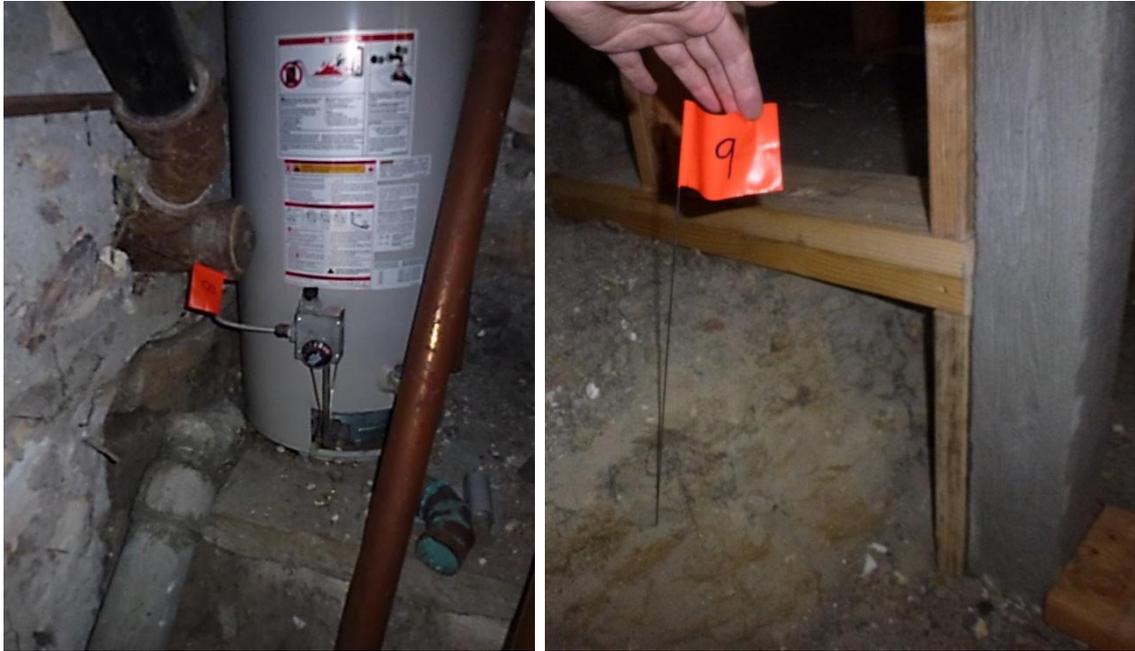
Figure 56. Example monitoring points at the residence's basement. Monitoring point #8 (left) by the cleanout next to water heater. Monitoring point #9 (right) near center of basement, over soil. Photographs by Exponent on March 21, 2014.

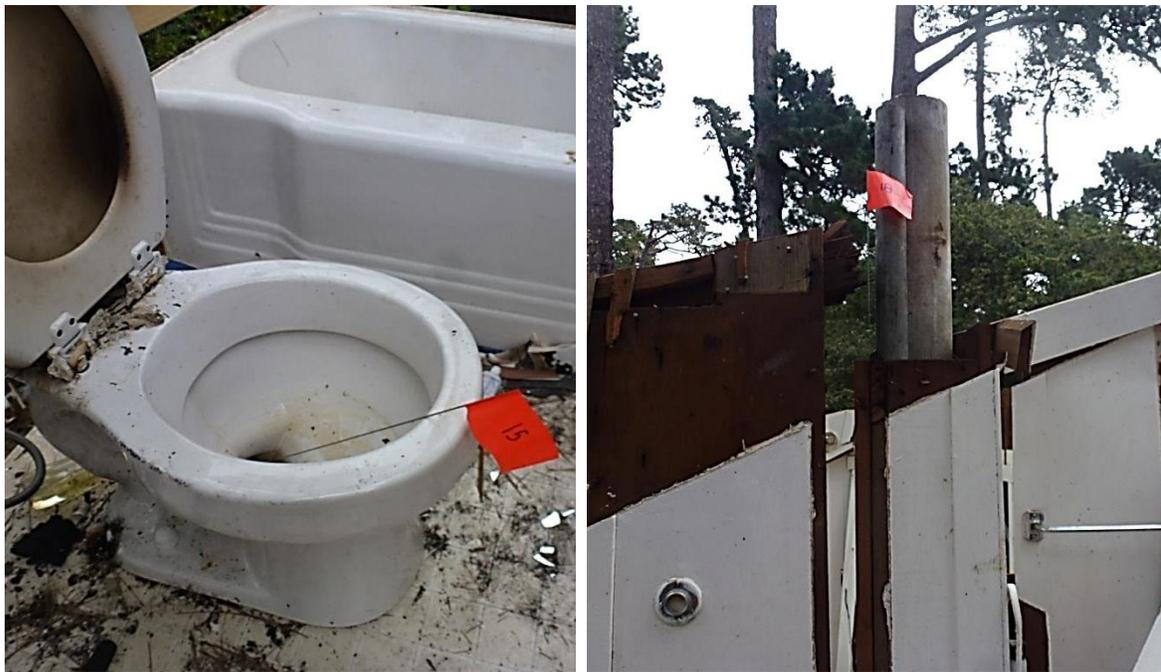
Figure 57. Example monitoring points at the residence's first floor. Monitoring point #15 (left) at the toilet. Monitoring point #18 (right) at bathroom vents. Photographs by Exponent on March 21, 2014.

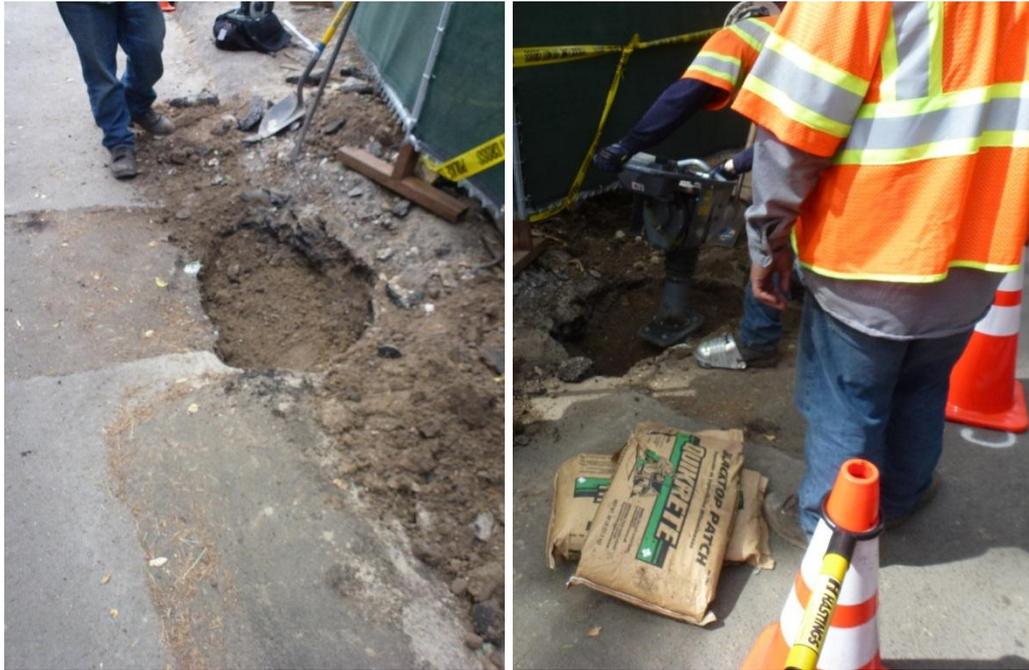
- Test 4: In an attempt to bring soil conditions closer to those present before the gas service tee excavation was performed by PG&E on the day of the explosion, the shallowest eight inches (approximately) of soil above the gas service tee were excavated, re-compacted in place and paved with an asphalt cold patch (Figure 58). Other field conditions were as described for Test 1.

Figure 58. Excavation (left) and re-compaction (right) near gas service tee. Photographs by Exponent on March 21, 2014.

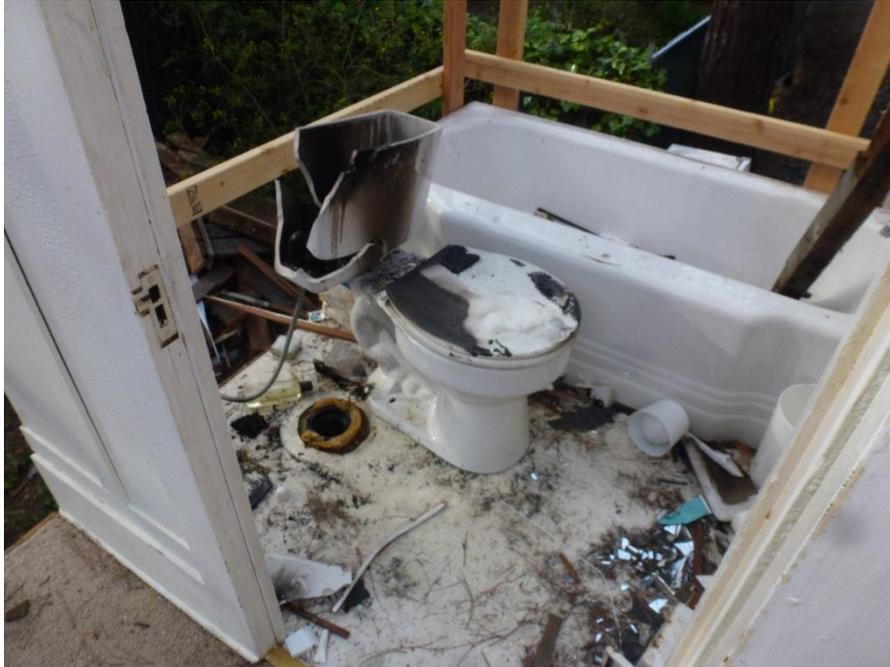
- Test 5: To test the condition of dry toilet bowl on the day of the explosion, the toilet was removed, and helium measurements were taken directly at the toilet sewer riser (Figure 59). Other field conditions were as described for Test 4.

Figure 59. Monitoring point #15 after removal of the toilet.
Photograph by Exponent on March 21, 2014.
