Carmel Gas Incident

April 2014

At the request of PG&E, Exponent has conducted an investigation of the gas leak and subsequent explosion on March 3, 2014 in Carmel-by-the-Sea (Carmel), California.

Inadequate verification of system status and configuration when performing work on a live line.

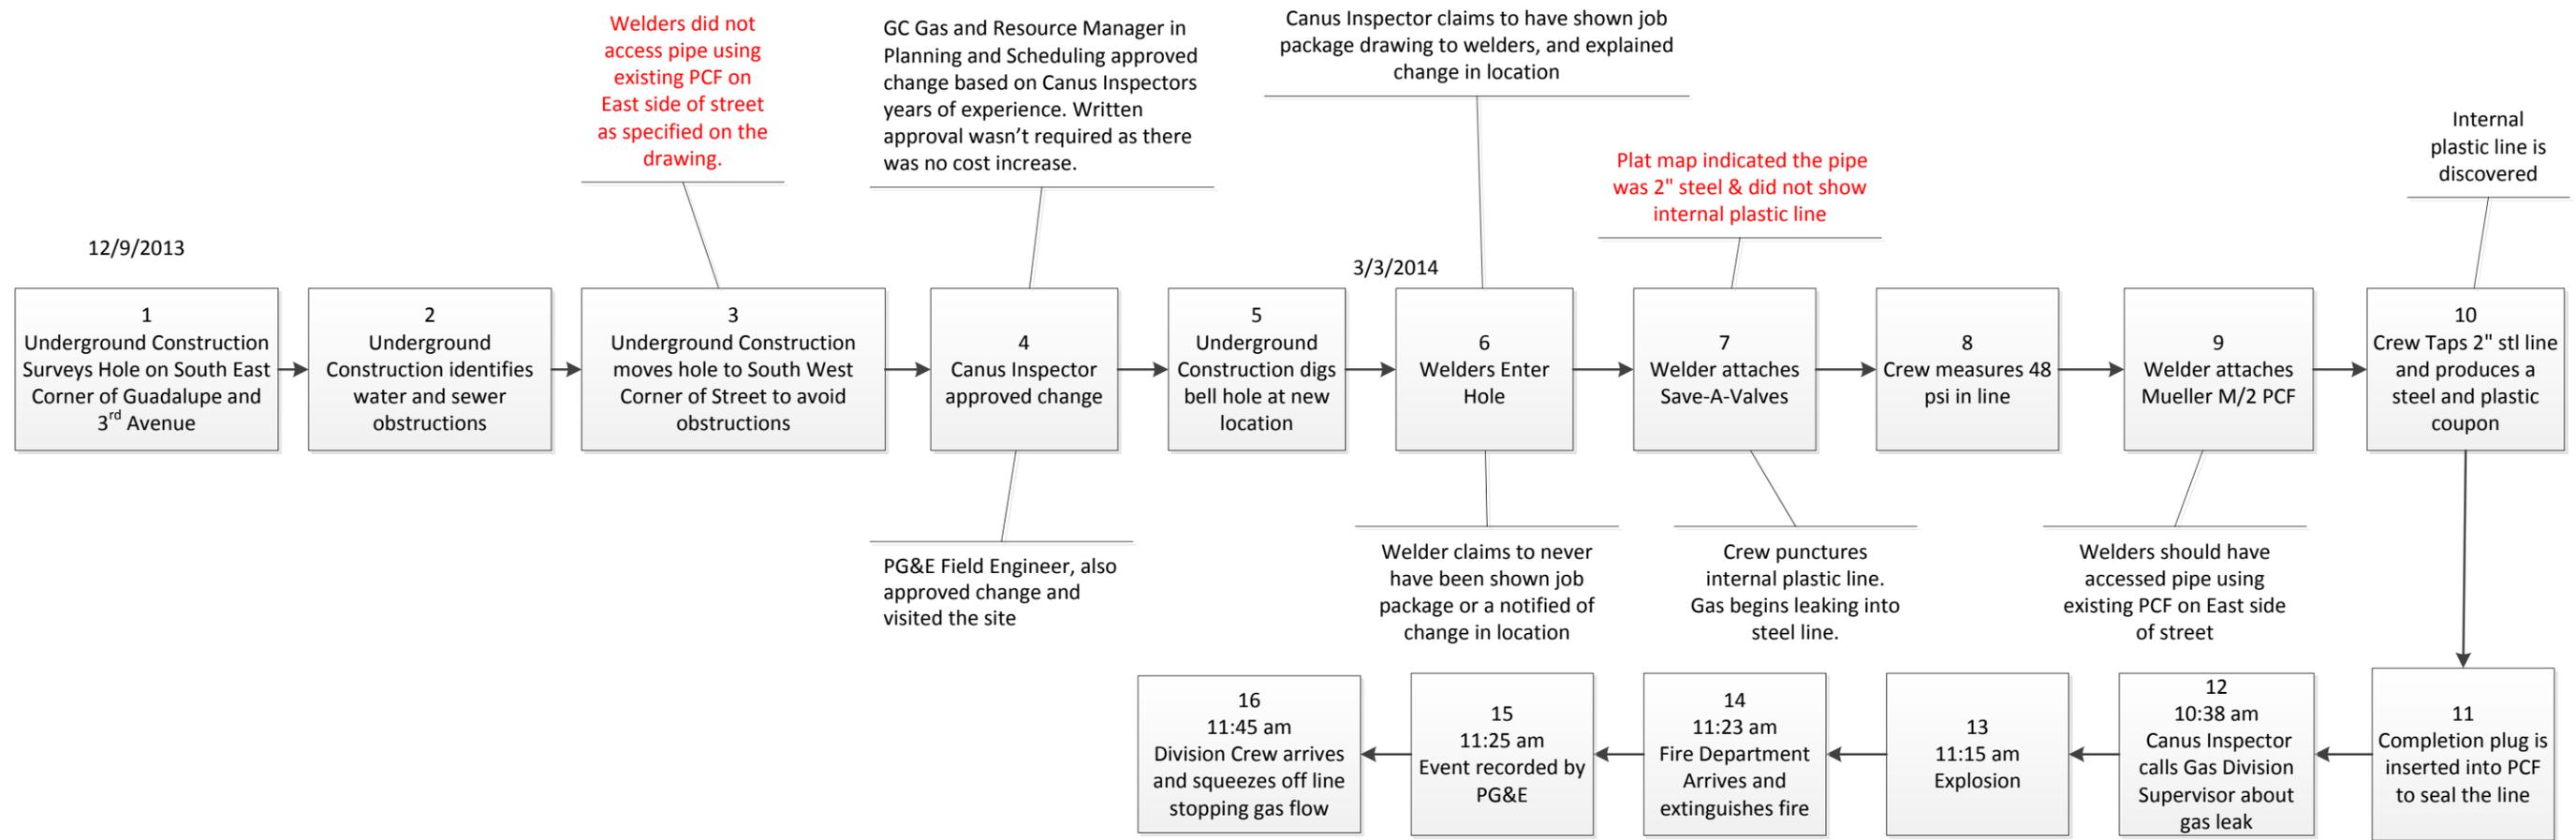
**Carmel Gas Leak and Explosion Root Cause
Diagram**
