CARMEL-BY-THE-SEA POLICE DEPARTMENT ASSESSMENT REPORT

Prepared by: Indigo | Hammond + Playle Architects, LLP.

Date: 10/26/2023

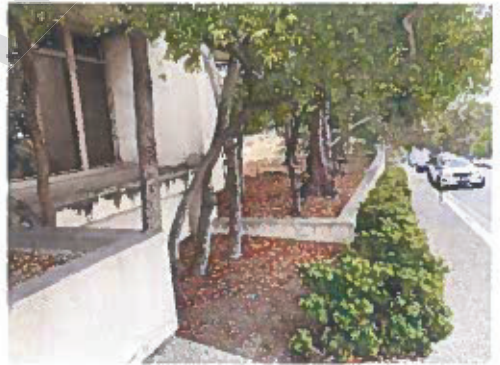
Figure 3 – Existing Front Landscaping

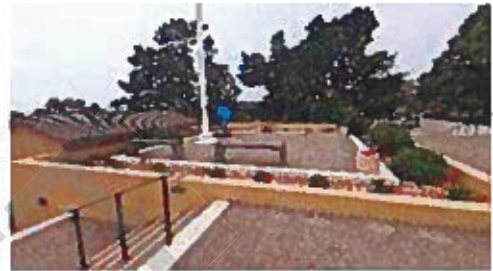
Figure 9 - Existing Site Paving

The site paving is in good condition, with only minor surface cracks (Figs. 4-6).

- ◆ Site Paving - No immediate action is to be taken at this time. Regularly monitor all areas of site paving and take remedial action when warranted by changed site conditions that may present a hazard for people and/or operations.

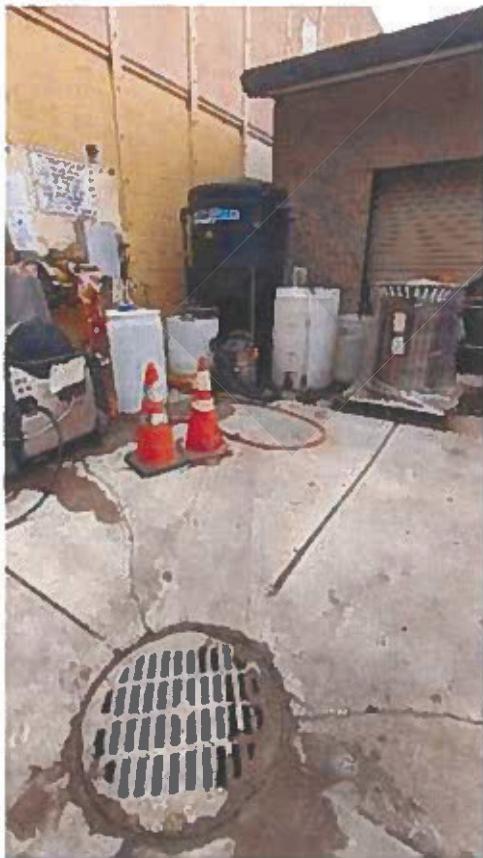
Figure 12 – Existing storm drain

Run a color dye test of the garage floor drains (Fig. 7) to confirm that they discharge to the sewer system and not routed to the onsite storm drain recycled water system (Fig. 8) as such a connection would be a violation of public health code.

- ◆ Run a color dye test of the garage floor drains to confirm that they discharge to the sewer system and not the onsite storm drain recycled water system as such a connection would be a violation of public health code.

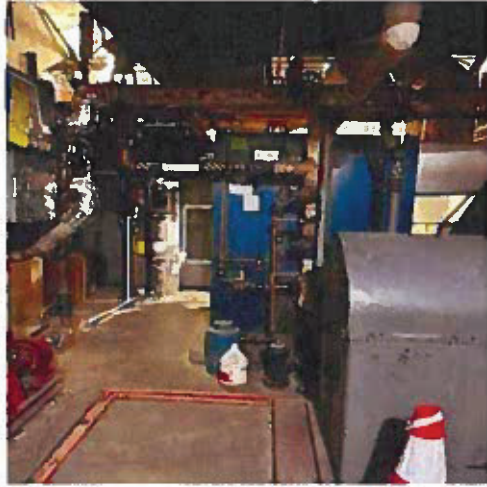
Figure 18 – Existing Hot Water Boiler (Mechanical Room)

The boiler flue pipe location does not meet code and needs to be extended to the proper height and location.

Provide a new, high efficiency heating boiler.

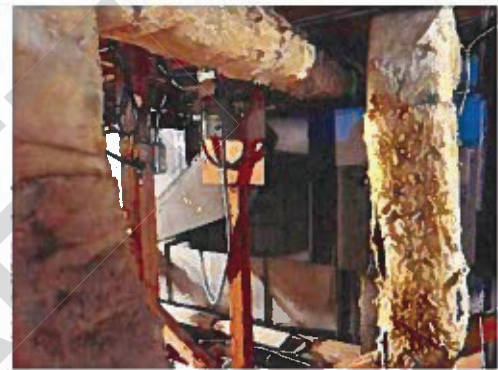
Figure 27 – Existing Air Handler in Attic

The existing HVAC systems in the Police department are old and beyond their useful life and need to be replaced. The remodel of the Police department will require an upgrade to the HVAC systems to ensure adequate ventilation. Personnel have complained about the lack of exhaust ventilation in many areas, indicating a need for improvement. The existing HVAC equipment only supplies heating, which may be fine, because personnel have indicated that non-cooled airflow is sufficient during the summer months. The hot water piping for hydronic heating is not insulated.

- ◆ *The new system should include exhaust ventilation in all necessary areas.*
- ◆ *The new system shall provide non-cooled airflow during the summer months.*
- ◆ *This will improve the working conditions for personnel and ensure that the building is properly ventilated.*
- ◆ *Replace the hot water distribution pumps, piping, ductwork, diffusers control valves, controls and piping.*

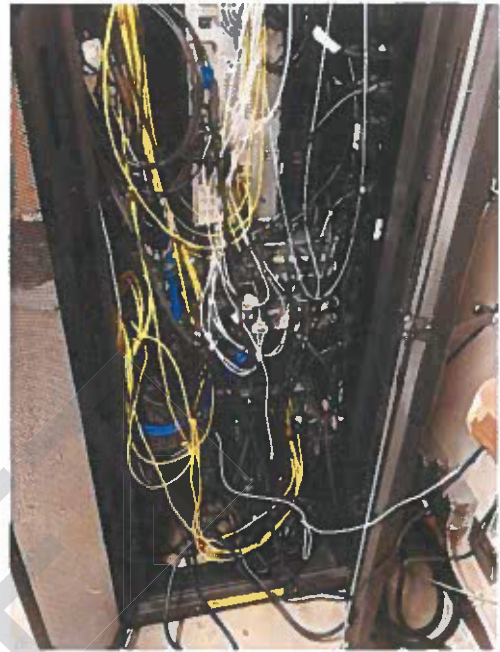
Figure 50 - Existing floor mounted security cabinet

Telecommunications system revolves around the intermediate level MPOE/MDF room 207. All service providers copper, fiber, and coaxial lines feed into this room. Many legacy items such as the existing Avaya PBX, abandoned / unused cables, 66-blocks, and equipment can be removed, consolidated, and cleaned up. However, it will be extremely difficult to try to change this room as the service provider point of demarcation and it is recommended that it is kept as such. A floor mounted cabinet within this room houses existing security head end equipment.

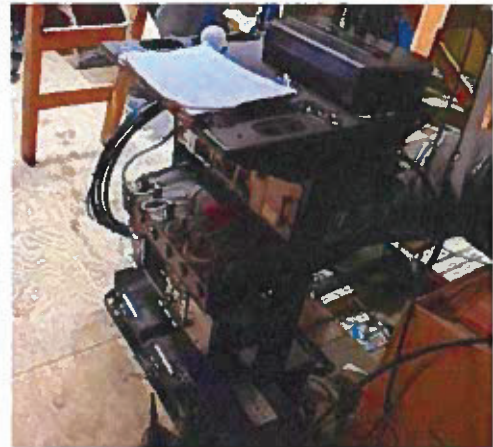
Figure 55 - Existing Motorola amplifiers and distribution

An intermediate station cabling distribution frame (IDF) and Motorola antenna amplifiers and antenna distribution exist in the attic space above the upper level accessible via drop down stairwell in the upper-level corridor.

- ◆ *An intermediate station cabling distribution frame (IDF) and Motorola antenna amplifiers and antenna distribution exists in the attic space above the upper level accessible via drop down stairwell in the upper-level corridor. This location can be re-used for new cabling and patch panels, but it is highly recommended that additional plywood flooring be placed for easier / safer access.*
- ◆ *The Motorola Radius SM50 mobile radio head end and power supply, Aiphone JO-1MD Video Intercom, and Intrado 911 cable and equipment reside in the current dispatch area on the upper level and will require special attention to relocate. Each will require secure mounting within floor/wall mounted racks.*
