## Structural Evaluation Memo

KE Project No.: 24-044

**Project:** Carmel Beach Existing Stairs: Preliminary Structural Evaluation  
**Location:** North of 10<sup>th</sup> Ave & 12<sup>th</sup> Ave Carmel-By-The-Sea, CA 93923  
**Subject:** Structural Observations and Evaluation of Stairways 4 & 7 at Carmel-By-The-Sea

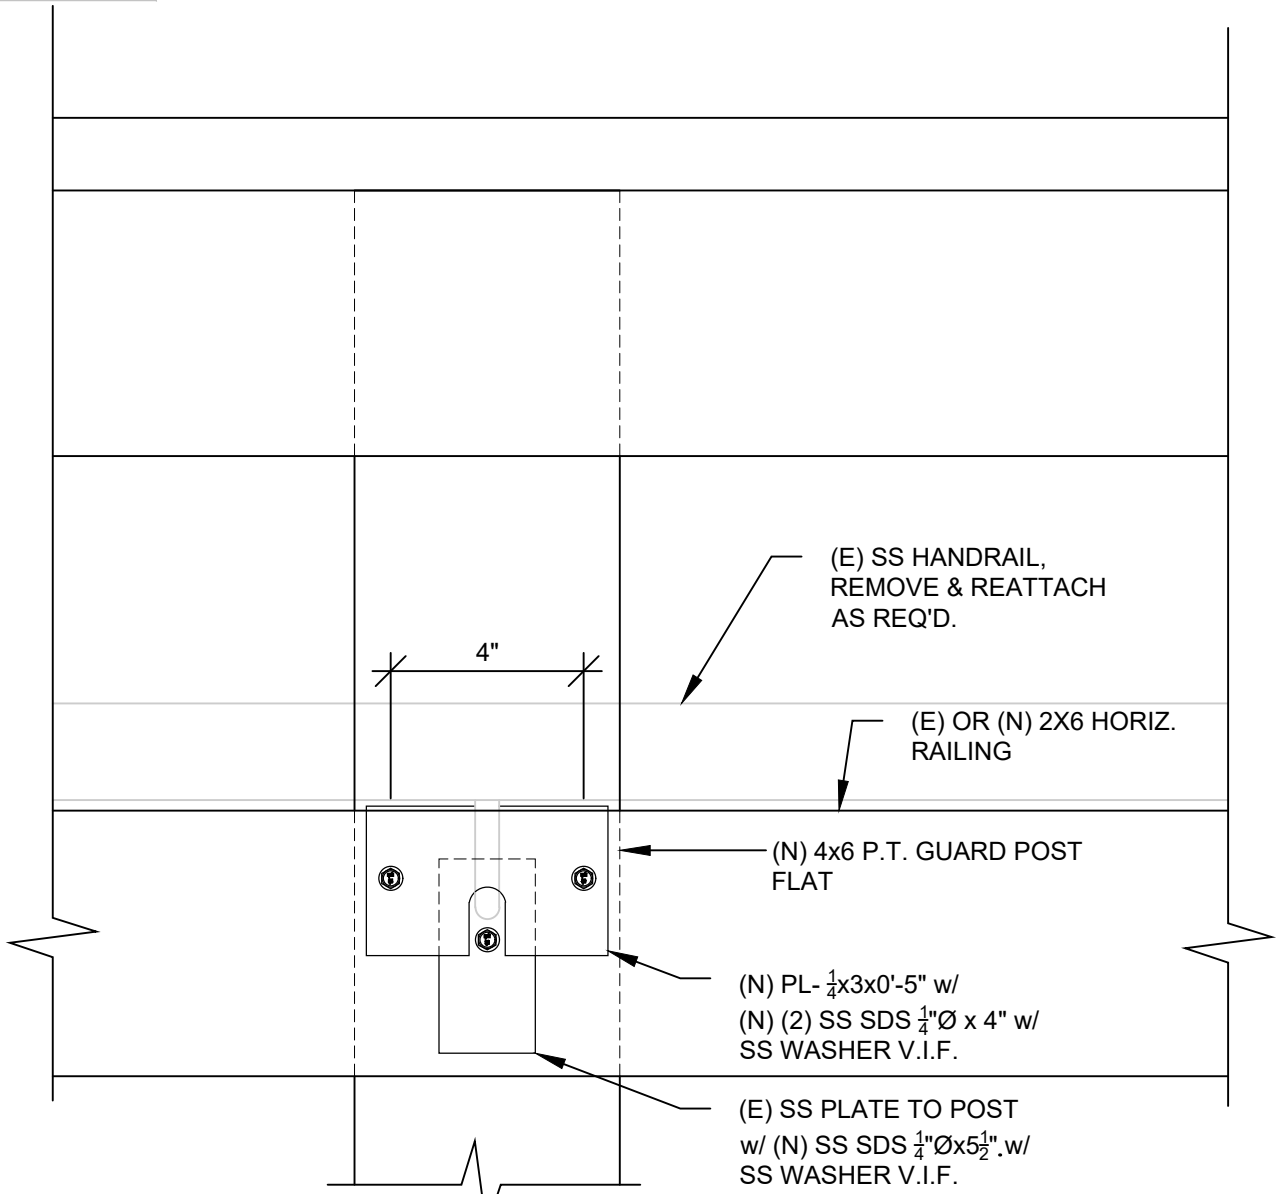
1a  
SSK1

In stairway 4, the 4x4 guardrail posts for the upper flight of the stairs are heavily split. Bolts from the guardrail post and handrails at the top of the flight of stairs to the landing can no longer support the required loading, see Figure 3. Each of the 4x4 posts (approximately 12 posts) and bolts at the upper flight shall be replaced with a 4x6 post per detail 1/SSK1. Some bolts connecting the guardrail post to the stringer at the lower flight of stairs show signs of heavy rust, see Figure 4. Bolts showing high corrosion levels shall be replaced per detail 1/SSK1. Angles and bolts that connect treads to the upper stair stringers are heavily rusted, see Figure 5. Replace all Angles and bolts used for connecting treads to stringer per detail 1/SSK2. Stringers at the top and lower flight of stairs show signs of splitting at the connection points of the guardrail posts and angles for the treads; see Figures 5 and 6. Stringers shall be replaced per detail 1/SSK1. Bolts used to connect posts to the landing and lower flight of stairs show high levels of corrosion. Field-verify all posts for splitting and replace per 1/SSK1 as required. Several support posts are split at notched portions. Field-verify locations and reinforce with SDWH structural screws per 1/SSK3; rusted bolts shall be replaced per detail 1/SSK1. The handrail connection is insufficient to support required loads; it shall be replaced per 1a/SSK1.
