G. A. Graebe & Associates, Inc.

Pursuant to our contract with the City of Carmel-by-the-Sea, dated November 12, 2014 which covers stairs "1" through "9", and our first amendment to the contract dated February 13, 2015, which covers beach access stair "0", we are pleased to submit the requested work for Structural Preventive Maintenance Program for the ten Carmel Beach Stairways at Carmel Beach, in Carmel, CA 93923.

STRUCTURAL BEACH STAIR MAINTENANCE
FOR
CARMEL BEACH STAIRS
CARMEL BY THE SEA, CALIFORNIA
OVERALL SITE PLAN

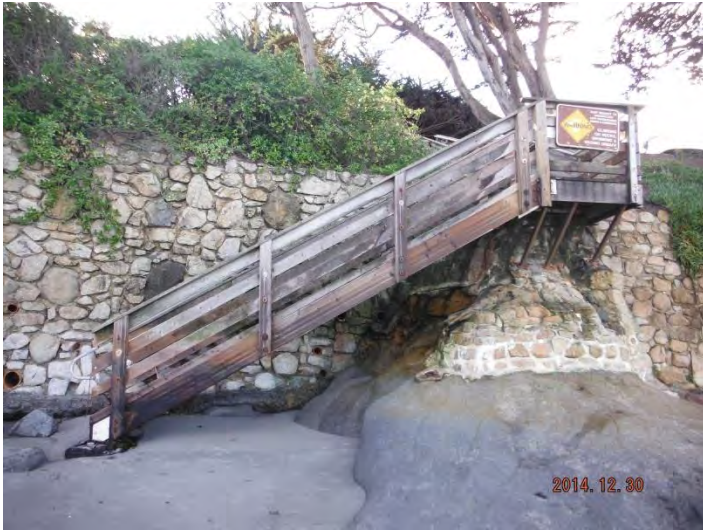
046

9	Rusted angle bolts at guard rail posts toward the ocean side.	see pictures 046, 088, 097.	Moderate	We recommend replacing the lower wood flight with concrete stairs and stone veneered retaining walls similar to lower flight of stair 4; see pictures 112 & 114 in stair 4.	Cost is included in item 2
10	Rusted / perforated hand rail at the bottom flight.	see pictures 082, 090, 091.	Moderate	Replace rusted / perforated hand rail at the bottom flight with stainless steel one, compliant to building code requirements.	\$6,500

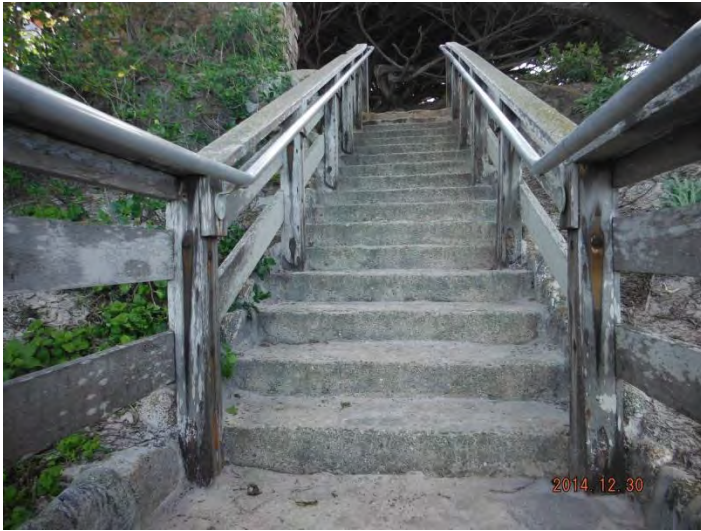
The upper flight consists of concrete / stone steps, see picture 054.

Nb	Deficiency Description	Picture #	Priority Ranking	Conceptual Remediation	Cost
1	The upper concrete stair flight has deteriorated / rusted steel pipe guard rails wrapped with 1x wood	see picture 054	High	All fourteen guard rail posts at the upper flight need to be removed and replaced with 1 ½-in diameter stainless steel post-installed posts conforming to current building code, see picture 054.	\$7,500
2	We noted excessive moisture in the bottom 4x6 pressure treated guard rail post and severe rust in the bolted connection of post to the stringer.	see pictures 081, 085	High	We recommend replacing the lower wood flight with concrete stairs and stone veneered retaining walls similar to lower flight of stair 4; see pictures 112 & 114 in stair 4.	\$30,000
3	Wet 6x12 pressure treated stringers at the lower wood flight	see pictures 079, 094, 095	High	We recommend replacing the lower wood flight with concrete stairs and stone veneered retaining walls similar to lower flight of stair 4; see pictures 112 & 114 in stair 4.	Cost is included in item 2

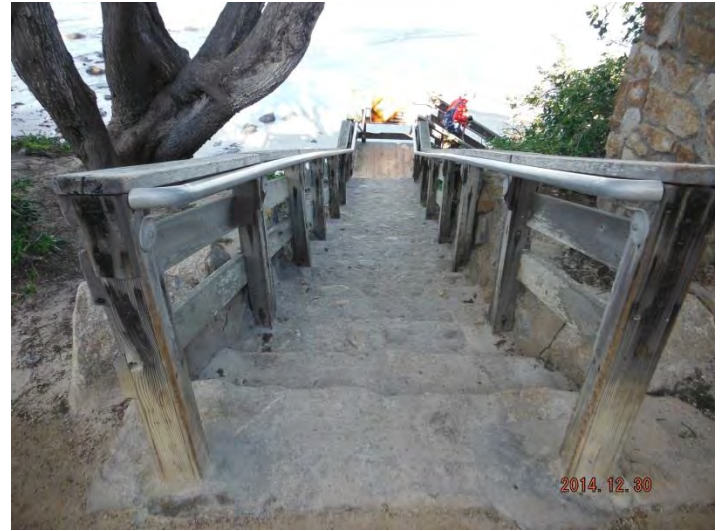
056

The guard rail posts at the upper flight consist of deteriorated / rusted 1-in steel pipe wrapped around with deteriorated wood members, see pictures 102, 103. We counted seven guard rail posts on each side of the upper stair flight, see picture 056.

Both flights have 1 1/2-in galvanized handrail with minor surface rust, see pictures 054 & 065. We measured 32-in clear distance between handrails. The top handrails did not appear aligned, see picture 056. Pictures 114 to 122 were taken on Friday, January 09, 2015. The tide was high and the water covered the bottom of stairs. All other pictures were taken on December 30, 2014.

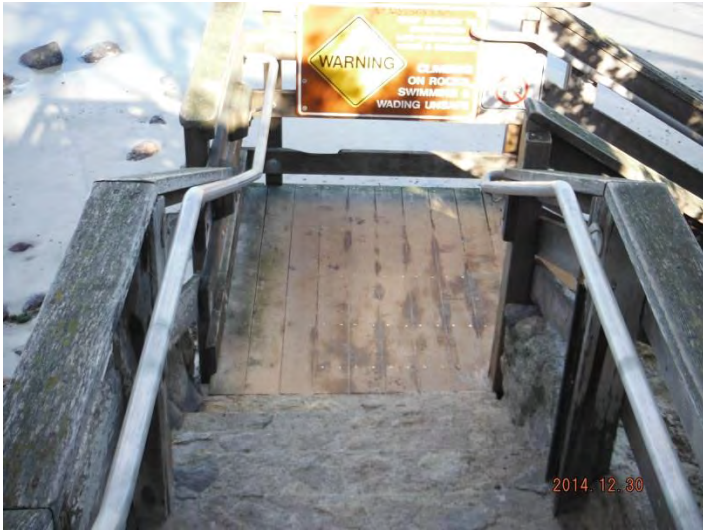
063

The 4'-7" wide x 5'-7" long rectangular landing, see picture 063, consists of 2x12 pressure treated perimeter members connected together with a 9-in x 2-in pre-bent steel plate, see pictures 067, 068, 069, 070, 071. A 3-in x 2-in steel angle with 4 rusted bolts with no heads supports the landing at the concrete edge, see picture 067.

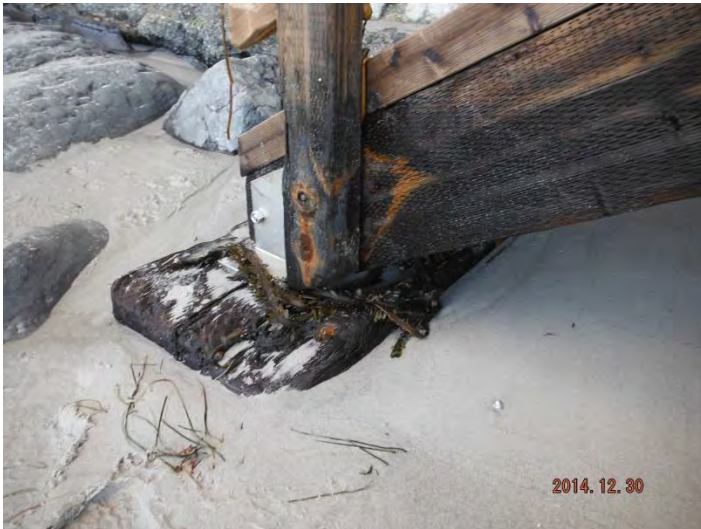
081

5	Deteriorated 4x6 pressure treated guard rail post at the bottom of the lower flight, see picture 081.	see picture 081, 094, 095	Moderate	We recommend replacing the lower wood flight with concrete stairs and stone veneered retaining walls similar to lower flight of stair 4; see pictures 112 & 114 in stair 4.	Cost is included in item 2
6	Rusted landing pre-bent steel bearing plates, steel joist angles and bolts, see picture 069. the tube steel diagonal braces have surface rust.	see picture 069, 073	Moderate	We recommend replacing the wood framed landing with concrete landing.	\$8,000
7	Rusted angle bracket between the two guard rail posts.	see picture 046	Moderate	We recommend replacing the lower wood flight with concrete stairs and stone veneered retaining walls similar to lower flight of stair 4; see pictures 112 & 114 in stair 4.	Cost is included in item 2
8	We noted rusted bearing angle connections supporting the wood steps.	see pictures 078, 079	Moderate	We recommend replacing the lower wood flight with concrete stairs and stone veneered retaining walls similar to lower flight of stair 4; see pictures 112 & 114 in stair 4.	Cost is included in item 2

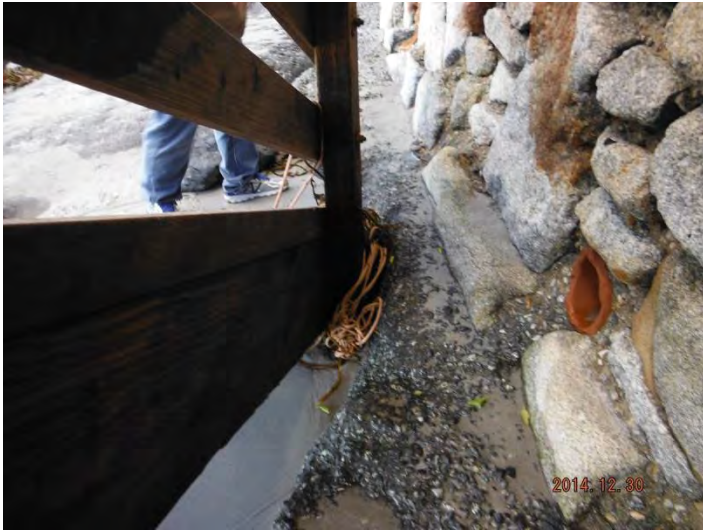
087

4	We noted deteriorated 2 - 6x 12 wood base at the bottom of the stair.	see pictures 087, 094	Moderate	We recommend replacing the lower wood flight with concrete stairs and stone veneered retaining walls similar to lower flight of stair 4; see pictures 112 & 114 in stair 4.	Cost is included in item 2

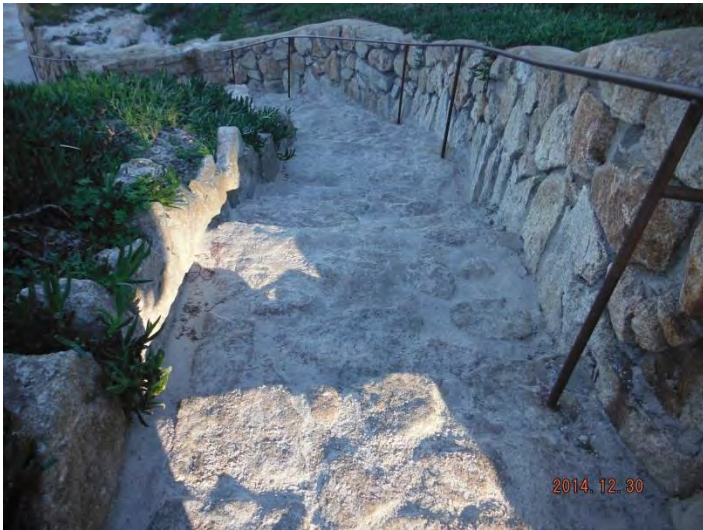
003

The guard rail consists of 1-in diameter galvanized pipe at one side only of the stairs, see picture 003.

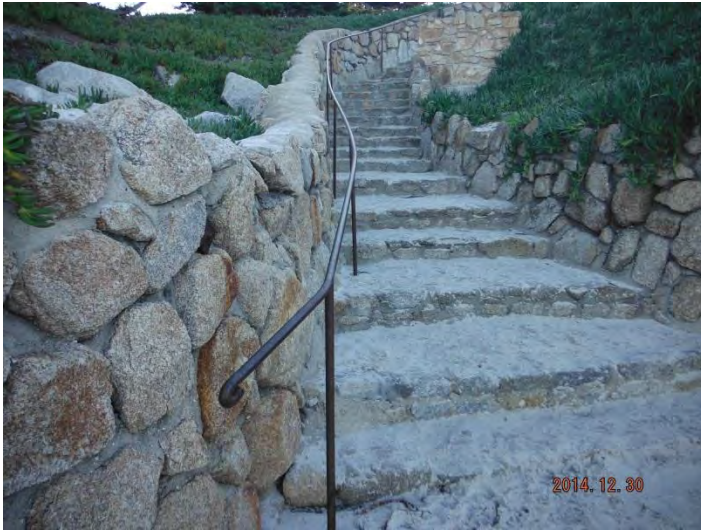
The riser height varied from 5-in to 7-in. The run varied from 3-ft to 14-ft at the bottom landing, see pictures 009, 010 & 015.

The stair width is approximately 4-ft and widens at the lowest step to 20'-9", see pictures 009 & 015. It is bound by two stone and mortar retaining walls. The maximum retaining wall height is approximately 5.5-ft at the bottom right side, see picture 009.

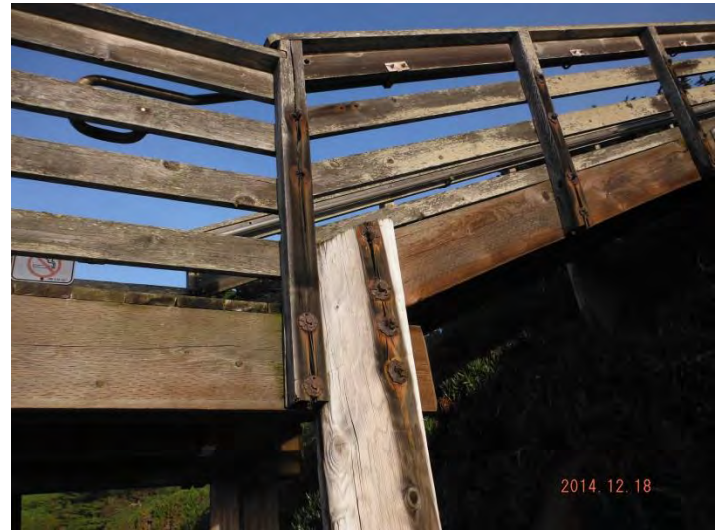
058

4	We noted rusted bolted connections in the timber poles;	see pictures 056, 058.	Moderate	We recommend replacing all rusted bolts with same size stainless steel.	\$2,500
5	We noted a 3/8-in wide vertical splitting in the 12-in timber pole supporting the lower flight and the landing	see picture 076 A	Moderate	We recommend running two 5/8-in stainless steel machine bolts at the top and bottom of the pole to support the split pieces together.	\$500
6	We noted a 1/4-in wide splitting in the 12-in timber pole supporting the lower flight;	see picture 055	Moderate	We recommend running a 5/8-in stainless steel machine bolt at the top of the pole to support the split pieces together.	\$500

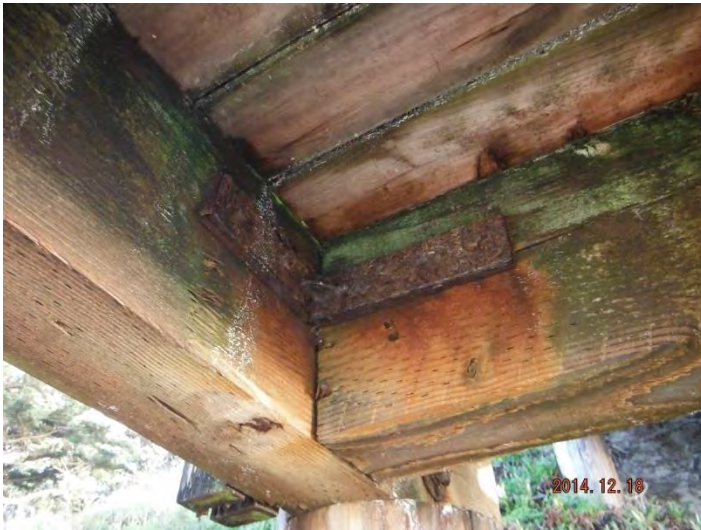
062

<u>Nb</u>	<u>Deficiency Description</u>	<u>Picture #</u>	<u>Priority Ranking</u>	<u>Conceptual Remediation</u>	<u>Cost</u>
1	Green moss coated the bottom of the steps, the 6x12 stringers, and 6x12 landing beams.	see pictures 062, 070, 083, 087	Low	We recommend scrubbing off all moss and treating the wood with approved protection material to prevent further deterioration of those members.	\$1,500
2	We noted Splitting in the upper flight posts and the landing guardrail posts, and heavy rust in bolted post connections;	see pictures 056, 057, 058	Moderate	We recommend replacing the guardrail posts as well as the 2x6 intermediate boards and using stainless steel bolted connections. Avoid splicing the 2x6 intermediate boards at the bolted connection. Note that the lower flight guard rail posts and their connections are in satisfactory condition see picture 076.	\$3,500
3	We noted rusted bearing angles between the step and the stringers;	see pictures 064, 065, 066, 069 & 070.	Moderate	We recommend replacing the angle and the screws with stainless steel material w/ same dimensions.	\$2,500

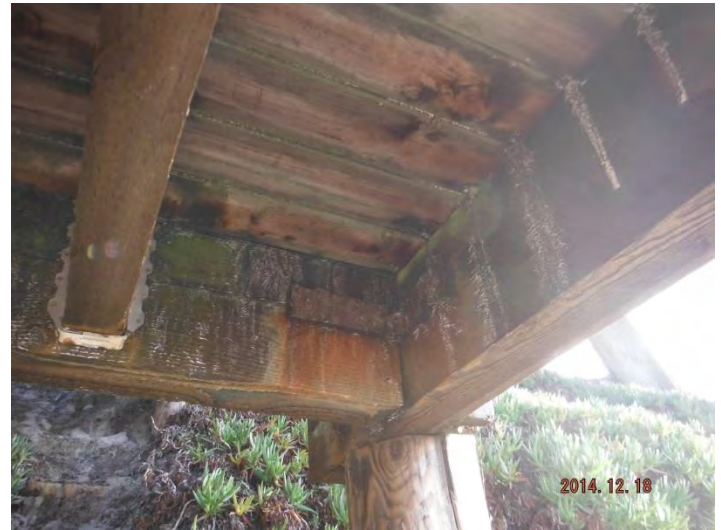
063

The 5'-0" wide x 10'-2" long rectangular landing, see picture 086, consists of 6x12 pressure treated perimeter beams connected together with a rusted steel angle, see pictures 062, 063. A single interior 4x12 joist runs parallel to the upper flight hung with stainless steel joist hangers to landing beams, see pictures 061, 063. Two x sheathing running in the short direction is nailed to top of landing framing. We measured 7'-8" from bottom of landing to ground. See picture 076.

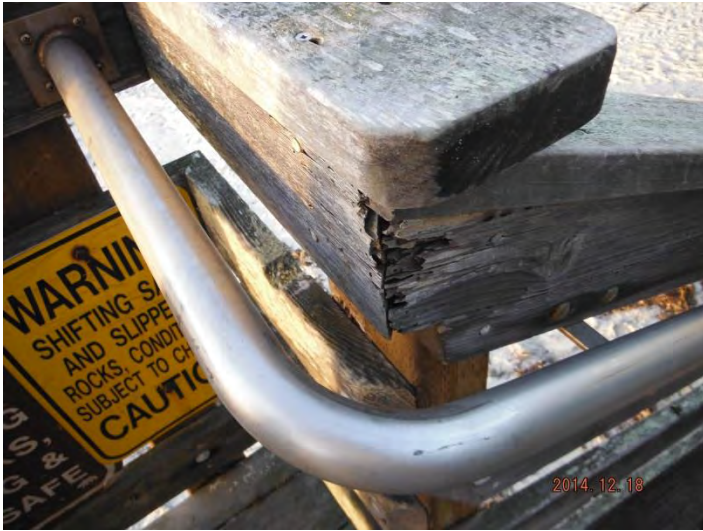
7	We noted splitting in the 12-in timber pole supporting the upper flight	see picture 089	Low	We recommend monitoring this pole.	\$0
8	We noted deteriorated 2x6 guardrail top boards	see picture 085	Moderate	We recommend changing these boards with pressure treated same size boards.	\$1,200
9	The bottom flight terminates in sand for an approximate distance of 9-ft	see pictures 075 & 082	Moderate	We could not verify the framing condition under the sand since it was not accessible. We recommend exposing those buried members and replacing them with pressure treated lumber in case they turn out to be deteriorated.	\$2,500
Total					\$14,700

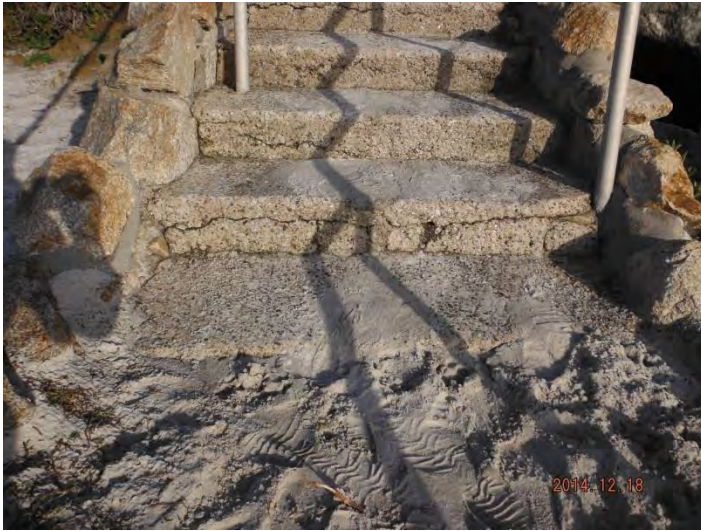
034

<u>Nb</u>	<u>Deficiency Description</u>	<u>See Picture #</u>	<u>Priority Ranking</u>	<u>Conceptual Remediation</u>	<u>Cost</u>
1	Horizontal cracks run left to right on the vertical face of the steps	034, 036	Moderate	We recommend demolishing the existing stairs & rebuilding it similar to the first couple of steps, see picture 050. The existing retaining wall appears to be in satisfactory condition and can stay unless it shows signs of structural defects during demolishing of the existing stairs.	\$15,000
2	Spalling concrete / mortar over what appeared to be natural stone steps	040, 046, 047	Moderate	This item is included in item 1.	Cost is included in item 1.
Total					\$15,000

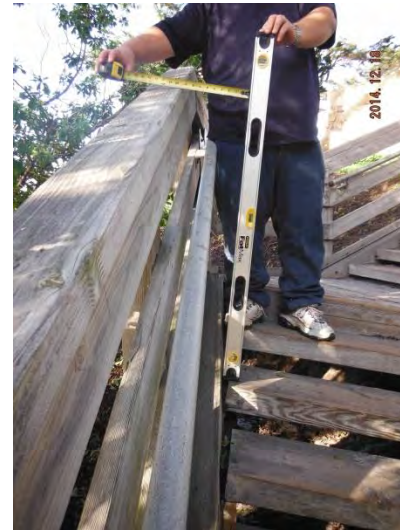
022

<u>Nb</u>	<u>Deficiency Description</u>	<u>See Picture #</u>	<u>Priority Ranking</u>	<u>Conceptual Remediation</u>	<u>Cost</u>
1	In both wood flights, the 4x12 steps, 6x12 stringers and 6x12 landing beams appeared to be in unsatisfactory structural condition due to structural foundation failure. The steps are sloping in the longitudinal direction while the right hand (coming down) guard rail is leaning to the right.	100, 101, 123 at upper flight & 105, 115 at intermediate flight	High	We recommend demolishing the existing wood stair portion and rebuilding it.	\$27,500
2	1 ½-in settlement at the end of some steps	015, 016	High	This item is included in item 1.	Cost is included in item 1
3	4 ½-in lean in the guard rail	018, 019	High	This item is included in item 1.	Cost is included in item 1
4	9 ½-in lean in the guardrail of the bottom wood stair flight	022, 023	High	This item is included in item 1.	Cost is included in item 1

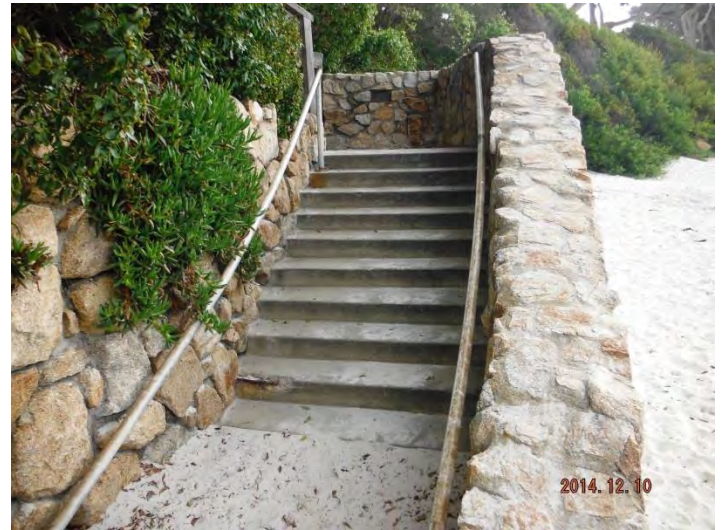
5	Concrete spalling on the second step from the bottom	111	Moderate	We recommend saw cutting the spalled portion of the step, drilling and doweling in existing concrete and pouring new concrete in that portion.	\$4,500
Total					\$32,000

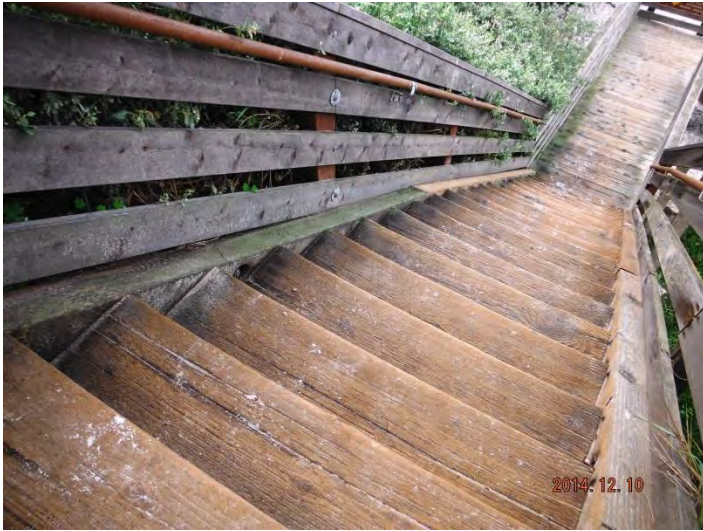
061

The guard rail consists of 4x6 posts at approximately 5-ft spacing w/ 2x6 intermediate wood boards and 2x6 flat top cap. See picture 061.

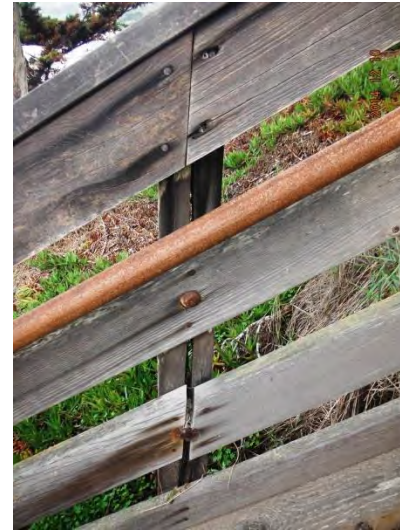
<u>Nb</u>	<u>Deficiency Description</u>	<u>See Picture #</u>	<u>Priority Ranking</u>	<u>Conceptual Remediation</u>	<u>Cost</u>
1	Slight angle between the two stringers that make up the upper flight. The bow is noticeable in the middle or at the splice point. This uneven layout of the stringers affects the nose alignment of the steps.	061	Low	City Assesment: "The stair tread misalignment identified is within the 3/8" allowed by code. The separation of the stringer appears due to slight settlement and wood shrinkage. Proper filler in the gap would be a preventative maintenance item."	T.B.D.
2	Splitting in the upper flight guardrail posts, and heavy rust in bolted post connections	062, 063	Moderate	Replace the guardrail posts as well as the 2x6 intermediate boards and using stainless steel bolted connections. Avoid splicing the 2x6 intermediate boards at the bolted connection as done in picture 062 lower board.	\$1,500

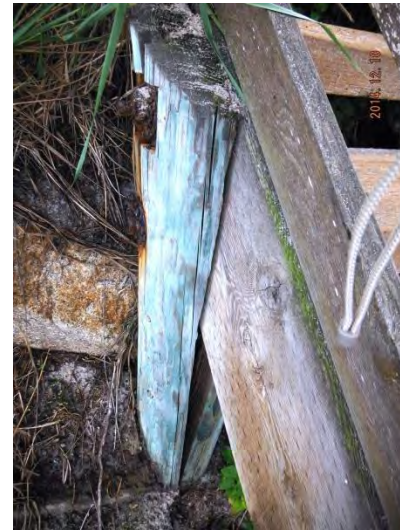
064

3	Splitting in the 8-in timber pole supporting the upper flight	064, 070 & 087	Low	Replace this pole in kind	\$5,000
4	Rust in the upper flight steel handrail	062 & 067	Moderate	Replace this hand rail with a stainless steel one compliant with the building code requirements.	\$6,500
5	Minor surface rust on the stainless steel angle connecting the lower flight stringer to top of landing.	085 & 086	Low	We will monitor these angles and bolts.	\$0
6	Rusted bolted connection at corner timber pole supporting landing	076	Moderate	Replace bolts and nuts with stainless steel with same size and dimensions	\$1,500
7	Missing 2 bolts in landing guard rail post	075	Moderate	Add stainless steel bolts with same dimensions as the existing bolts.	\$1,300
Total					\$15,800

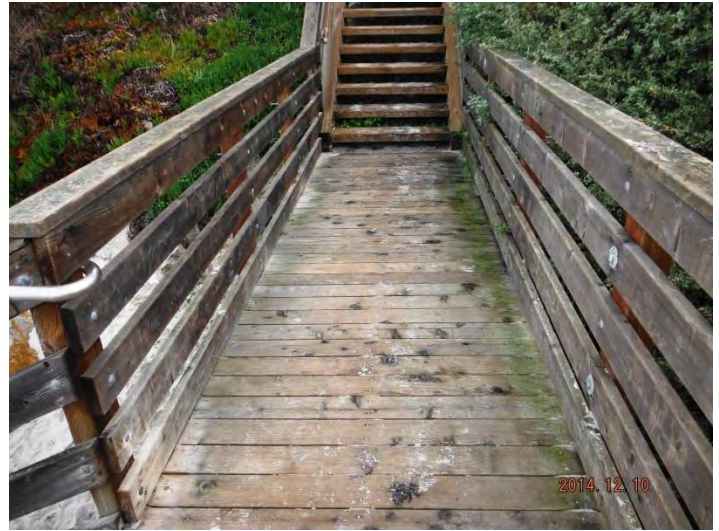
068

The 4'-9" wide x 20'-0" long rectangular landing consists of 6"x12" pressure treated perimeter beams connected together with a bolted stainless steel angle, see pictures 068, 079 & 080. A single interior 4x12 joist runs in the E-W direction hung with stainless steel joist hangers to landing beams. 2x sheathing running in the N-S direction is nailed to top of landing framing. We measured 0 to 4-ft of crawl space under the landing. See picture 078.

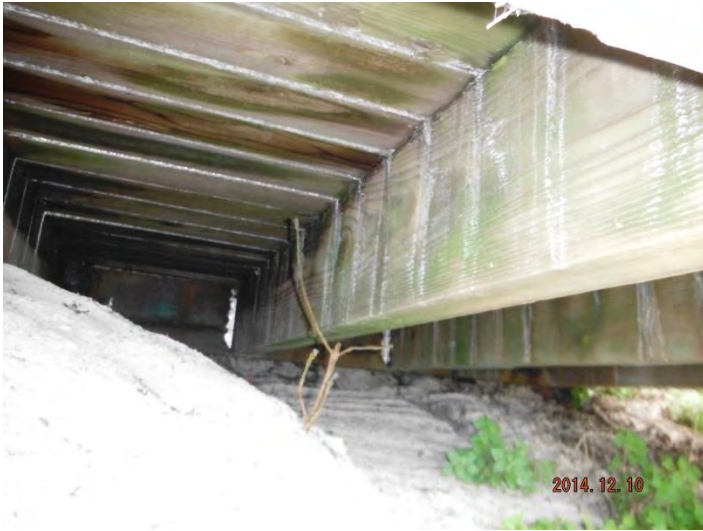
005

The 8-ft x 8-ft square landing consists of 6"x12" pressure treated perimeter beams with two interior 4x12 joists running in the E-W direction hung with stainless steel HUS412X slant nail joist hangers. 2x sheathing running in the N-S direction is nailed to top of landing framing. We measured 0 to 2-ft of crawl space under the landing. See picture 005.

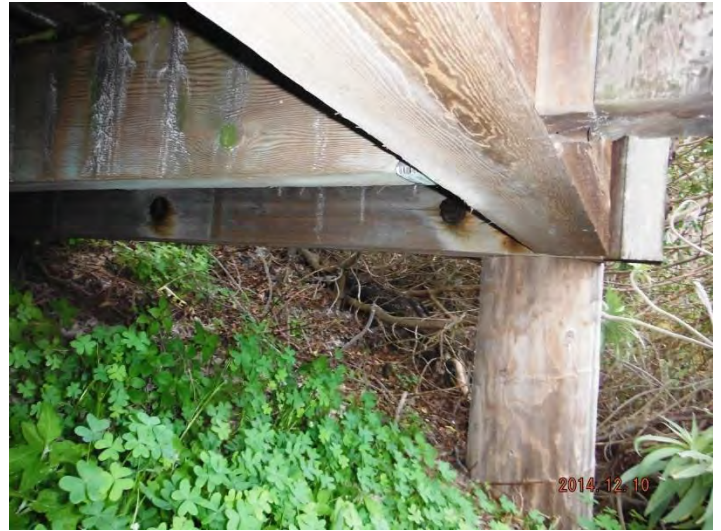
006

The stringers at the upper flight are supported by 1'-2" diameter timber pole embedded in the ground at approximately half span. See picture 028. The landing is similarly supported by 4-1'-2" diameter timber poles, one at each corner. See pictures 006, 035, 038, 048.

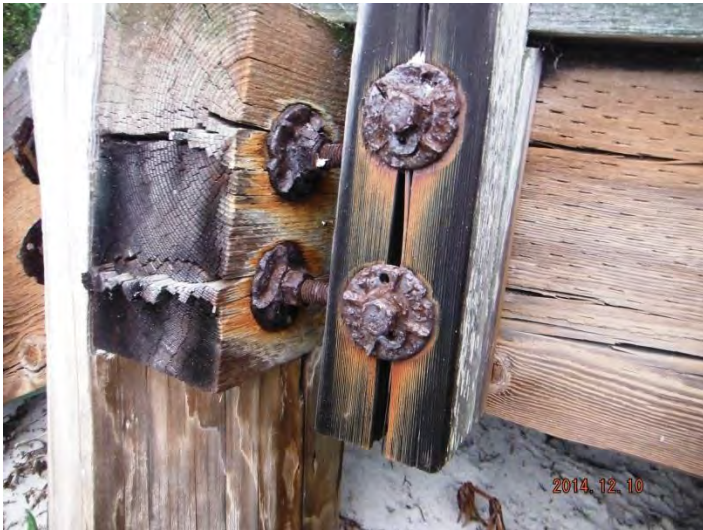
009

Nb	Deficiency Description	See Picture #	Priority Ranking	Conceptual Remediation	Cost
1	Splitting in guardrail posts, and heavy rust in bolted post connections	009, 013, 024, 025, 030, 031, 032, 033, 037, 039	Moderate	Replace the guardrail posts as well as the 2x6 intermediate boards and using stainless steel bolted connections. Avoid splicing the 2x6 intermediate boards at the bolted connection as done in picture 032 middle board.	\$2,000
2	Heavy rust in the steel handrail.	010, 011, 034	Moderate	Replace this hand rail with a stainless steel one compliant with the building code requirements.	\$4,500
3	Rusted angle iron connecting the lower flight stringer to top of landing	041, 042	Moderate	Replace this angle and its connecting bolts with stainless steel angle and bolts.	\$1,500
4	Deteriorated end of stringer at the end of the lower flight	044, 045	Moderate	replacing the stringer with pressure treated one having same size and length	\$3,500

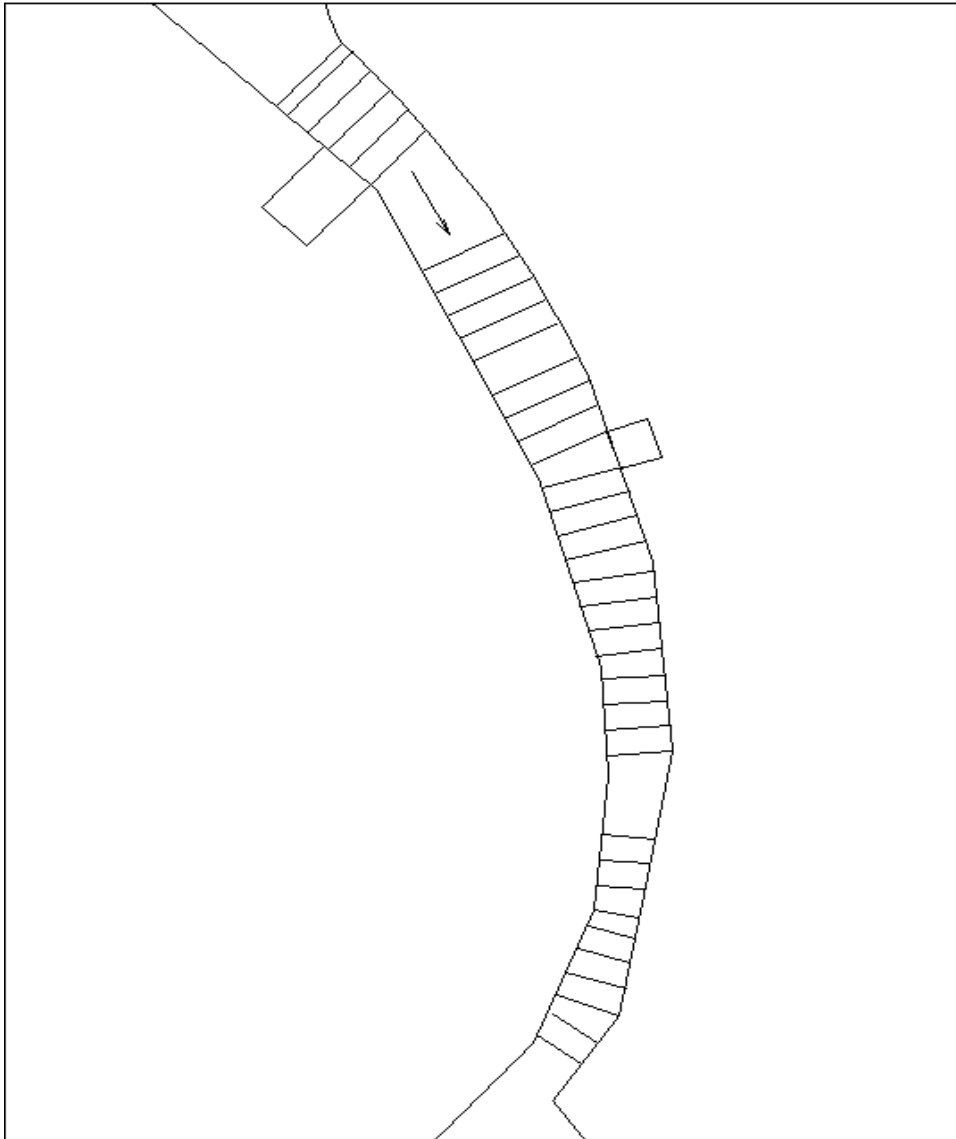
Stair 1

A trash enclosure with an approximately 5-ft high free standing wall is located at the bottom of the 9th step. A 2.83-ft square “wash” with a drain, surrounded by a 2.83-ft high stone and mortar retaining wall is located halfway within the stair.

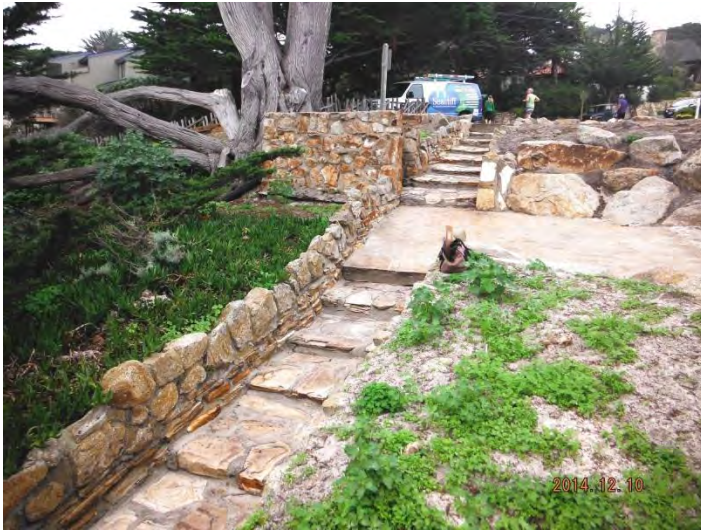
Nb	Deficiency Description	See Picture #	Priority Ranking	Conceptual Remediation	Cost
1	The 8.83-ft landing appears to slope about 9-in in the 8.83-ft run which is approximately 1:12, see picture 001. This slope appears to exceed the maximum slope allowed by the building code	001	High	Reconstruct the landing and insert one 6-in step as necessary.	\$20,000
2	The West free standing trash enclosure wall (towards the beach side) appears to have an undermined footing	001, 010, 011	Moderate	Pour a new 1.5-ft wide x 2-ft deep concrete footing along the undermined footing. The new footing shall be connected to the existing footing using #4 epoxy dowels at 2-ft. The new footing shall be reinforced w/ #4 top and bottom with #3 links at 16-in maximum spacing.	\$6,500
3	The drain in the wash area seems to be clogged	002	Moderate	Clean the drain	City of Carmel
4	All the steps are uneven and sloping down	001	Moderate	Reconstruct excessively sloping steps	\$20,000

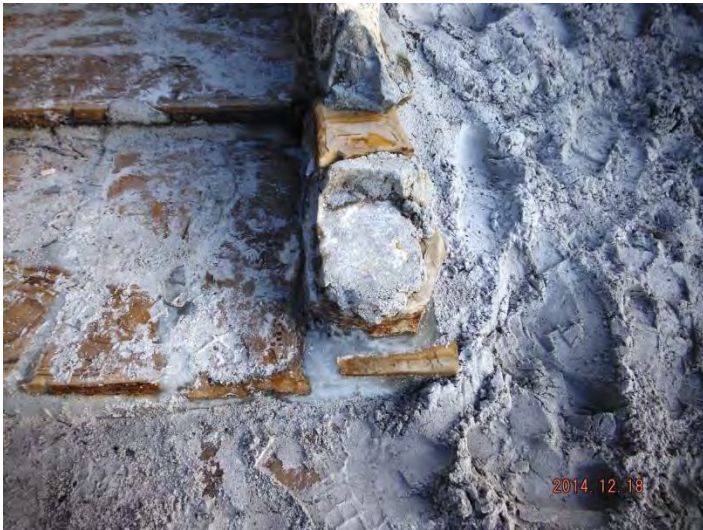
012

5	There are missing stones in the bottom retaining wall	012, 013	Low	Replace the missing stones in kind with high strength mortar.	\$750
Total					\$47,250

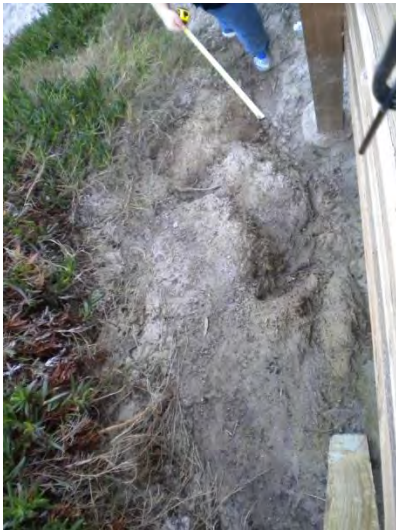
pic (45)

Nb	Deficiency Description	Picture #	Priority Ranking	Conceptual Remediation	Cost
1	The soil around the stair footings is eroding at the south side of flight F4 around column C33.	see pictures 45, 46, 47, 48, 65, 66, 67, 68, 69.	High	We recommend adding missing soil in the eroded / over excavated areas and planting vegetation similar to the opposite side.	City of Carmel
2	Rusted screws on corroded bearing angles	see pictures 30 & 78.	Moderate	We recommend to Brush off loose rust on the corroded bearing angles and apply a minimum of three thin coats of an approved Cold Galvanize Corrosion Inhibitor with ASTM standard per manufacturer specifications.	\$2,500
3	Rust on handrail welds at splice points;	see pictures 41, 89, 90, 95, 96, 98.	Moderate	We recommend to Brush off loose rust and apply a minimum of three thin coats of an approved Cold Galvanize Corrosion Inhibitor with ASTM standard per manufacturer specifications.	\$2,500

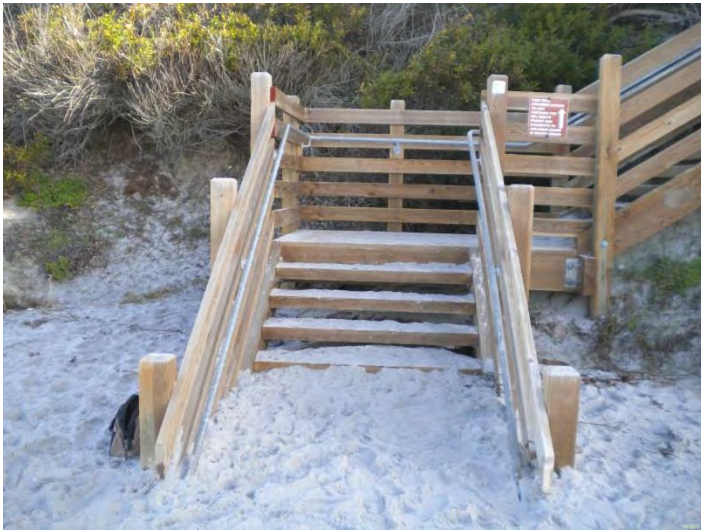
pic (57)

4	Checks in top 2x6 pressure treated handrail board.	see picture 57.	Low	We recommend replacing the board in kind.	\$500
5	Cracked concrete caisson in flight F4.	see picture 88.	Low	Fill crack with an approved low-viscosity crack injection epoxy, designed to repair cracks in concrete.	\$200
6	The bottom flight terminates in sand for an approximate distance of 9-ft.	see pictures 58, 59, 71, 72, 73, 74.	Low	We recommend exposing the buried members and replacing them with pressure treated lumber in case they turn out to be deteriorated.	\$2,500
Total					\$8,200
