JAYSON
ARCHITECTURE

The City of Carmel-By-The-Sea

LIBRARY MASTER PLAN PROJECT
FINAL REPORT

August 25th, 2023

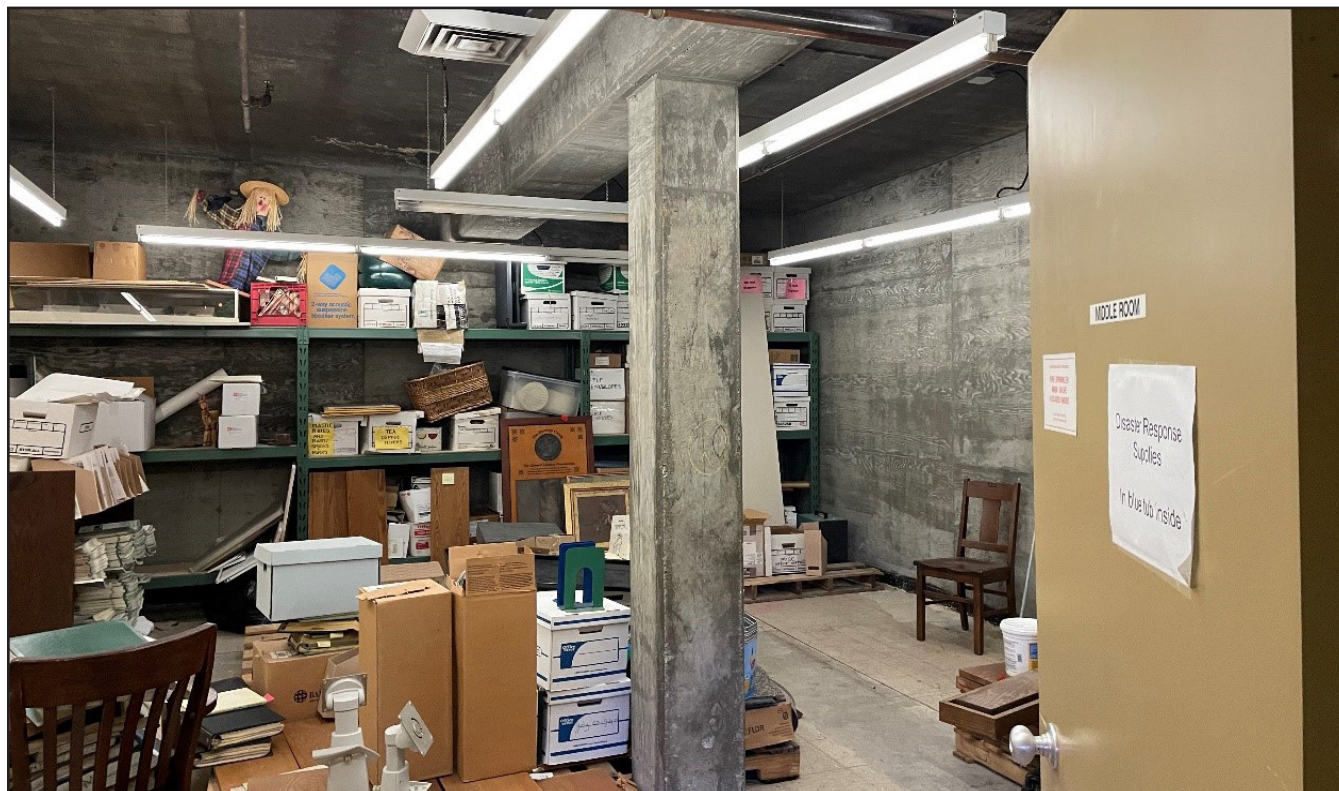
Structural Figure 9: Basement

if these dampers still function as intended. Based on the age of the actuators, they are likely at the end of their useful life.
