CARMEL SHORELINE ASSESSMENT

**FALL 2014**

Draft Report

April 15, 2015

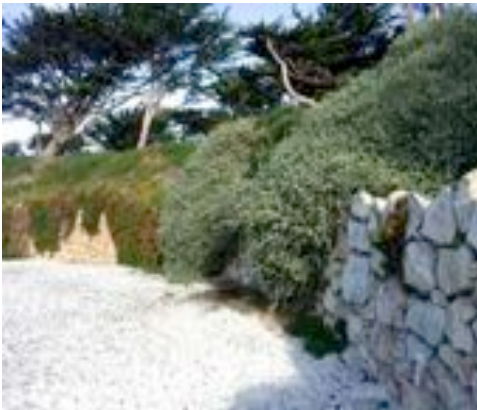
Fig 5#6

- Seawall North of Martin Way

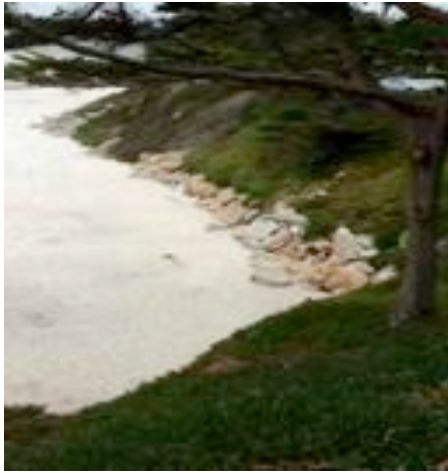
Fig 5#14

- Revetment in cove North of 12<sup>th</sup> Ave.

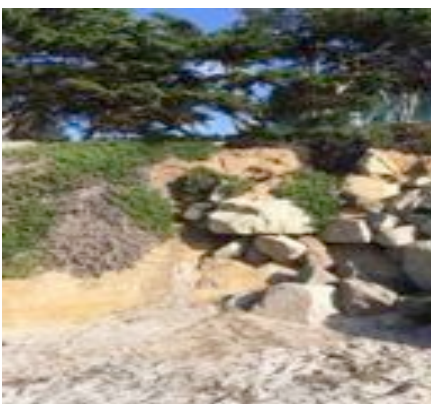
Fig 5#18

- Revetment between 13<sup>th</sup> & Santa Lucia Ave.s
